FORMER BULL & CHAIN PUBLIC HOUSE, 7 LANGWORTHGATE, LINCOLN

**SCHEME OF ARCHAEOLOGICAL MONITORING
AND RECORDING**

NGR: SK 9810 7191 (centred)
WLDC Planning Ref.: 2011/1369/F
Conservation Area
Consent Ref: 2011/1376/CAC
Archive acc. no.: LCNCC: 2013.49
Site code: LBCM12
PCAS job no.: 931

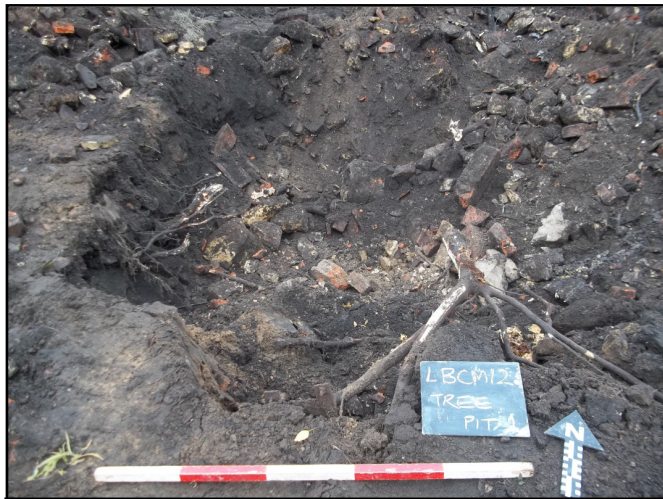
Plate 1: Tree pit cut by trench 3

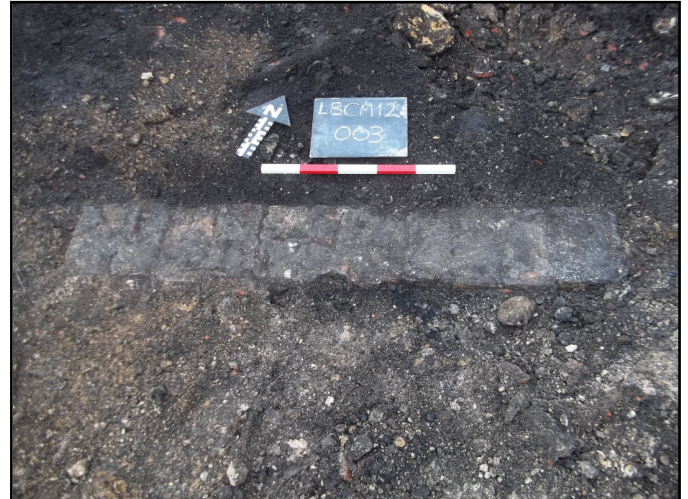
Plate 2: Wall section (003)

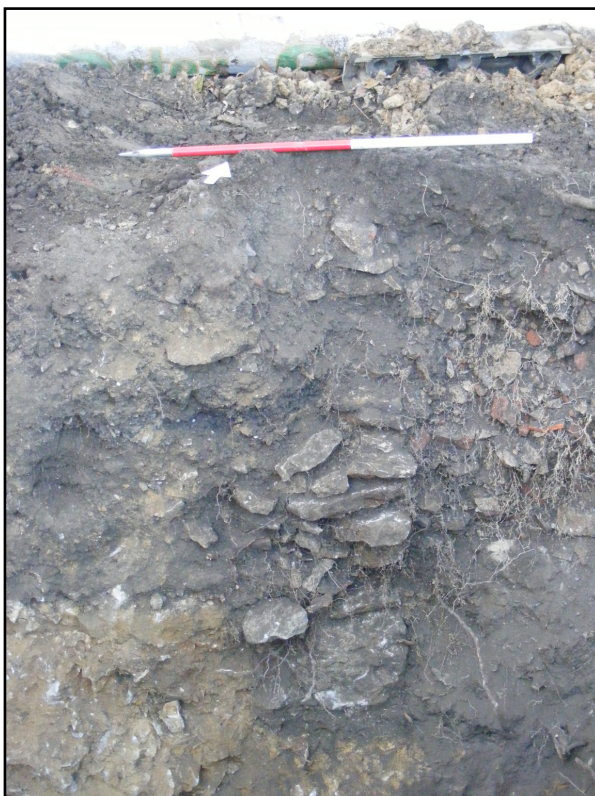
At the eastern end of the soakaway, all of the deposits present were cut by a construction trench [014] for the building of wall (015). This structure was built of natural and roughly hewn limestone blocks laid dry with no bonding material. Within the structure was a natural soil build up (016) containing small fragments of limestone and post-medieval to early-modern pottery and glass.

Plate 3: Wall (015) in eastern end of the soakaway (see Fig 2)

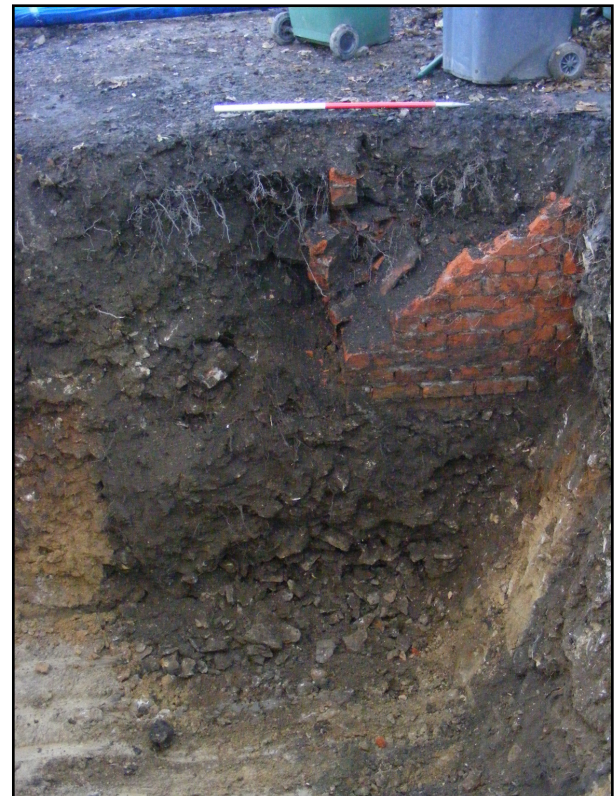
A modern brick construction at the western end of the soakaway had cut through layers (005) and backfill (013). The uppermost deposit exposed was a layer of modern levelling material (017).

Plate 4: Robbed out cellar (013) and modern walls in western end of the soakaway (see Fig 2)

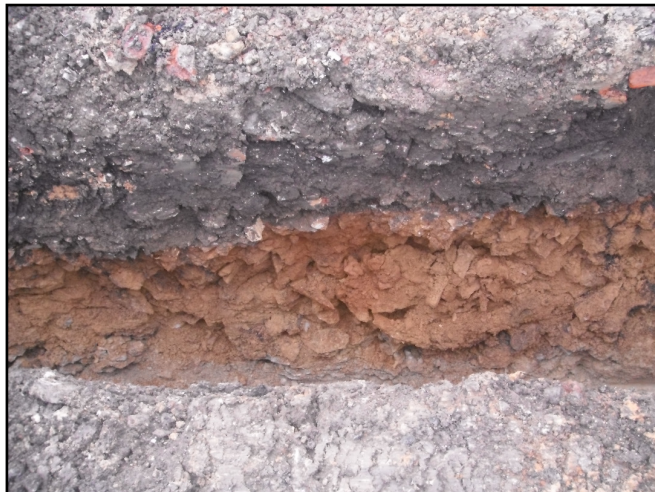
The earliest deposit reached in this area, as with the soakaway (above), was the natural limestone encountered 0.8m below the surface which continued below the base of excavation 1m further down. This depth was consistent with that seen in the soakaway, with the topsoil and modern overburden already having been stripped from this area. Directly above this natural layer was the continuation of the levelling represented by (006), retaining here the same thickness of 0.3m as seen in the soakaway (above). Rather than the further period of levelling represented by (005) elsewhere, this area sees a 0.5m thick rubble and mortar layer (004) connected with the construction of the buildings to the rear of the extant building (recently demolished as part of this scheme of works). Three layers were discernable within this; all are consistent with hardcore dumping and levelling within a short period of time, where it was thus not felt necessary to divide the deposit. Ceramic building material and two separate sheep or goat tibias were recovered from it, the CBM dated to the 13th-15th centuries. Whilst this is stratigraphically acceptable, the nature of the deposits and condition of the material confirm its re-deposition.

Plate 6: North facing representative section in extension footings to the North of extant building (see Fig 3)

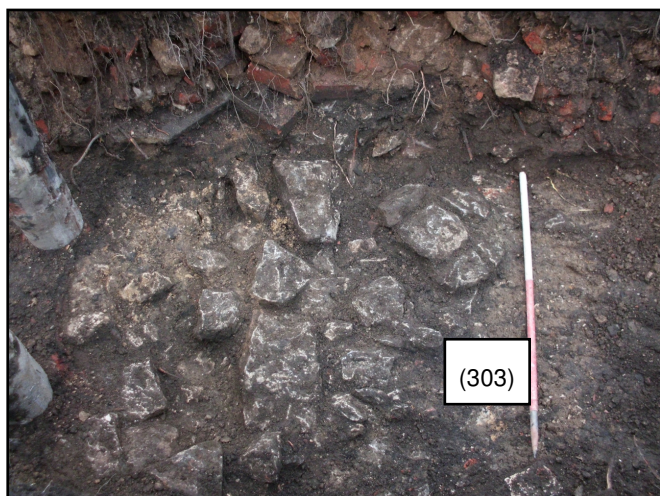
Plate 7: Wall (303) in eastern end of Trench 3 (looking south)

It is clear that medieval occupation occurred on the site, if only from the sheer quantity of artefacts of this date that were recovered; indeed the footings for a medieval structure were seen within Trench 3, (304) and (305). This was dissected by the construction cut [306] for a wall (303) which

ran north-west – south-east, itself connected to the large high-medieval building previously discovered on the site (Wood 2012). This stratigraphic relationship confirms an earlier date for the footings (304) and (305), and it is likely that they relate to a 13th-15th century structure, the demolition chalk rubble and CBM of which was discovered beneath the building (303) during the earlier work (Wood 2012). This later and larger medieval building (303) stood on the site into at least the 17th century, being clearly butted by a deposit containing remnants of a 16th-17th century brown glazed earthenware pot, glazed floor tile and clay pipe stem (302). This stem has a bore of 2.5mm, strongly suggesting a date in the early 18th century (Dymott 2012). It would seem likely that the earlier medieval property was connected with the re-exploitation of even earlier Roman quarries in the vicinity which were backfilled in the late 15th or early 16th century (Vince & Jones 1990). With this change of land use the larger high-medieval building was installed on the site following the destruction of its predecessor. With the development of the street frontage along Langworthgate, the later building would have been demolished and construction moved west.

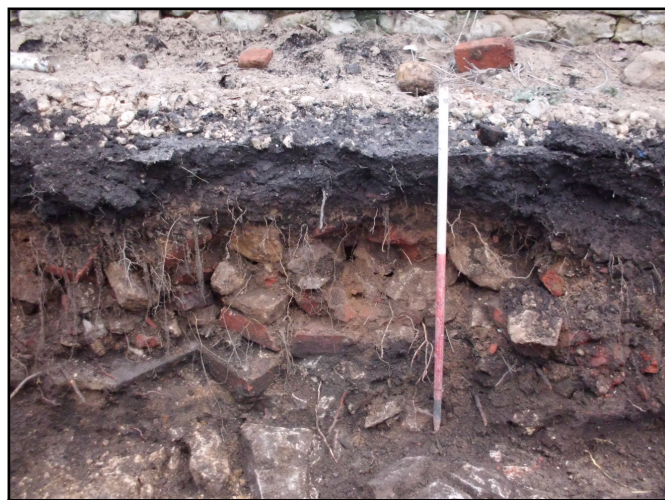
Plate 8: North facing section in Trench 3 (see
