**NEW SEWAGE TREATMENT WORKS,
HASSOP, DERBYSHIRE**

ARCHAEOLOGICAL MONITORING AND RECORDING

Planning Ref.: NP/DDD/0712/0769
Planning Authority: Peak District National Park
Museum Acc. No.: DERSB 2012.31
NGR: SK 2239 7222
PCAS Site code: DHVM 12
PCAS Ref. No.: 963

October 2013

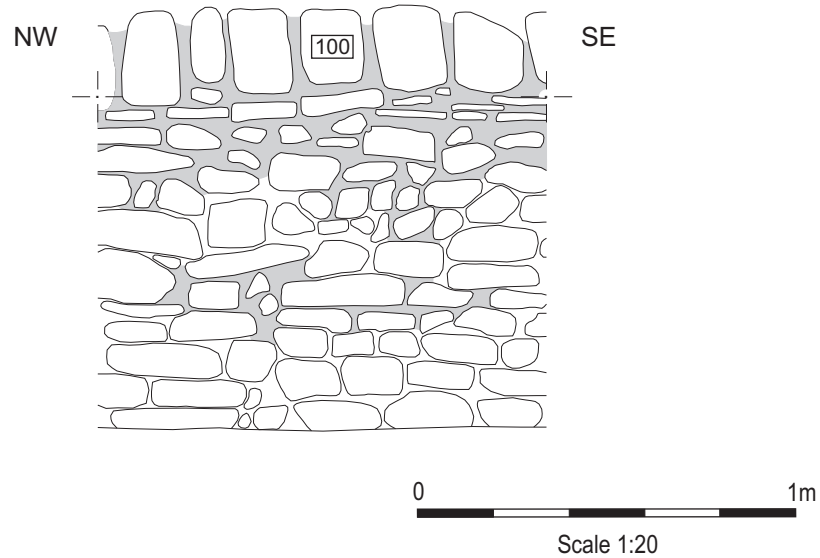
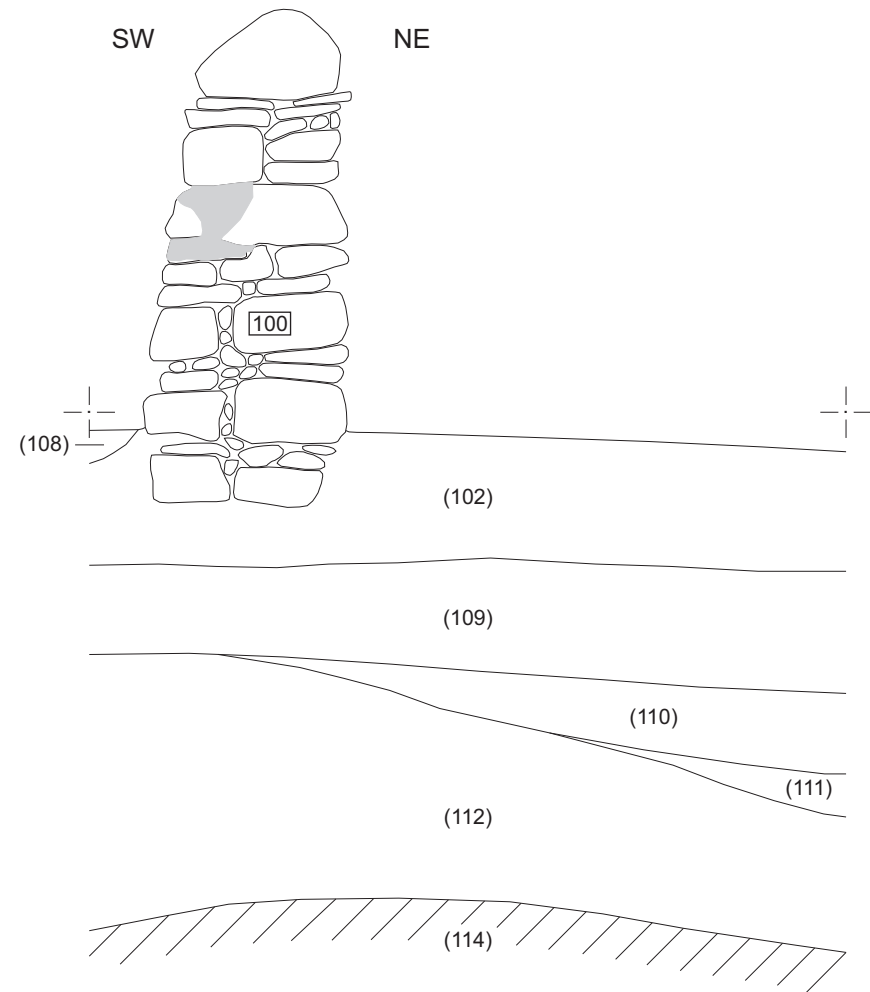
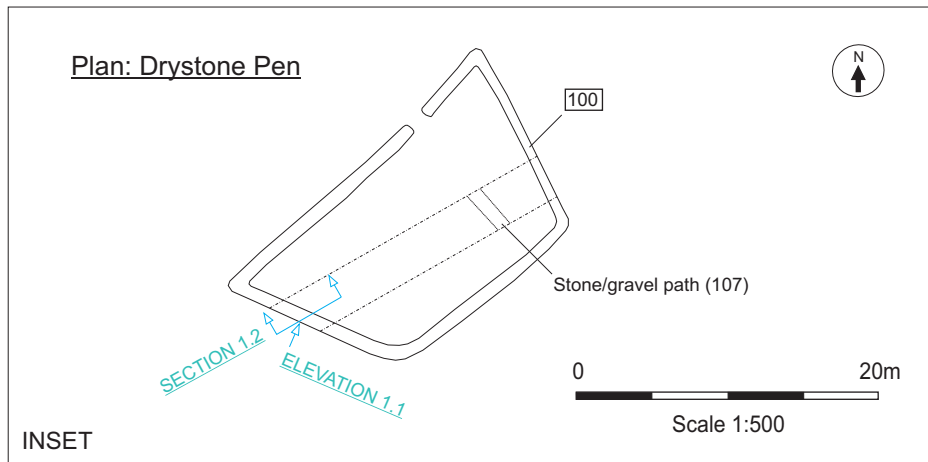
Fig.4 Elevation 1.1 and Section 1.2 with Plan of the Drystone Pen in inset.

The drystone wall of the pen itself was recorded as structure (100). Built of unworked limestone blocks, a cross section of this wall recorded only shallow footings. In places the wall had been stabilised using modern cement. The topsoil layer developing within the footing for the wall, (102), was up to 0.30m of dark brown silty loam.

ELEVATION 1.1

SECTION 1.2

Plan: Drystone Pen

Monitored Area 1 (Fig. 4 and Photo Nos. 3-5)

Monitoring in the area of the stone-walled pen included the topsoil strip and excavation of the pipe trench; it also involved the demolition of part of the wall.

Monitored Area 1 in the area of the drystone wall animal pen also identified no significant sub-surface archaeology. A modern path and the wall itself were recorded.

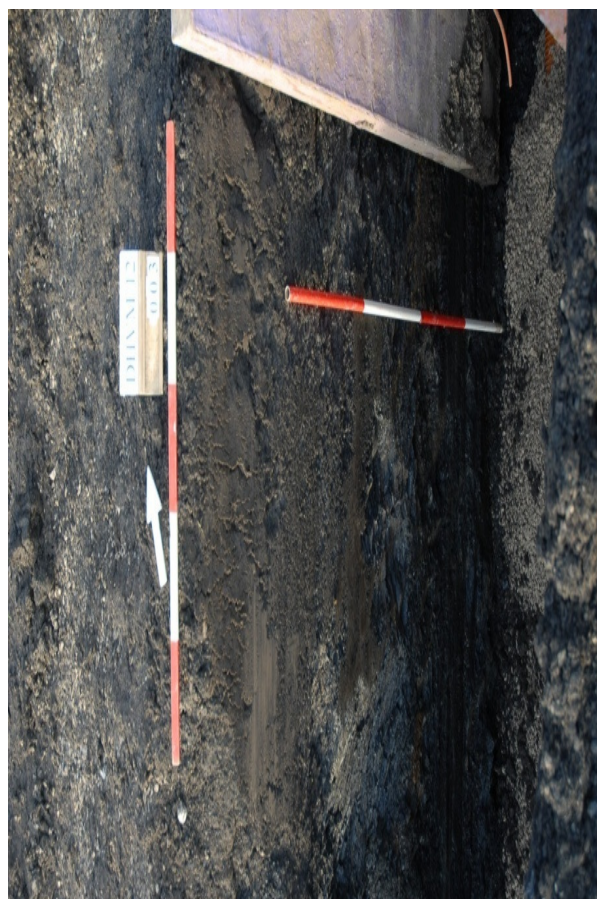
Plate 2: Sample section Monitored Area 0.
Section 0.1

The monitored groundworks in Area 0 comprised the initial topsoil strip followed by the excavation of a pipe trench between MHF 4a and MHF 1/STUB, which extended north-east from the central compound. A simple stratigraphy was observed and recorded along this length; dark brown silt-loam topsoil (001) over subsoil (002). Two natural substrate layers were recorded; dark grey platy shale (003) was observed overlying the solid limestone bedrock.

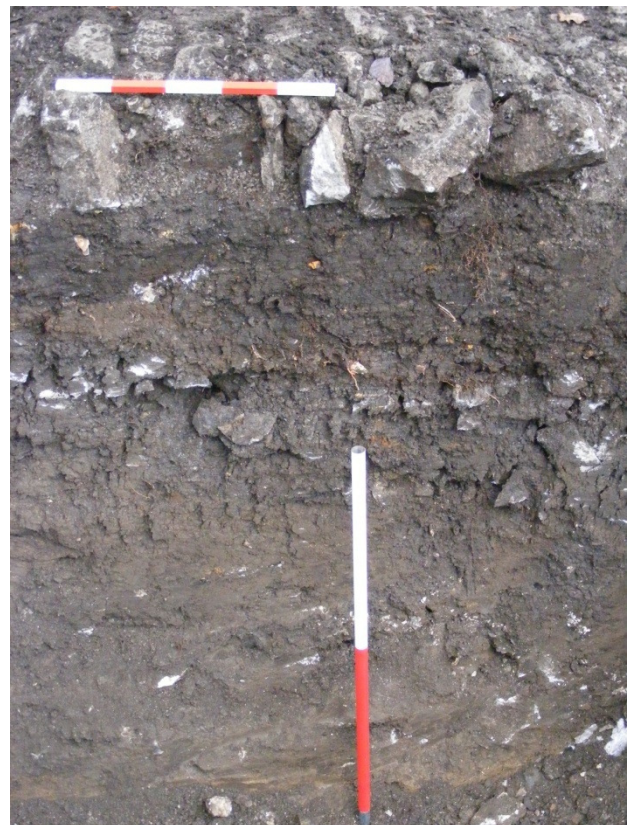
Plate 7: Representative section in Monitored Area 2. Figure 2.1.

The earliest layer recorded was at the western end of the trench: natural yellow-brown clay overlying shale fragments in a dark grey silt matrix (218). Throughout the remainder of the trench, a red-brown silty subsoil (204) which overlay the natural was the earliest context recorded.

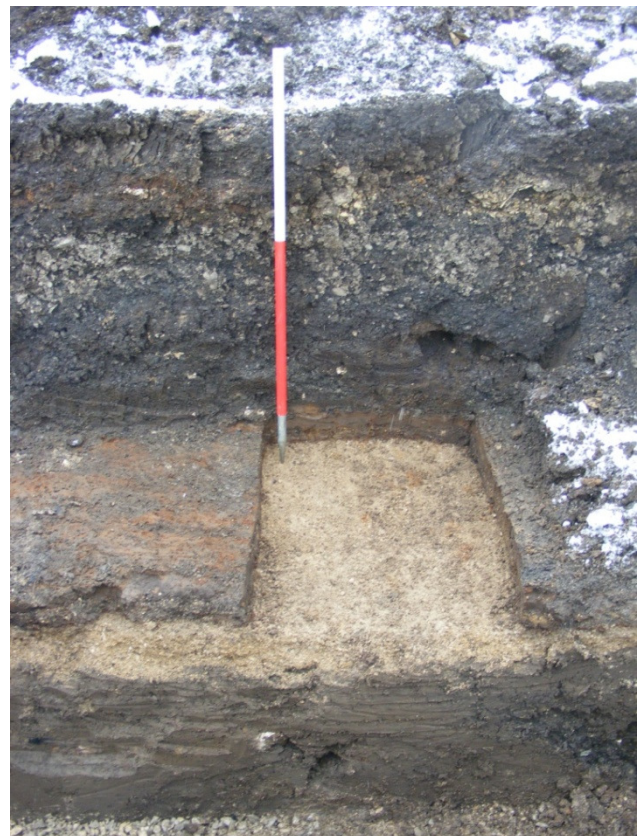
Plate 12: Representative section Monitored Area 3. Figure 3.1

The natural stratigraphy identified in this area was consistent with the others; solid limestone at depth, overlain by dark grey platy shale (303). Two subsoil layers were identified: a yellowish brown clay-silt (302) interpreted as natural hill-wash covered by a reddish brown silt (301), a second layer of material deposited at the base of the

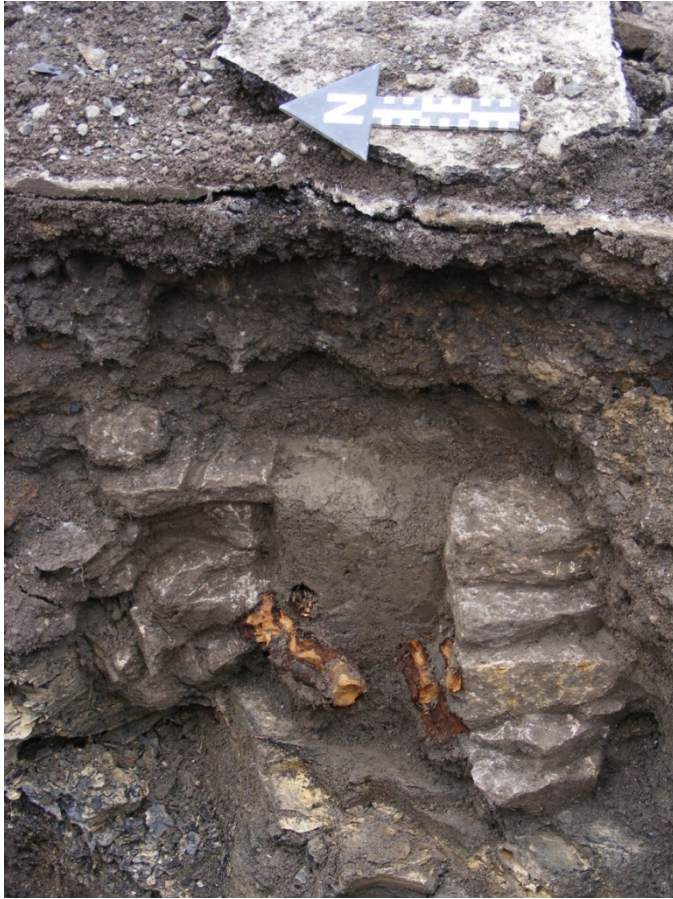
Plate 13: Stone built drain [403]. Figure 4.1.

A stone drain was noted towards the southern end of the pipe trench. The vertical side of its construction cut [403] severed through the mixed hill-wash. The drain itself was made from roughly shaped limestone blocks 404, laid directly onto the natural shale. It was filled with mid grey-brown silt (405), which presumably accumulated during the use of the drain.

The area was covered with modern tarmac and hardcore bedding layers (400). The top of the stone drain had been removed, probably during the construction of this modern surface.

The truncated base of a limestone built drain, laid directly onto the natural geology, was the only feature identified at the entrance to Hassop Hall stables, in Monitored Area 4. This drain remains undated, however the top of this feature was potentially destroyed when the modern tarmac drive surface was laid.
