**LAND AT THE FORMER CASTLE SOAPWORKS, THE CALLIS,
ASHBY-DE-LA-ZOUCH, LEICESTERSHIRE**

ARCHAEOLOGICAL EVALUATION REPORT

NGR: SK 35638 16978
Planning Ref.: 13/00517/FULM
Archive acc. no.: X.A177.2013
Site code: ADZE 13
PCAS job no.: 1137

January 2014

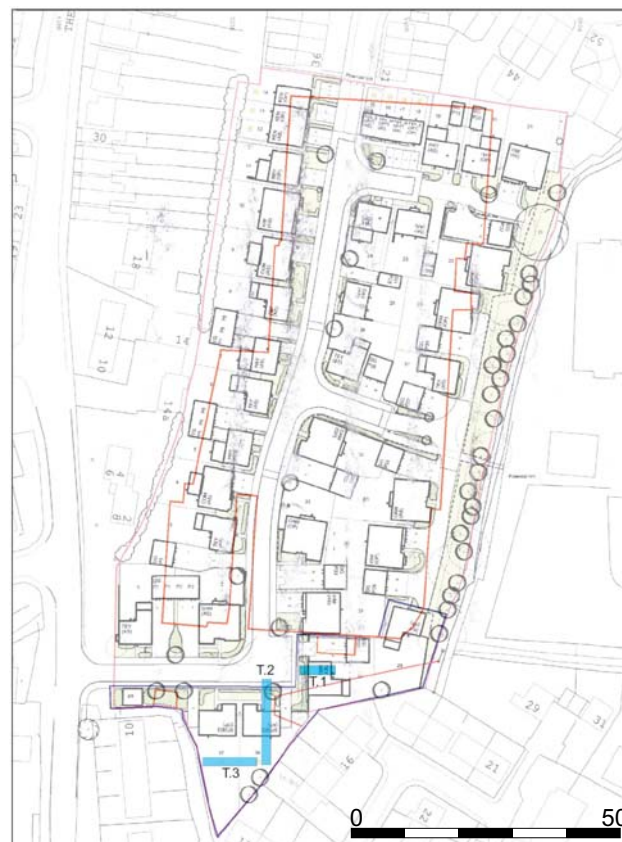
Fig. 2: Trench location plan on proposed development plan. Scale 1:1000

Three trenches were excavated in the south of the site (Fig. 2). Trench 1 lay in Plot 35, Trenches 2 and 3 in Plots 36-37 of the planning proposals. The trenches were positioned with a view to avoiding known cables and other services.

- Trench 1: measured 10mx2m, orientated east-west within Plot 35. This trench lay to the north of the existing old canteen building and was on the footprint of part of the leatherworks.
- Trench 2: measured 25mx2m, orientated north-south across the proposed footings of Plot 36, in an area occupied by a range of buildings in the historic mapping of the tannery.
- Trench 3: measured 15mx2m, orientated east-west and positioned within the existing car park over the leatherworks buildings along the western edge of the site, as shown on late 19th century mapping.

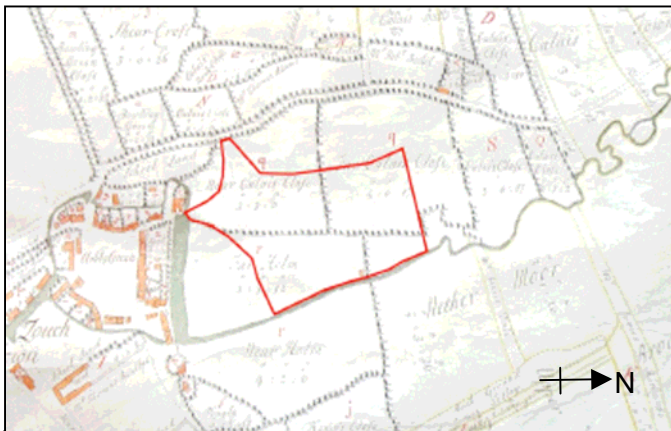
Fig 3: 1735 town plan with approx location of site marked. Not to scale

The development site was mainly agricultural land for much of the post-medieval period. Mid 18th century mapping (Fig. 3) indicates large fields, connected by the name *Calais*, accessed by a minor track way from the Market Place. The town was re-mapped in 1837, which is the first map to show the Glue and Leatherworks in the south of the site (Fig.4). A review of the town at this time described The Callis as “*The houses are poor; the roadway an open sewer;*

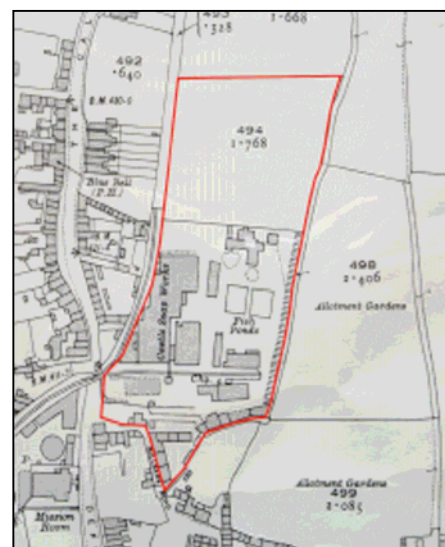
Fig. 6: 1923 OS map with approx location of site marked. Not to scale

Fig. 6: Extract from 1923 OS map, post acquisition of the leatherworks by the Castle Soapworks

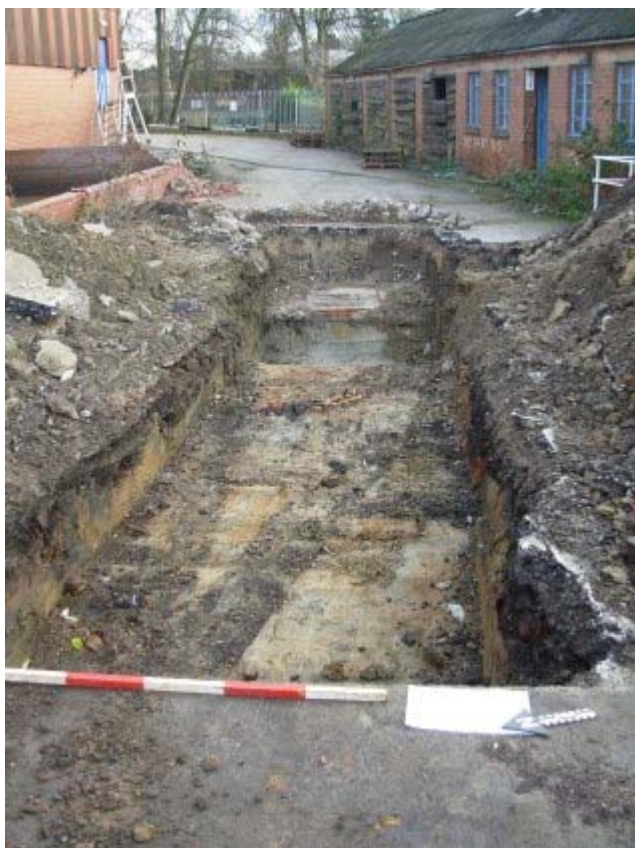
Plate 1: Overview of Trench 1 looking east
(see Fig: 7)

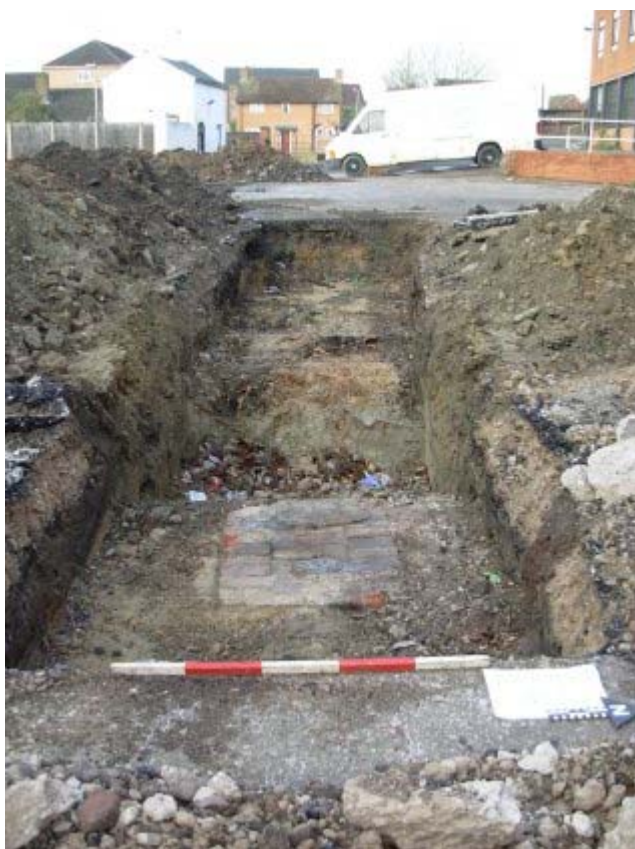
Plate 2: Overview of Trench 1 looking west
(see Fig: 7)

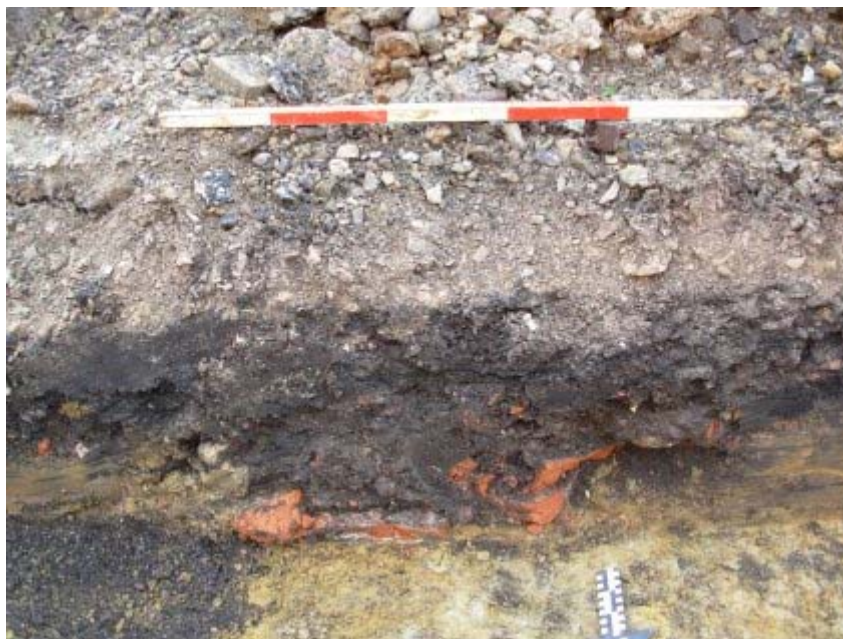
Plate 3: North facing representative section in Trench 1 (see Fig: 8)

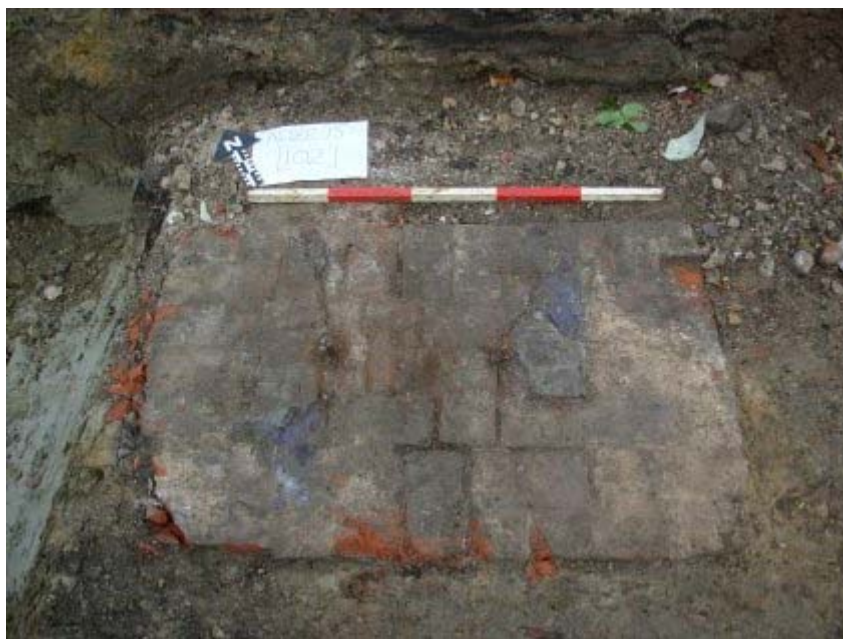
The drain [107] was not fully visible in either plan or section but appeared to have been a small brick built structure identified at the south west of the trench, and likely running north-south. More promising was the plinth base [102], consisting of bricks 230x115mm in plan with the remnants of a slate surface on top. The bricks were laid in a header course on the north and south faces irregularly filled in between and the ends of two iron rods, truncated at the surface, support its interpretation as a plinth.

Plate 4: Plinth structure [102] in east end of Trench 1 (see Fig: 7)

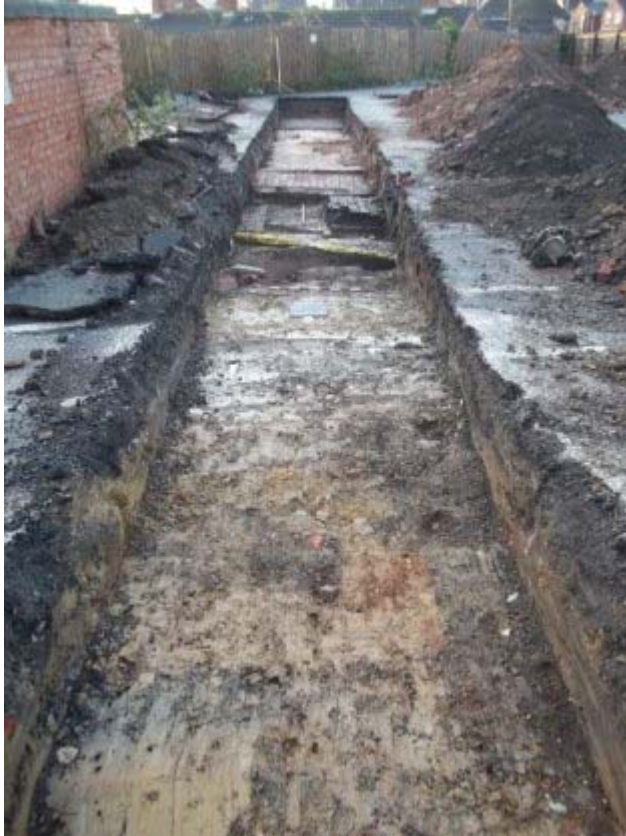
Plate 5: Overview of Trench 2 looking south
(see Fig: 9)

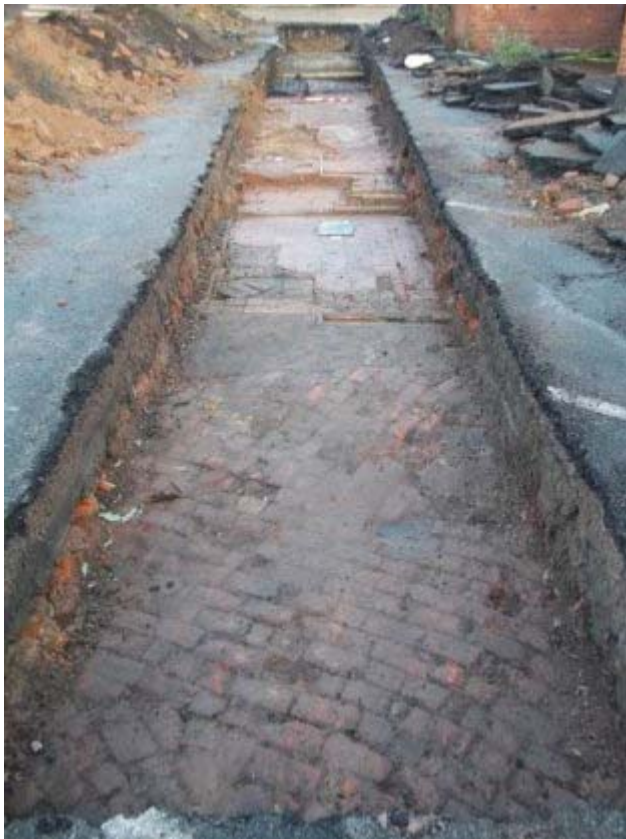
Plate 6: Overview of Trench 2 looking north
(see Fig: 9)

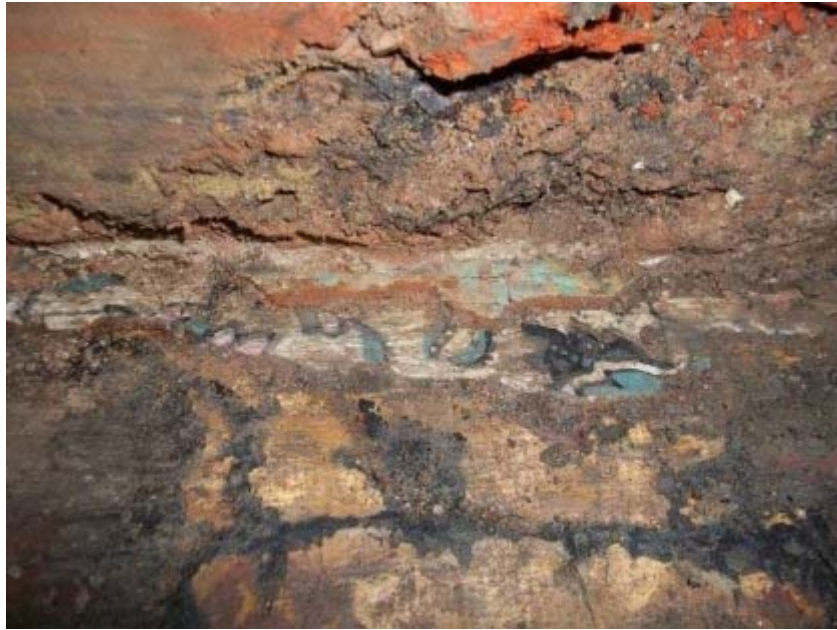
Through a doorway in the southern internal wall was a small room/passageway laid with north to south half overlapping runs of 150mm² red quarry tiles. The southern and northern walls of this room were joined by a raised area of bricks that could be a raised floor area or simply infilling of a space (all designated [217]). Both doorways for this room had well worn sandstone sills, worn to reflect the changing floor heights, with the northern room's floor (219) 120mm higher and the southern ones [215] 60mm lower. This southern room was walled on the west and south [214], with the latter arm certainly being an external wall. There was evidence on these bricks that the internal walls would have been painted green at one time. Although the floor was primarily composed of 200mm² red quarry tiles, laid in half overlapping north south runs, there was a small (0.5m²) area of concrete to the west and an interesting arrangement of bricks in the south west corner. No evidence remained as to the purpose of this arrangement, but it would appear to be an area re-enforced to withstand the heat of a hearth or burner placed in the corner.

Plate 7: close up of painted floor tiling in Trench 2. Showing multiple layers of re-painting

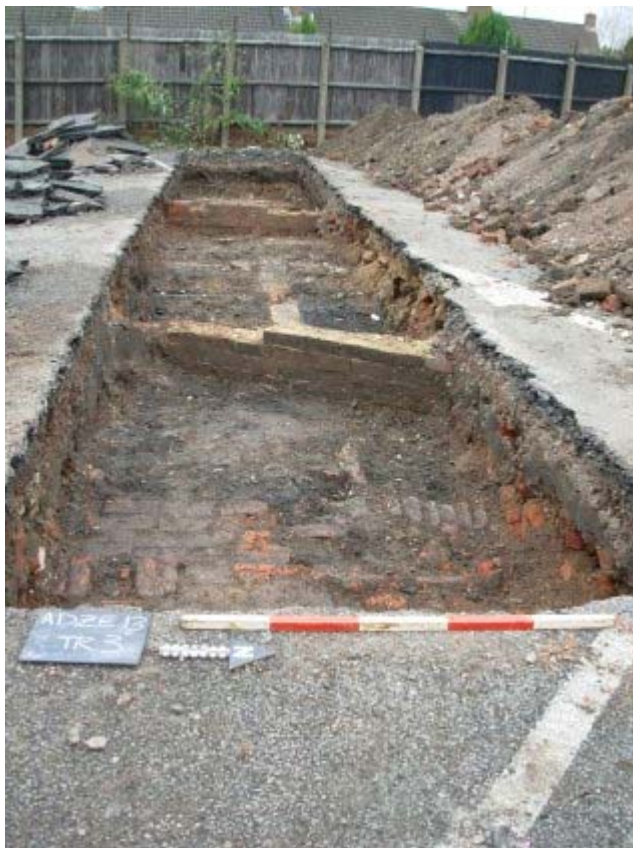
Plate 8: Overview of Trench 3 looking west (see Fig: 11)

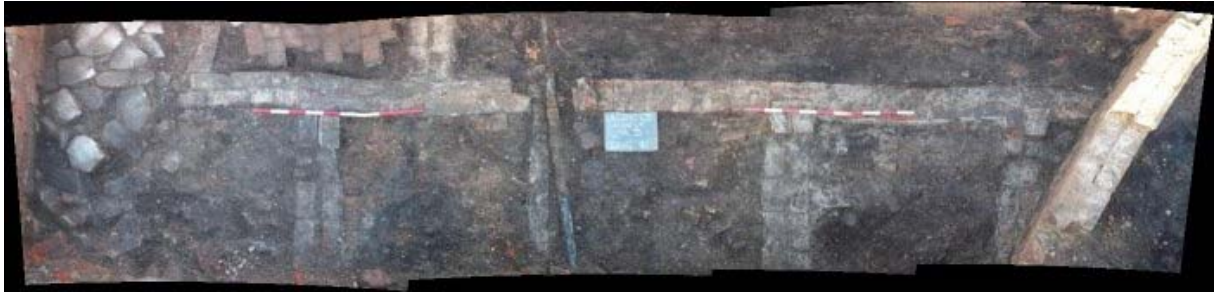
The most striking remains in this trench were a series of walls within this central section [314]. A main, presumably exterior, wall ran east – west down the centre of the trench, primarily laid in stretcher courses (there was a short run of header bricks that may represent an infilled opening or joining of two separate structures). Running south from this section, but clearly contemporary, were four walls which would have separated the internal rooms, all laid in stretcher fashion. This created a structure with at least three rooms c.1.10m wide, and probably more as the central run extended beyond the remaining south running walls. Each of these rooms was filled with a sandy clay, with varying levels of rubble and burning evident. The westernmost room had a brick and mortar rubble in light orange/yellow sandy clay matrix, with charcoal inclusions (317), that graded southwards into a black, burnt sandy clay with occasional brick fragments that dominated by slate rubble (319). This latter deposit continued in the central room, although here there were more frequent and larger chunks of brick (320), seen again in this form in the southern half of the eastern most room. Here, however it graded north into a very coarse cream coloured sandy clay with lots of brick rubble (321) that continued east of the easternmost south running wall. North of the central external wall the black, burnt sandy clay deposits continued (318), with the brick content increasing significantly to the east (323). In the west of this northern, external area a north running wall of stretcher laid bricks [316] had been abutted to the central wall, and along with an insubstantial single run of bricks further west [315], a room of the same width as those to the south was created. Within this room a brick floor had been laid, although it did not respect the alignment of the walls. The floor was laid directly on light brown sandy clay that may represent either trample on the surface of the natural or redeposited material to create a bed. Directly over this floor and into the section were large chunks of concrete that did not appear to be related to the floor but be part of the overlying deposit (311).

Plate 9: Composite photo plan of the middle section of Trench 3 (see Fig: 11)

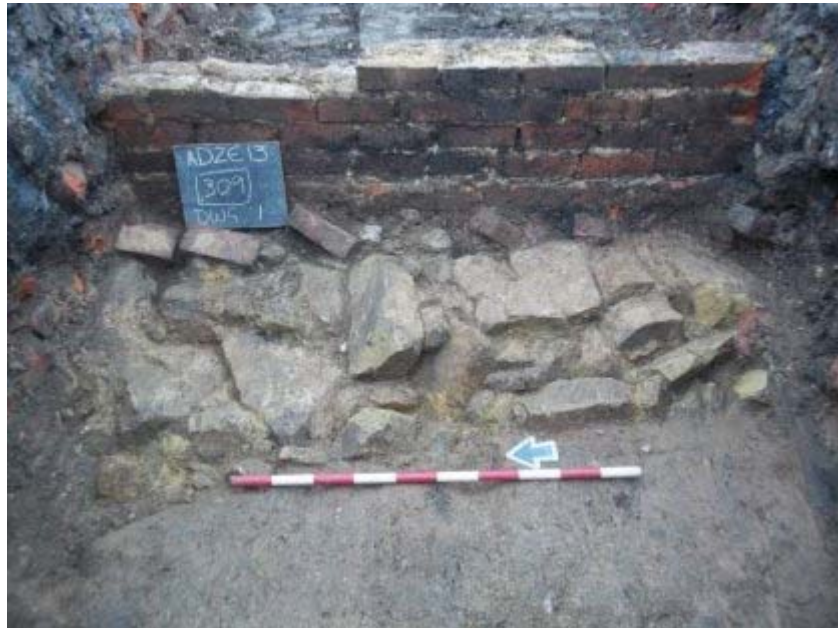
East of the exposed natural was probably the oldest archaeological material exposed on the site, a sandstone rubble wall running north – south [309]. This wall consisted of either undressed, or very roughly dressed sandstone blocks that looked to be laid directly into the natural. This wall appeared to have been demolished and built over by a brick successor [310], of which 5 courses remained, 4 laid in stretcher fashion with the bottom run in header (Fig. 13). This wall delimited the western section of the trench from the central one described below. The western face was well dressed, while the eastern face was rough, suggesting that a building ran away to the east. Against the external western face the remaining sandstone wall had a mixed grey brown sandy clay (308) compressed into it with some brick rubble also present, extending underneath the brick wall [310]. This was the only deposit on site to have produced artefacts: one piece of glazed white wear, two pieces of brown glazed earthenware, three pieces of clay pipe, and three pieces of drain pipe. All of the pot dates to the 18th or 19th century, whilst the sewage pipe is 19th to 20th century. The clay pipe material however, potentially spans a range from the 18th to early 20th centuries. This material provides a *terminus post quem* for the construction of the wall [310], indicating that it was built in the early 20th century.

Plate 10: Sandstone wall [309] at western end of Trench 3. (see Fig: 11)

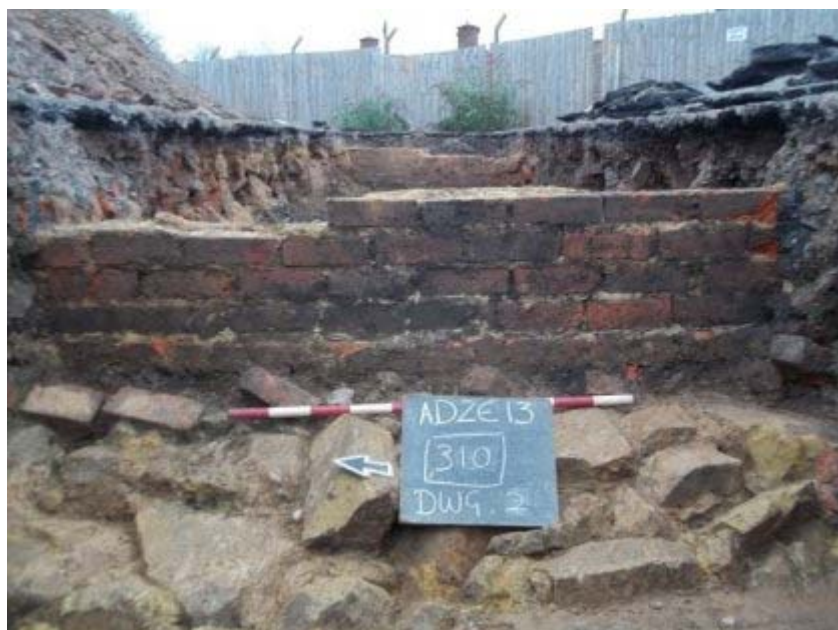
Plate 11: West face of wall [310]. (see Fig: 13)

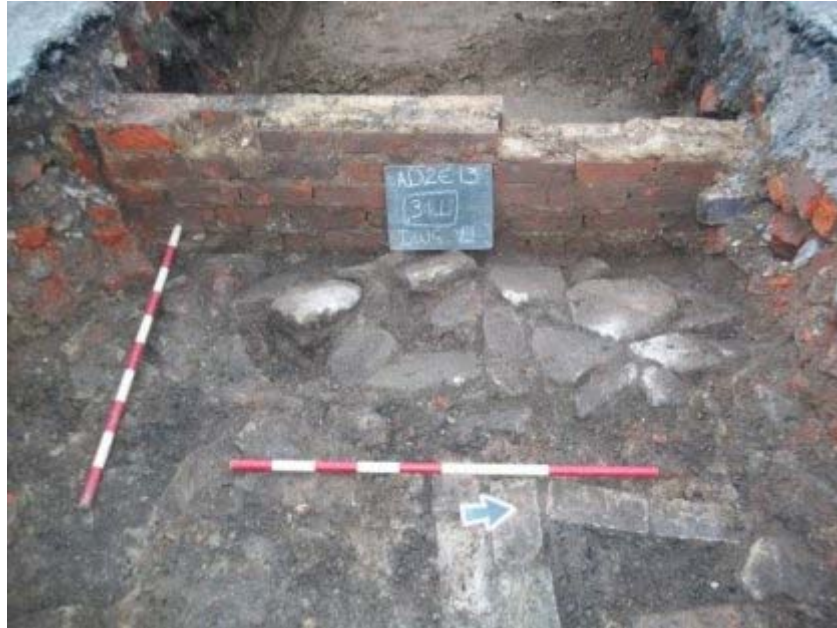
Another building was constructed in brick to the east, possibly running off the sandstone wall given that rubble from the demolition of the latter overlay this brick wall, although the 1903 O/S map (Fig. 5) does show two adjoining buildings running east west in this area that are actually separate from the main building. This new building was divided into several rooms, the sizes of which suggests they were probably for storage. A further room appears to have been added to the north of this structure at a later date, although equally this could be part of the northern adjoining building.

Plate 12: East face of wall [310]. Also showing rubble from wall [309] overlying wall [314]

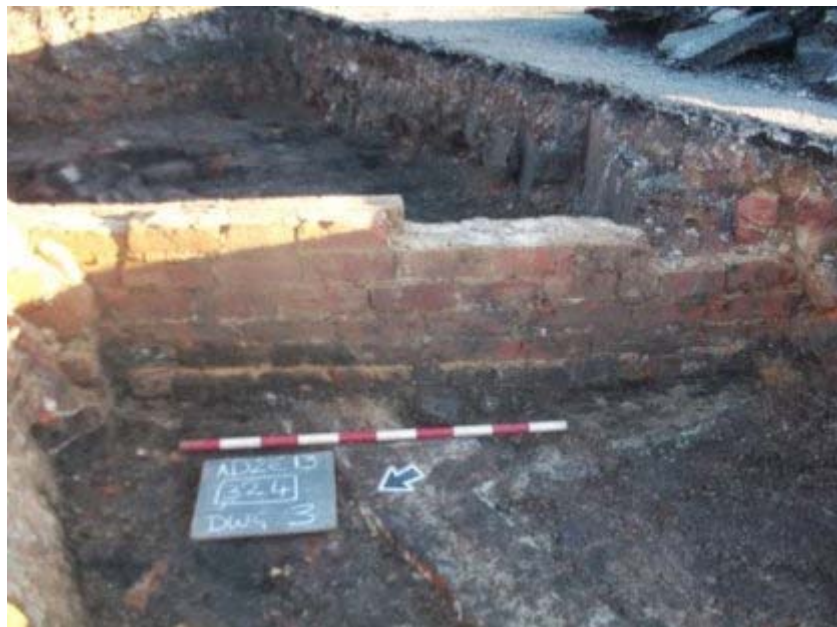
To the east of this central section was a second wall [324] that stood proud of the ground, separating the central and eastern sections of the trench. Some six courses remained, with the bottom course laid in header fashion as seen in the western wall (Fig.14). The five courses laid on this were predominantly stretcher, although with occasional header bricks. Although this wall was on a different alignment to the western one [310], running north east – south west, it was the eastern face that appeared to be a well dressed external wall. This suggests that it was the eastern return wall of a structure, also represented by the western wall [310]. In this it is worth noting that the central wall described above [314] ran directly beneath this wall.

Plate 13: Northwest face of wall [324]. (see Fig: 14)
