27 SAXON STREET, LINCOLN
ARCHAEOLOGICAL MONITORING AND RECORDING

NGR: SK 97476 72400
Planning Authority: City of Lincoln Council
Planning Ref: 2013/1018/F
PCAS Job No: 1163
PCAS Site Code: LSSM 14
LCNCC Accession No.: 2014.7

January 2014

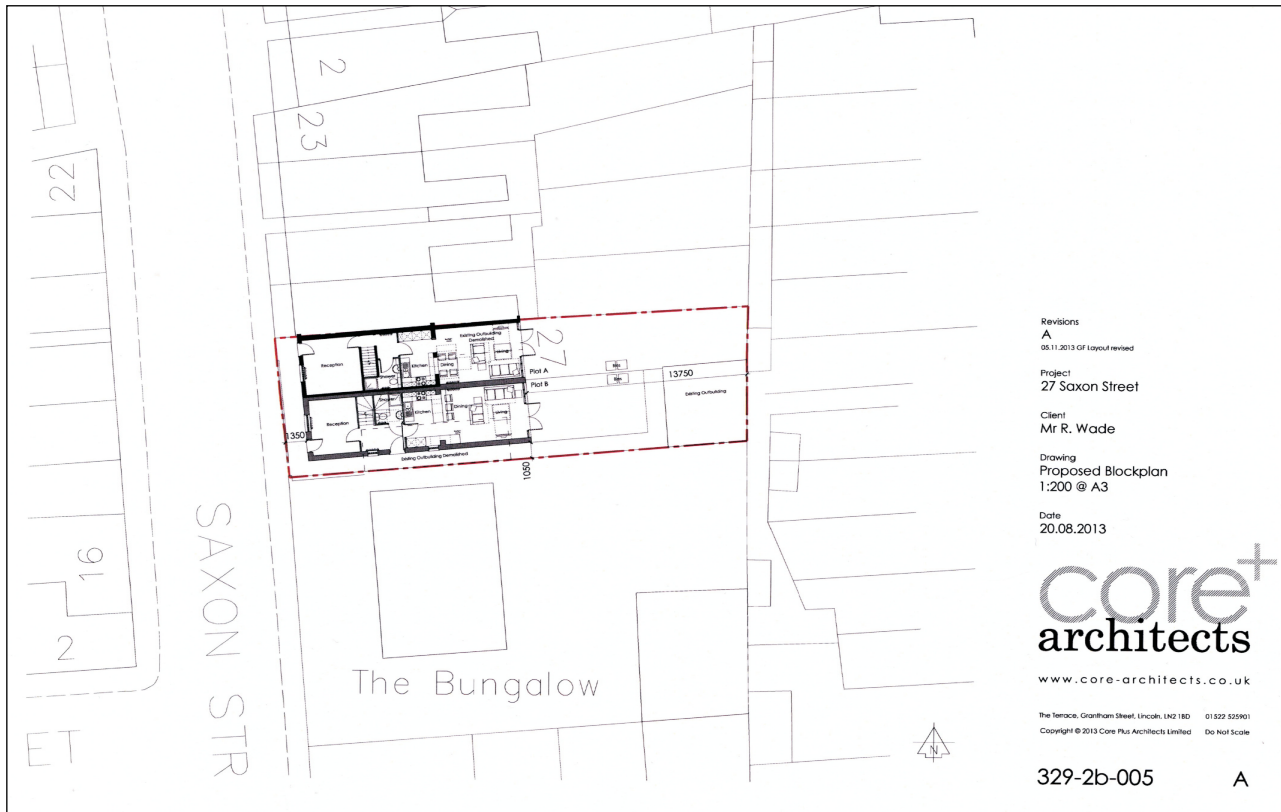
Figure 2. Detailed site plan courtesy of Core Architects. Scaled at 1:400 (originally at 1:200 on A3).

Saxon Street is located in the northern part of Lincoln City, approximately 500m north of the city's Cathedral Quarter, centred on NGR: SK 97476 72400. Saxon Street is aligned north/south and joins Rasen Lane at its southern end. The development site fronts onto the eastern side of the street and comprises a narrow area of overgrown waste ground containing a derelict garage. The site is located within Lincoln City's Burton Road Character Area and No. 9 Conservation Area (Newport and Nettleham Road). It is bounded to the north by terraced properties; to the south by 'The Bungalow'; to the west by Saxon Street and to the east by the rear gardens of properties on St Nicholas Street.

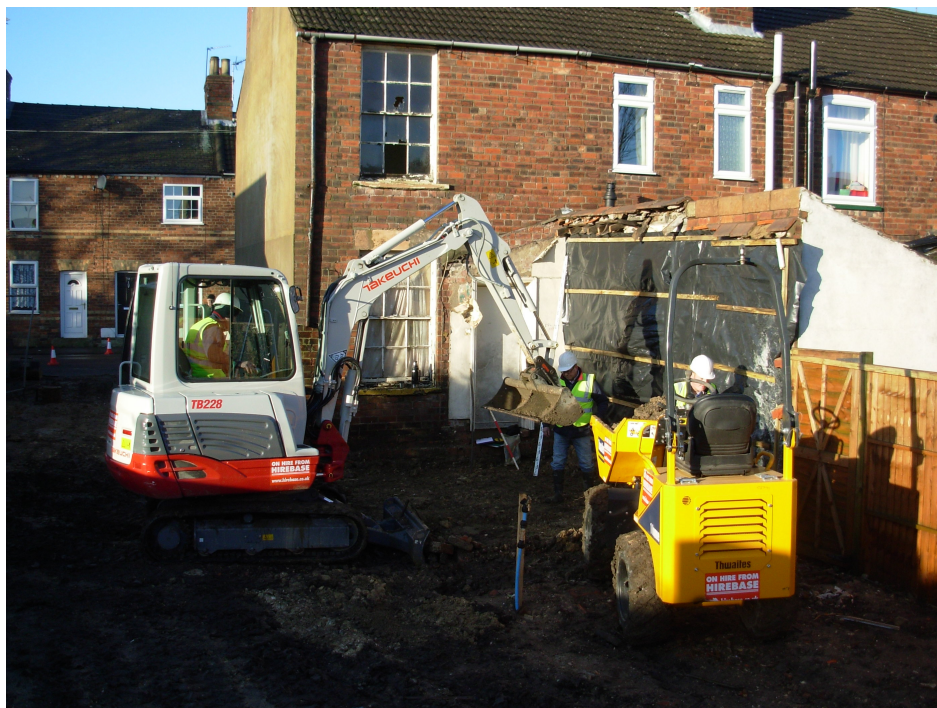
Plate 1: General site shot from rear of existing building looking northwest.

Excavation on site began on the 13th January 2014. A tracked mini-digger using a flat bucket (see **plate 1**) was used to strip the development footprint down to the required level whilst being monitored by an archaeologist at all times. The site itself had been lowered to construction level, 0.4m below existing ground level, prior to the archaeologist's arrival on site. This had included the demolition of a former extension at the rear of the house which had covered some of the excavation area. Whilst being monitored the whole of the excavated area (see **Fig. 2** and **3**) had been reduced by a depth of 0.6m. This exposed a stratigraphic sequence summarised as follows (also see **Appendix 2** and **Plate 2**):
