NO. 37 CECIL STREET, LINCOLN, LINCOLNSHIRE

**SCHEME OF ARCHAEOLOGICAL MONITORING
AND RECORDING**

NGR: SK 97526 72166
LCC Planning ref.: 2013/0077/F
PCAS Job No.: 1051
Site code: CSLM 13
Archive acc. code: 2013.91

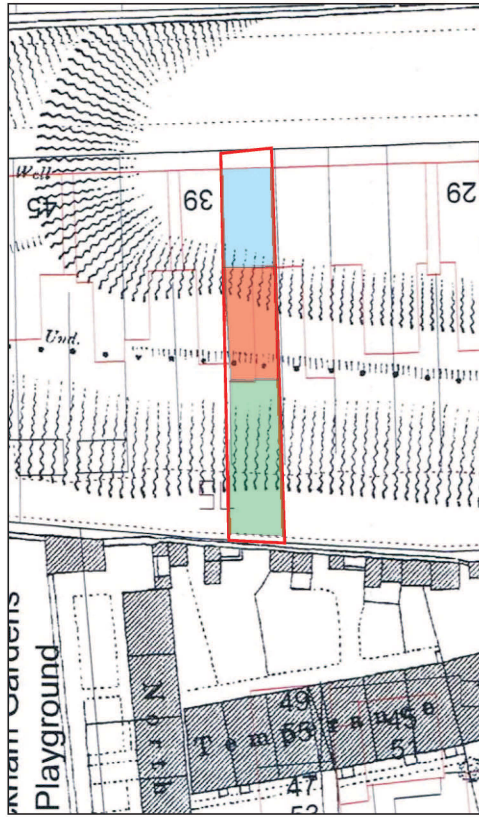
Figure 3: Plan of monitored groundworks at 1:100, and shown on a extract of modern and historic mapping detailing the location of the Roman ditches at 1:700.

The ground levels in the area of the new outbuildings in the rear garden of No. 37 Cecil Street were reduced by c. 1.10m below existing. This exposed 0.80m of made ground (002), a mixed clay sand containing frequent modern CBM, glass etc. The full depth of this layer was not exposed.

In the upper part of this layer, the concrete foundations and lowest two courses of the former garden wall (demolished to existing ground level prior to archaeological attendance) were identified, alongside a modern earthenware sewer pipe.

A 0.30m deep layer of modern tarmac (001) forming the former yard surface overlay the area of excavation.

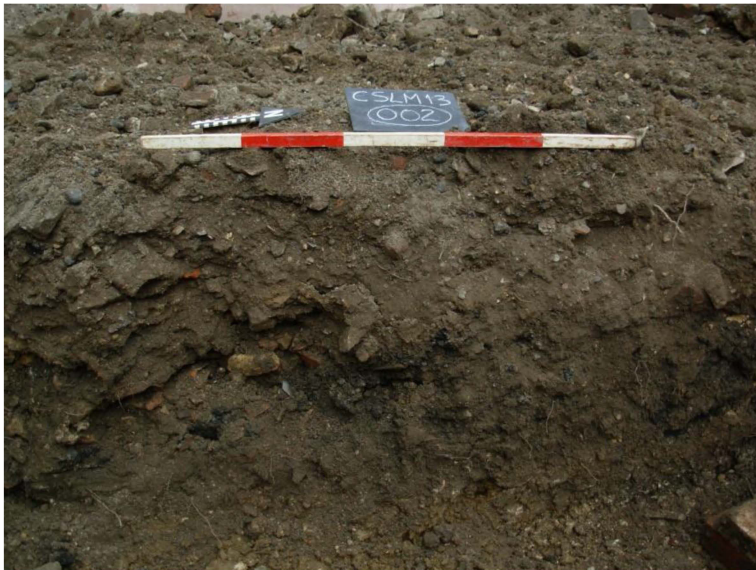
Plate 4: Excavations exposed 0.80m of early 20th century made ground (002).

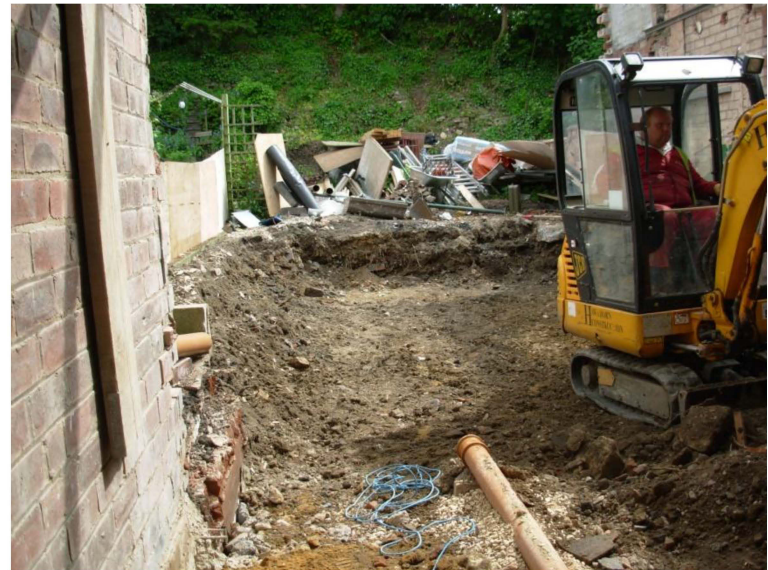
Plate 4: Completed excavations, looking south over reduced ground level.
