**LAND AT DEERLANDS ROAD, WINGERWORTH,  
DERBYSHIRE**

**ARCHAEOLOGICAL EVALUATION REPORT**

July 2014

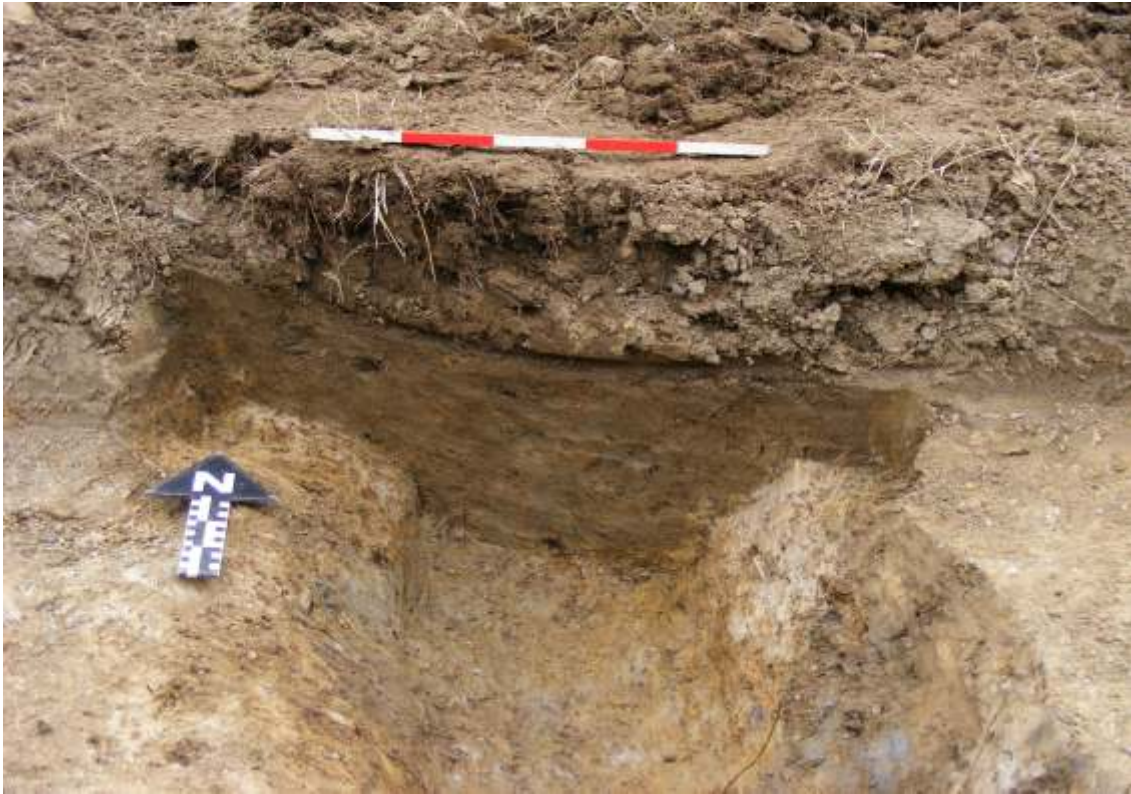
**Plate 1:** South facing section of ditch [404], situated in the north-western end of Trench 4, which was relocated 30 metres west of its original location. A land drain cuts the ditch towards the south-east.

The location of Trench 4 was moved slightly north-west due to a spoil heap. A thin topsoil (401) covered a very thin subsoil layer (402) which was more of an interface with the natural (403). A shallow ditch [404] 0.44m wide by 0.16m deep, and aligned north to south, was located in the western end of the trench and contained a single fill (405). A track (406) made of stone fragments and slag was noted towards the western edge which was directly on top of the natural, suggesting a modern date.

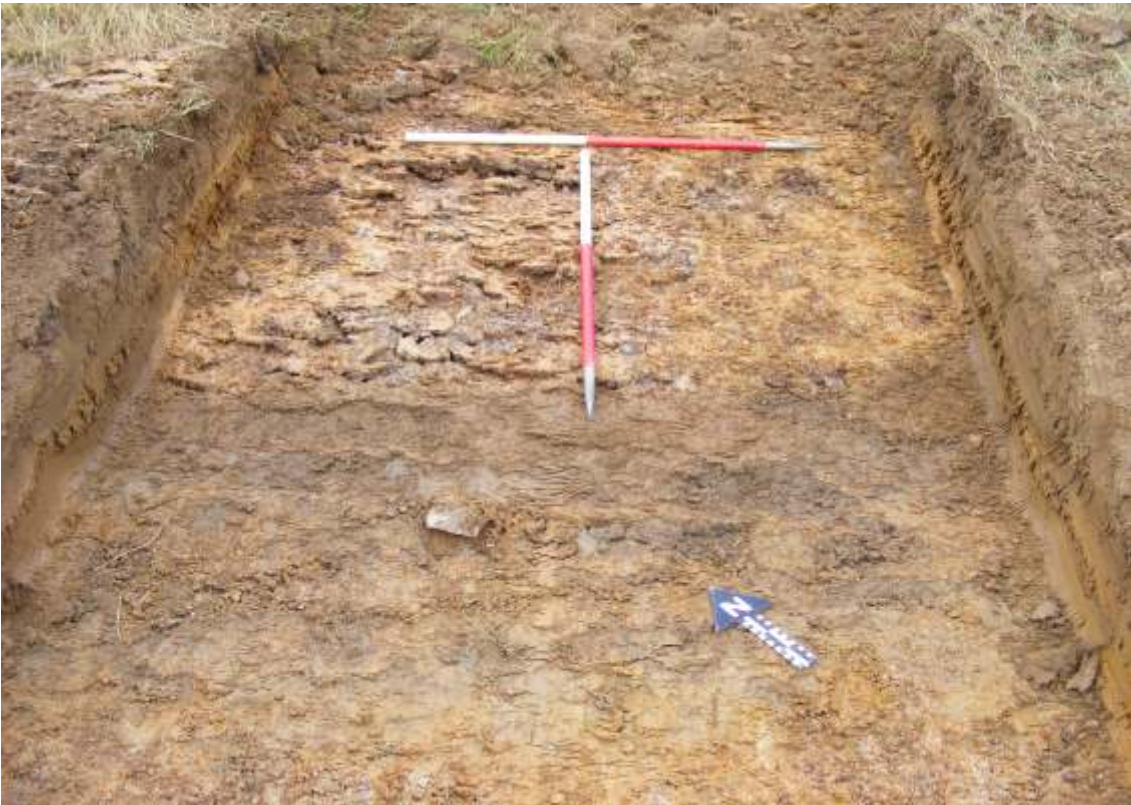
**Plate 2:** Ditch [504] prior to excavation. Looking north-east.

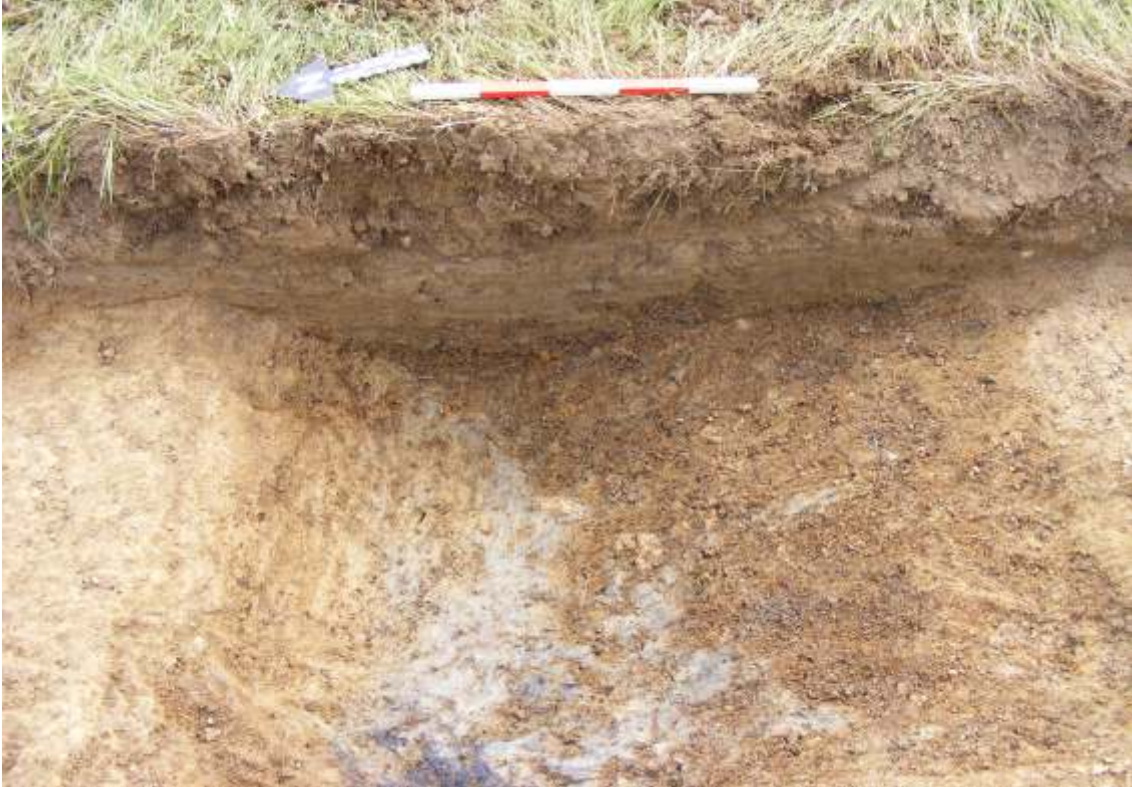
**Plate 3:** South-east facing section through ditch [504]. There seems to be some plough disturbance on top.

Trench 5 was aimed at a large round geophysical anomaly. After a sondage was excavated, this anomaly was rendered likely to have resulted from modern material being deposited over the topsoil. Located in an undisturbed part of the site, the profile revealed a good example of a complete soil profile consisting of topsoil (501), a subsoil interface (502) and the clay natural (503). A large modern test pit truncated the northern end. Approximately 2m south of this, a NW-SE aligned ditch [504] 1.10m wide by 0.30m deep traversed the trench, and this contained three discernable deposits; a primary fill (505) and two secondary deposits (506) and (507). The latter may have been dumped to offset the effects of slumpage, perhaps revealing the presence of a bank along the southern side of the ditch. Even so, there was nothing to suggest that the ditch was pre-modern in date.

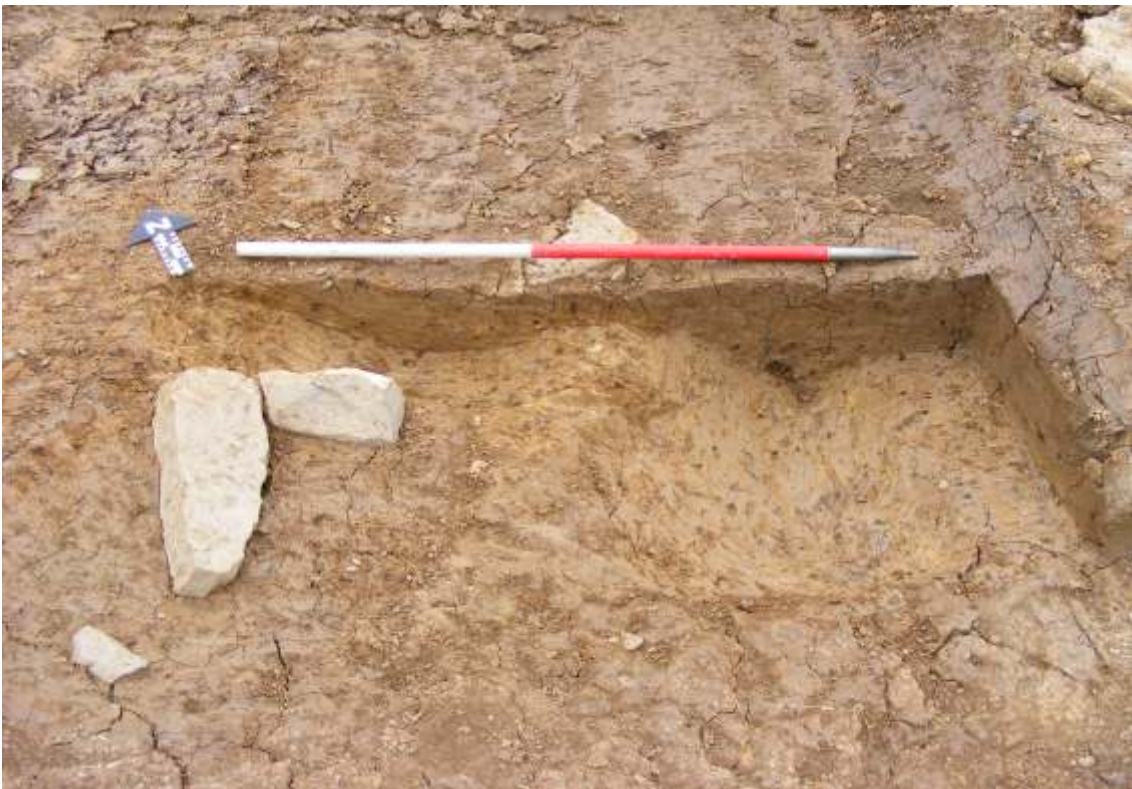
**Plate 4:** Section through gully [604]. A small extended area had to be excavated since a modern test pit had destroyed the southern end of the feature. Looking north north-east.

The topsoil (601) had been stripped from most of the trench and a large modern test pit had been excavated towards the western end. This cut directly through a shallow gully [604] 1.10m wide by 0.20m deep, which contained fragments of the type of stone seen in stone-filled land drains. The subsoil interface (602) was thin and overlay the mottled clay natural (603).

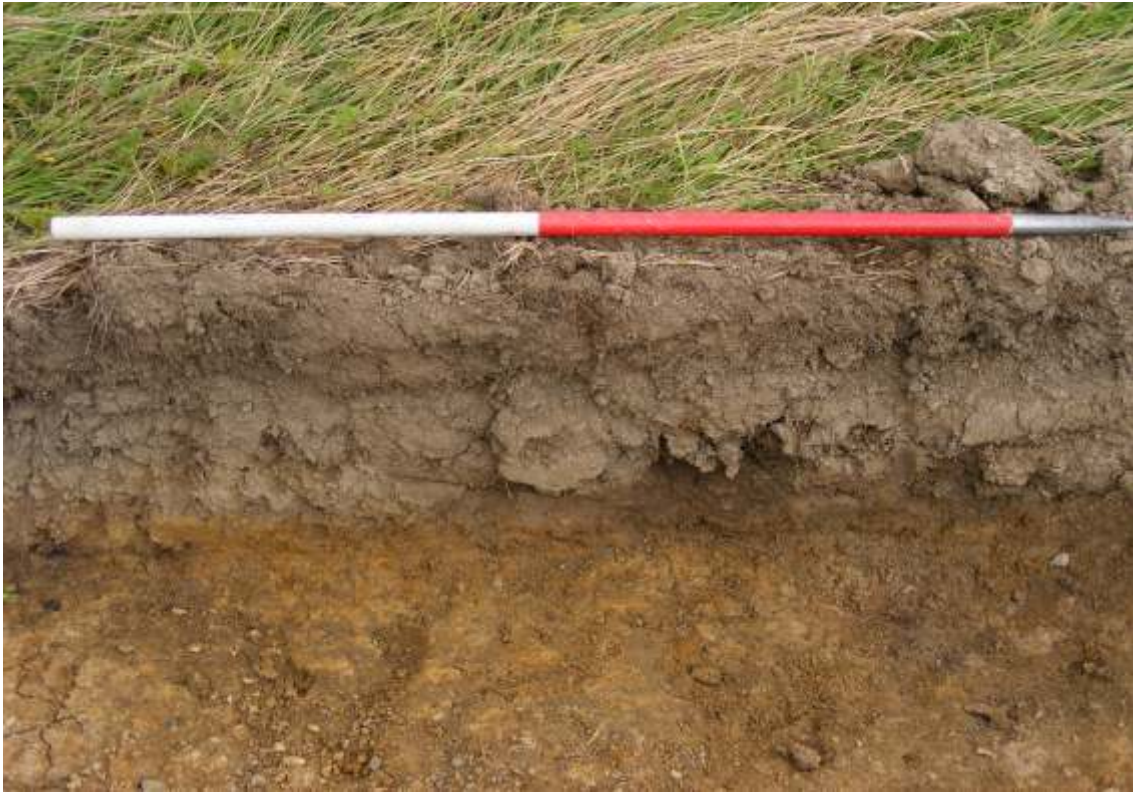
**Plate 5:** Representative section through Trench 7, looking north-east. Across the site, most of the natural substrate, where undisturbed, was sealed by a very thin subsoil interface and a mid brown silty loam topsoil.

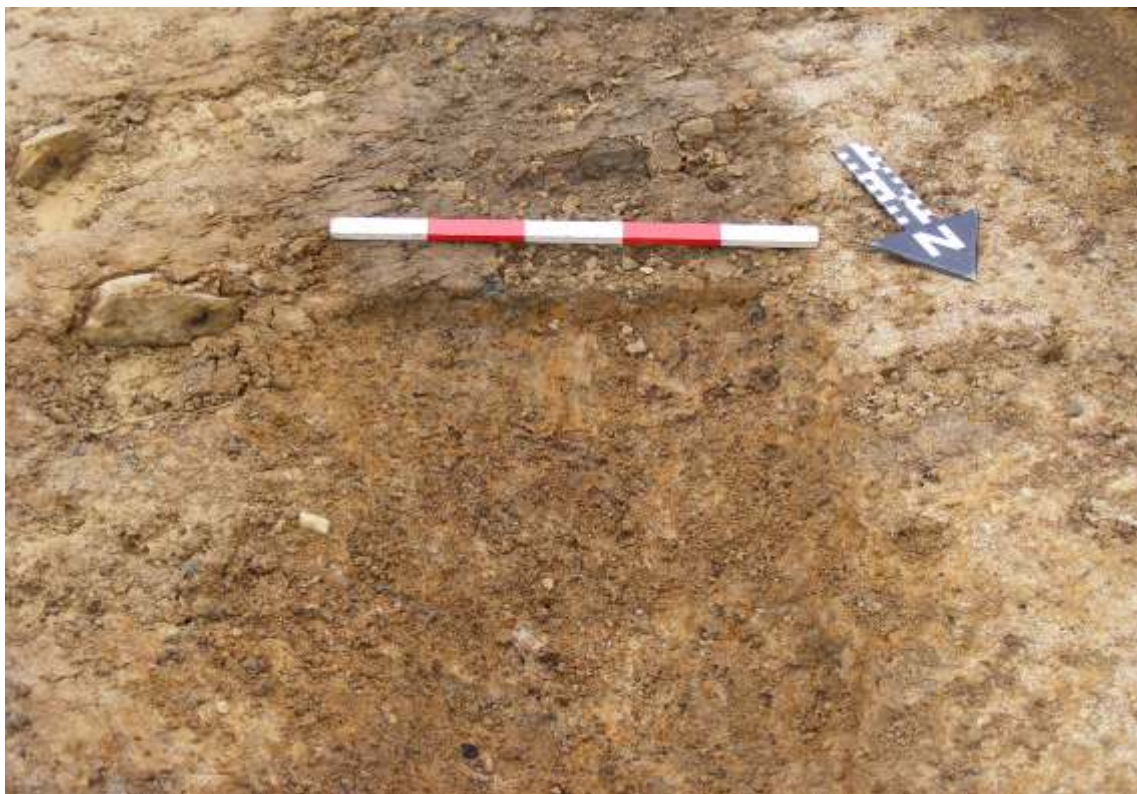
**Plate 6:** Very shallow gully [804] aligned north to south, parallel with land drains situated in Trench 8. Looking south south-west.

Topsoil (801), a subsoil interface (802) and natural (803) were identified. A very shallow linear feature, 0.45m wide by 0.05m deep was identified running parallel to the land drains at either end of the trench. Its flat base suggests the possibility of a wheel rut, or perhaps a small undated gully.

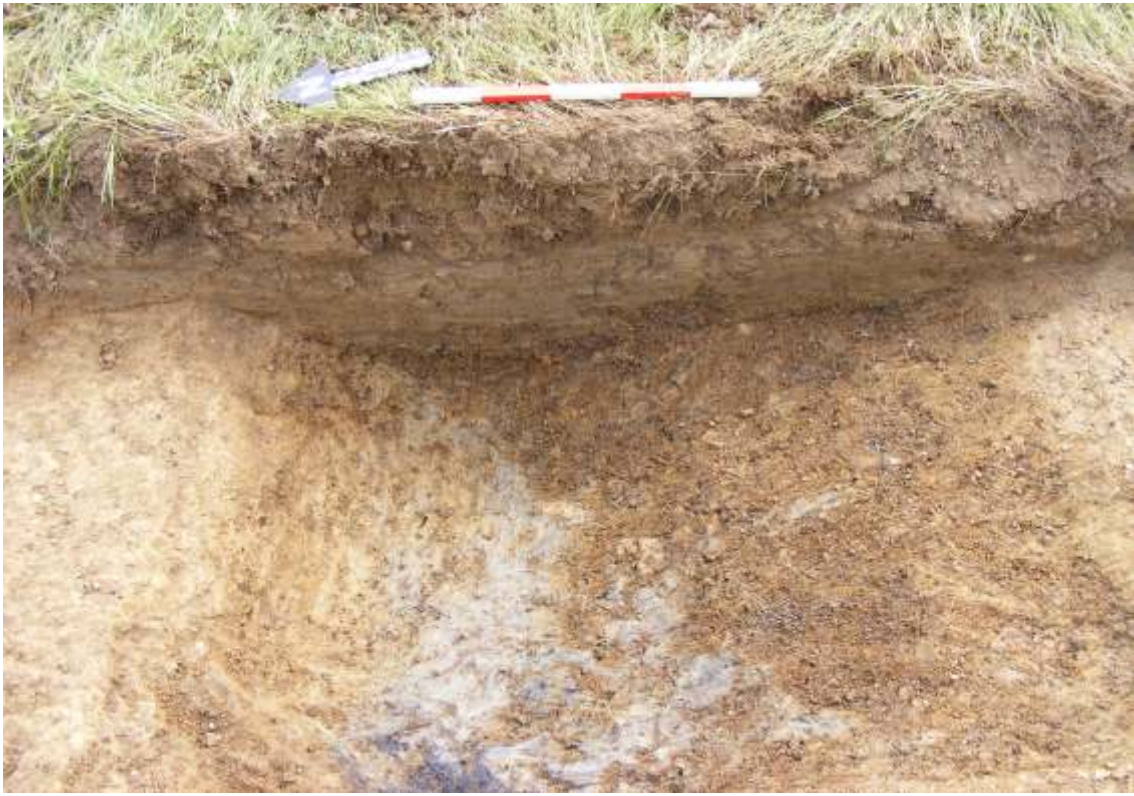
**Plate 7:** West facing section through ditch [1004]. Finds recovered were pieces of coal and glassy slag, and a clay pipe stem, all likely to be of a modern date.

Topsoil (1001), a thin disturbed subsoil (1002) and natural deposits (1003) were identified. Perpendicular to the trench, a shallow but fairly wide linear feature [1004], 1.25m wide by 0.16m deep, was identified towards the north end. The associated fill (1005) contained an undecorated cream coloured clay pipe stem, two pieces of coal and two pieces of vitreous glassy slag. Since the dating of pipes is ascertained from the bowl, which holds the tobacco, it is not possible to assign a date other than between the late 17<sup>th</sup> century and the late 19<sup>th</sup> century. The slag pieces and pipe stem are all likely to have been residual and modern in date.

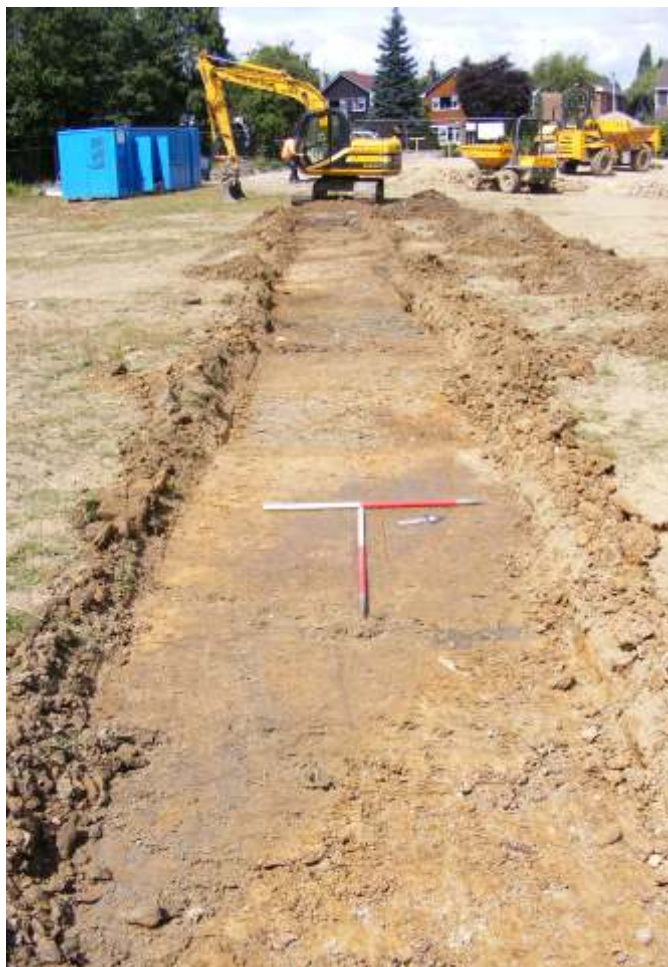
**Plate 8:** Trench 11 after excavation, looking west north-west. Ditch [1102] can be seen in the foreground, with land drains in the middle of the trench.

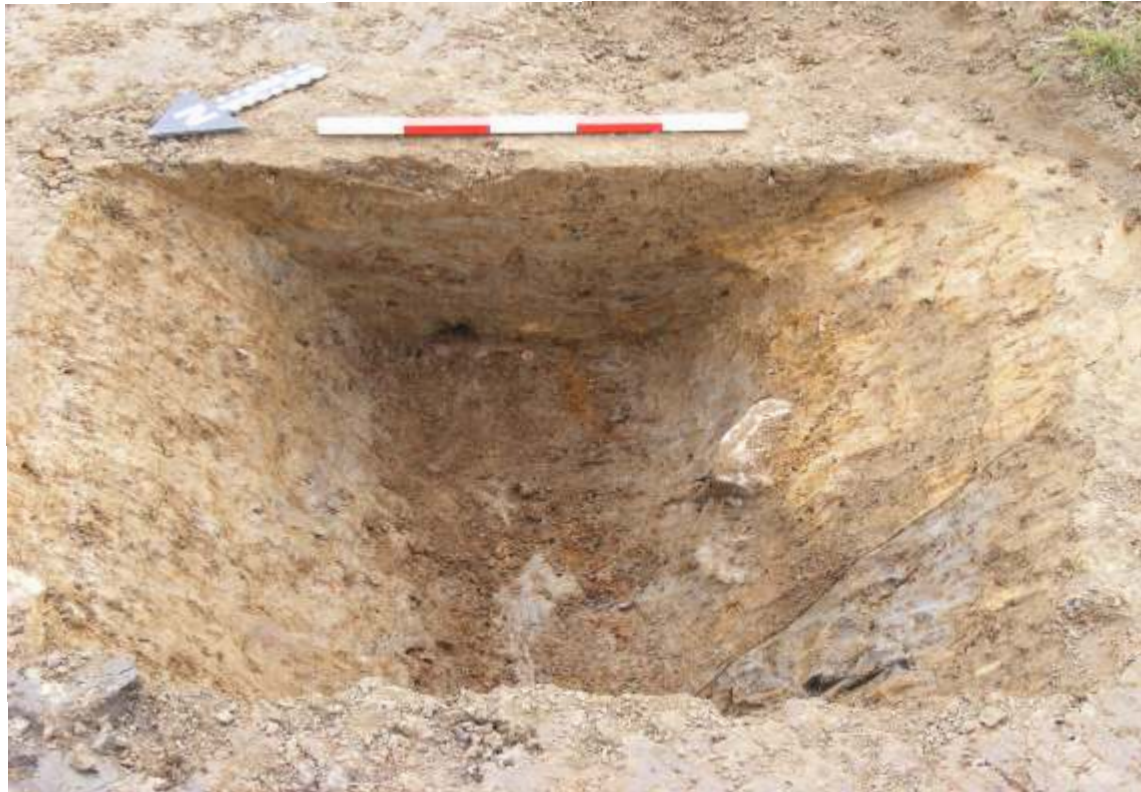
**Plate 9:** Ditch [1102], looking south-east. A land drain cuts the western edge of the excavated area.

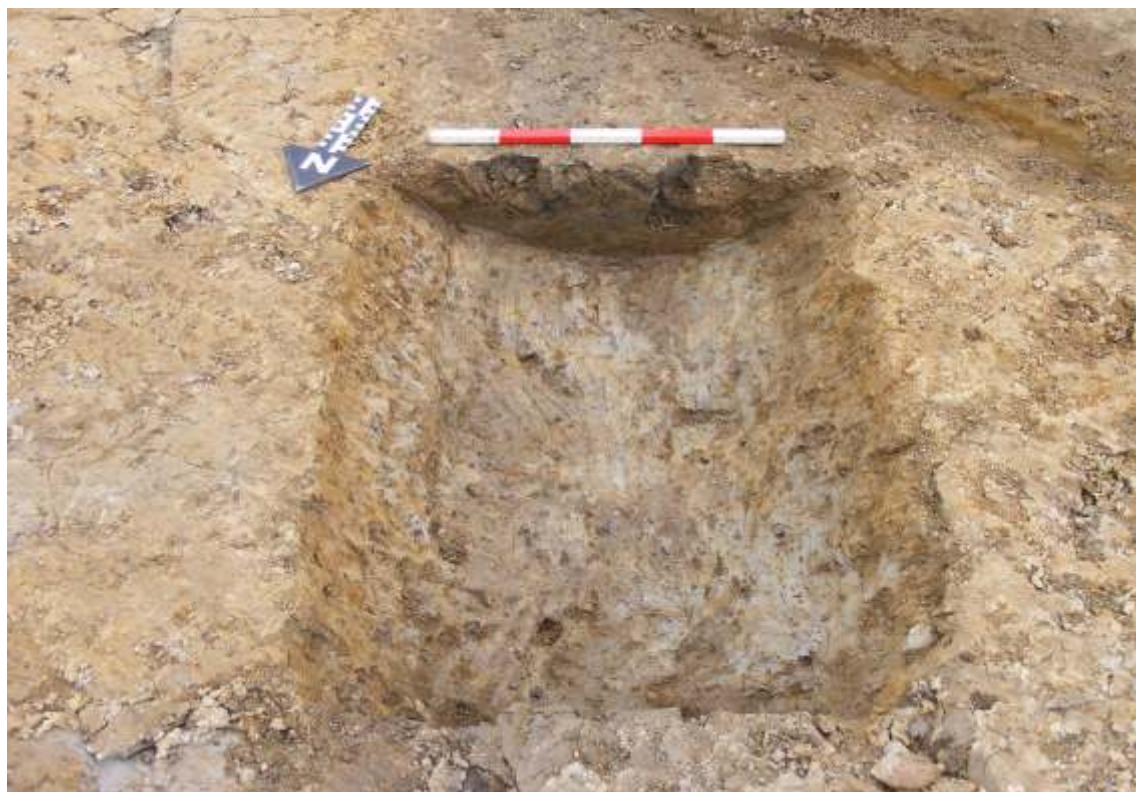
**Plate 10:** Ditch [1104], probably the same feature as [404], looking south. This is in the same alignment as the trackway (1106) and another ditch [1107].

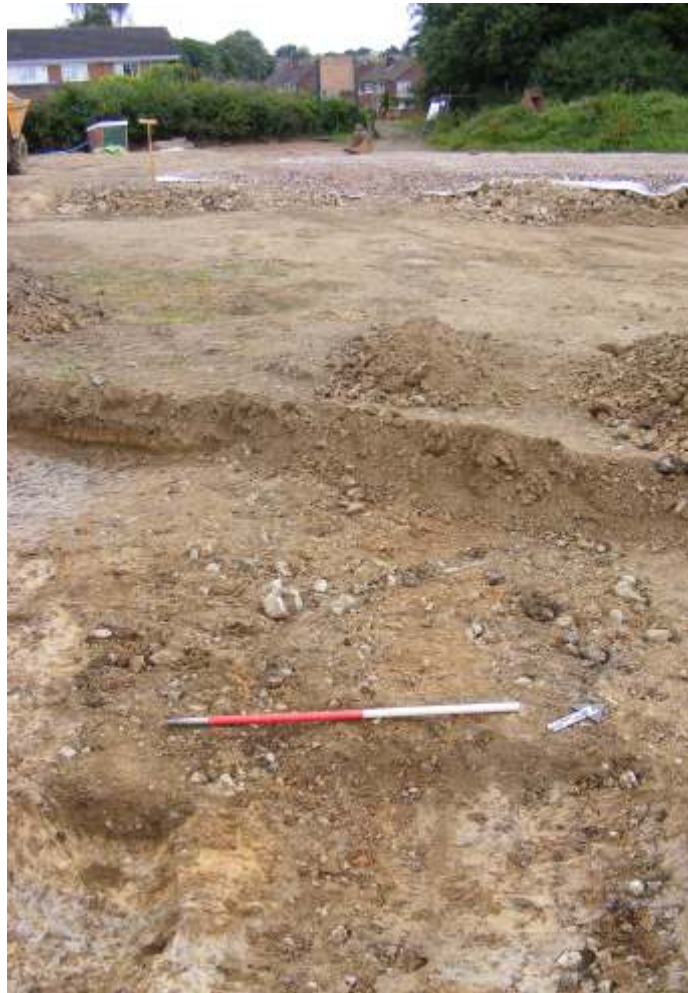
**Plate 11:** Rough trackway (1106) looking north-west. This ran across the site and was made of hardcore and contained stone fragments and some glassy slag material.

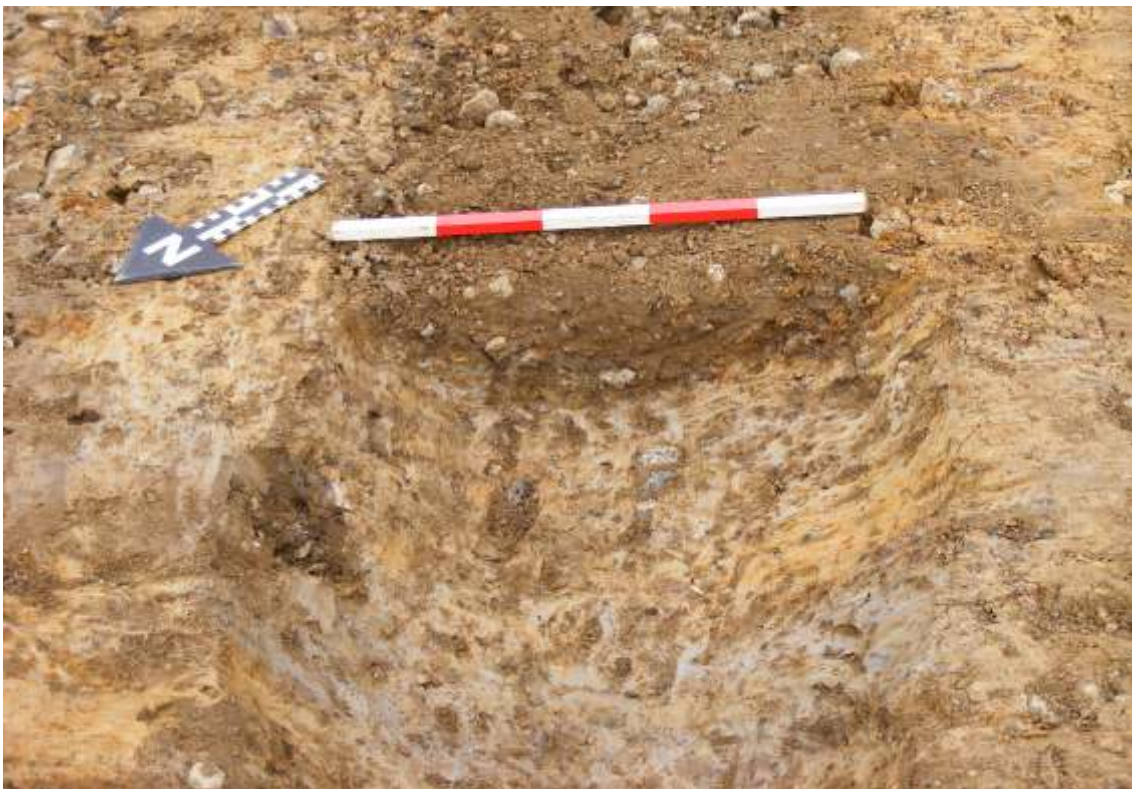
**Plate 12:** Ditch [1107] was buried under the hardcore track (1106), and followed the same north-west to south-east alignment. Looking south-east.

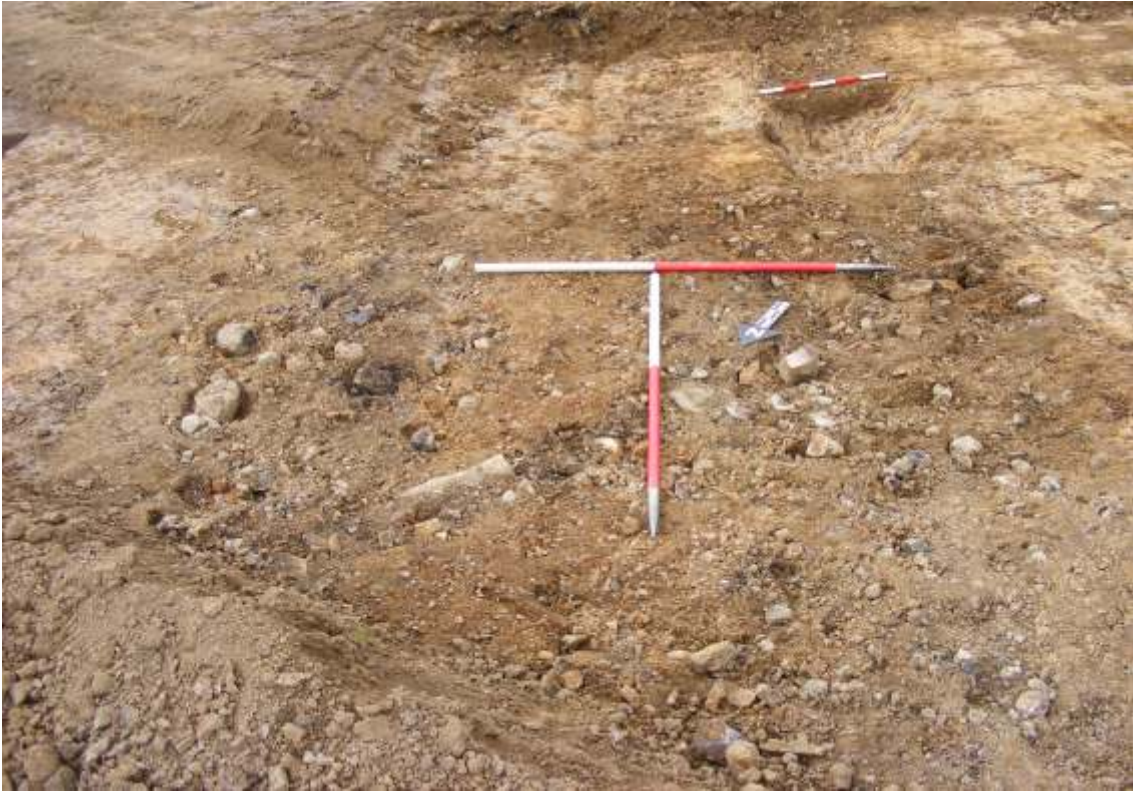
**Plate 13:** The parallel courses of trackway (1106) and ditch [1107] are clearly shown where a sondage was extended to the south of Trench 11. Ditch [1104] is just visible in the top left corner of the photograph; this also runs parallel.

This trench was excavated to compensate for parts of Trenches 1, 2 and 3 which had been lost to development. The top layer remaining was a thin subsoil (1101), which revealed three linear features when removed. An undated ditch [1102] aligned SE-NW 1.10m wide by 0.40m deep was situated at the south east end, while shallow ditches [1104] and [1107] were situated 4m apart and followed the same SSE-NNW alignment. The latter, measuring 0.47m by 0.15m, was revealed below a hardcore track (1106) when this was removed - five pieces of modern industrial slag were recovered from this track, which ran across the site in a roughly north to south alignment. The two linear features may have been related to each other. The hardcore track was found to be deposited directly on top of [1107], with no additional deposits present between the two features. The source of the slag and waste was likely to have been "The Avenue", a local coking works situated in Wingerworth and operating during the middle of the 20<sup>th</sup> century.

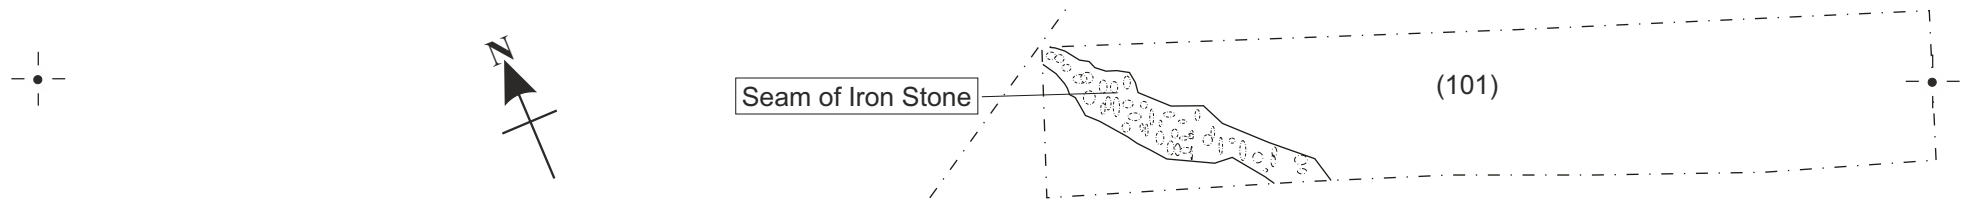
**Fig. 3:** Plan of Trench 1. The west side is under hardcore

Only the eastern end of the trench was excavated as the west end had already been covered by modern hardcore, and what remained had been reduced to the natural level (101). A strong geophysical reading in this area resulted from a natural seam of iron stone. Nothing of archaeological interest was revealed.

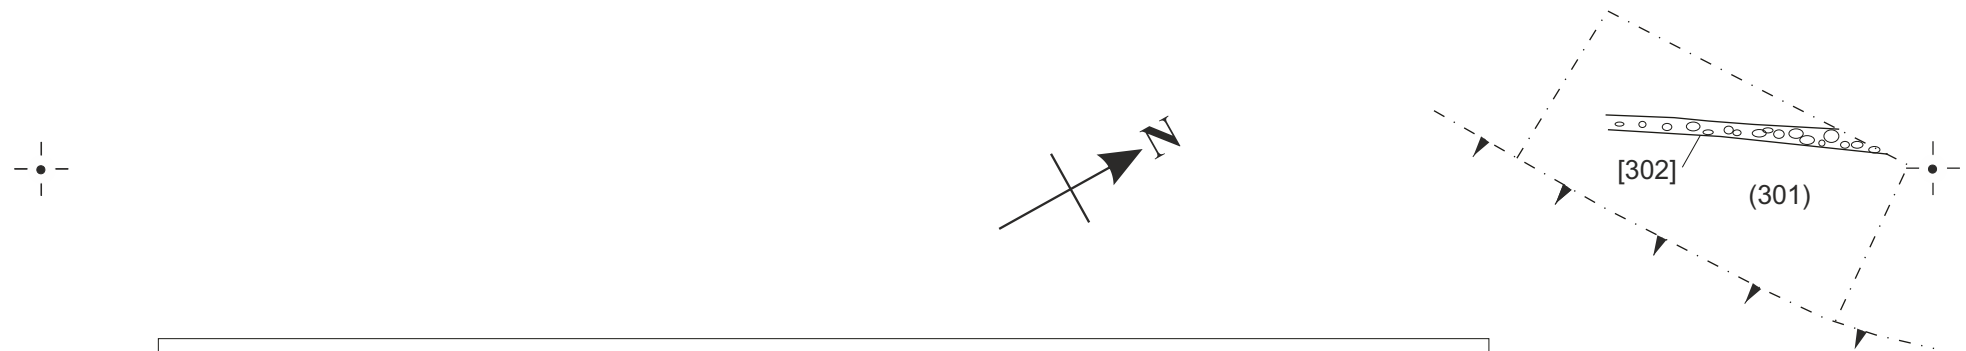
**Fig. 5:** Plan of Trench 3. The south side had been machined below the natural level for the new road

Where present, the subsoil (301) had been heavily disturbed by recent plant movement. Most of this area had been reduced to a level below that of the natural (302) by the new road. Only a small part of the north end was not already excavated. No archaeological remains were present.
