HARVEST HOUSE, NO. 126, CARHOLME ROAD, LINCOLN

**SCHEME OF ARCHAEOLOGICAL MONITORING
AND RECORDING**

Report prepared for
John Roberts Architects Ltd.
on behalf of Carecall Ltd.

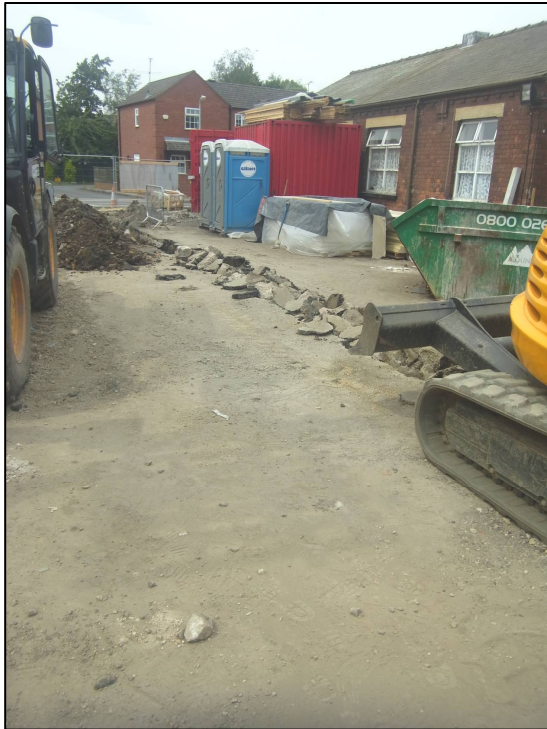
Plate 1: General shot of the site during groundworks, looking WNW across the rear of the site towards Roman Wharf (the two-storey building in the background is on the far side of Roman Wharf).

Excavation was carried out using a 360° excavator, fitted with a variety of buckets according to the width of the trench or pit to be excavated; due to the presence of tarmac, concrete and compacted rubble layers on the site, the majority of the work had to be carried out with toothed buckets (plates 1 and 2).

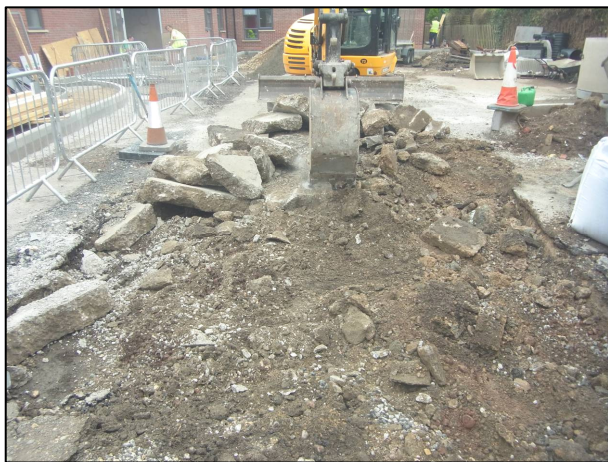
Plate 2: Working shot, looking E across the monitored area, showing the concrete and rubble that required the use of a toothed bucket for machining.

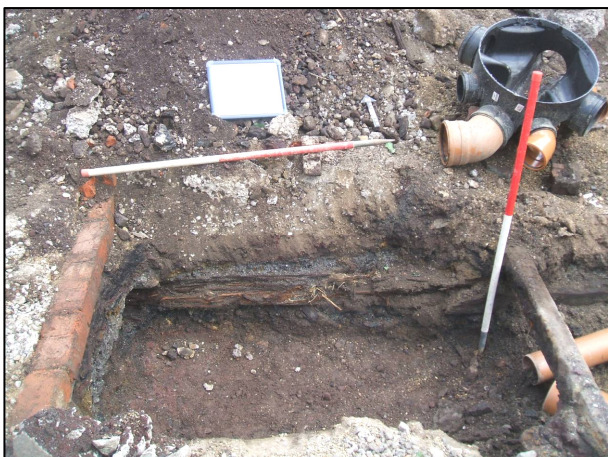
The only feature that could confidently be identified and dated was a railway line, encountered at the eastern extent of a trench running eastwards from the soakaway pit. A single railway sleeper, timber 130, was exposed, supporting two metal rails, jointly recorded as context 127 (plates 3 and 4). The railway was oriented north to south, and can be identified as part of the northern extent of the fertiliser works' internal railway line, depicted on the 3rd edition OS map (fig. 4). The western rail had been overlaid by brick structure 126: a single row of dry-laid bricks lay directly on the rail, suggesting that it had been utilised as a secure footing for a makeshift structure after it had gone out of use (plate 3; section drawings O-P and Q-R). The railway was laid on a series of compacted made ground deposits – 128, 129 and 131 – none of which could be dated except by their relationship to the track.

Plate 3: The railway exposed at the eastern extremity of the service trench, with brick structure 126 overlying one of the rails; timber sleeper 130 is exposed in the facing section. Photograph looking N.

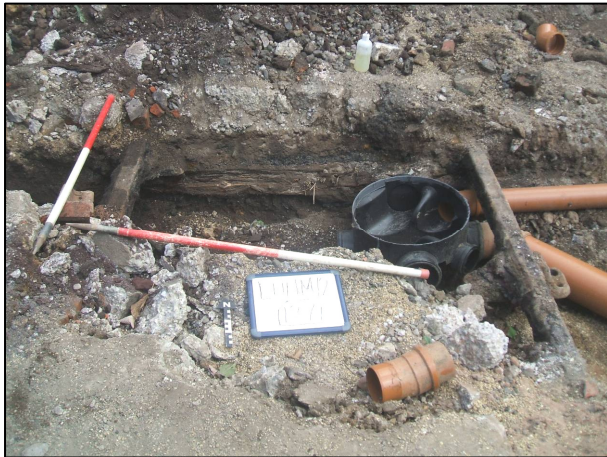
Plate 4: The railway fully exposed after the removal of brick structure 126, looking N.

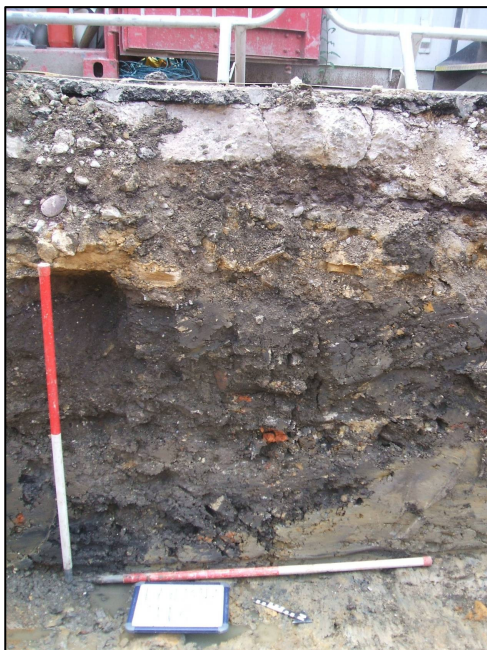
Apart from brick structure 126, no other structural remains were encountered. A possible cut feature was observed in the sides of the large soakaway pit: feature **116** was cut into potentially natural clay 111. It was extremely irregular in depth and profile, and it seems likely that this was a small clay extraction pit (plate 5; section drawings I-J and M-N). Feature fill 110, which extended as a spread to either side of the feature it filled, produced the majority of the finds assemblage for this project, including a single sherd of late medieval to post-medieval pottery, a number of sherds of post-medieval to modern pottery, chiefly 19th-century, fragments of bottle glass and a fragment of clay tobacco pipe (Appendices 3-5), suggesting that the pit was probably back-filled as part of the ground raising and consolidation process when either the ropewalk or the fertiliser works were constructed.

Plate 5: Possible cut feature 116 in the side of the large soakaway pit, looking S.
