NO. 20A, UNION STREET, MARKET RASEN, LINCOLNSHIRE

**SCHEME OF ARCHAEOLOGICAL
MONITORING AND RECORDING**

NGR: TF 10730 89044
Planning application: 126925
PCAS job no. 1229
Site code: USTM 14
Archive acc. no.: LCNCC:2014.104

Prepared for
Lincs Homes Ltd.

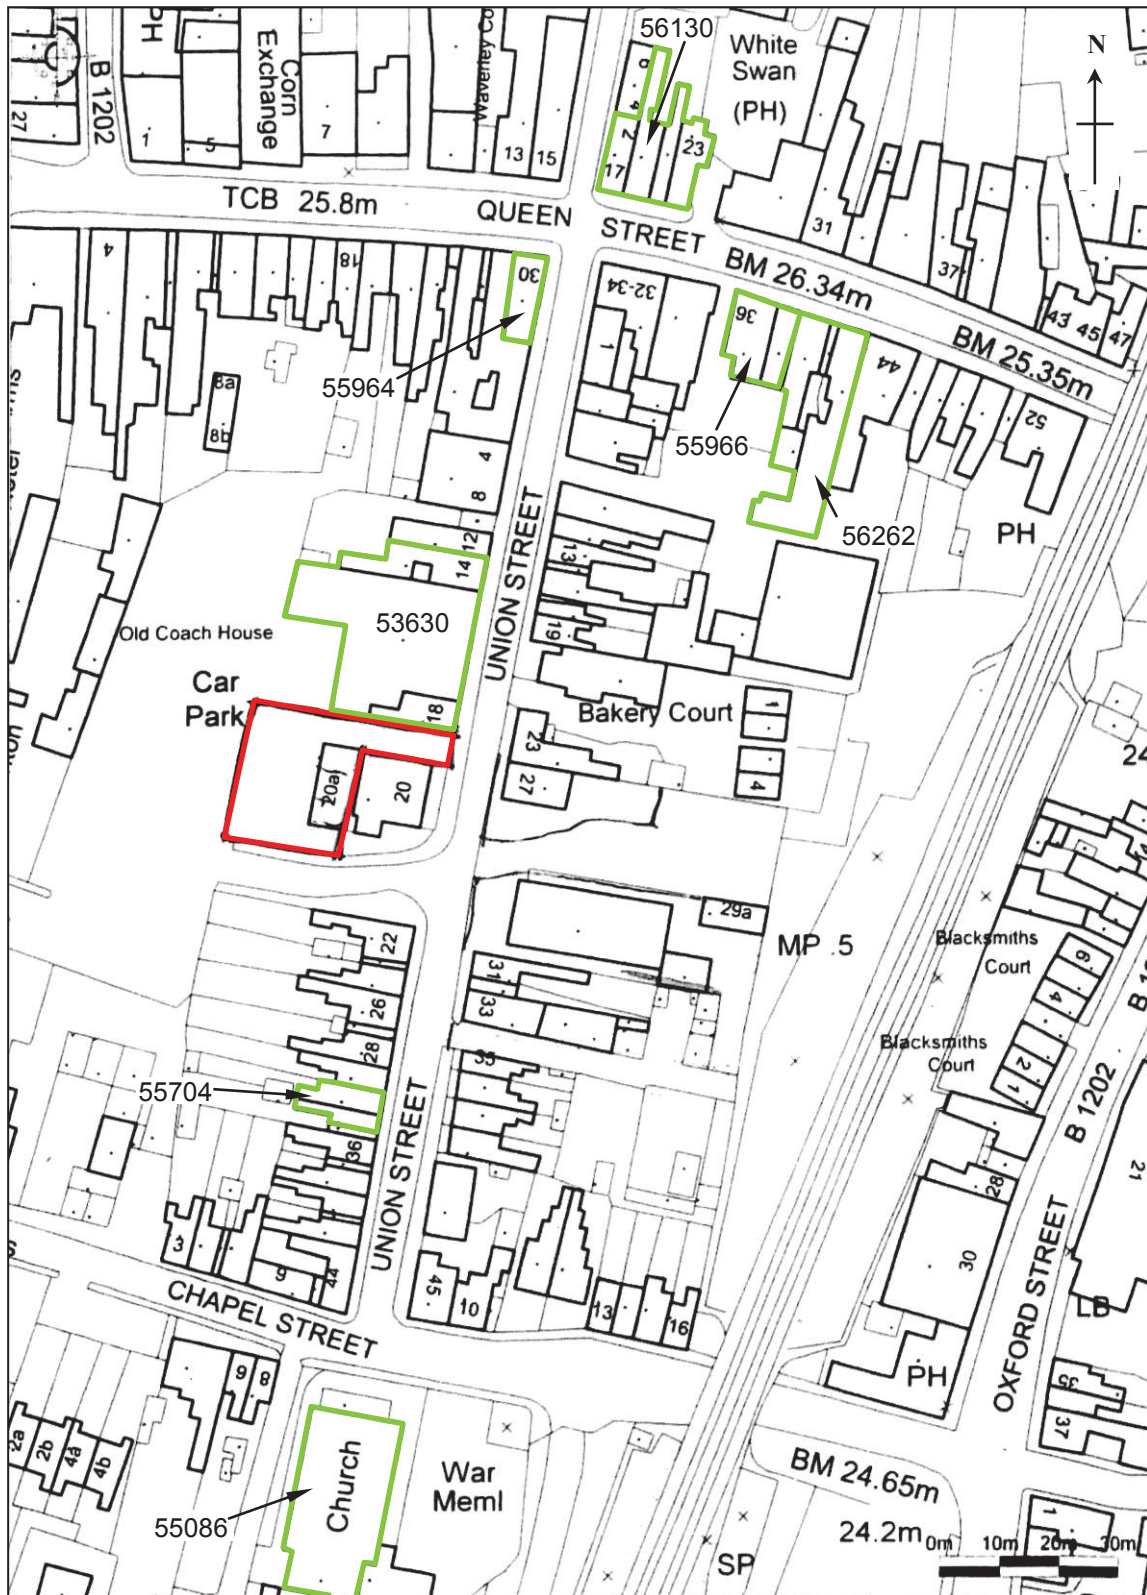
Figure 2: Location plan of the site at scale 1:1250. The site is outlined in red, and Listed Buildings in its neighbourhood in green. Plan supplied by client.

The historic town centre contains a large number of surviving post-medieval buildings, many of which are listed: those in the immediate neighbourhood of the site are marked on figure 2. Nos. 14, 16 and 18, Union Street, directly adjoining the north side of the site, are jointly a Grade II Listed Building. They consist of a former Co-operative store, built in 1897, incorporating a manager's house on its south side and a separate but matching shop front to the north; most of the original shop fronts survive (HER ref. 53630). To the south of the site, no. 30, Union Street, now Rasen DIY, is a Grade II listed early 19th-century building, possibly converted to a shop from a house (HER ref. 55704), while the south end of Union Street is closed by the Grade II* listed Centenary Chapel (HER ref. 55086) on the far side of the junction with Chapel Street. To the north, the Grade II listed no. 30, Queen Street, now Spencer's Newsagent, at the junction of Union Street and Queen Street, also dates to the early 19th century (HER ref. 55964), while nos. 17-23 Queen Street, on the opposite corner of the junction, is a Grade II listed corner block of four early 19th-century shops (HER ref. 56262). The early 19th-century shops at nos. 36/38 and nos. 40/42, Queen Street are also Grade II listed (HER refs. 55966 and 56262).

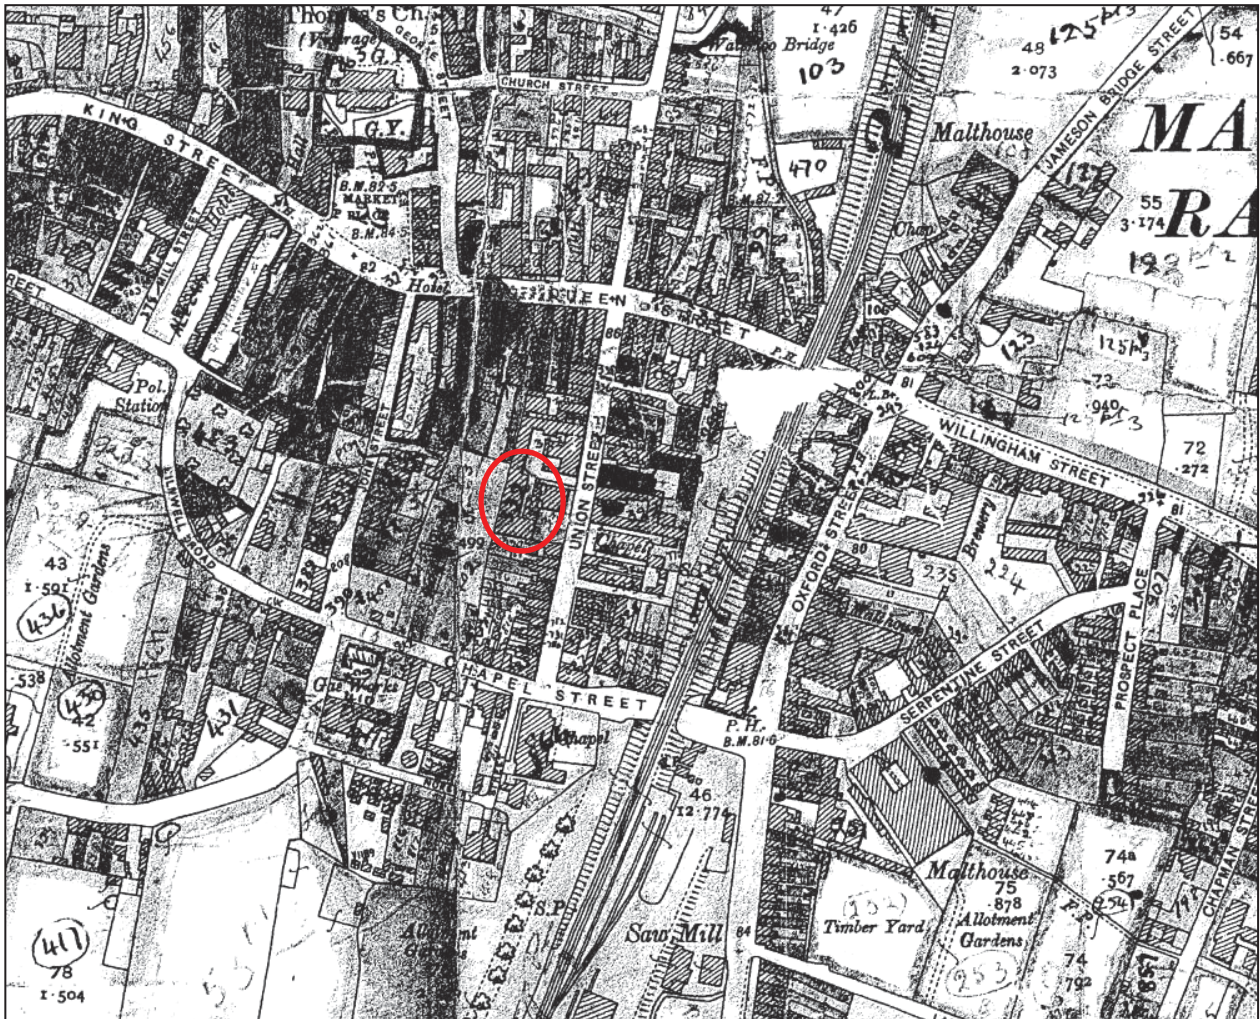
Figure 3: Extract (not to scale) from the 1910 Land Tax surveyors' plan of Market Rasen, drawn up on 25" to the mile Ordnance Survey mapping from 1906. The site is ringed in red.

The enclosure award plan of Market Rasen parish, dating to 1780, shows Union Street as laid out and developed (HER ref. 52752), while the 25" to the mile 1st and 2nd edition Ordnance Survey maps, which are detailed enough to depict individual buildings, show the present development site as occupied by a large, roughly square building (fig. 3).

The 1910 Land Tax surveyor's plan of Market Rasen (Fig 3) shows a small rectangular structure (Building B) south-east of a larger building (Building A) on the site. Building A, a factory used to make plastic bags, was the latest structure on site, truncating the well on the south end of the site. After it was demolished, the site was levelled, and areas were covered in concrete and tarmac.
