ARCHAEOLOGICAL EXCAVATION AND MONITORING REPORT:

**Land at the Former Castle Soap Works, The Callis,
Ashby de la Zouch, Leicestershire**

Report prepared for

January 2015

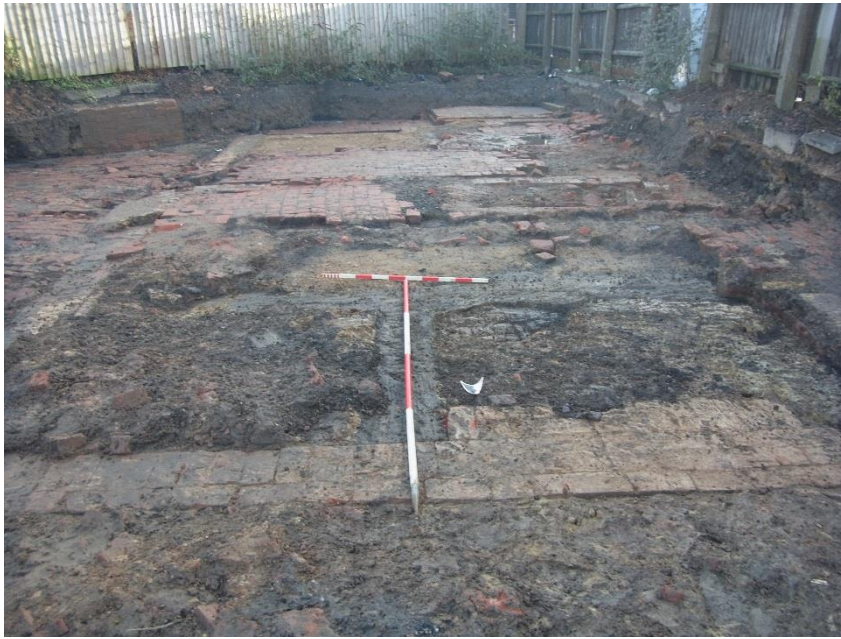
3. South end of the Glue and Leatherworks showing walls 138 (N-S) & 184 (E-W) and floors 196,199 & 200. Looking south.

In the West Range the room formed by wall 184 on the south side and 138 on the east was observed to contain a dump of lime. This product was used in solution to loosen the hairs of the epidermis prior to the tanning process (Yeomans 2006:31). It is probable this lime was being stored on site for this precise purpose.

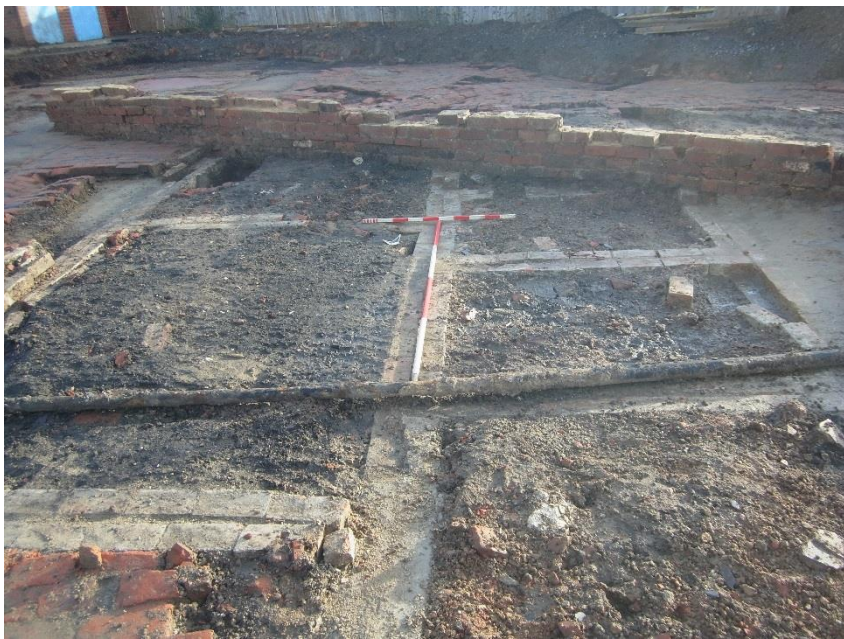
12. General shot of soaking tank structure 110 truncated by wall 107. Looking east.

In the central 'yard area' between the exposed wings of the Glue and Leatherworks, structure 110 comprised of 8 brickwork tanks of varying sizes. For purposes of clarity these tanks were subdivided A to H. Tank A contained a brickwork drain 183 which was covered by a substantial accumulation of sandy silt (111). Finally Tank A was capped with brickwork 183 which was observed to have slumped into the fill. Tank B contained an iron water pipe or gutter affixed to its north side interior which was covered by modern fill (112). Tank C was covered with a brickwork capping 113.

To the immediate north of structure 110 was a brick pathway 180. Both structures were truncated by a later northeast-southwest orientated wall 107 and overlain by a redundant water main (fig. 8-11). The later addition of the wall 175 also truncated foundation 154 of the Leatherworks building.

A possible modern construction was indicated by walls 107 and 175. Site records indicate that the brickwork was of a more 'recent' type, therefore it is considered to be part of a later modern structure. In addition, these walls truncated the structures of the Leatherworks demonstrating that they were stratigraphically later features however, no available mapping depicts this later structure. The Leatherworks building had been used by the Castle Soapworks as part of the factory from 1910 until the late 1950s when the building was finally demolished. Deposit (148) within the

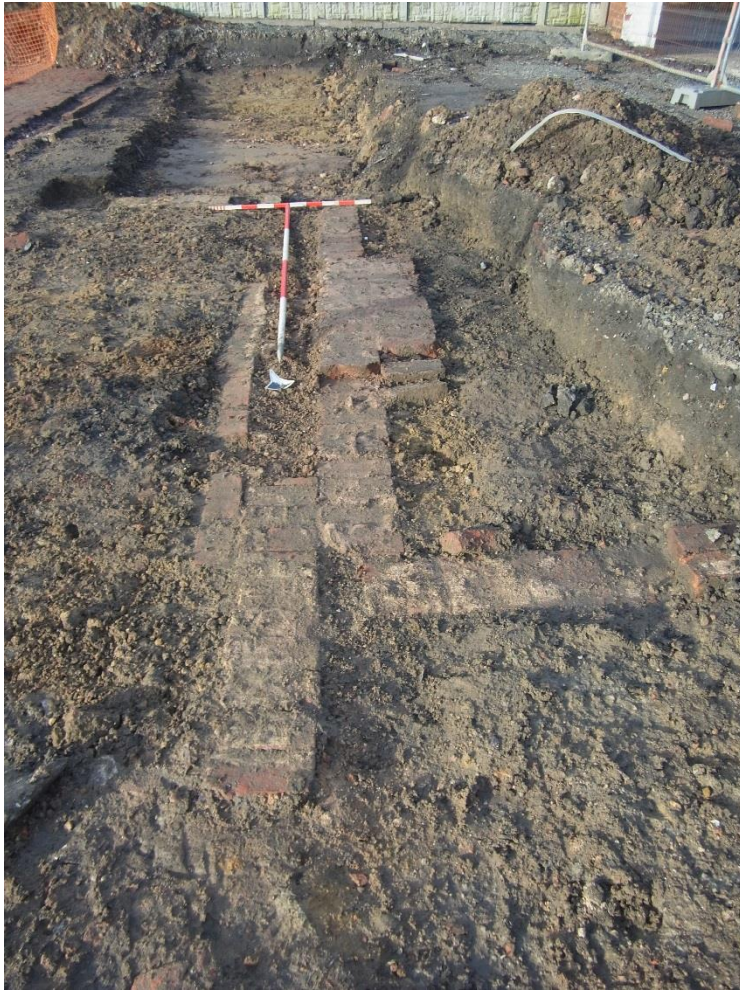
18. Drain 140 north of pathway 141. Looking west.

Structural feature 140 north of path 141 appeared in plan as a wall however, there was no visible construction cut containing the brickwork or bonding agent maintaining the integrity of the 'wall'. The bricks were laid out on bed in a header pattern, from which a similarity was drawn with brickwork 146 at the east of the North Range. This structure was laid out likewise without a bonding agent. The function of these structures is unclear but their loose structural integrity may indicate they are disturbed brickwork footings.

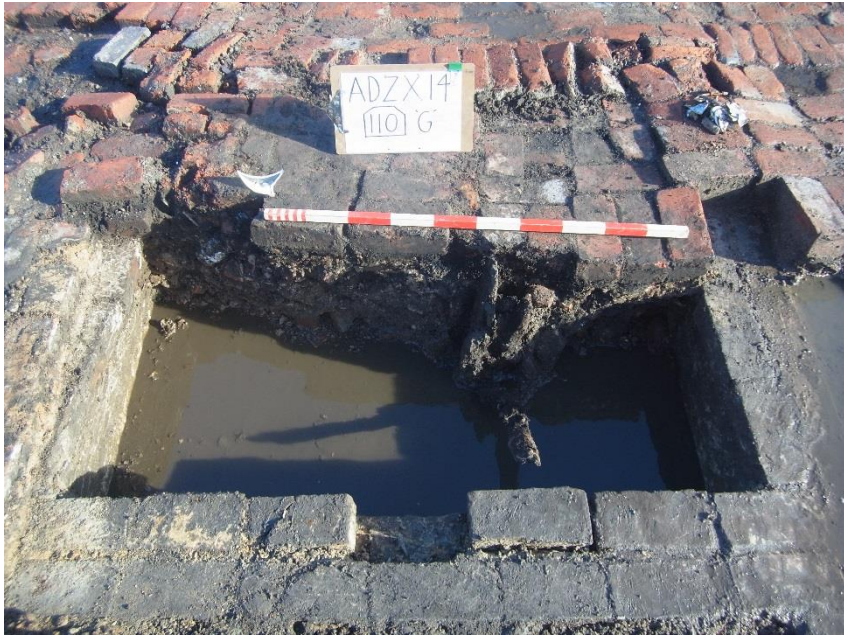
22. Structure 110, soaking tank 'G', west facing section. Looking east.

Tanks D and E were filled with rubble and silt deposited by the backfilling of evaluation Trench 3; Tank F contained a dark silty clay; Tank G a silty backfill (120). Tank H contained a deposit much the same as that in Tank G.

The brick cappings of the soaking tanks and brickwork yard area may also indicate later additions - the brick flooring of the yard area partially overlay Tank G. Brickwork capping over the tanks was perhaps contemporary with the construction of the yard area, allowing it to extend over the pre-existing structure; however to the north and west no brick floor was extant. Certainly the capping would indicate a change of use and may relate to the adaptation of the Leatherworks building for use by the later Castle Soapworks established in the 19th century. The tanks of structure 110 were still present at the time of the 1903 OS map (fig. 5), but are not depicted in the 1913 edition (fig. 6) which may indicate the change of use occurred during the intervening period. Previous work has suggested that the building's change of use occurred in 1910, which is borne out by the cartographic information above (Underhill 2014). The backfill within structure 110, Tank G, produced finds dating to the 19th-20th century which further supports this hypothesis.

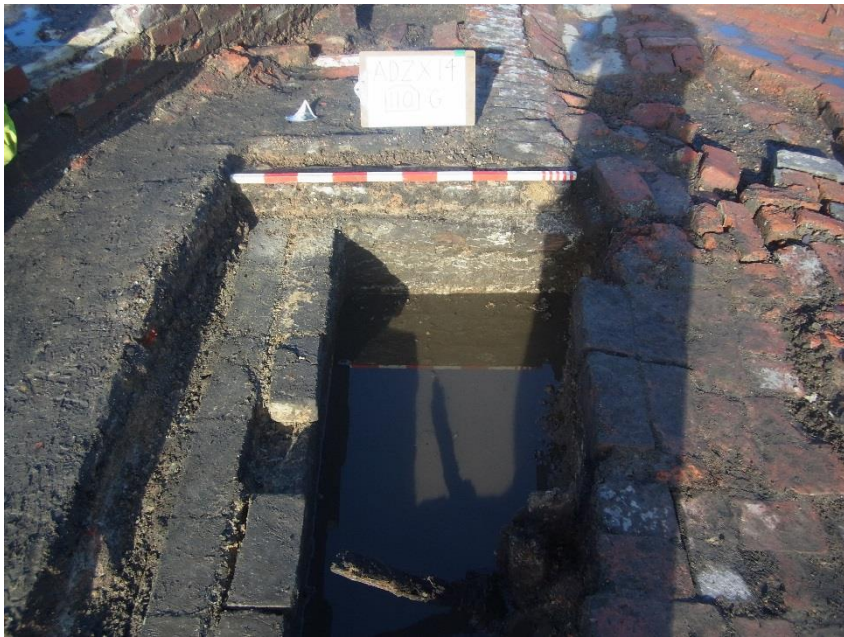
23. Structure 110, soaking tank 'G', south facing section. Looking north.

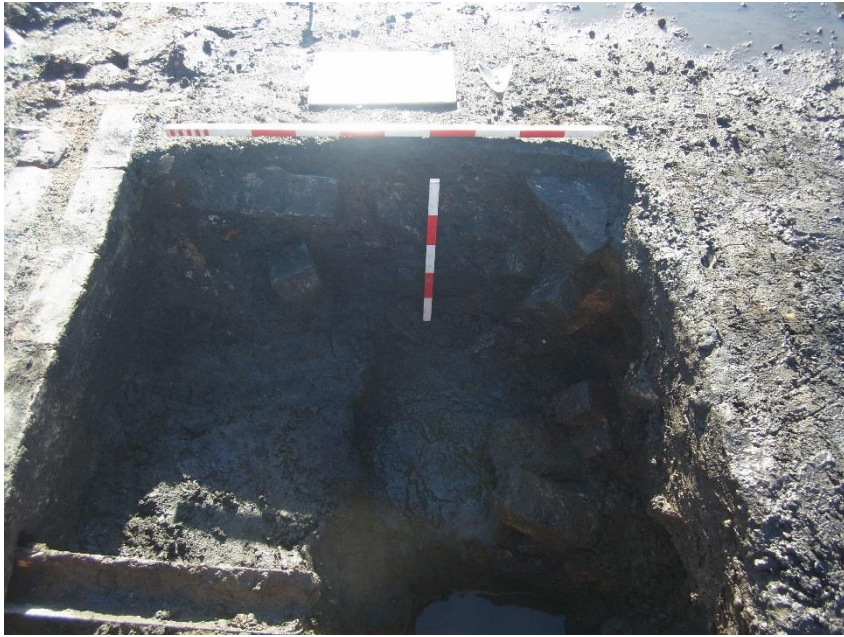
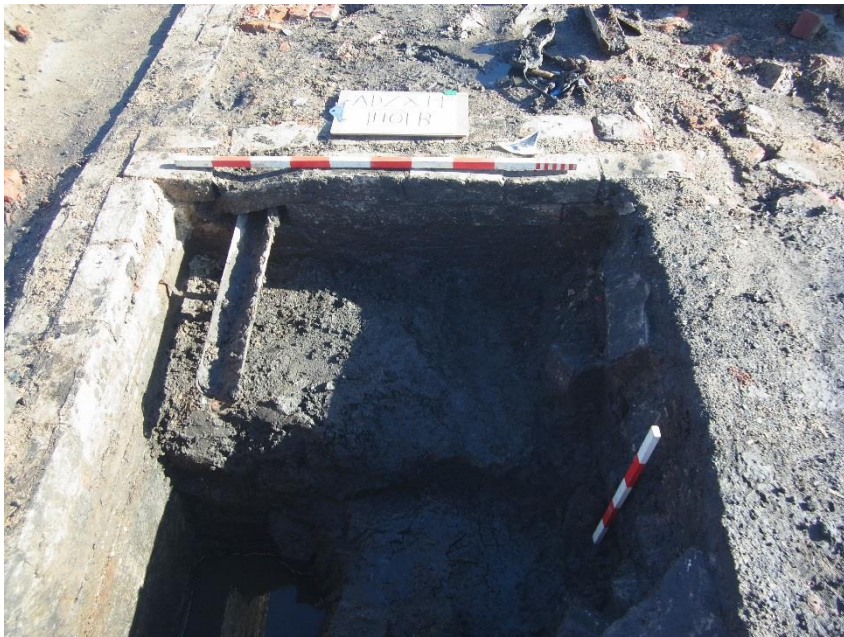
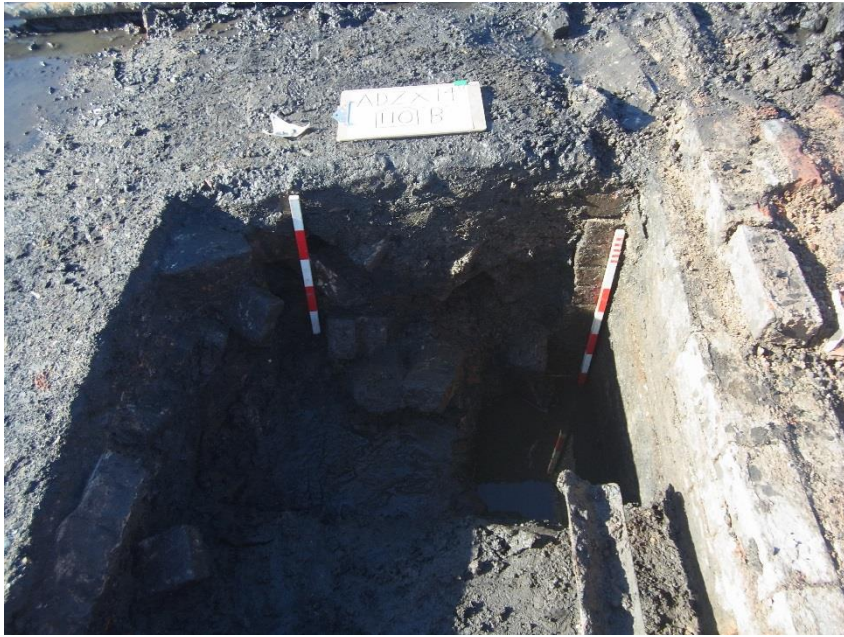
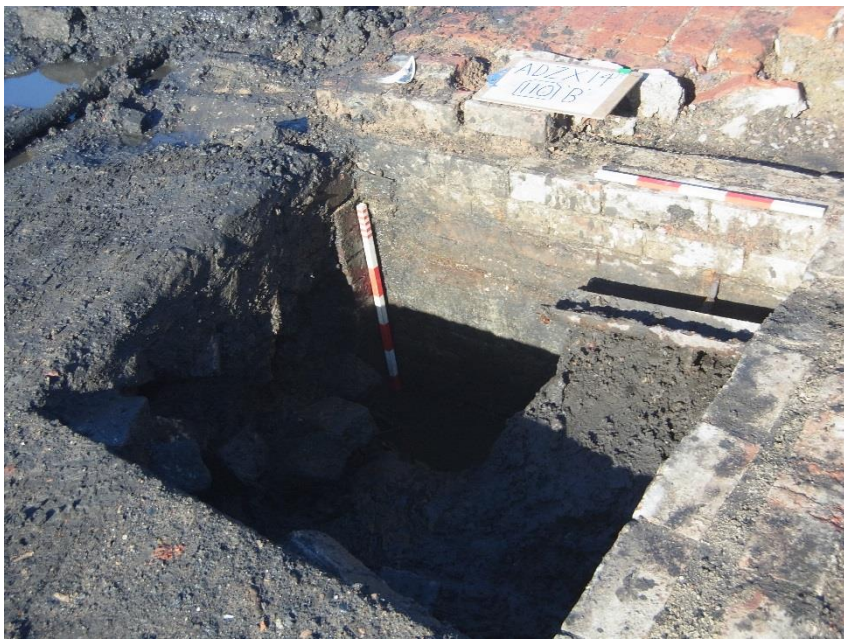
26. Structure 110, tank 'B', north facing section. Looking south.

27. Structure 110, tank 'B', west facing section. Looking east.

28. Structure 110, tank 'B', east facing section. Looking west.

29. Structure 110, tank 'B', south facing section. Looking north.

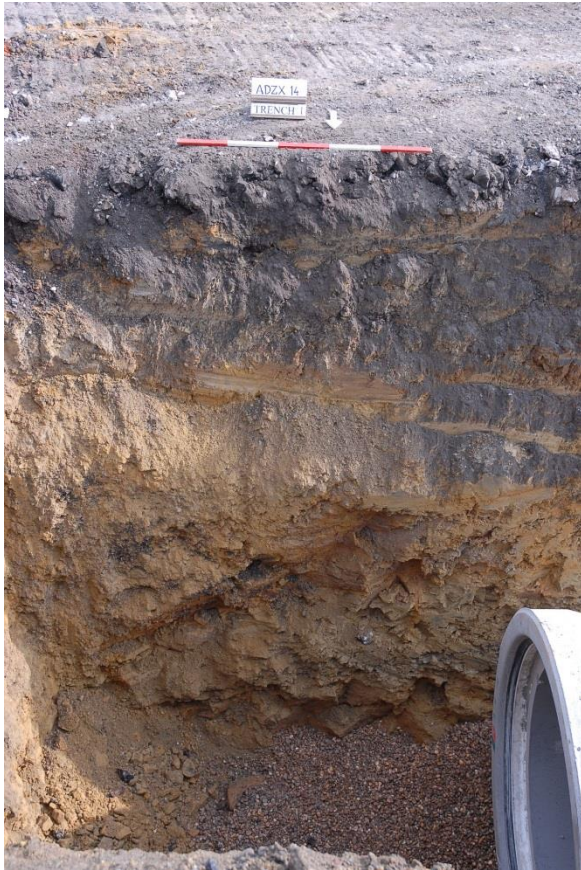
32. Representative Section of Phase 2 trench, looking north

Asphalt surface (001) was seen to overlie demolition layer (002) which in turn covered layer (003). Deposit (003) lay directly on top of the natural sandstone substrata (004).

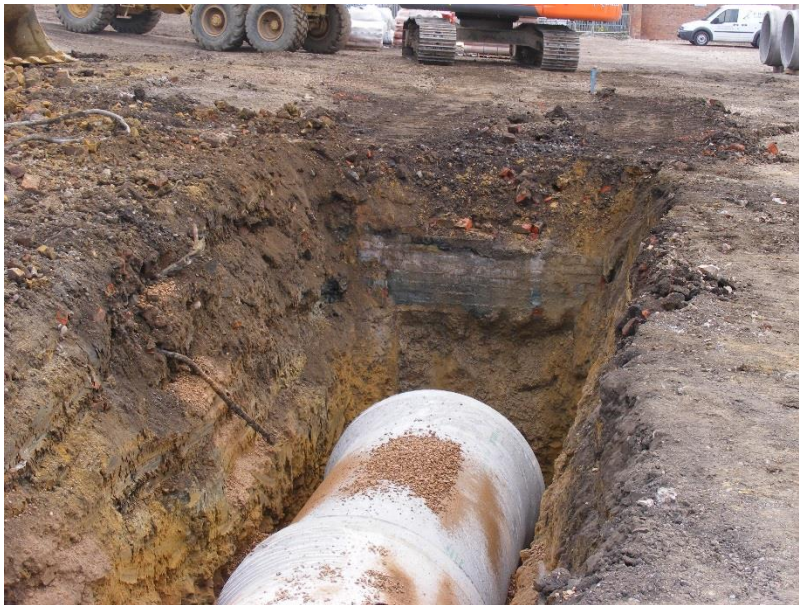
33. Structure 006, looking east

Structure 006, possibly a brick built tank, was observed at the most easterly extent of the Phase 2 excavations. Covering the structure was demolition layer (002). Structure 006 was contained within a construction trench [005], cut through sandy clay layer (003). The primary fill (008) was a black industrial deposit containing demolition material. The secondary fill (007) was a mixed brown-grey clay present within 006 and surrounding the structure.

The only feature of archaeological significance observed during Phase 2 monitoring was the putative brick tank indicated by wall 006. Detailed recording of the structure was not carried out as it was deemed unsafe to enter the excavation due to the narrow width and depth of the trench. The site records suggest that the primary fill may indicate an industrial function. No dateable material was recovered from associated deposits. The structure was sealed by demolition material. A relationship with the leatherworks, if any, was not established.
