WILLIAM STREET BUSINESS PARK, WILLIAM STREET, SAXILBY, LINCOLNSHIRE

ARCHAEOLOGICAL MONITORING AND RECORDING

Prepared for Pride Homes

by R. Mandeville January 2015

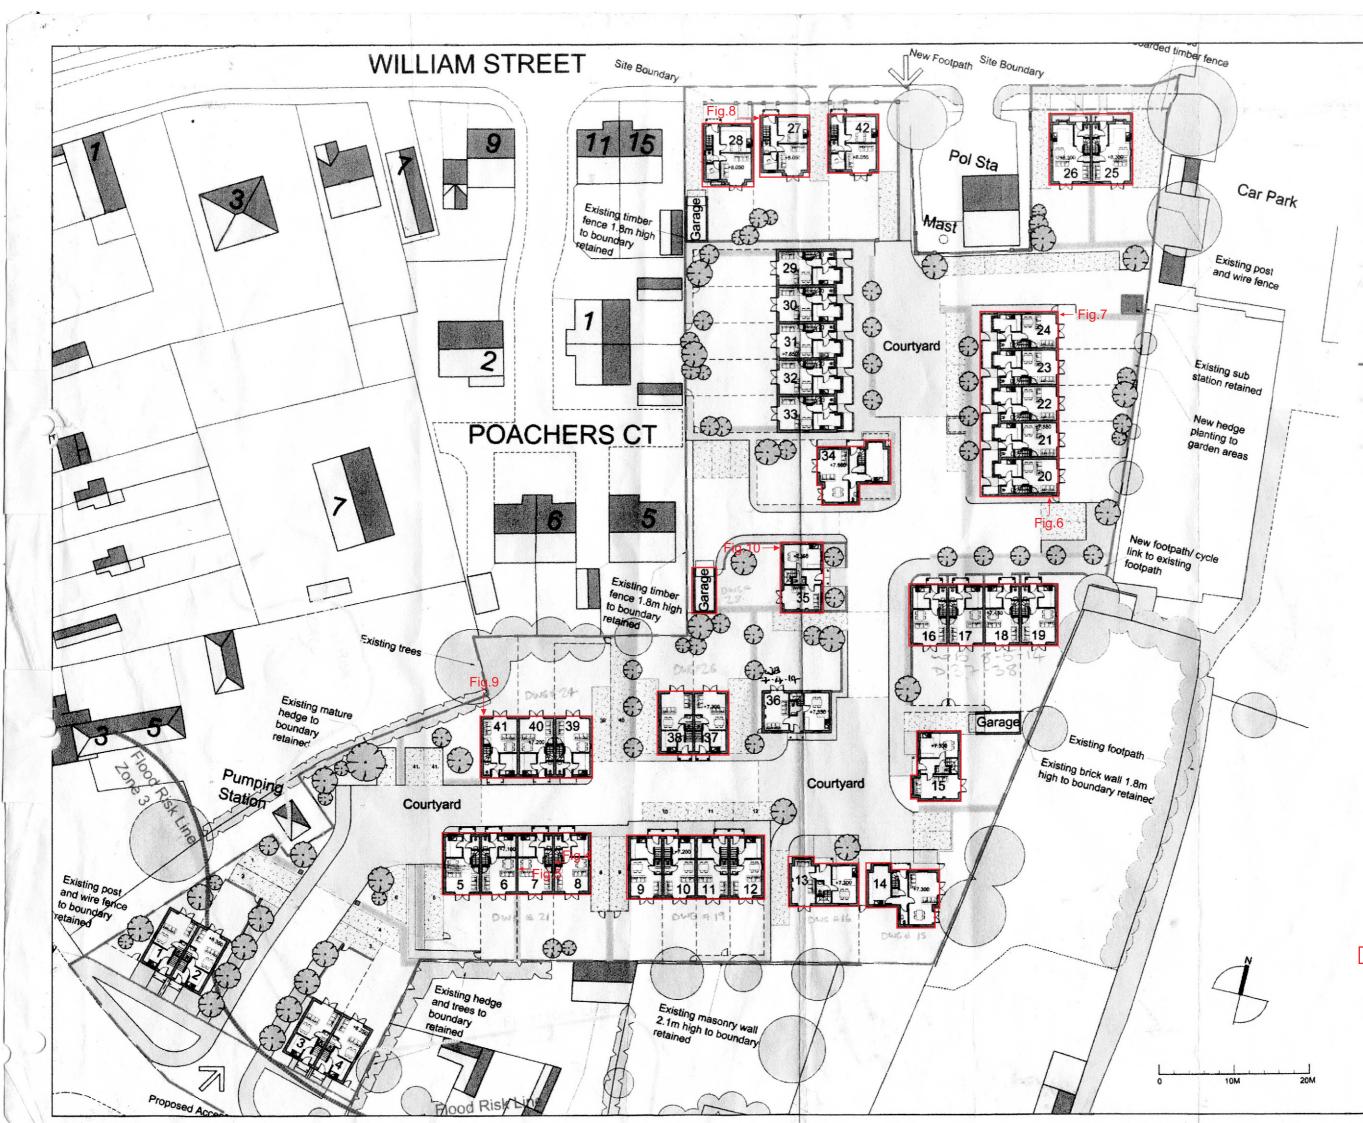
Figure 3: Plan of the site showing house plots and the areas monitored. Plan supplied by developer. Scale 1:500.

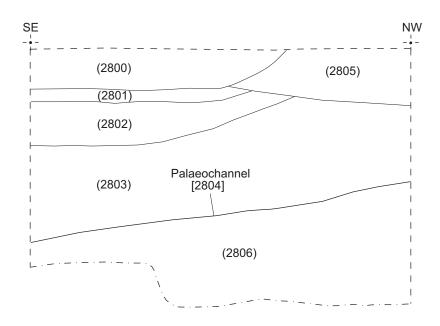
Fig. 8: NE Facing Section of Palaeochannel [2804]

These plots were located in the north-western corner of the site. A natural palaeochannel [2804] ran along a north-east to south-west alignment, measuring 4.60m wide by 0.74m deep; this was the same feature as that recorded in Trench 2 of the preceding evaluation. No features of archaeological interest were encountered.

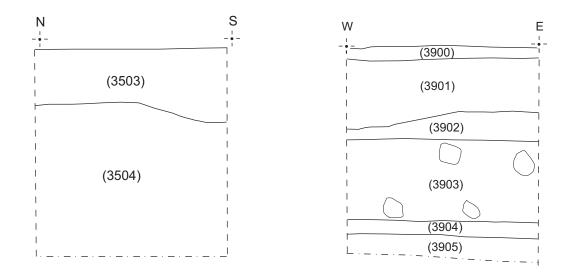
Fig. 10: Representative Section of Plot 41

These plots were located adjacent to the north of Plots 5-12. Nothing of archaeological interest was encountered.

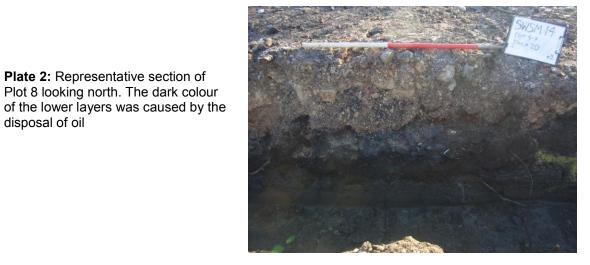
Plate 1: Plots 5-8 looking north-east. The condition of the ground suggests the engineering works were at this location of the site

disposal of oil

Beneath parts of this zone, a hardcore layer (500) overlay a black tarmac-based layer (502) which had been contaminated with oil, either leeched from above or contained within the layer itself. It would appear likely that this location was a dumping ground for oil discarded from the engineering works situated on the site. Nothing of archaeological interest was encountered.

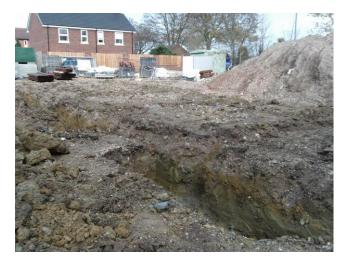
Plate 3: Plots 20-24 looking north-east. Prior to monitoring, there had been less hardcore removed the south of the plot

Plots 20-24 were located on the eastern side of the site, slightly north of Plots 16-19. Nothing of archaeological interest was encountered during the monitoring programme.

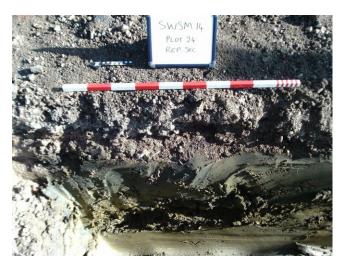
Plate 4: Representative section of Plot 24 looking east. Hardcore layer (2000) is present only in Plots 23-24.

Context No.	Туре	Description
2000	Layer	Light greyish brown hardcore in Plots 23-24. 0.15m thick
2001	Layer	Mid yellowish brown sandy gravel with brick in Plots 20-22. 0.15-0.30m thick
2002	Layer	Mid yellowish brown silty clay subsoil, small gravel inclusions. 0.25-0.70m thick
2003	Layer	Mid-dark yellowish brown clay natural with occasional stone

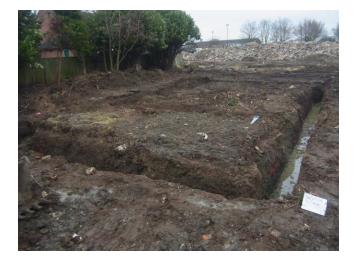
Plate 7: Plots 39-41 looking north-east.

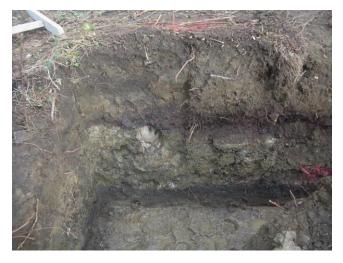
Plate 8: Representative section of Plot 41 looking north. This is a good example of the stratigraphy of the site, clearly showing layers of hardcore, subsoil, building materials and the clay natural

Context No.	Туре	Description	
3900	Layer	Dark greyish brown slightly sandy silt topsoil with some rubble. 0.08m thick	
3901	Layer	Dark yellowish grey loam with building rubble. 0.25m thick	
3902	Layer	Dark reddish brown silty sand, some coal, charcoal, stones. 0.06-0.10m thick	
3903	Layer	Mid yellowish grey slightly sandy clay with pieces of limestone. 0.42m thick	
3904	Layer	Dark greyish brown slightly sandy clay, some small stones. 0.08m thick	
3905	Layer	Light orange-grey clay natural with no inclusions.
