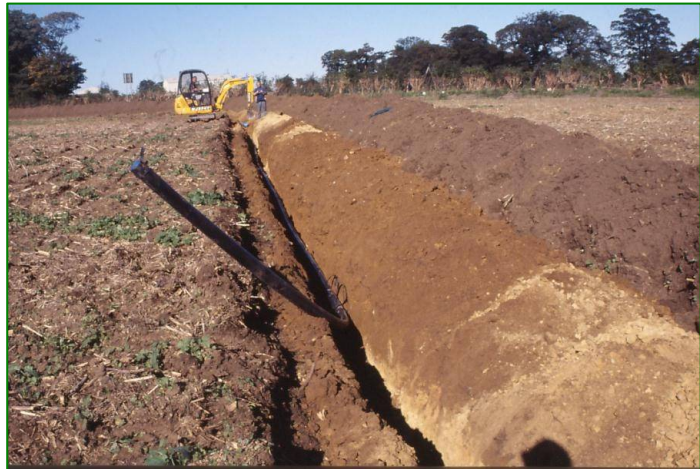
**Plate 4 (right):** The excavated pipe-trench running across the corner of the field, looking west. The low sunlight makes the trench sections difficult to see, but the colour variations on the adjacent spoilheap show the changes from limestone brash to solution material.

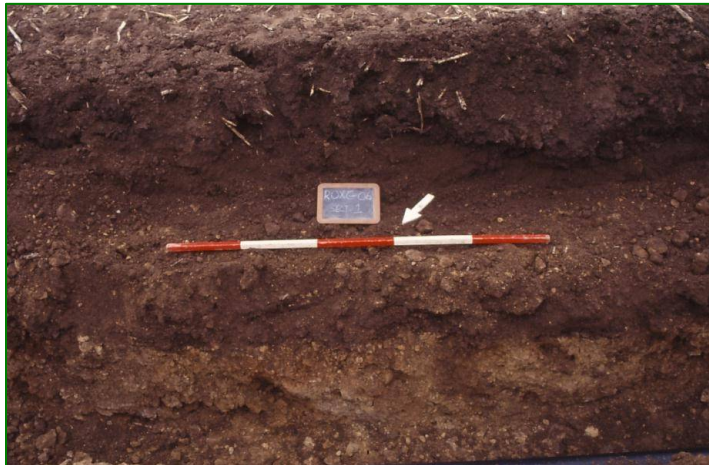
**Plate 5 (left):** Sample section A-B, looking south-east, showing the depth of topsoil adjacent to the north-western field edge.

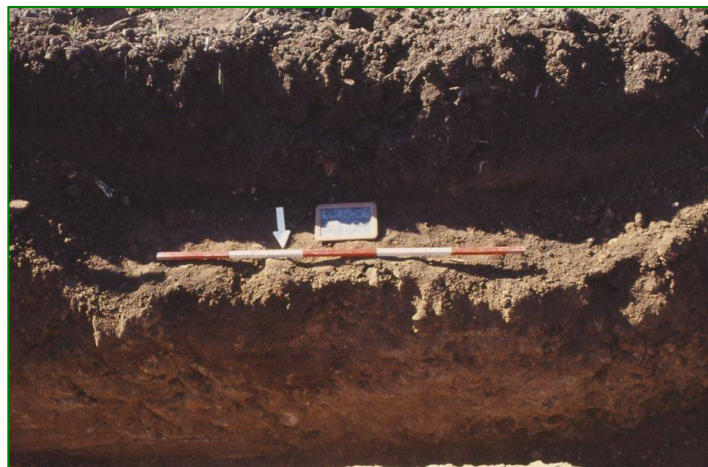
**Plate 6 (right):** Sample section C-D, looking south. Light conditions were extremely adverse, but the change in topsoil depth can be made out; a small solution feature is visible to bottom left.
