**LAND OFF PORTLAND STREET,  
MANSFIELD WOODHOUSE, NOTTINGHAMSHIRE**

**COMPREHENSIVE WATCHING BRIEF REPORT**

Central NGR: SK 5432 6341  
Planning app.: 2007/1125/NT  
Site code: PSMW1214  
PCAS job no.: 928

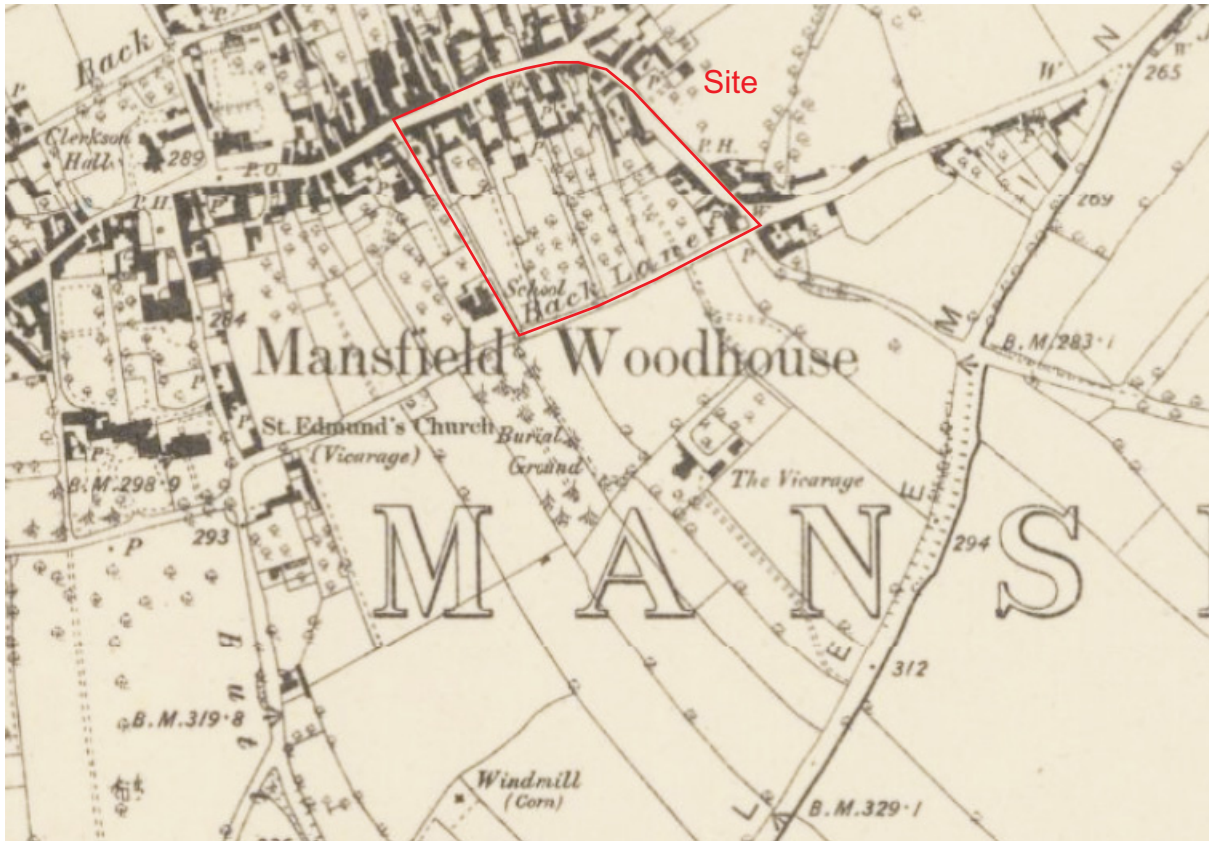
**Fig. 4:** Extract from the 1884 Ordnance Survey map of Nottinghamshire. Portland Street is bordering the north-east of the site, denoted by the red area

The features exposed during the course of the watching brief were associated with partially demolished stone structures, which were recorded on the Ordnance Survey map of 1884 (see Figure 4).

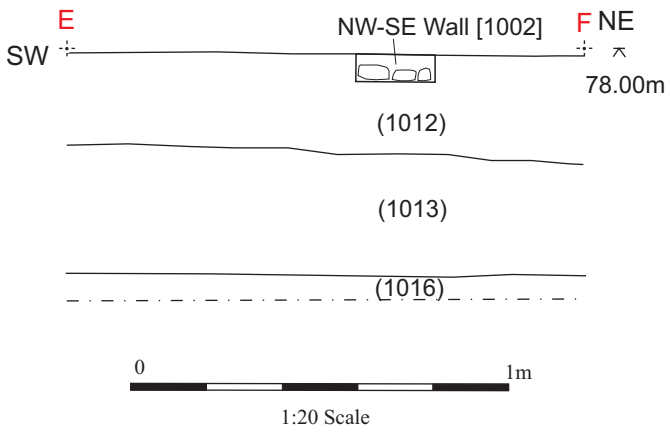
**Fig. 6:** South-east facing section of manhole C2

Trench C1 (3m x 2.6m) was excavated prior to the insertion of manholes C1 and C2, to a depth of 1.40m. Several modern layers created an obstacle, but no archaeological features or finds were identified.

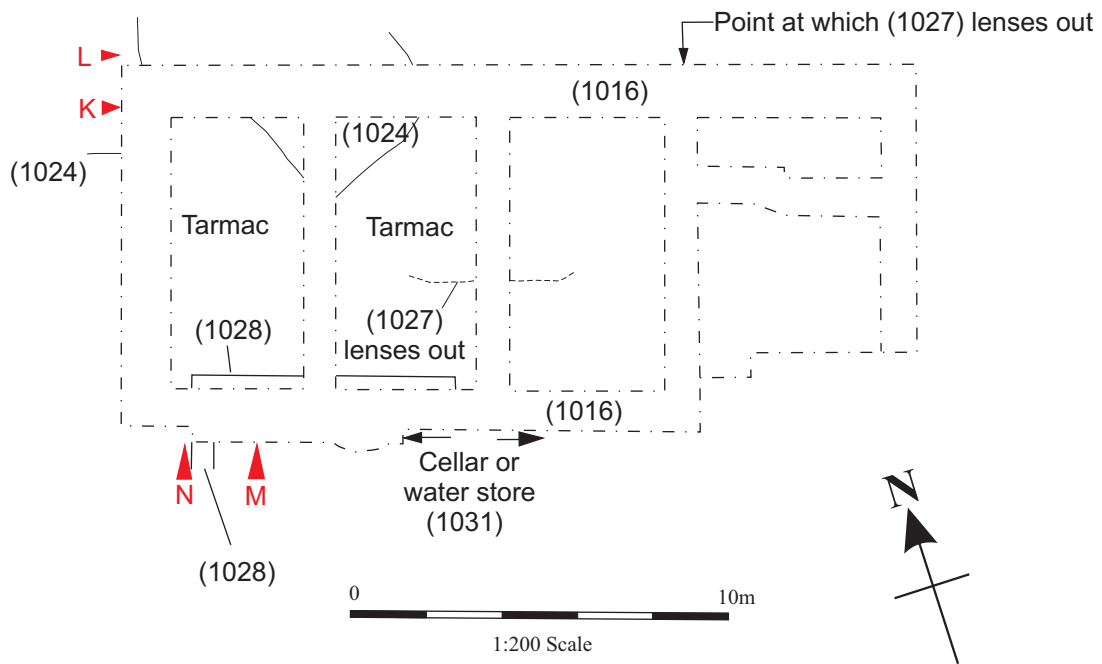
**Fig. 10:** Plan of Plots 27-30, showing the locations of the brick floor (1024), wall (1028), and the cellar/water store filled with rubble (1031)

The southern end of the area revealed a foundation trench (1029), which contained the remains of a wall (1028) made from sandstone blocks held together with lime mortar. After the building of the wall, there was backfilling of a slightly clayey sand material (1030) containing a high amount of stone and rubble. Also identified east of the sandstone wall was what appeared to be the rubble fill (1031) of a former cellar, which may have been used as a water storage tank in the late 19<sup>th</sup> century. No access to the rubble was possible, therefore it was not excavated or recorded. No other archaeological features or finds were identified in Plots 27-30.

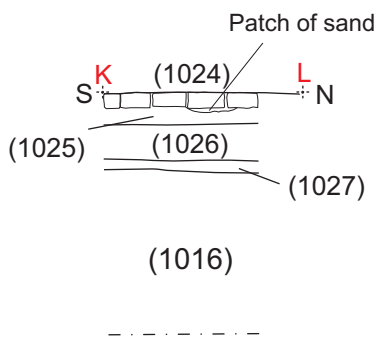
**Fig. 11:** East facing section through brick floor (1024) in Plot 27

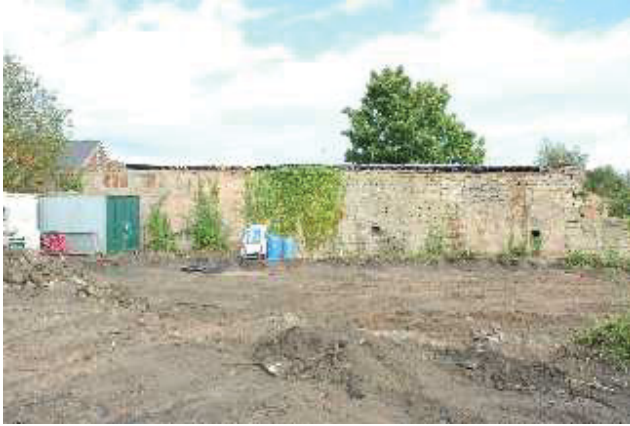
**Plate 1:** Outbuildings as viewed from the south-west. These were lace-making cottages during the 19<sup>th</sup> century. Boundary wall (1004) is on the far right of the photograph.

A group of outbuildings was located to the east of the terraces, which contained three rooms with four external entrances, and was certainly a 19<sup>th</sup> century lace-maker's cottage - the long windows in the first floor were designed to allow light in, and were characteristic of a building which was part of the Nottinghamshire lace-making industry. A boundary wall [1004] was situated to the south of these outbuildings, but any relationship between the wall and buildings or the terraced housing structure had been obscured by rubble.

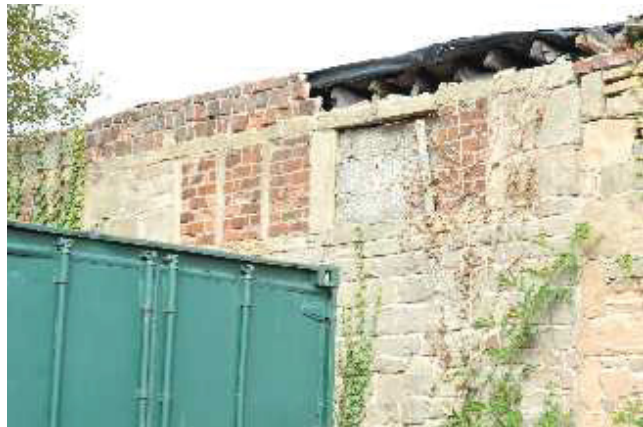
**Plate 2:** Windows of the outbuildings. Situated on the first floor, the long styled windows were characteristic of lace-making cottages in Nottinghamshire.

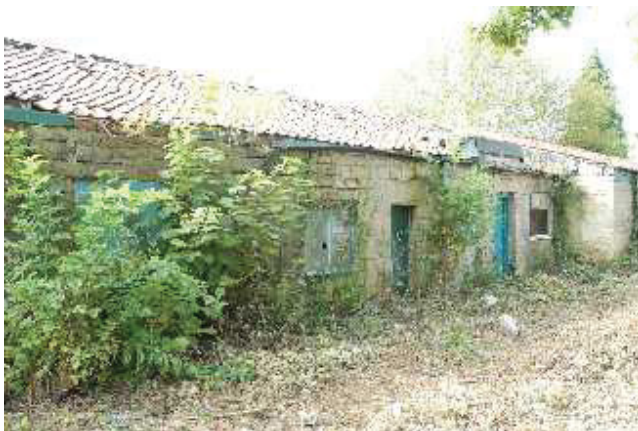
**Plate 3:** The central section of the 19<sup>th</sup> century lace-making cottages, as seen from the front.

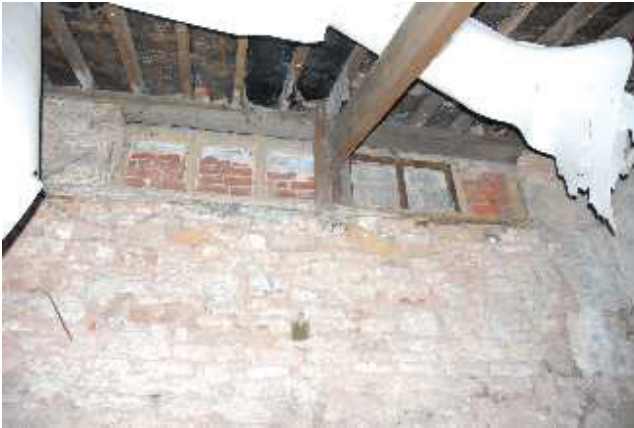
**Plate 4:** The central section of the 19<sup>th</sup> century lace-making cottages, as seen from the inside. The windows have been boarded up by modern bricks, but their form is clearly defined.

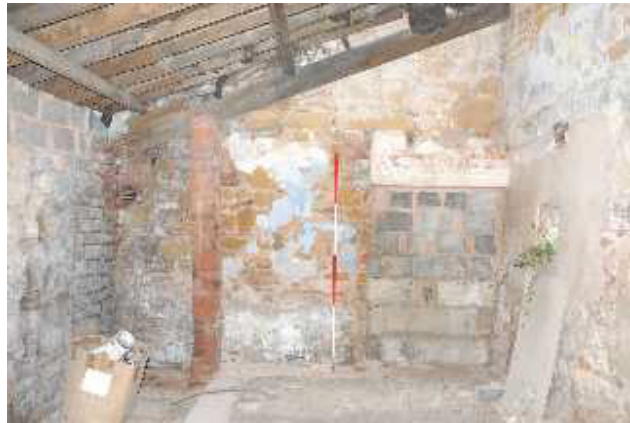
**Plate 5:** The internal walls of the lace-making cottages remained standing, but the internal doorway has been boarded up.

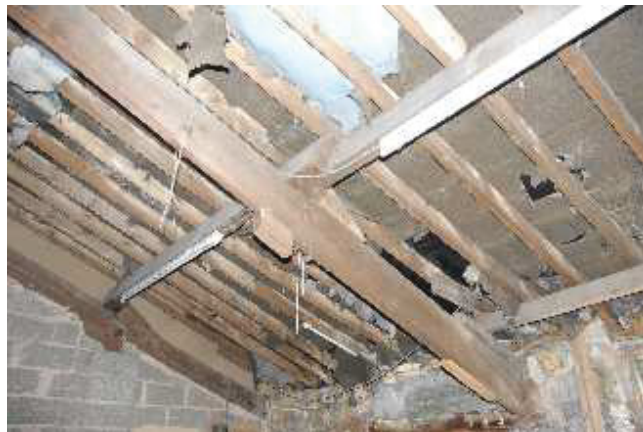
**Plate 6:** The roof of the central section of the lace-making cottages. Most of the structure remained, understandably in a state of disrepair.

A standing building was situated to the north-east of the site, and clearly visible on the 1884 map; a lace maker's cottage dating from the 19<sup>th</sup> century. The external walls of the building were fully standing, and the internal walls and concrete floor were generally structurally sound, although internal doors and the windows had been boarded up in modern times. Many of the beams in the roof were present, and the roof itself was also largely intact.

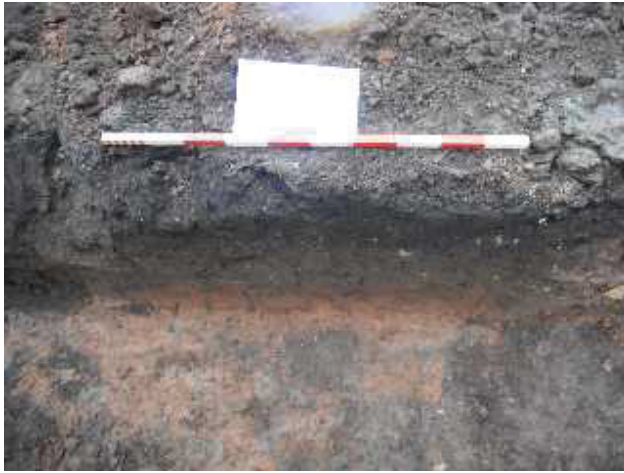
**Plate 7:** Representative section through Garage Plot 2. The sandstone natural substrate (1020) extends over most of the site, but the hardcore layer (1023) does not.

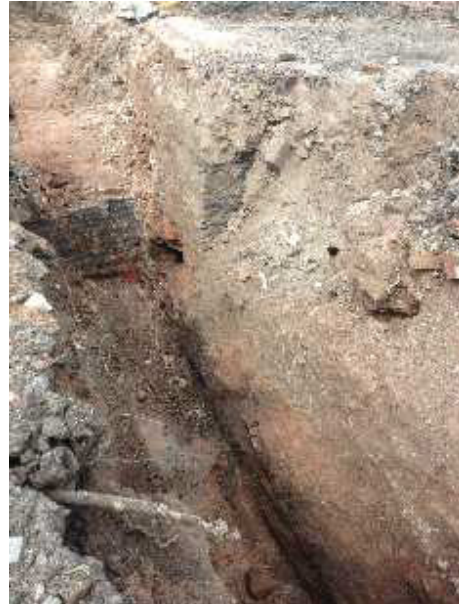
**Plate 8:** View looking south-east along the southern footing of Plots 27-30. The wall formed part of the cellar.

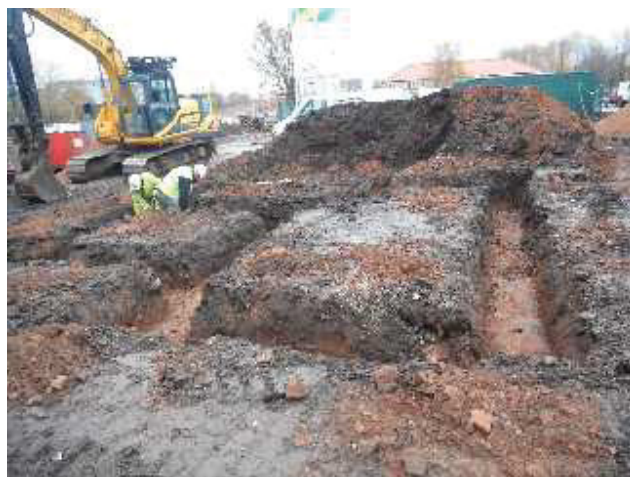
**Plate 9:** Plot 9 after excavation of the footings. The layer of demolition rubble (1022) was especially prevalent at this location.

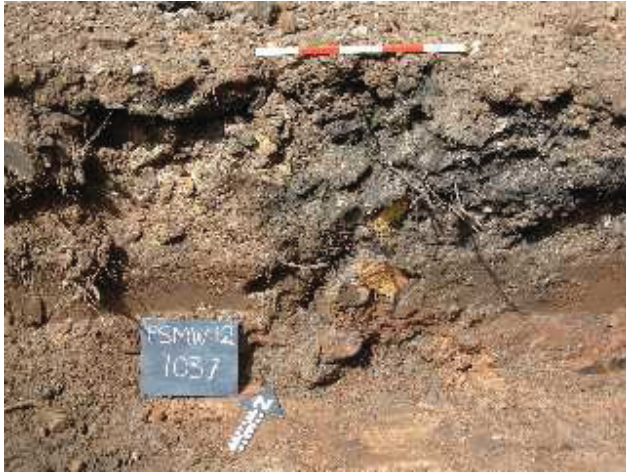
**Plate 10:** Foundation of sandstone wall (1037) looking north. It is probably the Foundations of the current boundary wall to the rear of Plot 9.

From the north-west side of the road, a wall foundation (1037) which followed the line of the foundation of the boundary wall at the rear of Plot 9 was believed to be part of the same wall. The foundation consisted of a number of small blocks and fragments of sandstone lying in a haphazard manner, in a poorly visible construction cut [1038]. No coursing or working on the stone was noted.

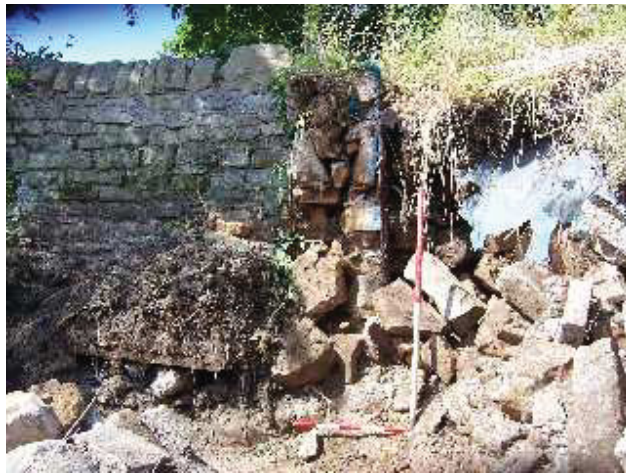
**Plate 11:** Sandstone boundary wall (1048) looking west. The wall to the left is modern.

In Garage Plot 12, what appeared to be a boundary wall (1048) nearly 2m high and constructed of sandstone blocks ran along a north-west to south-east alignment. There were small packing stones along with the occasional piece of modern brick contained within the wall, but no indication of a wall cut due to the disturbance of the ground. Apart from this, nothing of archaeological interest was exposed in this area.
