**STONEFIELD SCHOOL, CHURCH LANE, LINCOLN**

**SCHEME OF ARCHAEOLOGICAL MONITORING  
AND RECORDING**

NGR:	SK 97906 72308
Planning Ref.:	2013/1000/F
PCAS job no.	1150
Site code:	LSSM13
Archive acc. no.:	LCNCC 2013.218

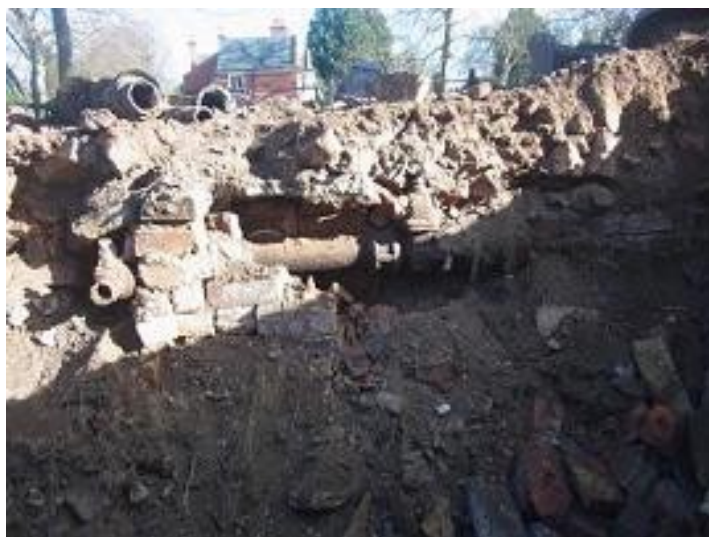
Layer (003) contained the remnants of an east-west aligned brick wall [010] which after further excavation of footings to the east was associated with partially exposed north-south aligned brick walls [012] and [014]; the latter containing two heavy cast iron pipes suggestive of conducting water or perhaps steam from a heating boiler. Similar iron pipes were observed to the south in brick structure (019), likely part of a heating system, which rested on a foundation of re-used limestone blocks (017).

**PL. 3:** Brickwork with cast iron pipe, possibly heating system.

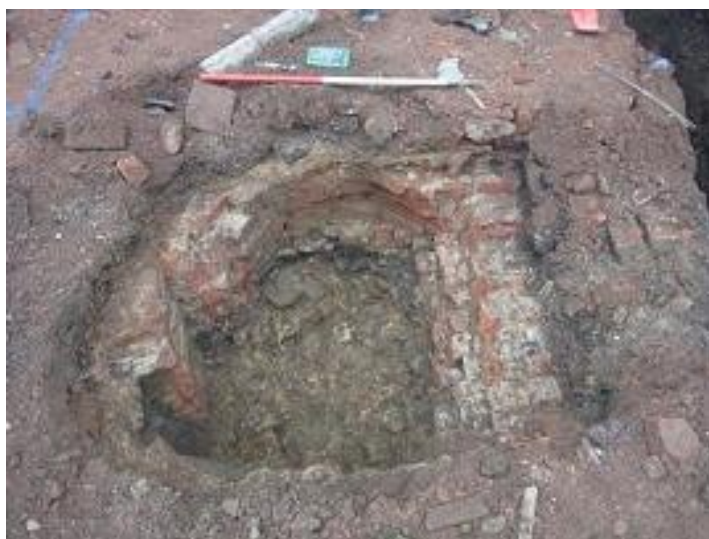
Near the south end of the footings, feature [018] was partially exposed located 1m to the east of the main building. Initially thought to be the remnants of a well, the brick structure exhibited a semi-circular wall edge on the west side, with the remaining three sides being comparatively square and the north edge of brickwork appearing to be slightly stepped. The fill of this feature consisted of redeposited soil, (035), similar to buried garden soil (003), with the construction cut of the feature partially observed at a depth of 1.39m from surface level. However the purpose of this structure was not ascertained from the available evidence.

**PL. 4:** Brick built feature [18], 1m scale. Facing west

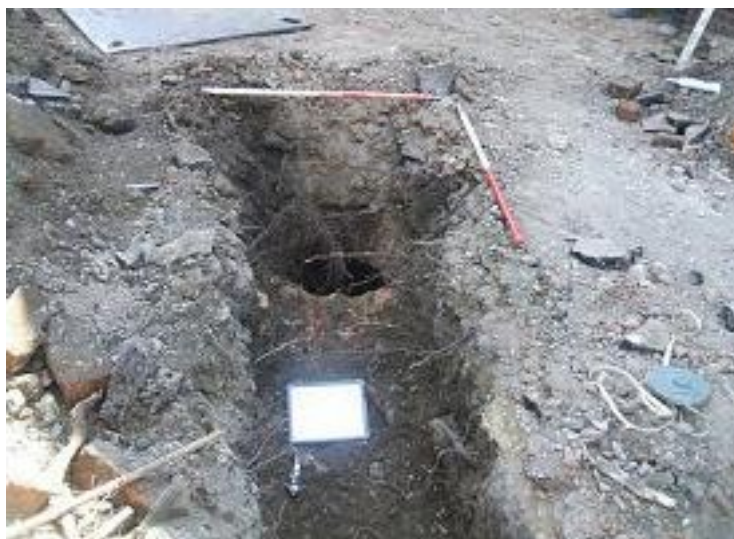
A well, [039], was located on the far eastern edge of the footings, in a north-south aligned trench approximately 13m to the east of Stonefield House. This was a circular structure built of machine manufactured plain brick with a domed brick built well-head. The main structure beneath the dome had a diameter of around 1.7m and an exposed depth of at least 2.3m.

**PL. 5:** Brick built well [39] with cap removed. Facing South

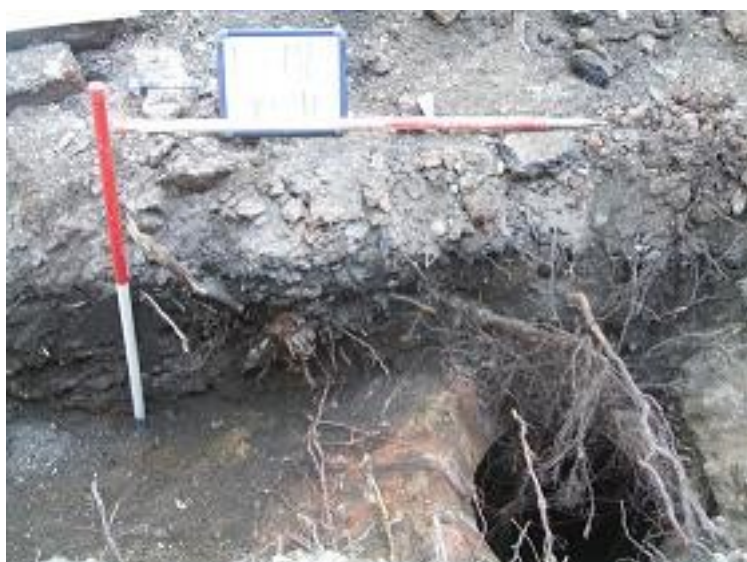
The brickwork observed consisted of two types, a frogged type set in cement in the centre of the well-head and clearly more recent than those bricks of the main structure of the shaft which were set in lime mortar. The interior of the well shaft was coated with plaster which had been either over-painted or possibly iron-stained, producing a mottled colouring. A lead pipe of 45mm diameter with a perforated base was retrieved from the shaft. The well shaft was considered to be contemporary with the original building, with continued use signified by the later domed well-head. The structure was later broken out and backfilled. The location of a second, capped, well was encountered adjacent to the stable buildings to the north of the site but, being outside of any intended groundworks, it was left undisturbed.

**PL. 6:** Edge of brick well [39] showing overhang of well mouth.  
Facing east
