**UTILITIES SCHEME, SITE OF ST. MARY'S PRIORY, GREENFIELD,
NEAR ALFORD, EAST LINDSEY, LINCOLNSHIRE**

**REPORT OF A SCHEME OF ARCHAEOLOGICAL
MONITORING, CONTROL AND RECORDING**

NGR: TF 4327 7798
PCAS Job No. 1438
Site code: SMPM15
Planning ref. N/001/02018/14
Scheduled Monument
Consent Ref.: S00096617
Archive acc. no.: 2015.82

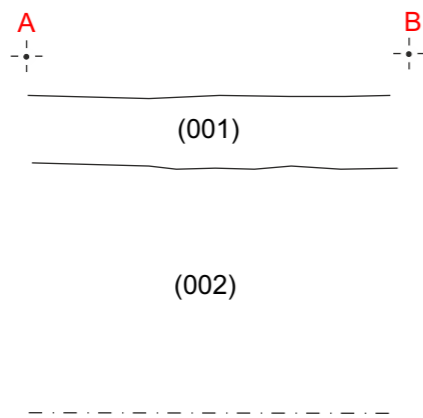
a) Section through road

The trench was 90m in length and 0.3m wide, with two 5m elements branching towards the White Cottage. Three layers of material were revealed: modern tarmac and redeposited topsoil, overlying compacted chalk; some 0.6m below the present surface natural glacial till (002) was exposed. Nothing of archaeological interest was noted.

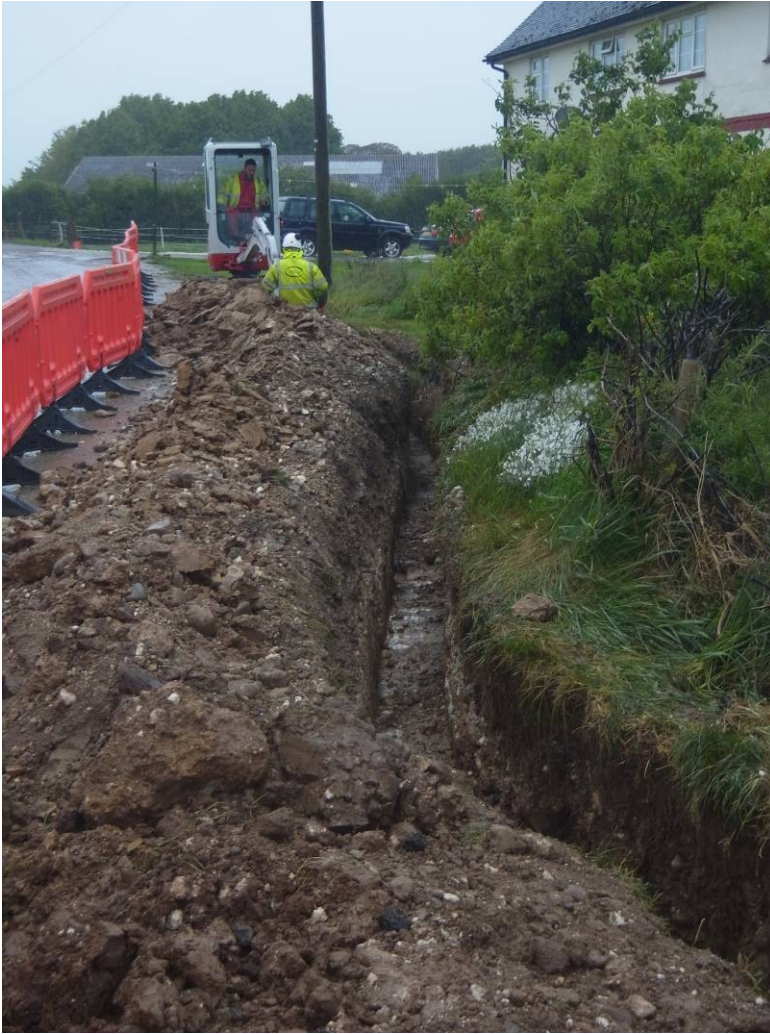
Plate 1: The south end of the trench adjacent to the White Cottage, looking north.

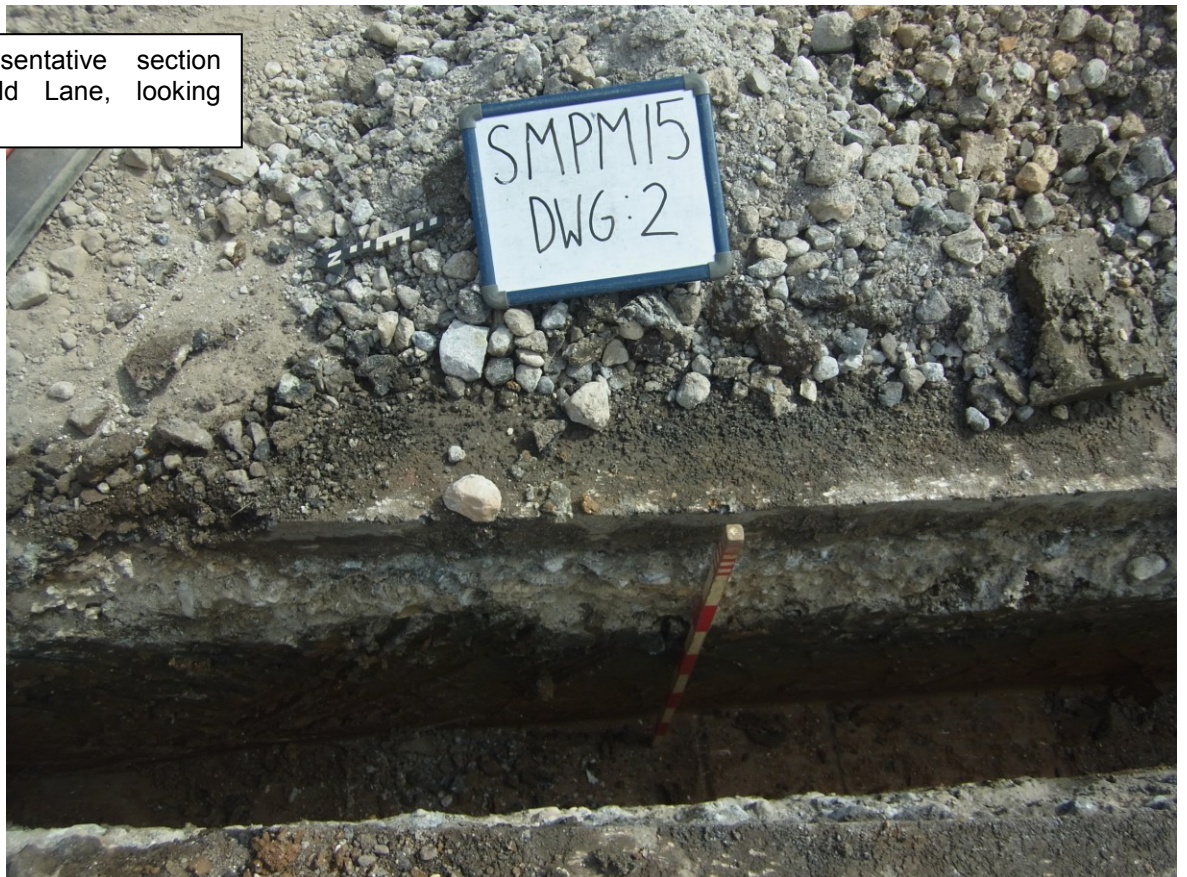
Plate 2: Representative section through Greenfield Lane, looking east.

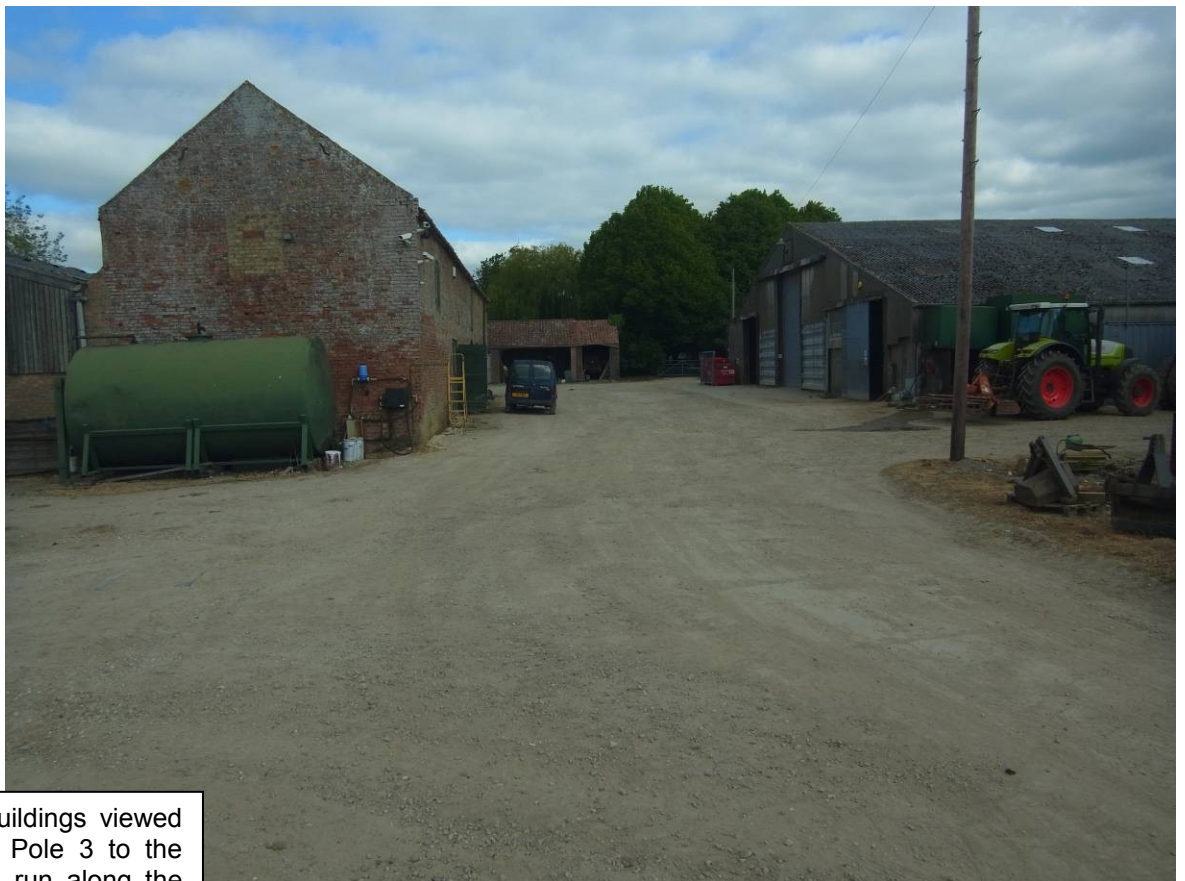
Plate 4: The farm buildings viewed from the south, with Pole 3 to the west. The trench will run along the road between the buildings.

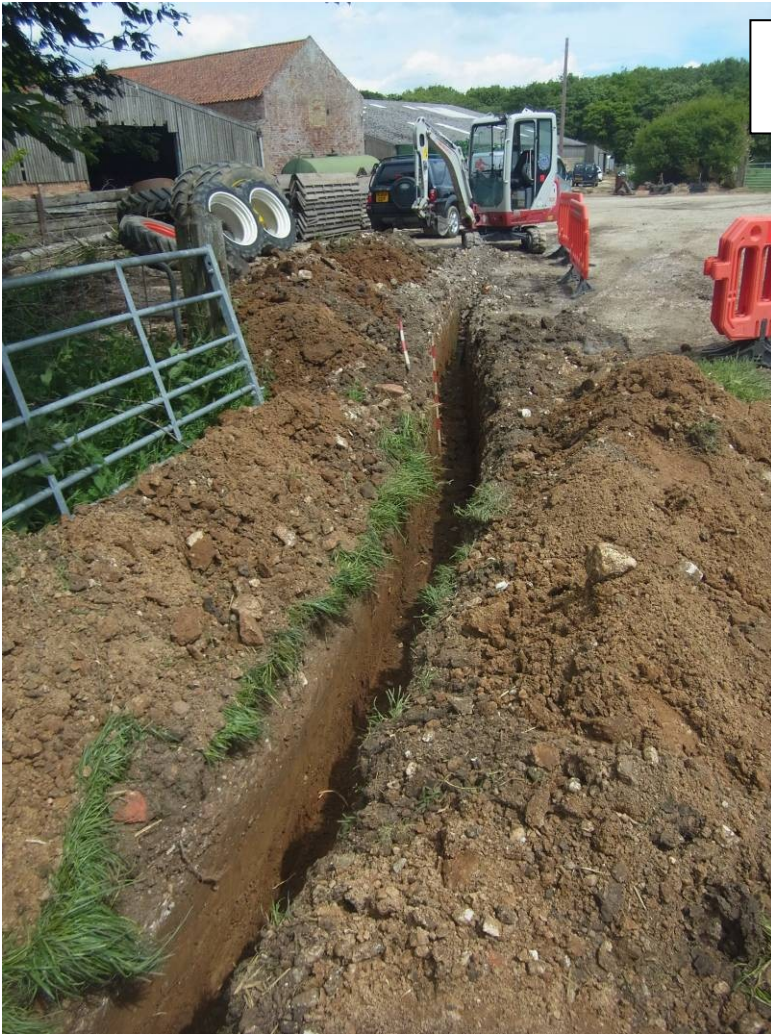
The utilities scheme revealed very little in the way of identifiable medieval activity. The main cut across the length of the backfilled moat at the south-western corner only revealed dense layers of modern demolition material, and the trench did not penetrate into the earlier backfill deposits of the moat.

Plate 5: The trench as it heads north-east over the backfilled moat. There was no indication of any cut in the section.

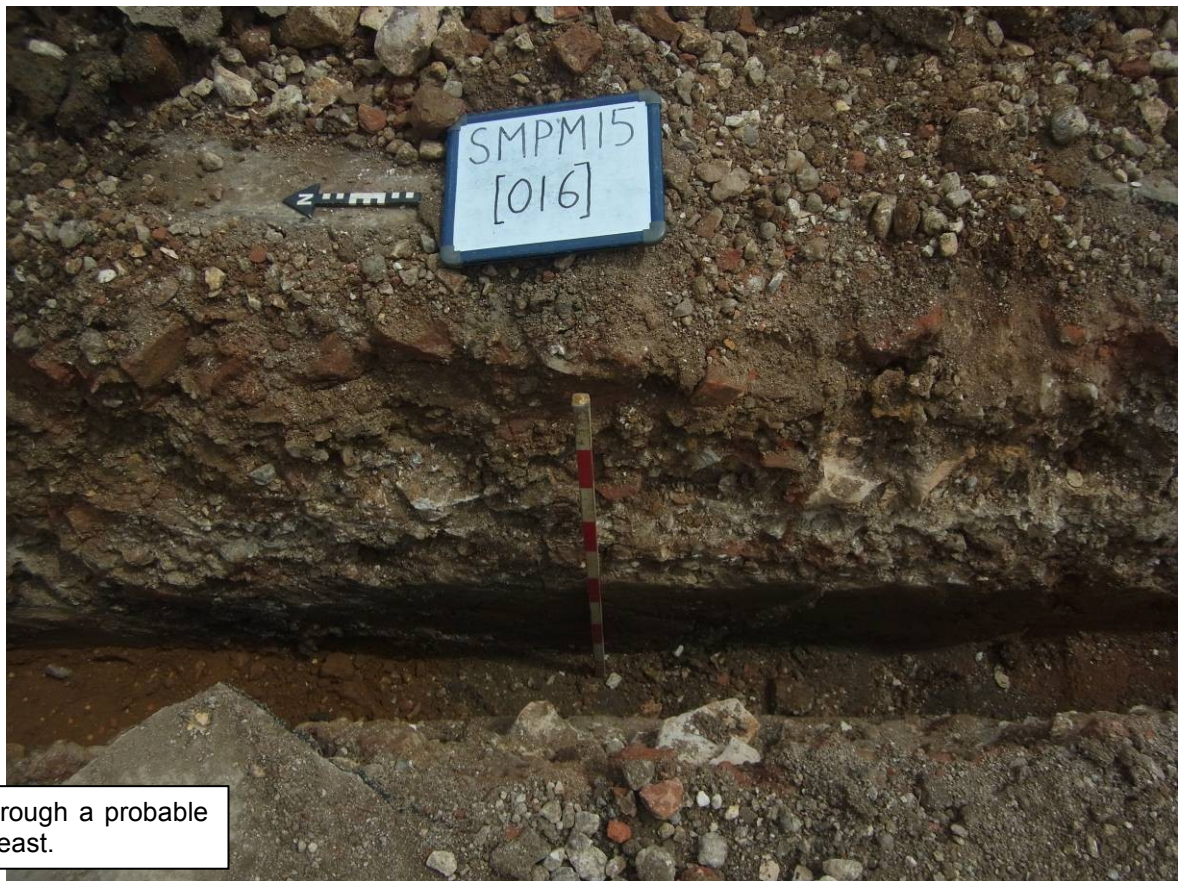
Two undated features [016] and [019] were possibly ditches, located in the farmyard and cut into what appeared to be made ground. This suggests that these features did not pre-date the post-medieval period.

Plate 6: Section through a probable ditch [016], looking east.

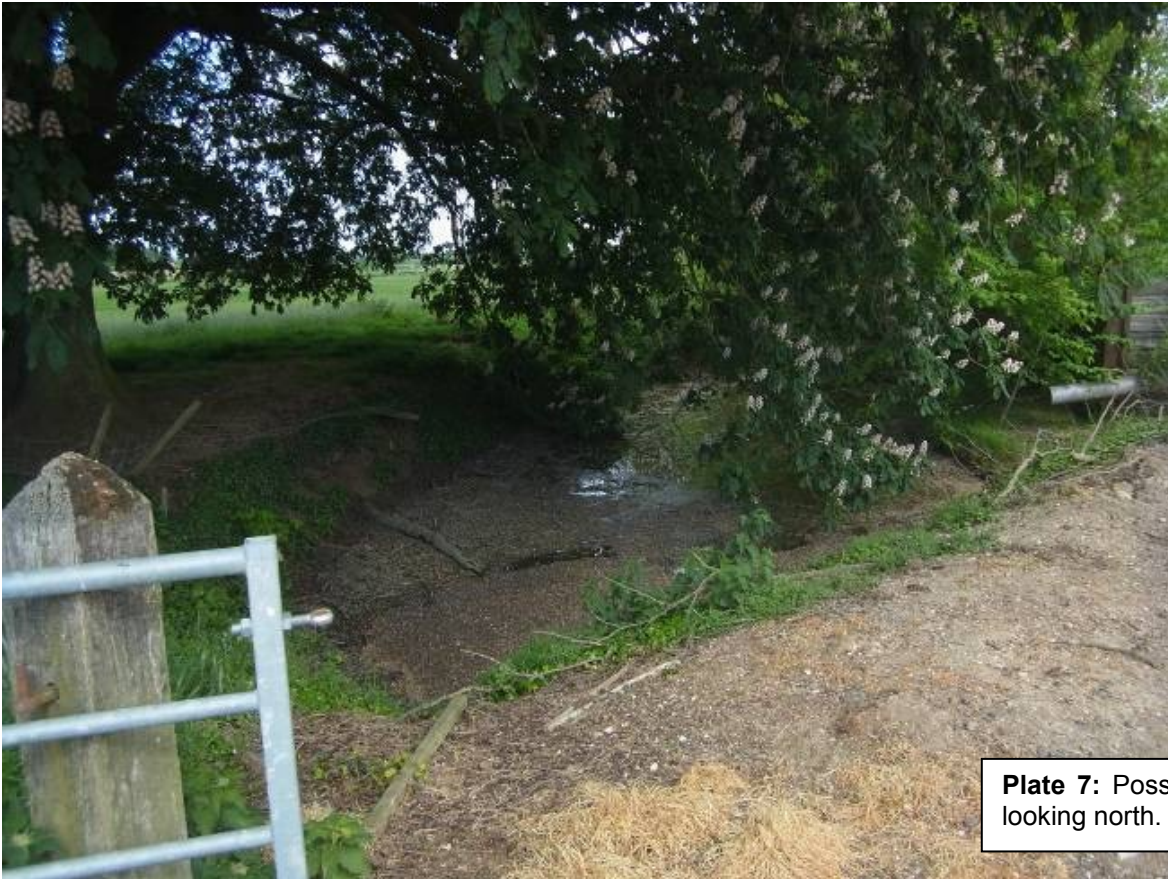
Plate 7: Possible moat near Pole 3, looking north.

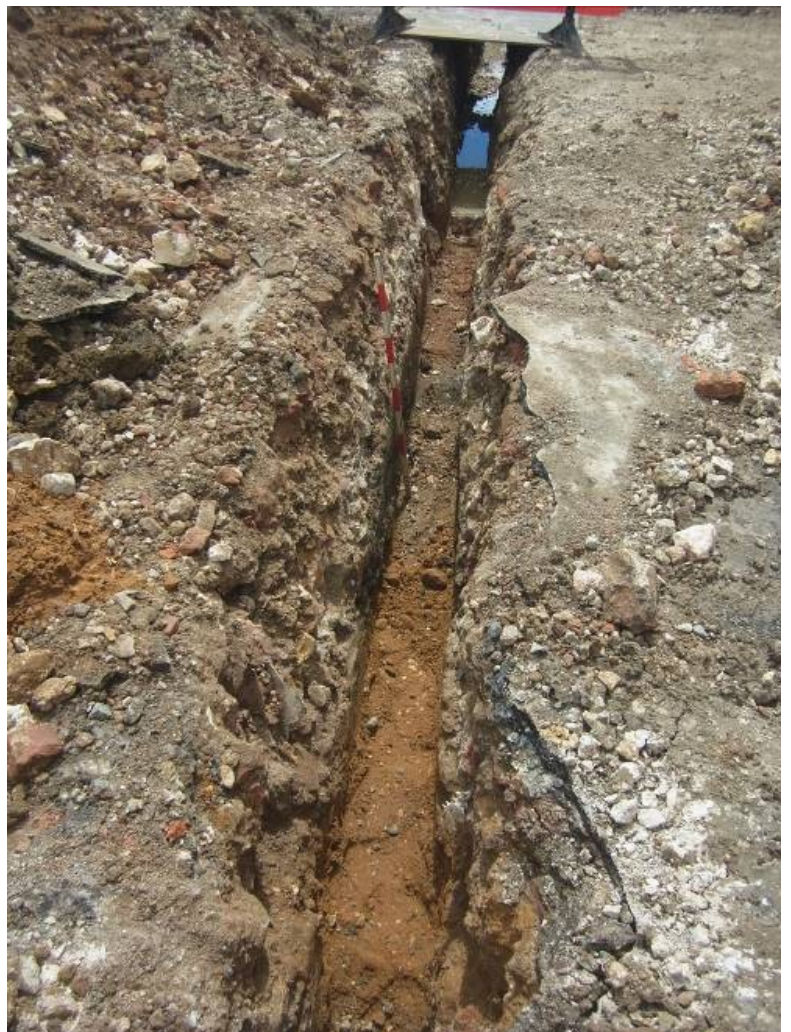
Plate 8: The southernmost end of the service run through the farm and ditch [016].

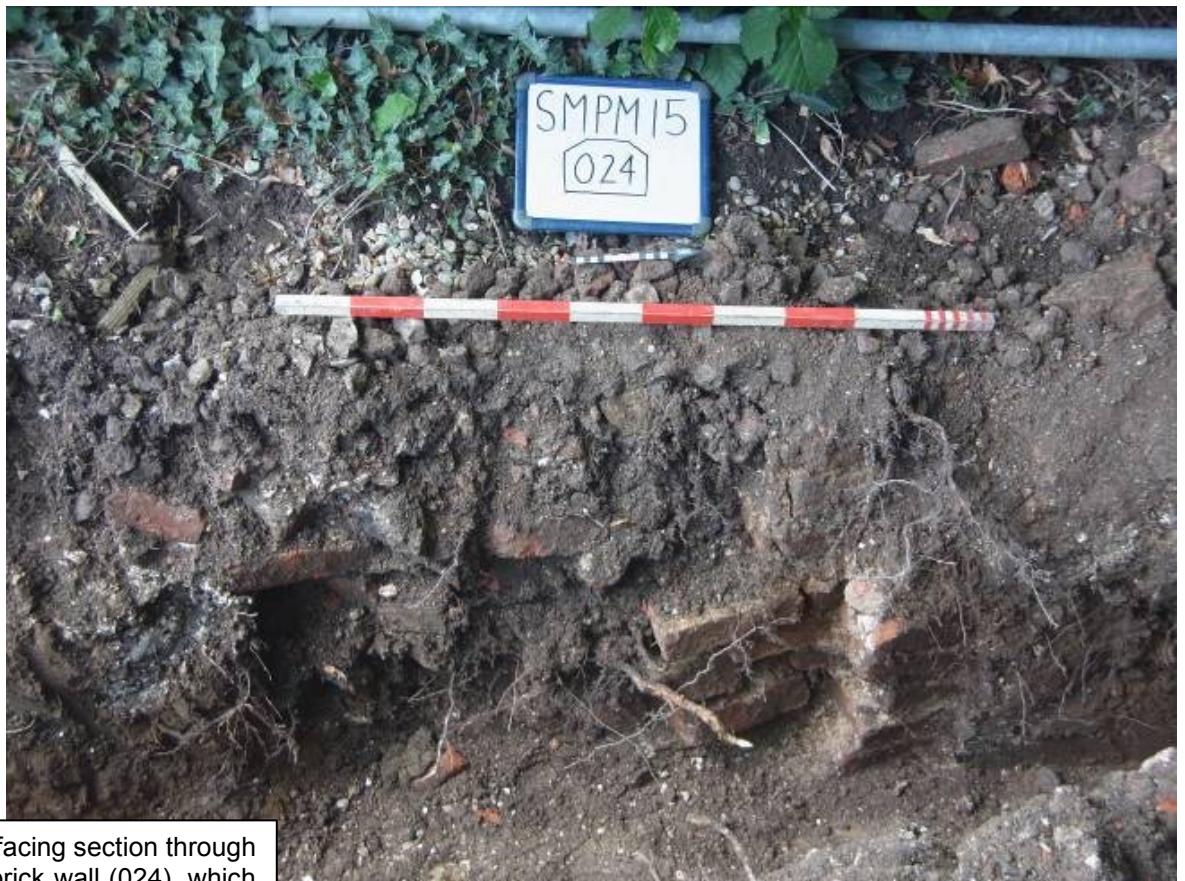
The northern part of the trench ran into the gardens of Priory House, revealing a 1m-wide stretcher-coursed brick wall (024) at its southern end, 0.5m into the ground. The wall was oriented north-west to south-east, made of red bricks typically 220 x 110 x 70mm held together with a buff coloured mortar. The western part of the trench went through garden turf overlying a crushed limestone and mortar demolition layer, which was possibly related to the wall. Beneath this was a layer of dark greyish brown sandy silt soil (028); both layers were cut by a ditch [029] running north to south - 1m wide and 0.8m deep (to the limit of excavation).

The service run up into the gardens of Priory House revealed a brick wall (024) above the only possible medieval layer (028) encountered during the course of the monitoring. A ditch [029] cut into this layer was almost certainly of a modern date and related to the farm. The form of the wall and mortar suggests that it was of 19th century date and also probably related to the farm buildings.

Plate 10: East facing section through a 19th century brick wall (024), which was related to the farm buildings

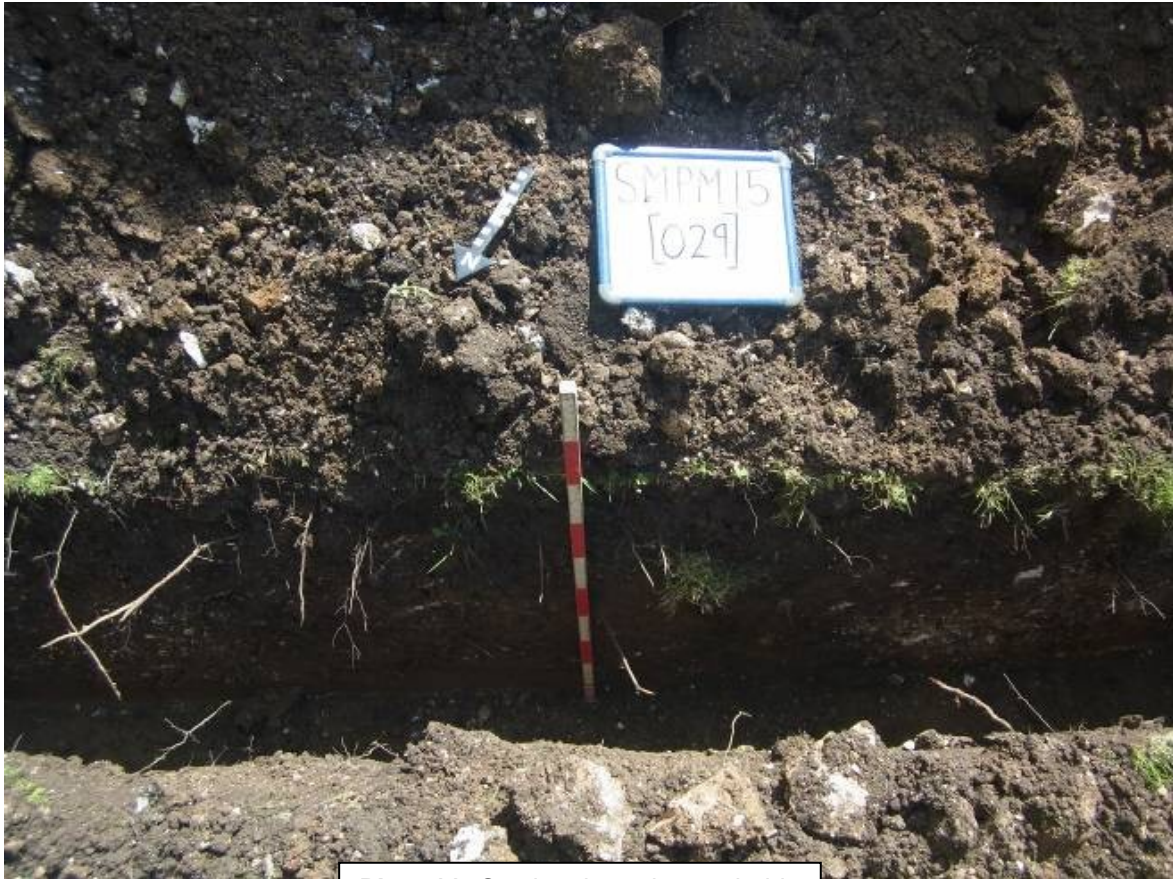
Plate 11: Section through a probable ditch [029], looking south-east.
