**LAND SOUTH OF BANOVALUM GARDENS
HORNCastle,
EAST LINDSEY, LINCOLNSHIRE**

ARCHAEOLOGICAL EVALUATION

Report prepared for

September 2015

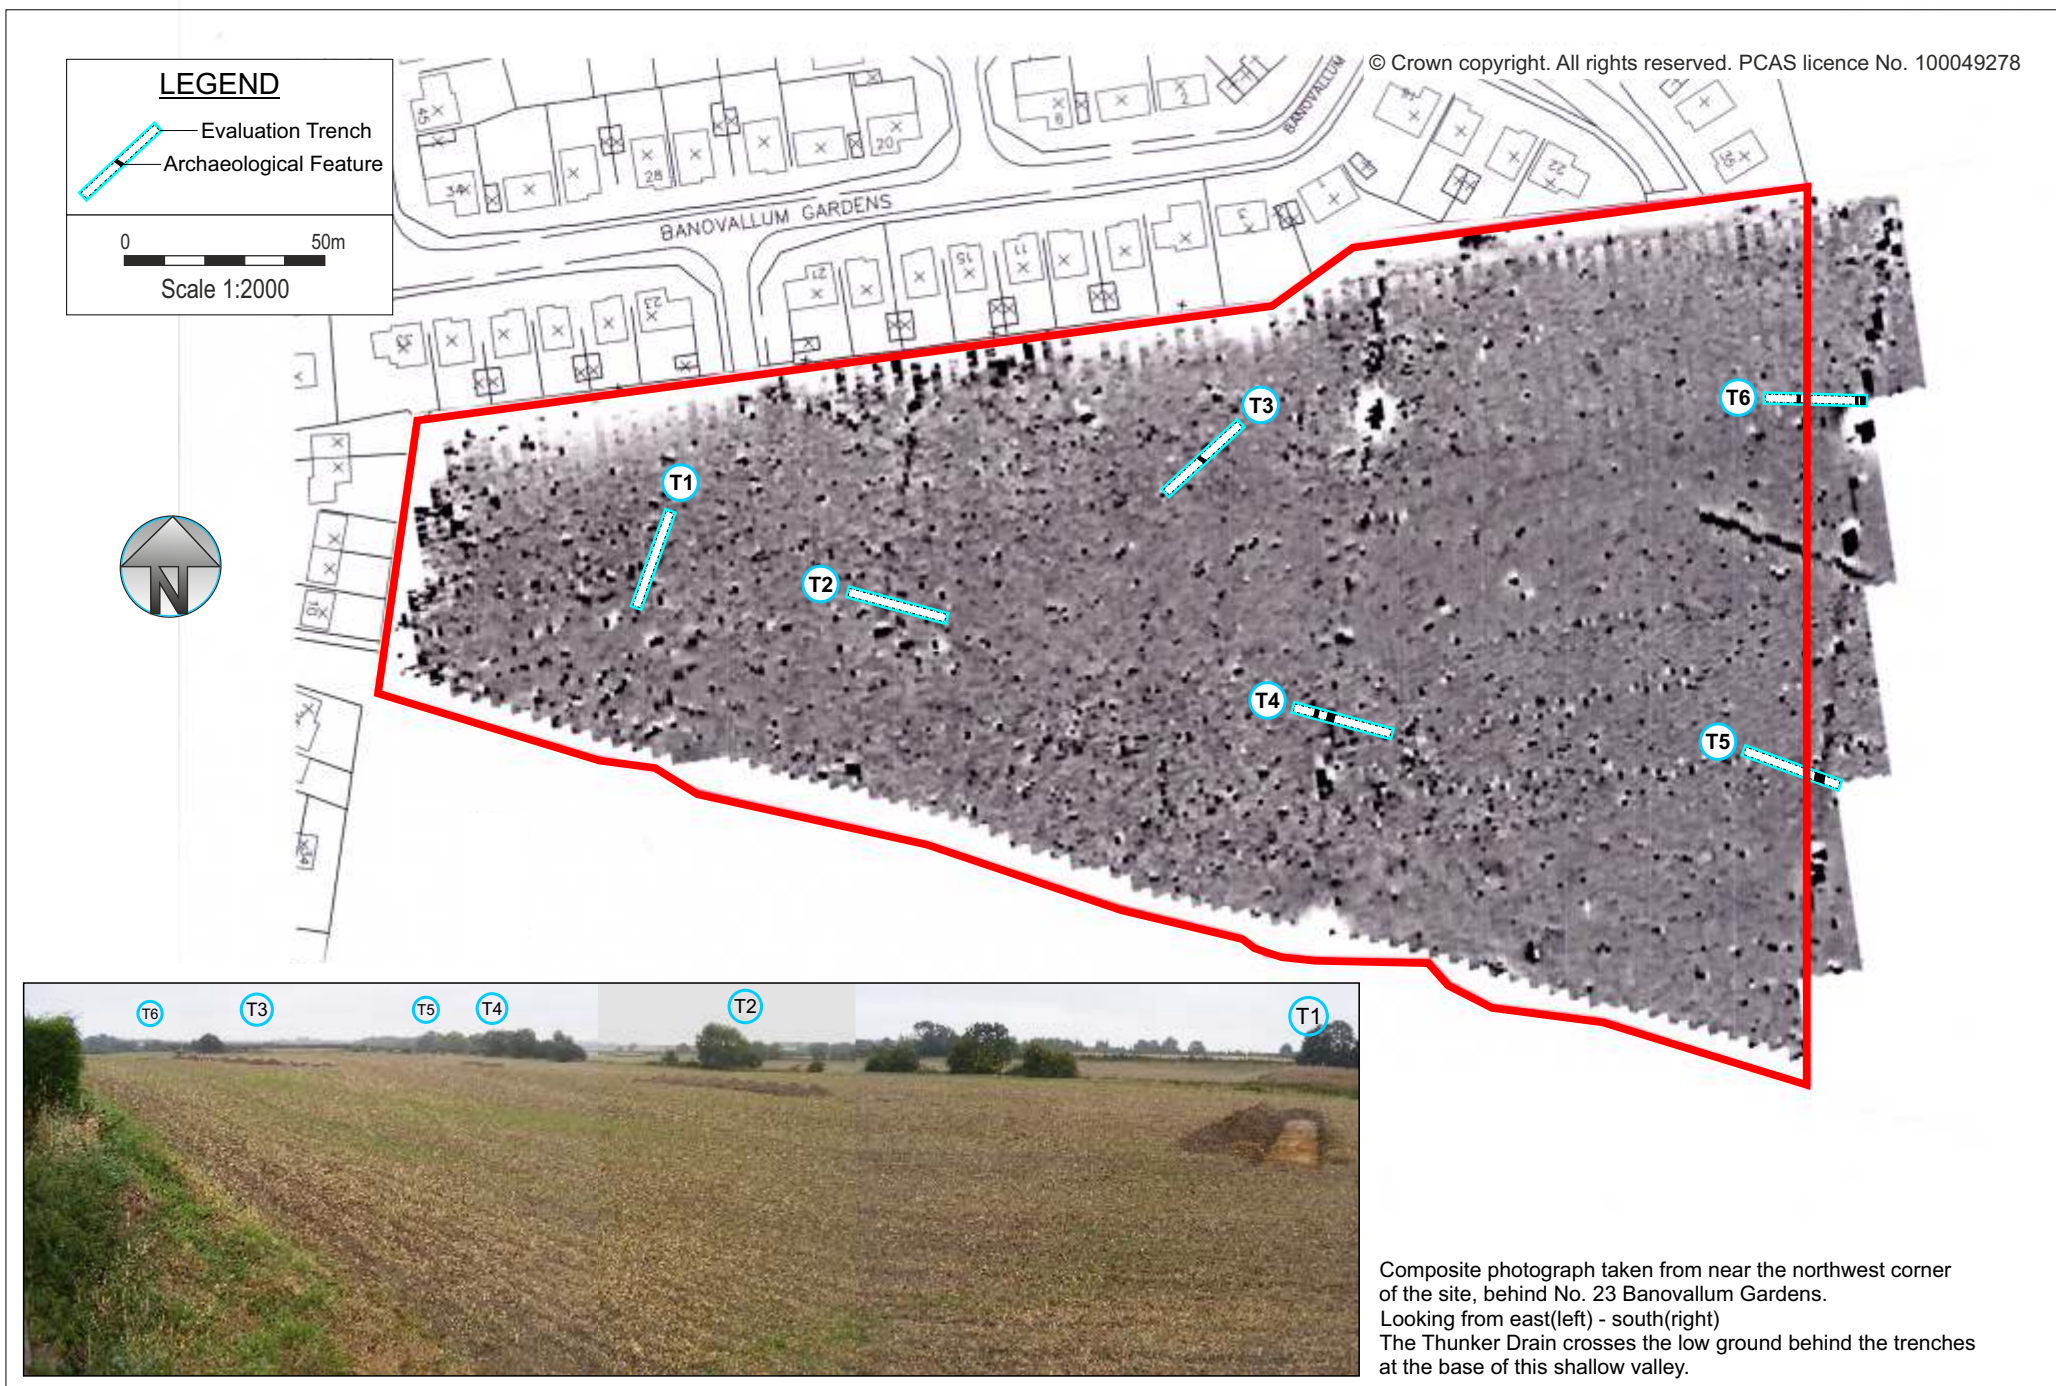
Fig.2 Trench location plan superimposed over grey scale plot of the geophysical survey (after Bunn 2015. Scale 1:2000) with composite photograph of the site.

As noted above, this site has been subject to a geophysical survey which has only identified three linear features which correspond with historic field boundaries (Bunn 2015). As the site lies on the periphery of a speculated Romano-British farmstead identified to the northwest, with undated ditches found to the north, there is potential for archaeological remains to exist on this site which have not been identified by the geophysical survey because of the background magnetic variation within the Till deposits.

The six proposed trenches were excavated across the site as indicated in **Fig. 2**.
