**Land at the former Lord Tennyson public house,
72 Rasen Lane, Lincoln, LN1 3HD**

Archaeological Evaluation

Prepared for
LCT Properties Ltd.

by J. Sleaf
November 2015

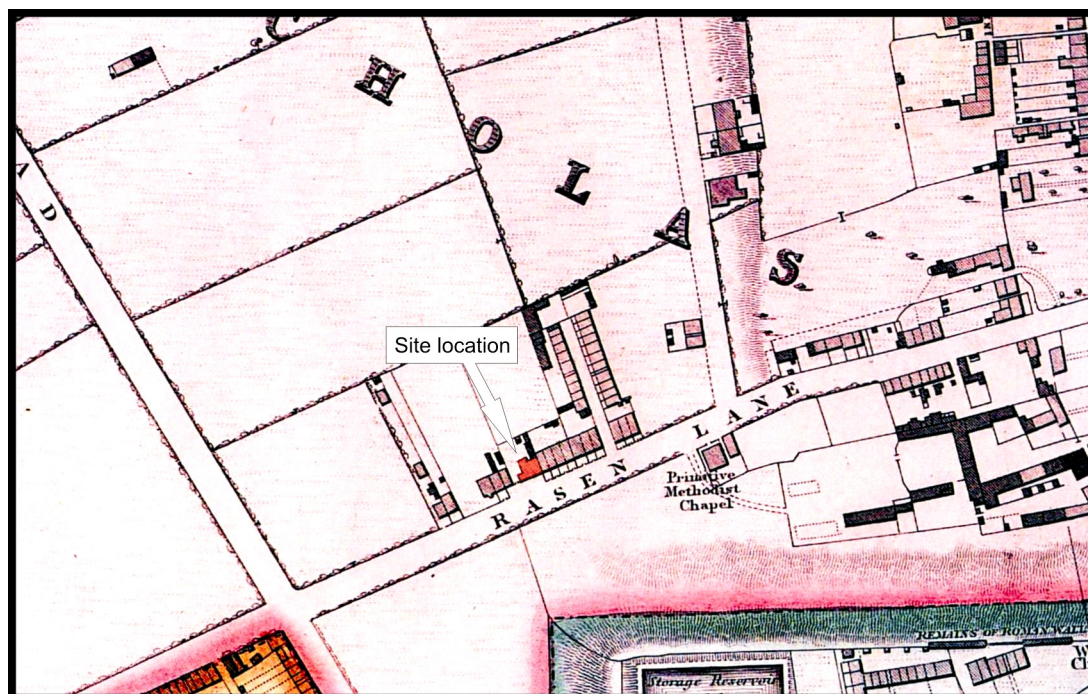
Figure: 2. Extract from 1851 map of Lincoln by J. S. Padley, highlighting in red the location of the dwelling later to become the Lord Tennyson public house. (Mills, & Wheeler, 2004, Historic Town plans of Lincoln 1610-1920, The Lincoln Record Society, Lincoln)

The two recorded wall footings (204) and (207) appeared to align with Rasen Lane and presumably form part of the dwelling indicated on the 1851 map (fig: 2) which is similar in plan to later OS mapping of 1956 where the Lord Tennyson public house is clearly labelled. The associated 'passageway' between the walls clearly implies some form of subdivision of the original property although no visible change in the surrounding deposit (209) could be seen to suggest either floor or yard surfaces which, had they survived, were more than likely to have been truncated at a later date.

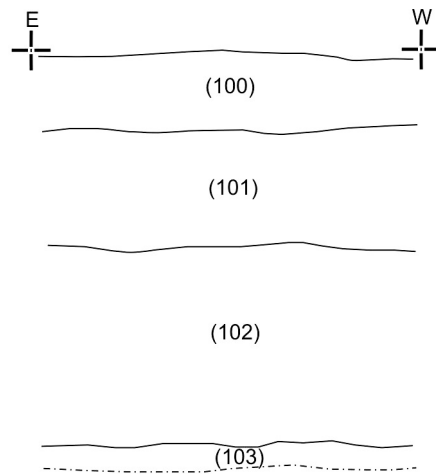
Figure: 4a
North facing representative section Trench 1
0 1m
Scale

Trench 1 (fig: 4a)

Negative trench, exposing modern demolition material above made ground and natural limestone brash.

Trench 1 located towards the southern extent of the site, parallel with Rasen Lane revealed natural limestone brash (103) as the basal deposit encountered at c. 1.0m below existing ground level .

Above this was c. 50cm of possible made ground deposit (102), below a buried topsoil horizon (101), which itself was sealed by a modern demolition deposit (100).

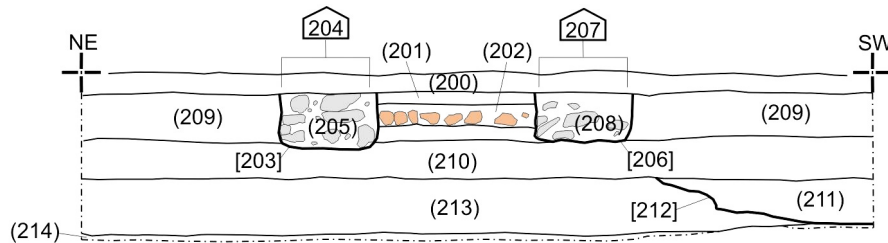
Figure: 4b
North-west facing section of walls 204 & 207 in Trench 2
0 2m
Scale

Cut through deposit (209) were two north-east to south-west aligned walls (204) and (207), approximately 1.0m apart. Both construction trenches [203] and [206] were of similar dimensions, 0.65m wide and 0.38m deep and filled with a loose yellow sand (205), (208) surrounding the remnants of roughly hewn limestone footings from which two sherds of mid 19th century transfer printed pearl ware were recovered (from (205) and a sherd from a Chinese export porcelain dish.

The 1.0m wide space between the walls had been consolidated with a 0.14m thick surface comprised of brick rubble sealed with very compact yellow sandy silt clay (201). Initially interpreted as a demolition layer, this material was probably a consolidated and compacted surface forming a narrow passageway between both walls (204) and (207).

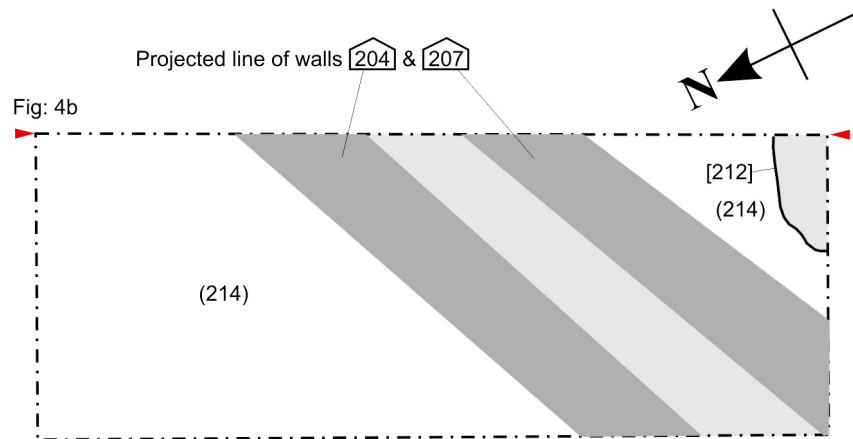
Figure: 4c
Trench 2 plan
0 2m
Scale

Trench 2 (figs: 4b & 4c)

Trench 2 revealed two north-east to south-west aligned walls with an associated passageway/path of mid 19th century date, as well as the partial remnants of a small medieval pit and buried soil horizon.

Trench 2 was located towards the south-east corner of the site and revealed natural limestone brash (214) as the earliest deposit encountered at c. 1.0m below existing ground level.

Directly above the natural substrate was a 0.36m thick deposit of mid grey brown sandy silt (213) containing frequent, small limestone fragments and interpreted as a medieval buried soil horizon. Cut into this in the southern corner of the trench was a small, shallow pit [212] containing a single deposition of mid grey sandy silt (211) which yielded two small fragments of medieval tile, one partially glazed and a residual outer flake from a Roman Tegula or brick.

Sealing deposit (213) and pit [212] was 0.26m of dark grey silt (210), probably a 19th century buried soil horizon which contained a small section of clay pipe. This layer was subsequently covered by (209), a 0.34m thick mixed deposit of dark brown/black silty clay with frequent limestone fragments; interpreted as made ground to facilitate the construction of two walls, (204) and (207).

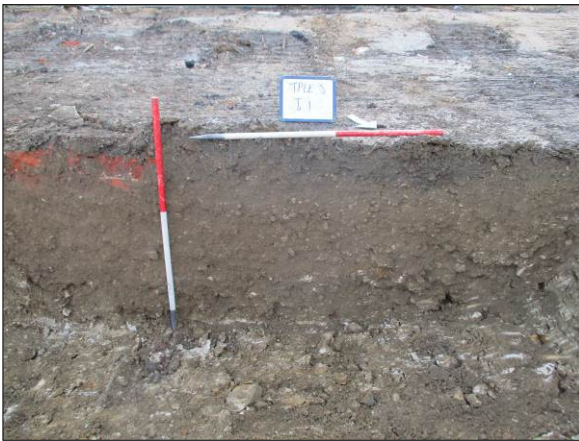
Plate: 3. Trench 1 representative section, looking south-west.

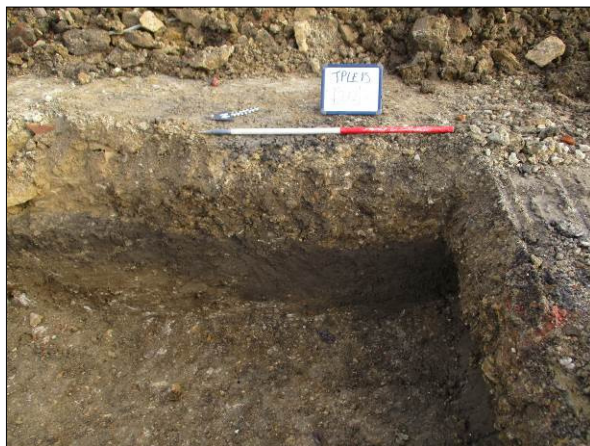
Plate: 5. Pit [212] looking south-east.

The earliest feature recorded within Trench 2 was the part-exposed shallow medieval pit, cut into a possible medieval buried soil horizon (213). No other features associated with this deposit were encountered, and this may be indicative of the low level activity within what was thought to be common land during this period.

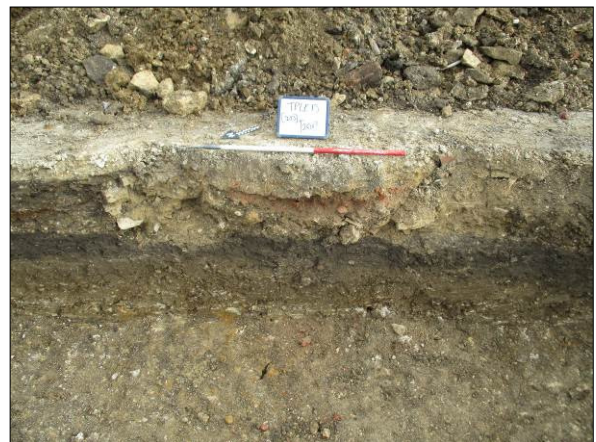
Plate: 6. Walls (204) & (207) with surface (202) looking south-east.
