THE FRENCH HORN PUBLIC HOUSE ARCHAEOLOGICAL MONITORING REPORT

Site code:	UFHM 13
NGR:	SK 7380 5439
LPA:	Newark & Sherwood District Council
Planning Ref:	10/01663/FUL
PCA Ref:	1160

Report prepared for
Guy Taylor Associates

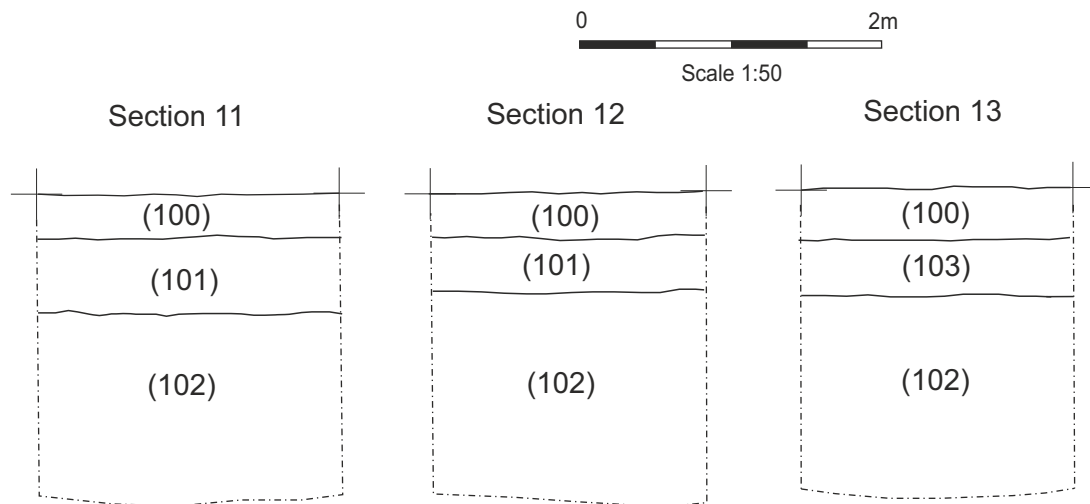
Figure 3:- sections and location plan for soakaway pits 1, 2 and 3 (sections 11-13)

Deposits identified as undisturbed natural geological drift were revealed in all three of the soakaway trenches and comprised loose orange sand with frequent rounded pebble inclusions (context [103]). The top of the deposit was reached at 0.80m below the pre-excavation ground surface. A similar deposit was identified in three of the service trenches where its surface was revealed at between 0.68 to 0.76m below the pre-excavation ground surface (contexts (003), (005) and (109)).

Location plan for soakaway pits 1, 2 and 3 with associated sections

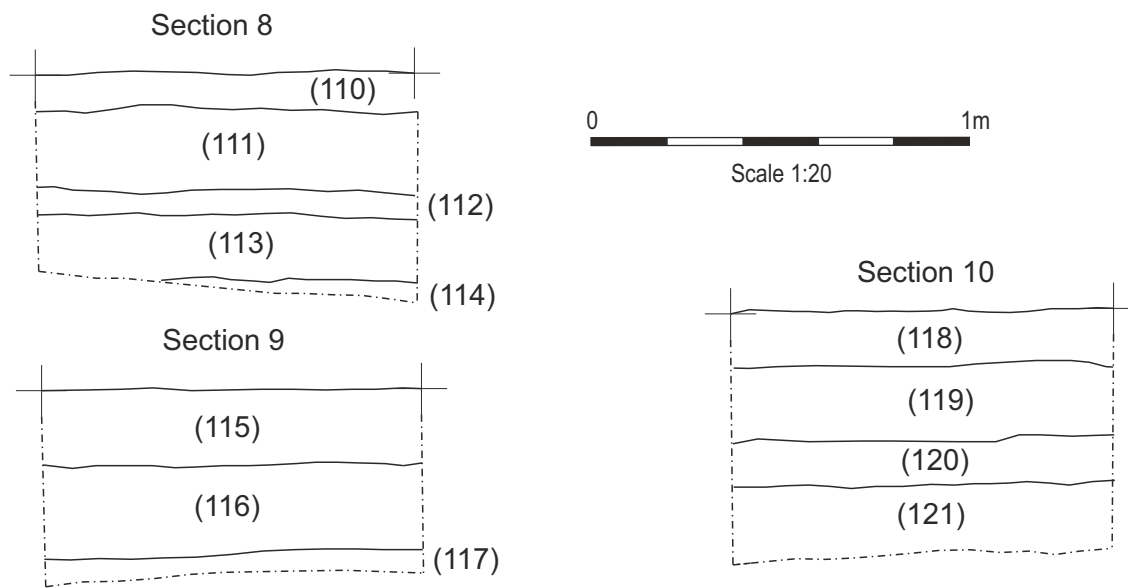
Figure 4:- Sections and location plan for wall foundation trenches (sections 8-10)

Location plan for sections 8, 9 and 10

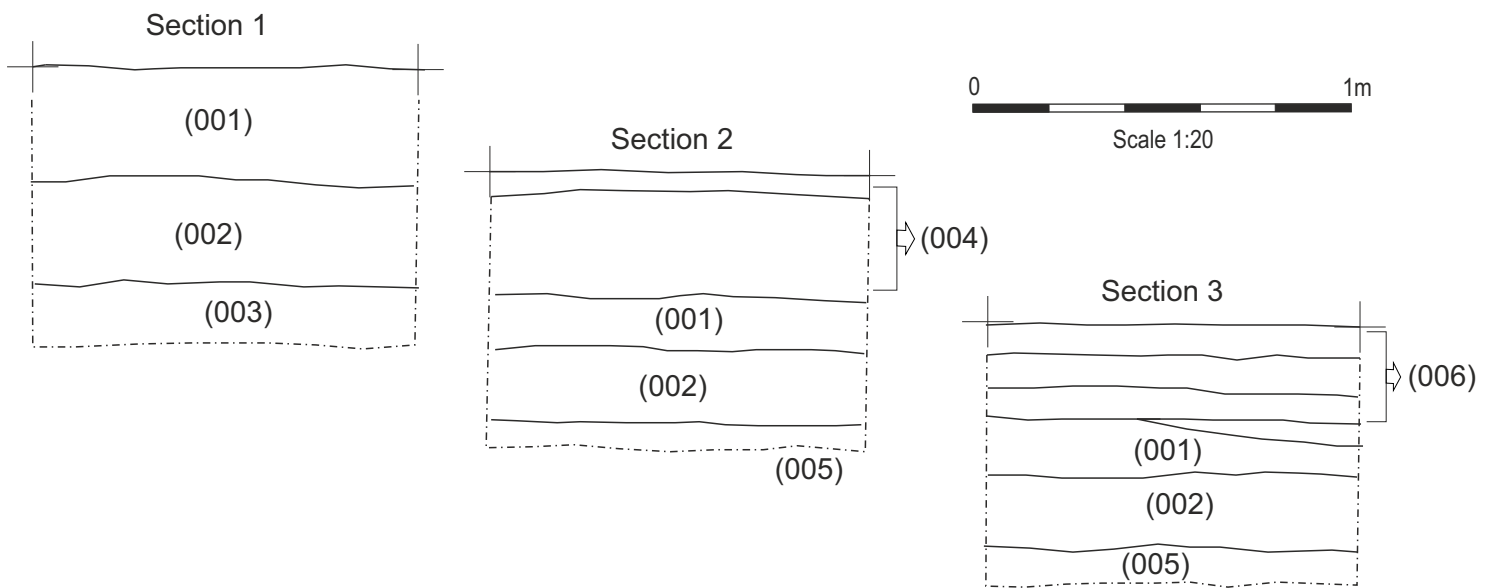
Figure 5:- Sections and location plan for northern part of service trenches (sections 1-3)

Location plan for sections 1,2, 3 and 4

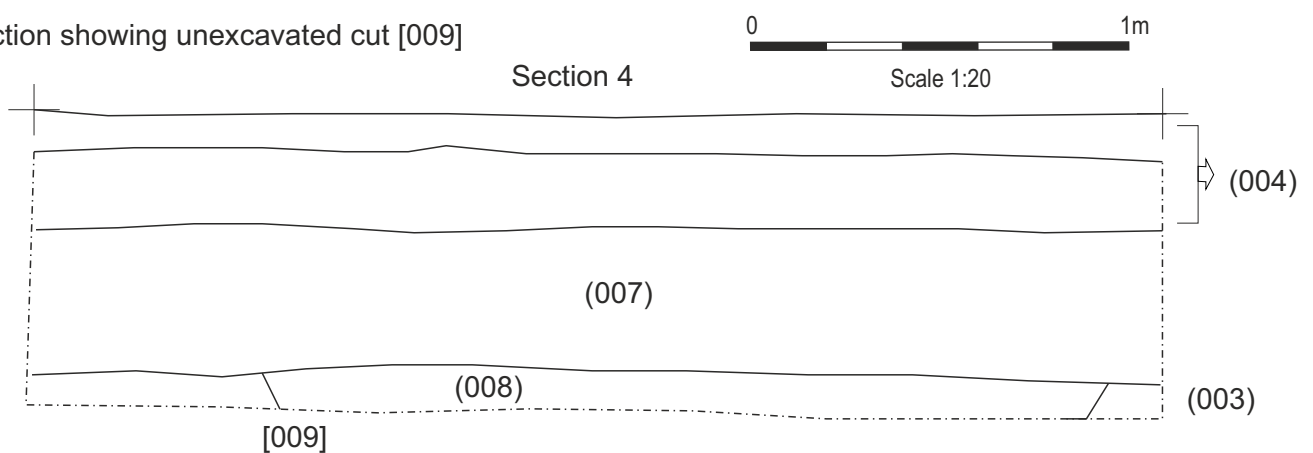
Truncating the subsoil in one of the service trenches, a steep sided cut was partly revealed (context [009]). The extent as seen measured 2.20m NW-SE x 0.60m NE-SW, whilst an excavated depth of 0.12m represents only the base level of the trench. The exposed portion of the cut feature contained a single fill that comprised a mid to dark grey sand with tile, brick and mudstone fragments (context (008)). Both the cut and associated fill are believed to represent a post-medieval soakaway, likely to be directly related to the existing adjacent properties.

Section showing unexcavated cut [009]

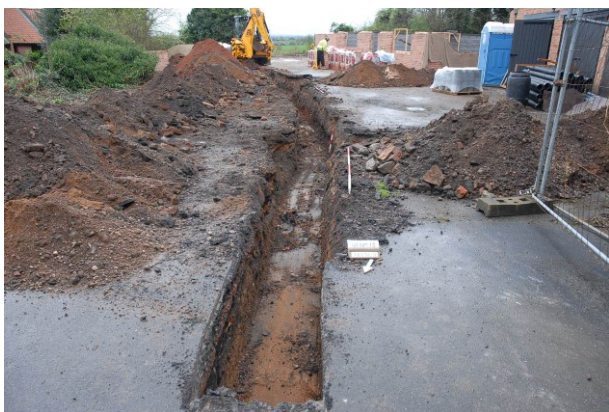
Plate 3

General shot of excavated service trench, looking SSE

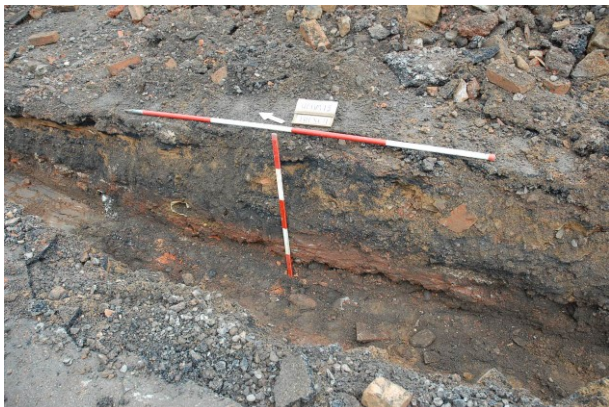
Plate 4

Shot of service trench, looking NE and showing unexcavated cut [009].
