**CROWLE DRAINAGE IMPROVEMENTS, ISLE OF AXHOLME  
NORTH LINCOLNSHIRE: PHASE 2**

**ARCHAEOLOGICAL MONITORING AND RECORDING**

January 2016

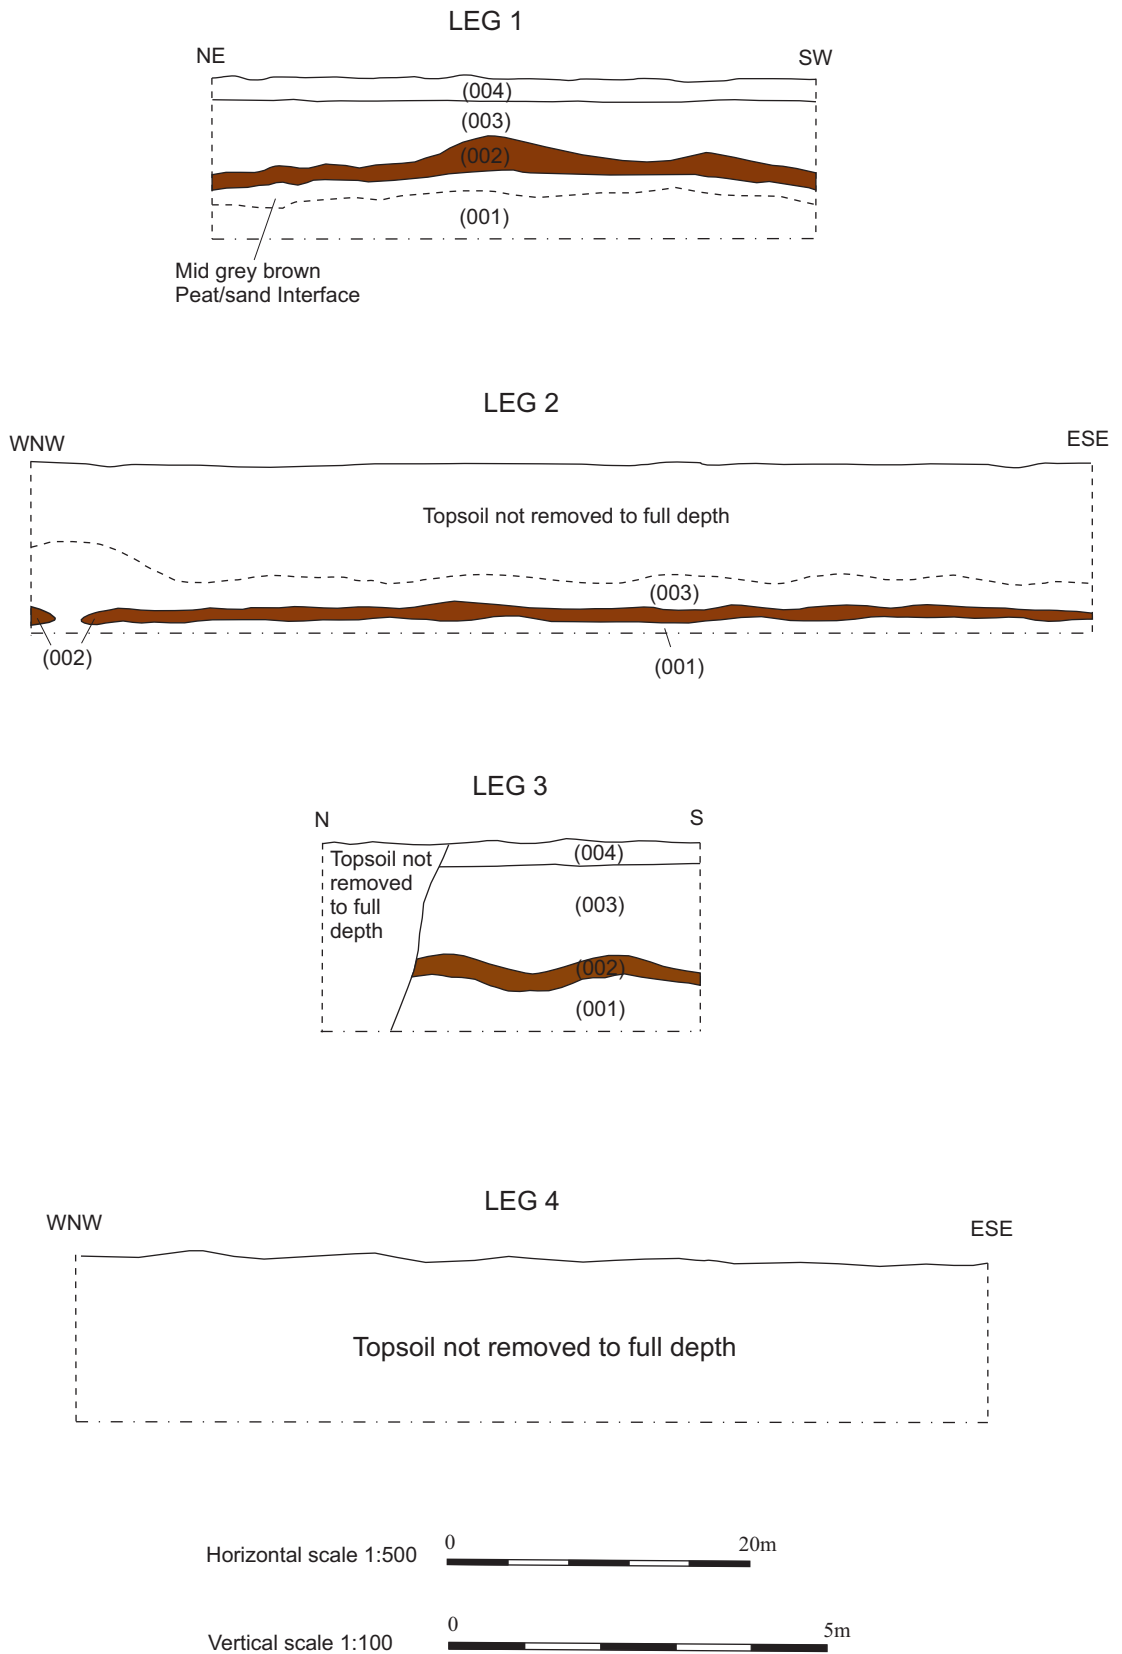
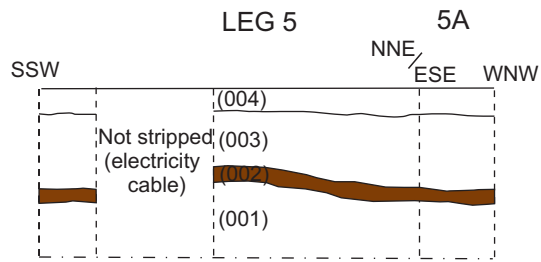
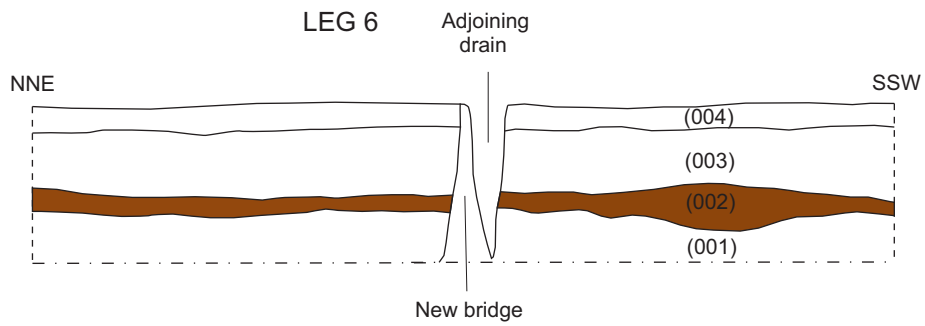
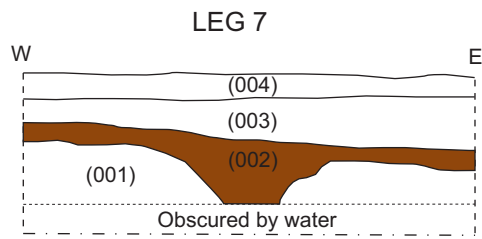
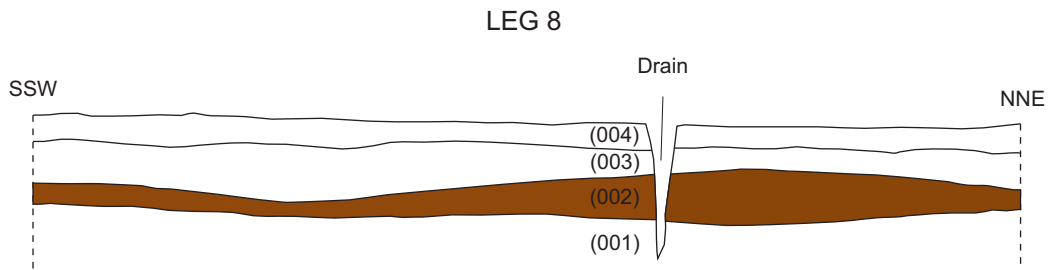
**Figure 3: Sewer Drain Improvement Scheme - schematic sections of peat deposits**

The lowest level encountered was a layer of natural sand (001), which was for the most part covered by a clearly distinct layer of peat (002), ranging between 0.20m and 0.60m thick. This was covered by silty sand layer (003). The peat layer and the underlying natural sand correspond broadly to similar deposits observed in the eastern end of the previous Paupers Drain works; in the earlier phase, the silty sand overlying the peat was identified as a finely laminated warping deposit, and it is possible that this is also the case with layer (003), in keeping with the local drift geology recorded by the British Geological Survey (bgs.ac.uk). The whole of the bank was overlain by topsoil (004): in some areas the bank profiling works did not remove the topsoil to full depth over portions of the profile, while in Leg 4 of the works, the base of the topsoil was left *in situ* across the whole of the profile, so that none of the underlying stratigraphy could be seen (see Plate 4). A soil profile section was drawn for each leg of the monitoring to demonstrate the extent of the peat (Figure 3).

Schematic sections of the monitored areas were drawn, to show the depth and thickness of the peat deposits along the length of the drain. These are reproduced in figure 3: in order to show the deposit depths in visible detail while compressing the sections sufficiently to display on the page, these drawings are at different horizontal and vertical scales. Written records of the deposits observed were made on the section drawings. A digital photographic record of the works was maintained – selections from this are reproduced in Appendix 1 – and a site diary was also kept.

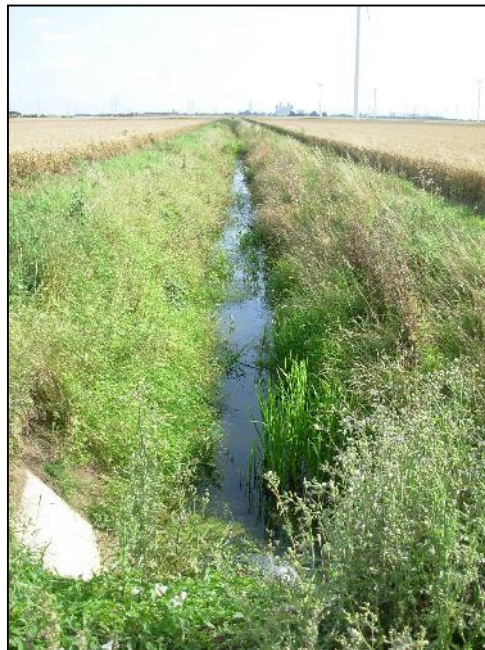
**Plate 1 (right):** The Sewer Drain before the commencement of works, looking south from its junction with the Paupers Drain.

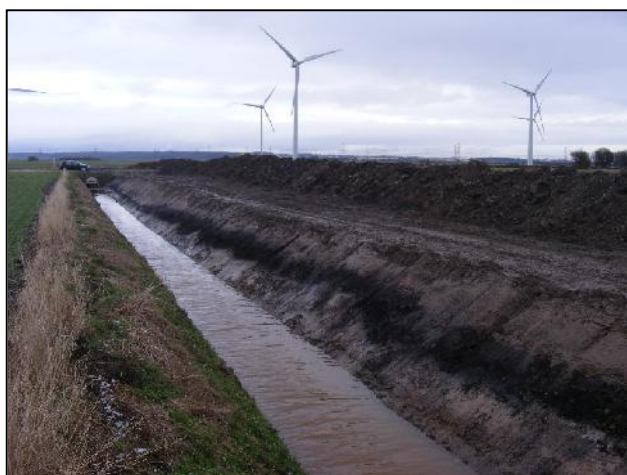
**Plate 2 (left):** Stripping of L1 revealed an undulating layer of peat (002). This was observed throughout the monitoring.

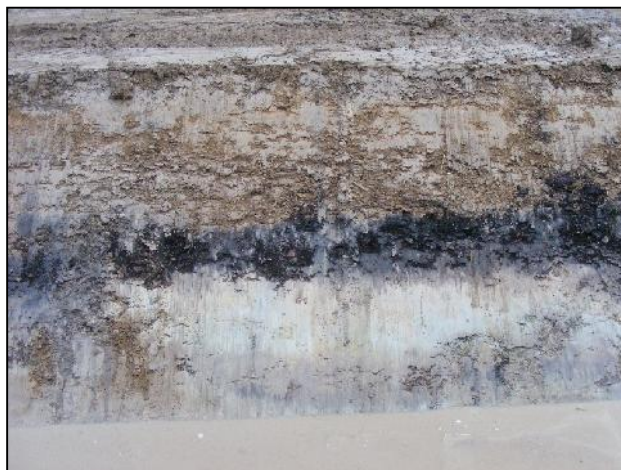
**Plate 3 (right):** Peat layer (002) exposed in the bank profile, overlain by possible warping deposit (003).

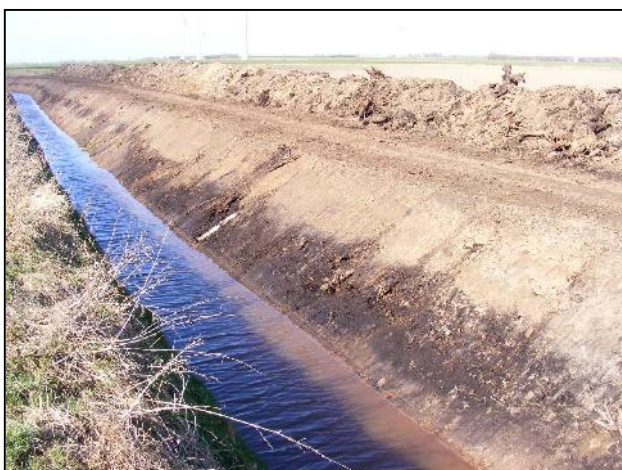
**Plate 4:** The peat deposit at a particularly deep point in L7, looking NW. The embedded tree roots can be seen protruding from the peat, while more roots and the associated timber have been removed and are on the spoil heap behind.

the previous phase of the works, the roots were of a fresh, light colour, suggesting that they were recent growth within the peat layer (plates 4 and 5). No 'bog oaks' of the kind recorded by other works were seen during either phase. Some of the wood fragments were within the peat and may thus have been contemporary with its accumulation, although it seemed more likely that the majority of this material derived from trees growing in the peat layer after its deposition, which in this area took place from the late Bronze Age onwards. An environmental sample taken from the same peat deposit during the earlier phase of works identified the remains of pine trees, including wood, pine cones and seeds; the report noted that Scots pine was native throughout Britain in early prehistory, potentially suggesting that the remains may have been contemporary with or not long post-dated the peat layer. Pine was reintroduced in many areas in the historic period (O'Brien, 2014); no coniferous plantations are marked on historic mapping, but the identification of the overlying layer as warpland suggests that the tree cover must, at least, have pre-dated these maps.

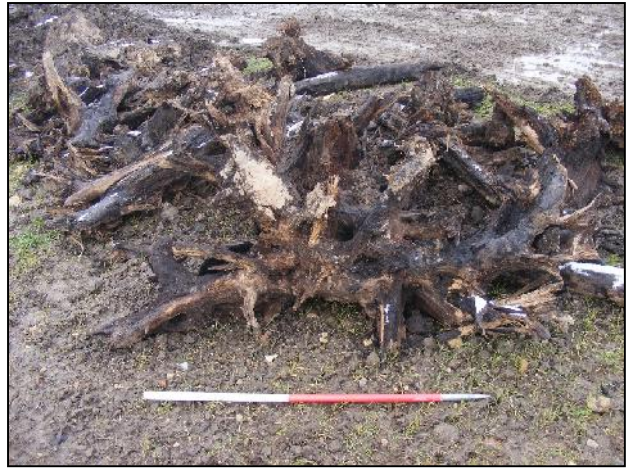
**Plate 5:** L1 unearthed around fifteen tree roots, which appeared to be buried in the peat (002). The light colour of the wood suggests that they are of recent date.

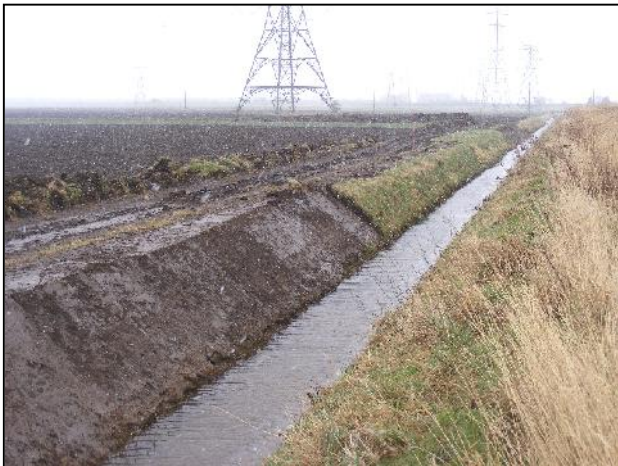
**Plate 6:** The bank profiling in L4 did not remove the full depth of topsoil, preventing any meaningful recording.

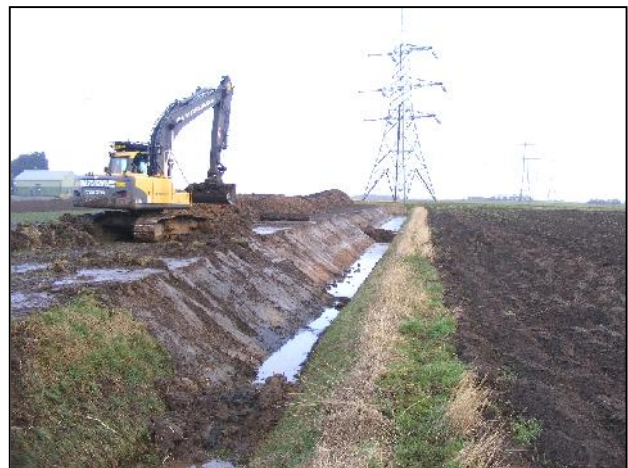
**Plate 7:** The amount of material removed is visible in this working shot of L5.

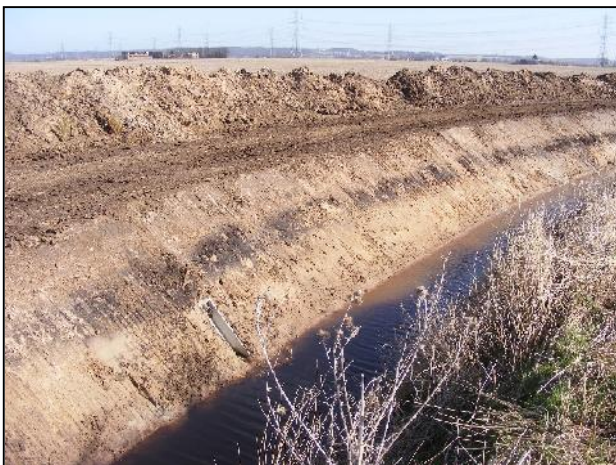
**Plate 8:** The peat layer (002) as seen in L7. It is not continuous in terms of colour, content or thickness.
