**FORMER CO-OP DAIRY, NORTHOLME,
GAINSBOROUGH, LINCOLNSHIRE**

**SCHEME OF ARCHAEOLOGICAL
MONITORING AND RECORDING**

NGR: SK 81694 90262
WLDC Planning Ref.: 125240
PCAS Job no. 1037
Site Code: CDNM 13
Archive Acc. no.: 2013.104
OASIS ID: preconst3-239731

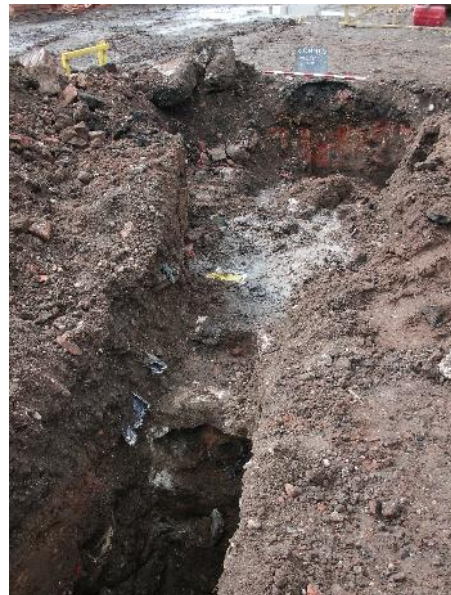
Plate 3 (right): The remains of the modern wall **205** which had a fibreglass tank on the inside. Located in Plots 9-11

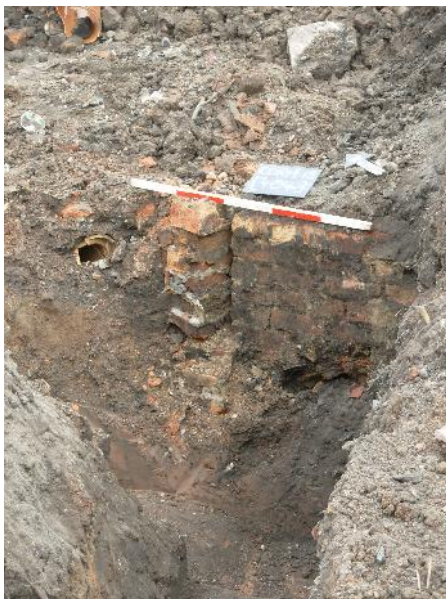
Plate 4 (left): Wall fragment **404** in Plot 13, looking north-east. This was a modern manhole associated with modern drainage

Occasionally, the remains of a detached structure associated with the dairy building was noted, such as a fragment of a brick structure 404 in Plot 13 which was covered with a metal plate when found by the contractor (Plate 4). This was evidently a redundant manhole associated with modern drains.

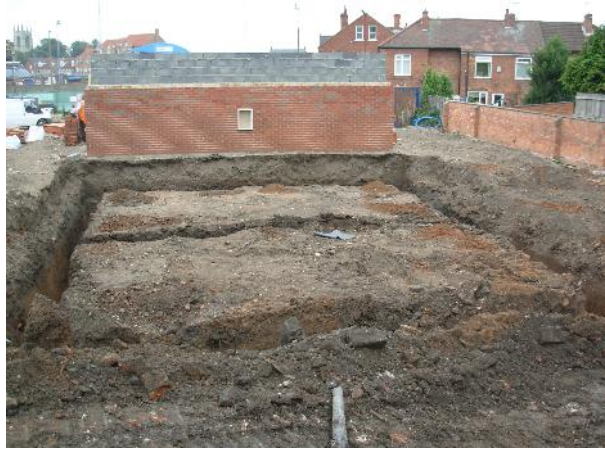
Plate 5: Plots 12-13 after completion, looking south-west. The wall 404 was located in the bottom right corner of the photograph

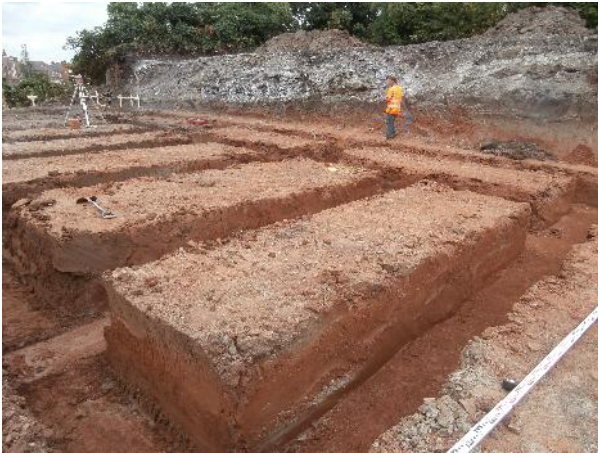
Plate 6: View of Plots 21-24 looking west. The topsoil, subsoil, and part of the natural sandy material have been removed, as seen in the section in the background

Almost the entire footprint of the monitored area had been disturbed, to the extent that no topsoil was recorded in any of the house plots. Even in Plots 21-24 (Plate 6), the highest point of the monitored area where the land was clear of the dairy building, it was not possible to provide an exact measurement of soil depths; upper topsoil to top of natural. The area of higher ground, partly visible in section outside the construction area, was covered in rubble and construction material and yielded no further details.

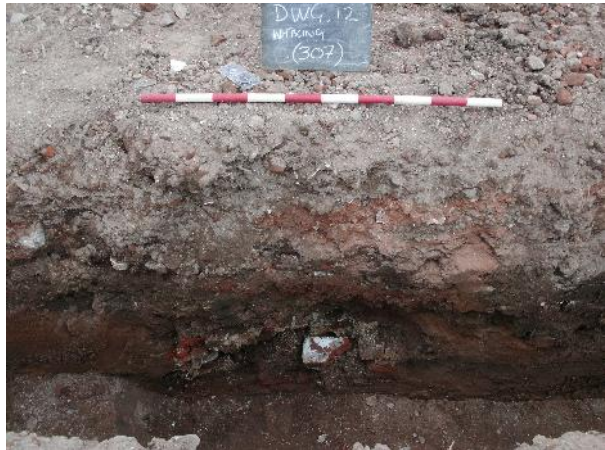
Plate 7: South-west facing section through the drain 307 in Plots 50-53 before excavation

The only area of interest which appeared not to relate to the previous dairy building was a drain 307, which is shown in Plates 7 and 8. This measured 210 x 110 x 70mm and was constructed of single coursed red brick with mortar, and had an arched roof. The associated fill (309) of the drain was the only context yielding finds: two sherds of glazed pottery were sent for specialist assessment, and proved to originate from the period between the mid-17th and the 18th centuries (Appendix 3), indicating that the infill of the drain was 18th century or later.

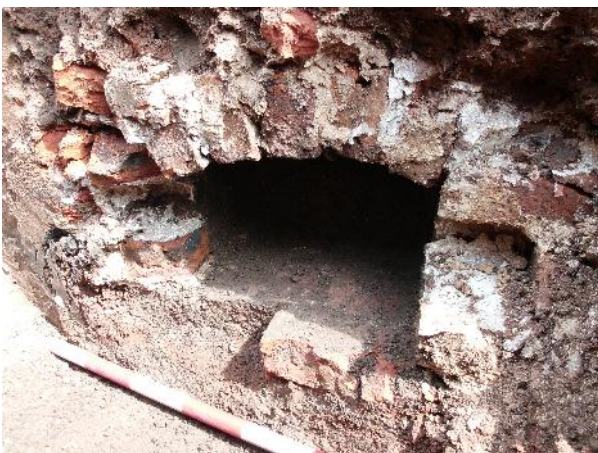
Plate 8: Plots 50-53 drain 307 after excavation

The recovered pottery suggests that the in-fill of the drain is of 18th century or later date.

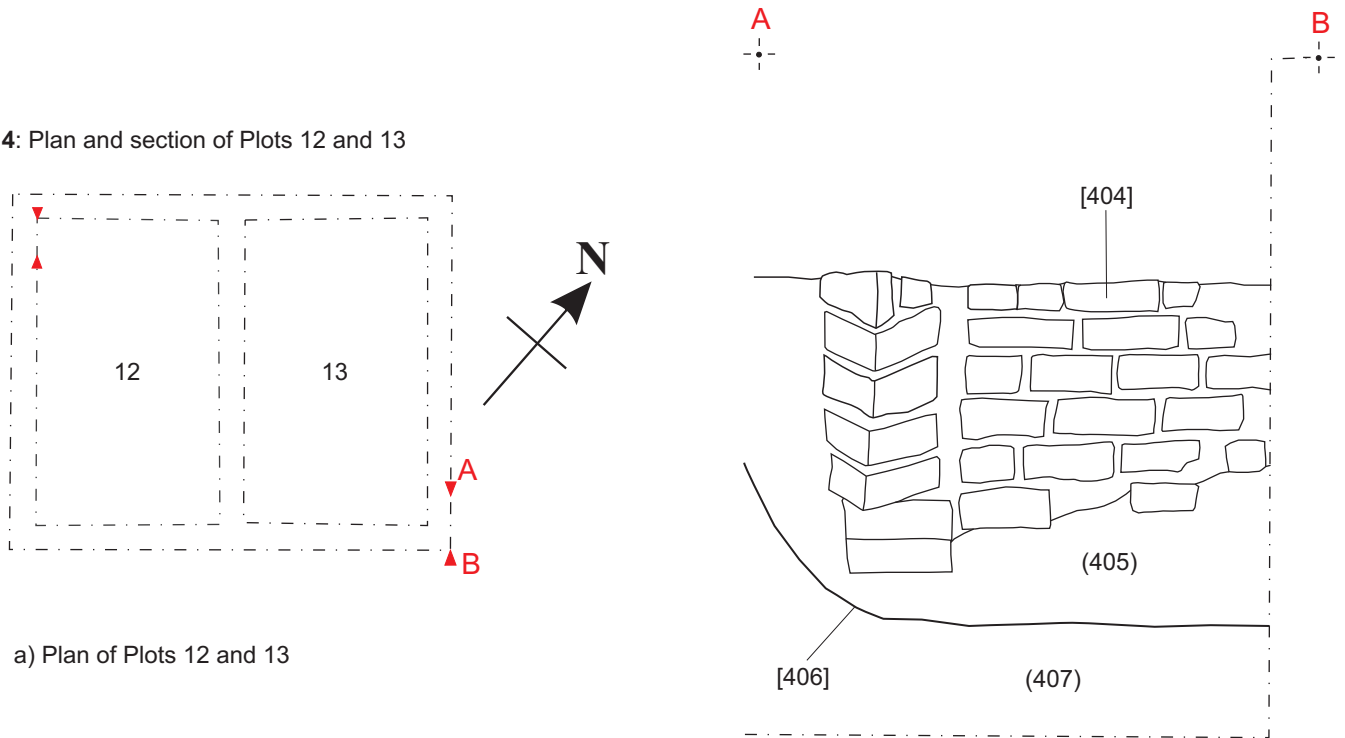
Fig. 4: Plan and section of Plots 12 and 13

a) Plan of Plots 12 and 13

b) SW facing section of Plot 13

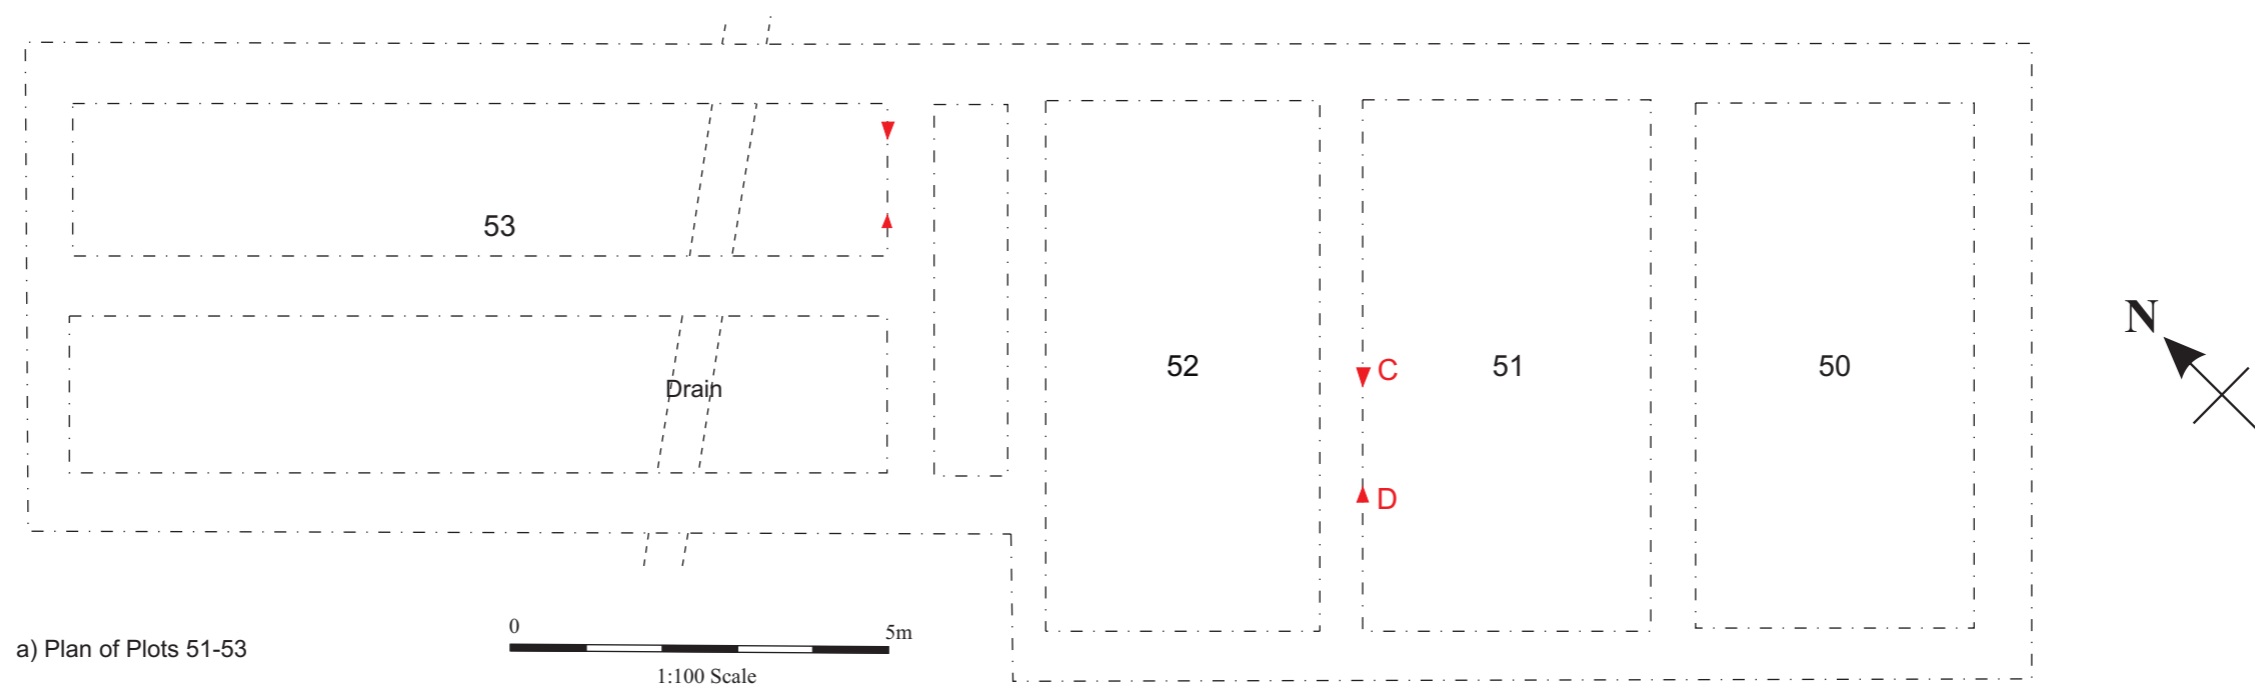
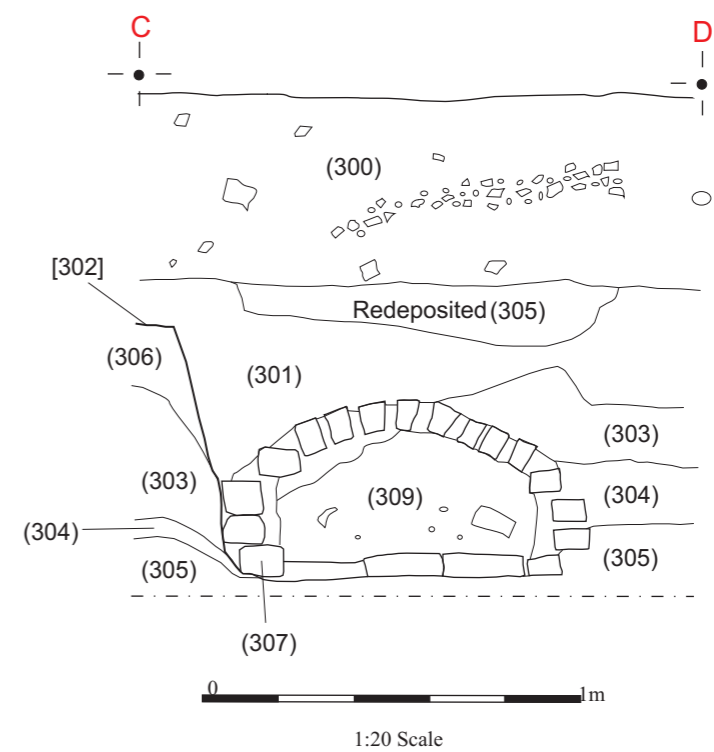
Fig. 7: Plan and section of Plots 50-53

b) South-west facing section through drain [307] in Plot 51

a) Plan of Plots 51-53

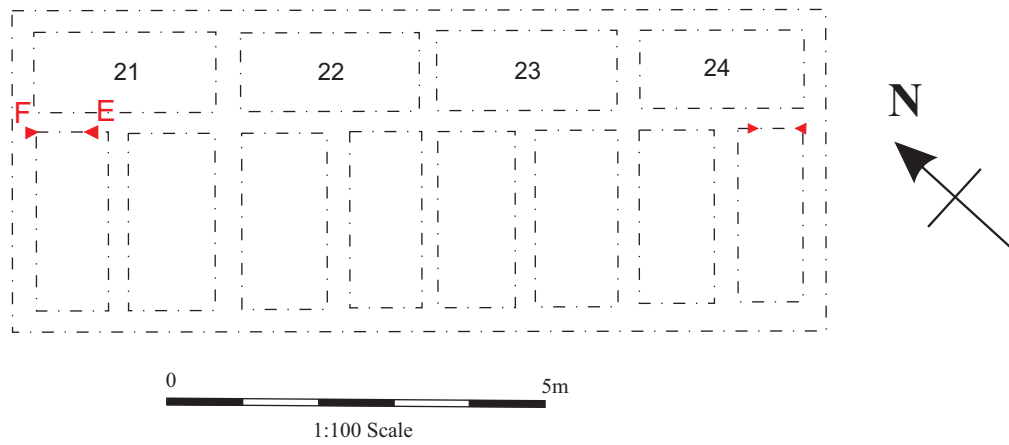
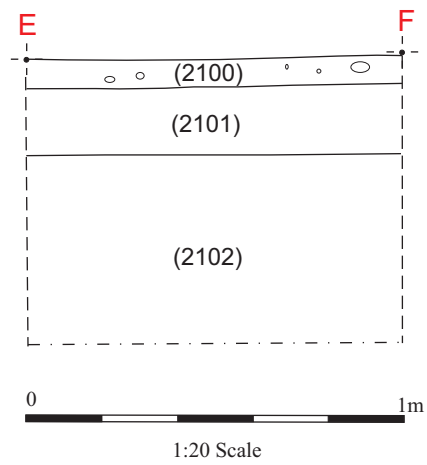
Fig. 9: Plan and section of Plots 21-24

a) Plan of Plots 21-24

b) South-east facing section of Plot 21

The natural clay was slightly sandy, and was overlain by one or more layers of silty sand. Plots 21-24 indicated the presence of sandy clay above this; such a layer (2002) was more than 0.50m thick.
