**LAND NORTH OF MILL LANE, LEGBOURNE, EAST LINDSEY,
LINCOLNSHIRE**

ARCHAEOLOGICAL EVALUATION REPORT

April 2016

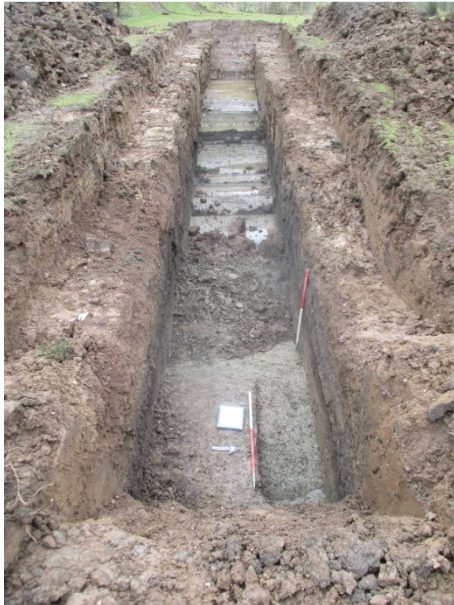
Plate 1 (left): Trench 6 (looking west).

Trench 6 measured 16m x 2m and was oriented east to west; it was positioned to investigate the linear earthwork identified on aerial photographs. This earthwork was exposed in the form of a ditched feature at the eastern end of the trench.

Above the buried soil, (603), a large bank had been constructed using imported clay material, approximately 1.9m in depth and covered by modern topsoil, (601).

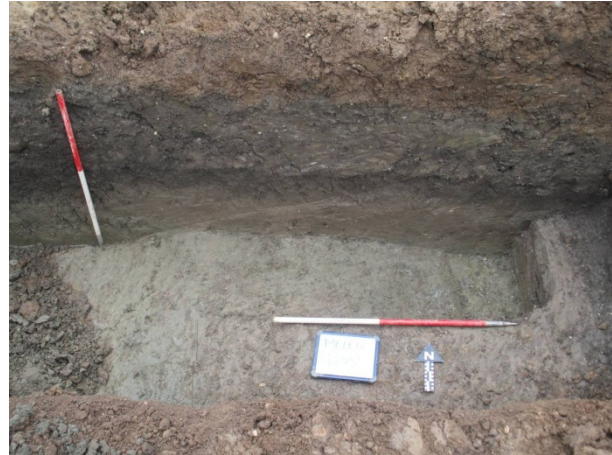
Plate 2 (above): Ditch [605] (looking north).

At the very eastern end of the trench, sealed beneath a dark buried soil (603), the western edge of a north-south orientated ditch-like feature, [605], was identified. Very little of this feature was exposed, with the c.2.0m excavated portion only revealing a fairly shallow slope, getting deeper at the eastern limit of excavation. The lower fill encountered, (606), consisted

of redeposited natural clay. Above this, the bulk fill was a dark brown silt clay, (607), from which no finds were recovered.

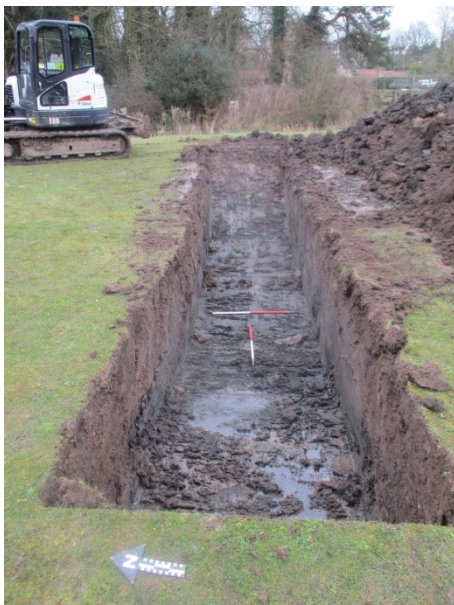
Plate 3: Trench 5 (looking east). Notice no natural has been exposed.

No remains of archaeological interest were exposed in Trenches 1 – 5 or 7 - 10. The majority exposed a stratigraphy of topsoil and subsoil overlying the natural clay substrate. Trenches 4 and 5 were located in an area of a backfilled former bay of the river to the north of the site, and were excavated to a depth of 1.2m, without the natural substrate being encountered.

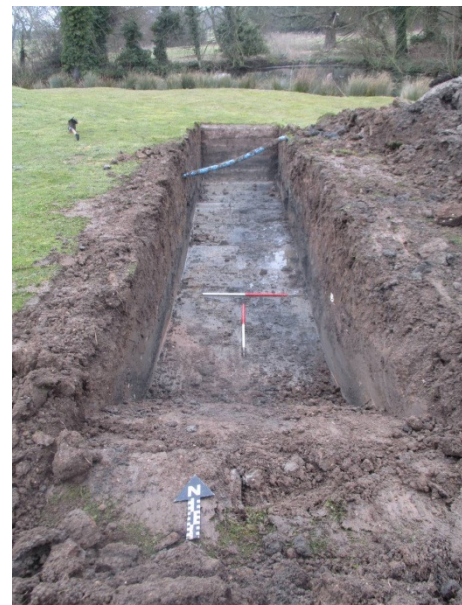
Plate 4: Trench 4 (looking north). As with Trench 5, no natural has been exposed.
