LAND NORTH OF STOW PARK ROAD, MARTON, WEST LINDSEY

ARCHAEOLOGICAL EVALUATION REPORT

NGR: SK 8444 8200
Planning Ref.: 133907
Archive acc. no.: LCNCC 2016.34
Site code: SPRE 16
PCAS job no.: 1652

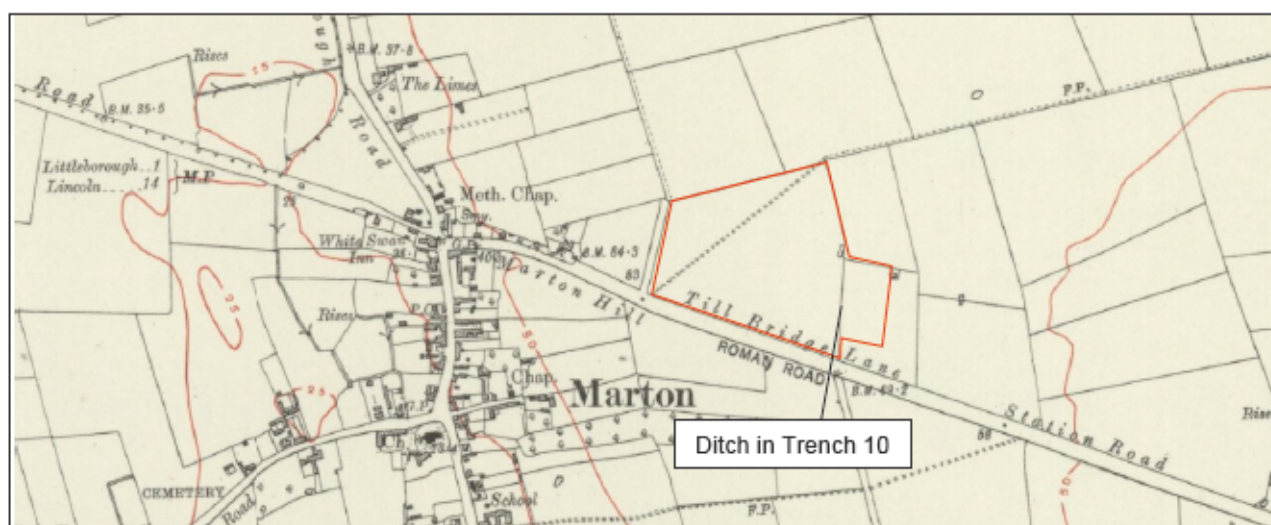
Figure 2: Extract from the 1920 OS 6" map, showing the site outlined in red. Not to scale.

Historic OS mapping of the site shows no buildings on the site throughout the 20th century. A footpath cuts across the site from the southwest corner to the northeast corner on the late 19th – early 20th century maps, however this access is not shown on mapping from the later 20th century. The 1920 6" map shows a quarry pit on the eastern boundary of the site at approximate NGR SK 84611 81976, which corresponds with magnetic anomalies seen on the geophysics.

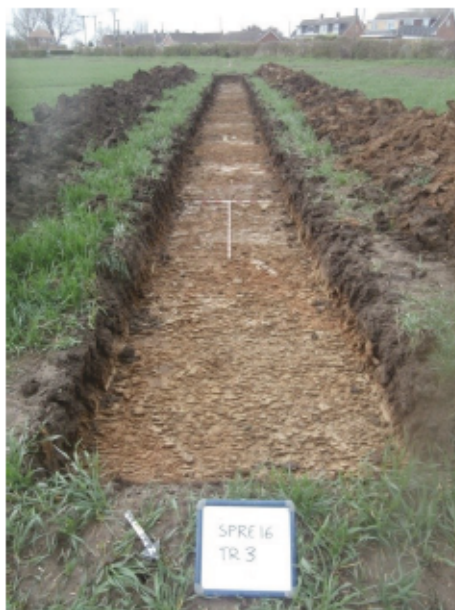
Plate 3: Trench 3 (looking SW),

Trench 3 was oriented northeast-southwest; positioned to evaluate the northwest corner of the development area. A single linear was most likely the base of a furrow.

The natural clay substrate was encountered at a depth of approximately 0.54m below original ground level.

At the very northeastern end of the trench, sealed beneath a light yellow brown subsoil (302), a west-east orientated linear was exposed. This feature had very shallow sides and was 0.77m wide and 0.13m deep. The profile and shape of this feature would indicate that it was most likely the remains of a furrow, from which no finds were recovered.

The subsoil, (302), was covered by approximately 0.3m of modern topsoil (301). A single sherd of 16th – 17th century pottery from a German stoneware cup was recovered from the topsoil; the slightly abraded condition of the sherd indicates it has been in the topsoil for some time, and may have been deposited as part of early post-medieval midden waste introduced to the field to improve soil quality.

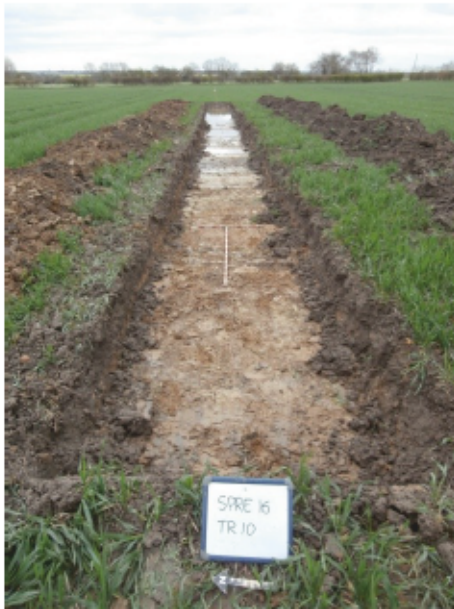
Plate 5: Trench 10 (looking E).

Trench 10 was orientated east-west; positioned to investigate the southeast corner of the proposed development area. A single ditch identified at the western end of the trench was most likely a post-medieval field boundary,

The natural clay substrate was encountered at a depth of approximately 0.55m below original ground level.

The exposed ditch, orientated approximately north-south, was sealed beneath modern topsoil (1001) and cut into subsoil (1002). It had steep sides, a narrow concave base and was 0.52m wide and 0.32m deep. It contained two deposits, neither of which yielded any finds. The profile of this feature and the stratigraphic relationships would indicate that it was most likely a disused field boundary. This interpretation is corroborated by 19th century OS mapping (fig. 2). Two sherds of pottery dating from the 17th – 18th century were recovered from the topsoil around this trench, which perhaps indicates the field boundary was in use at this time.
