**Archaeological Monitoring Report:  
Land to the East of Iver, South Bucks, Buckinghamshire**

Site code: CROM 16  
NGR: TQ 04594 80808 - TQ 04563 79067  
PCA Ref: 1730  
OASIS ref: preconst3-259835  
Accession ref: AYBCM : 2016.89

ADAS UK Ltd.

July 2016

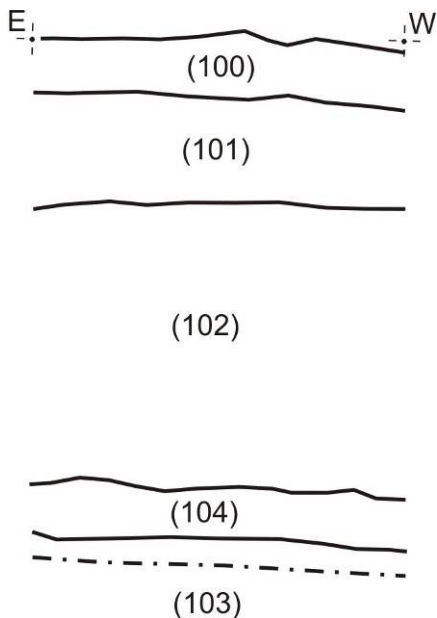
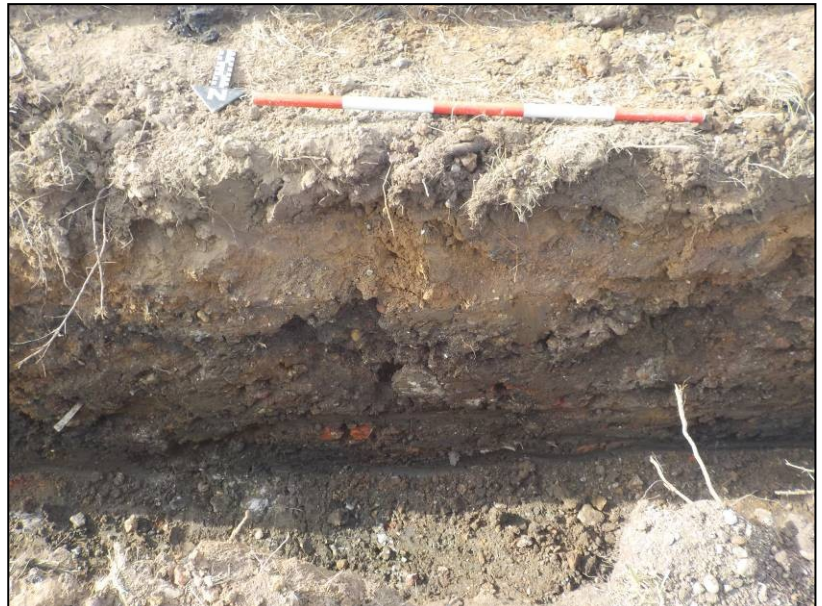
Approximately 90m of open trenching was monitored at the southern end of the cable route. The trenching had a maximum depth of c. 1.8m and was excavated through five distinct layers (100-104) all five were observed to contain modern waste and demolition material and as such this area appears to consist of entirely modern made ground to a depth of over 1.8m. No archaeological features or deposit were observed and no natural geological deposits were encountered at this location.

Figure 2 / Plate 1: Excavation 1 open trenching south of Thorney Lane representative section (1:20) and corresponding plate. Approximate location TQ 04601 79319.

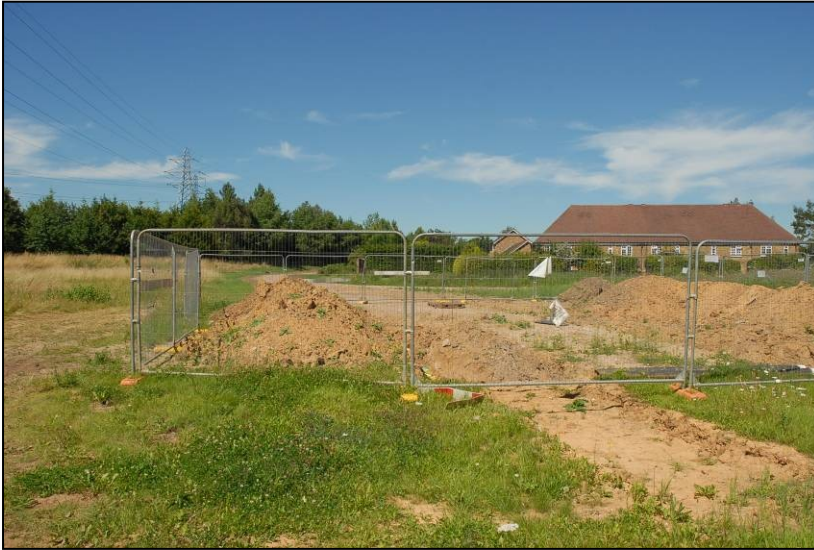
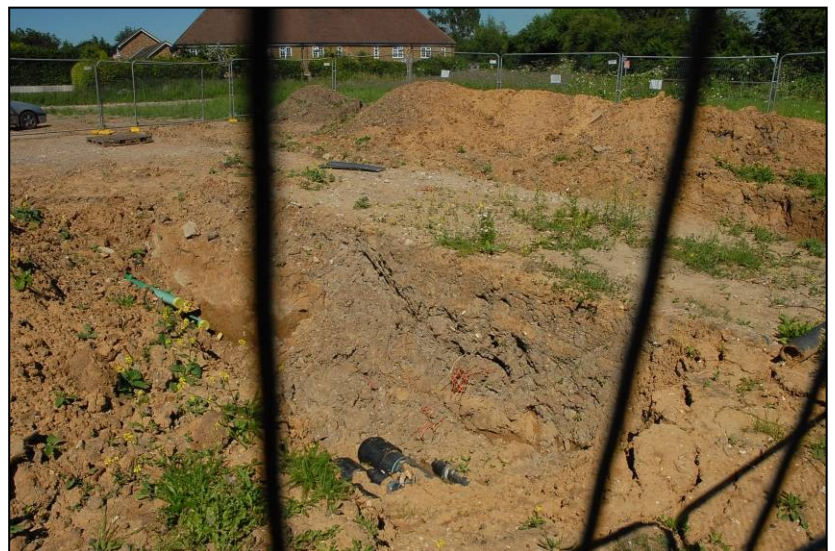
There was no access to this pit due to safety considerations. The excavation of a receiving pit at this location identified the natural mid orange clay (202) at c. 0.45m below the existing ground level. This was sealed by a distinct subsoil (201), described as mid grey clay, which had a depth of c. 0.15m which in turn was sealed by the topsoil (200) which was c. 0.3m thick and recorded as dark brown humic soil. A modern backfilled pit [204] was also observed, but as it had modern plastic material within its backfill (203) it was not further recorded. No archaeological features or deposit were observed.

Plate 2&3: Looking north towards Excavation 2, and below, modern pit in section.

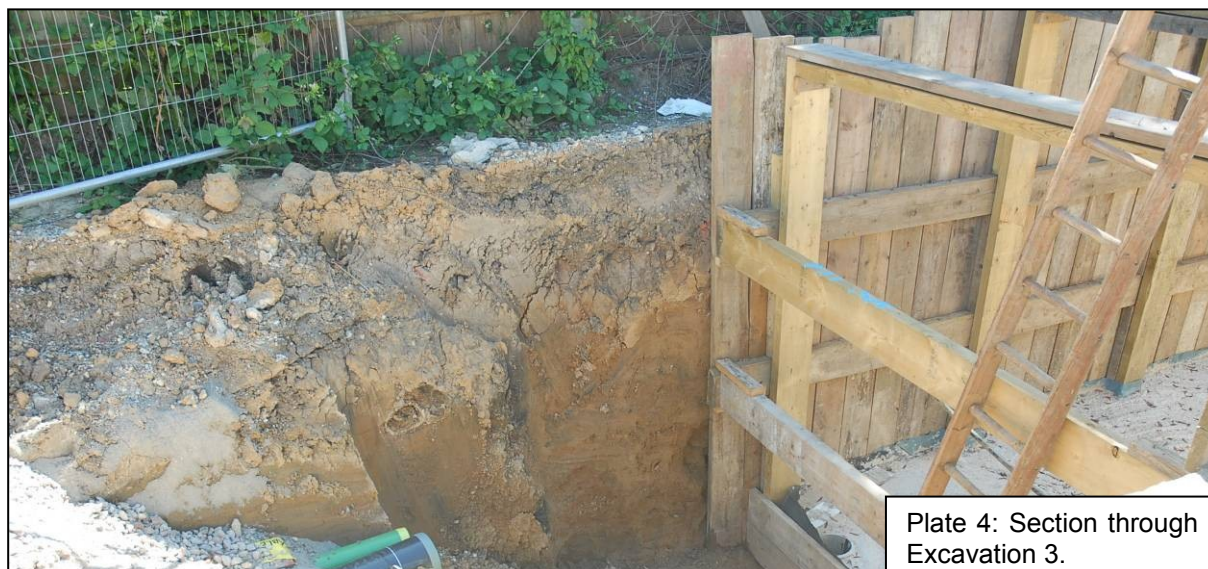
There was no access to this pit due to safety considerations, and much of the pit was shored immediately after excavation. Exactly the same sequence of topsoil (206) over subsoil (207) over natural clay (208) was also recorded at this location as for Excavation 2, although additionally the topsoil here was sealed by a layer of hardstanding (205). No archaeological features or deposit were observed.

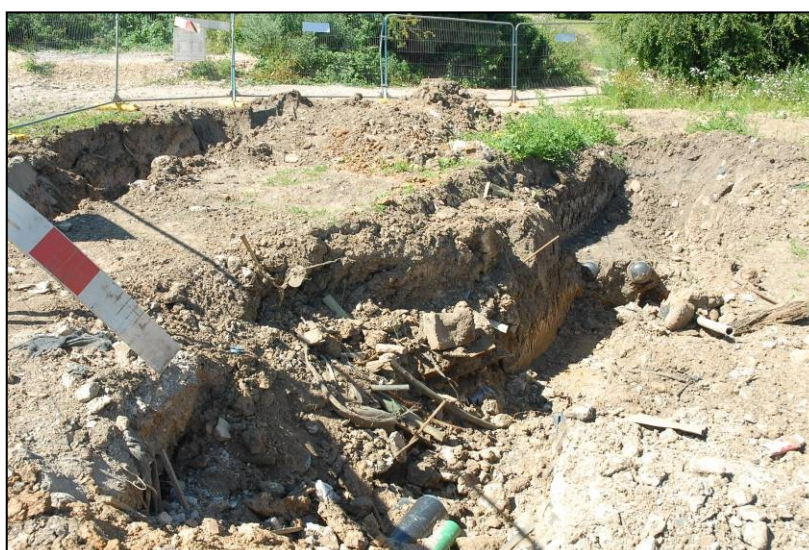
There was no access to this pit due to safety considerations. The natural clay was only observed at one end of the pit where it had been truncated by a modern feature/deposit (212) which contained modern demolition material and was not further recorded. No archaeological features or deposit were observed.

Plate 5: Modern demolition material in Excavation 5

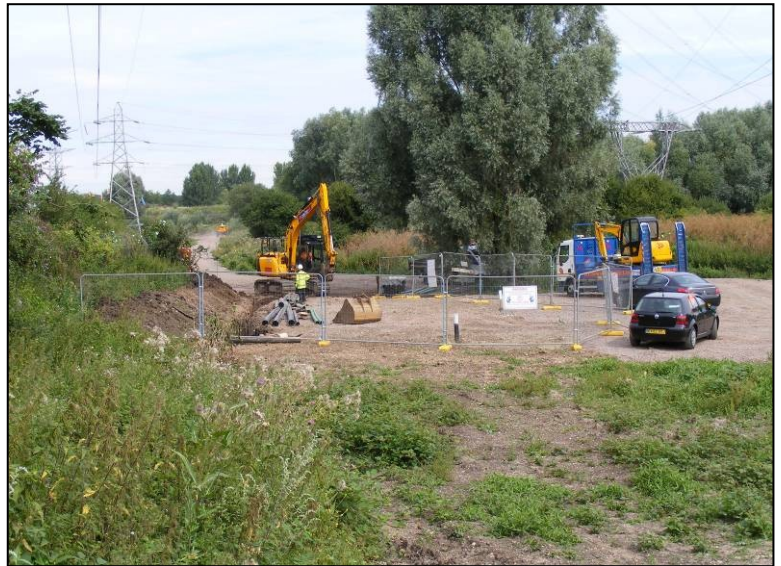
Two lengths of open trenching were monitored at this location. Trench 6 was c. 20m long and Trench 7 was c. 15m long. These two trenches were only c. 5m apart and ran parallel with each other. The maximum depth of both trenches was 1.6m.

Plate 6: Area of Excavation 6 & 7.  
Machining of Excavation 6  
underway.

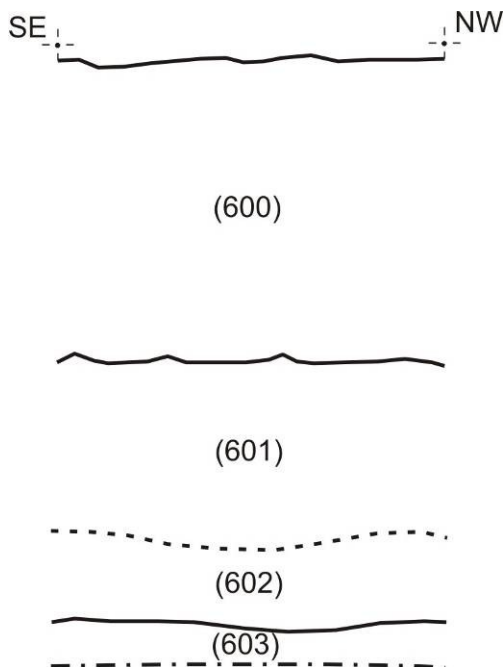
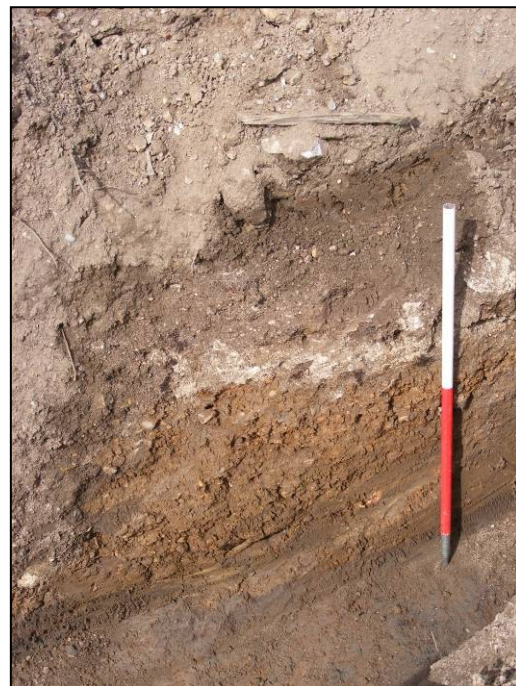
The earliest deposit encountered in Trench 6 was a mottled dark grey/mid orange-red brown slightly sandy silt (603) which was over 0.1m thick and extended below the limit of excavation. This was sealed by c. 0.25m of mid red-brown slightly sandy fine silt (602), which in turn was sealed by c. 0.45m of a similar sediment which containing frequent small river gravels (601). These three deposits appear to be consistent with natural riverine deposits. They were in turn sealed by c. 0.8m of modern dumped material (600) which included some demolition material and appeared to be part of an extensive surface deposit which covered much of cable route at this location.

Figure 3 / Plate 7: Representative section from Excavation 6 (1:20) and corresponding plate. Approximate location TQ 04617 80157.

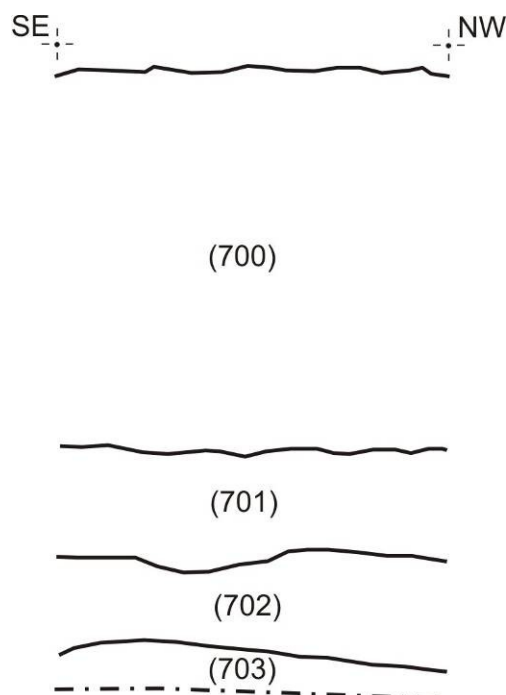
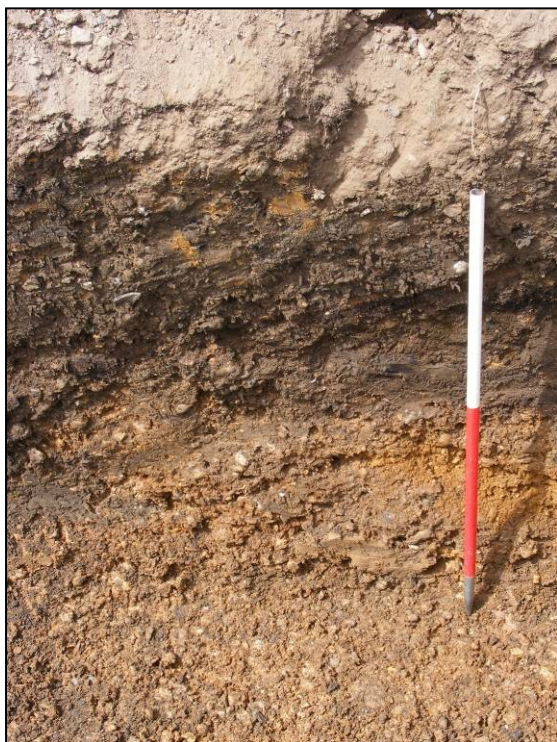
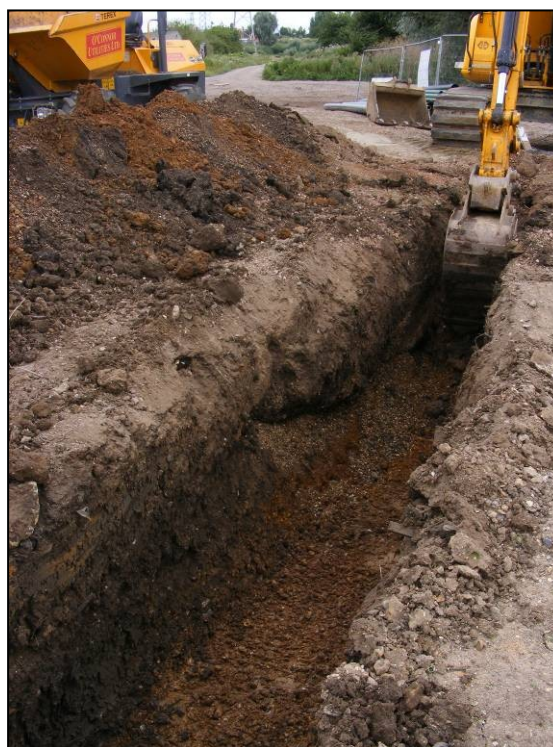
The earliest deposit encountered in Trench 7 was a mid-brown fine silt-clay with common small river gravels (703). This was over 0.1m thick and extended below the limit of excavation. It was sealed by c. 0.25m of mid orange-brown sand and gravel (702), which in turn was sealed by c. 0.3m of mid-brown fine silt-clay with frequent small river gravels (701). As with adjacent Trench 6 these apparent riverine deposits were sealed by c. 1m of modern dumped material and hard standing (700).

The lower deposit encountered in these two trenches appeared to be entirely natural water lain deposits despite their diversity over a relatively short distance, which may have been the product of a meandering river system which eroded and re-deposited material with some frequency.

Top right: Figure 4: Representative section of Excavation 7. 1:20. Approximate location TQ 04626 80153.

Above: Plates 8 & 9: Representative section of Excavation 7 and Trench under excavation.

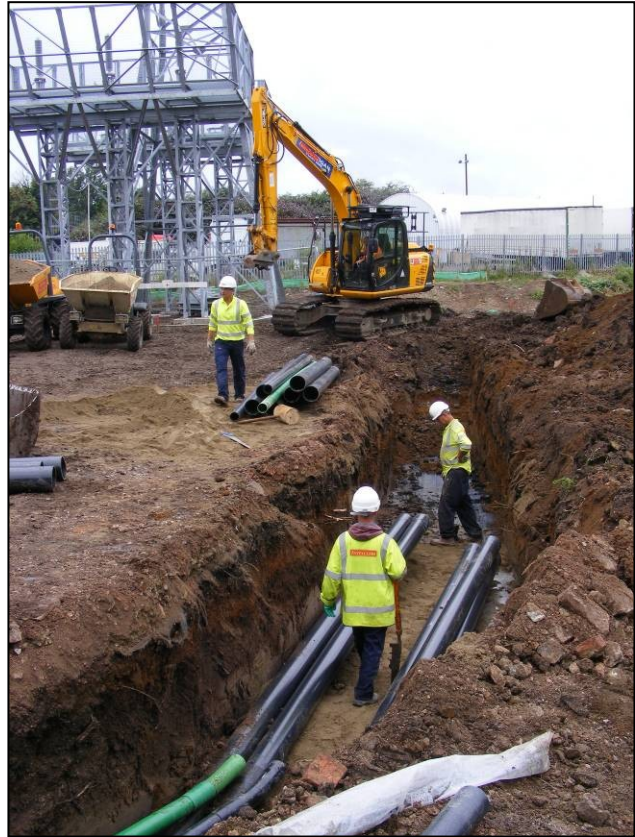
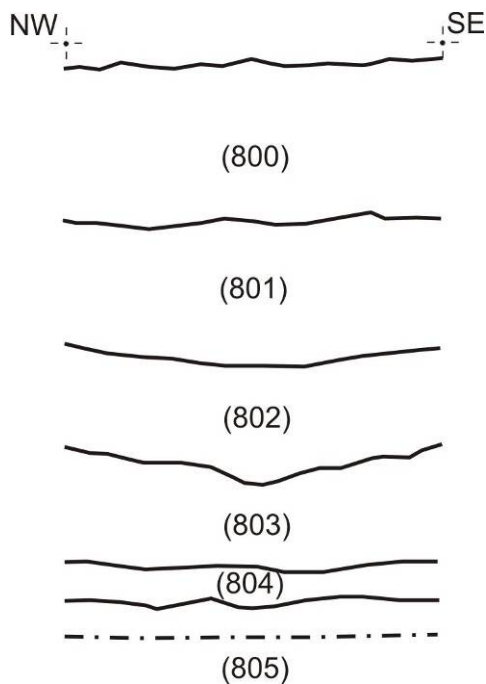
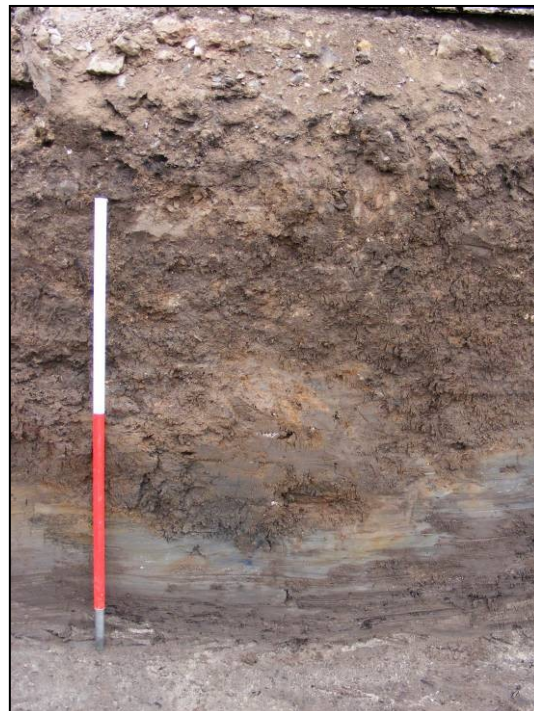
Approximately 35m of open trenching was monitored at the northern end of the cable route. This had a maximum depth of c. 1.7m and was excavated through six distinct layers (800-805). The earliest deposit encountered was a mid grey-brown silt with frequent small chalk fragments and small wood particles and root fragments (805). This was sealed by c. 0.15m of mid brown slightly sandy silt with frequent small wood particles (804). This layer was in turn sealed by c. 0.3m of mottled dark grey/mid orange fine silt-clay with occasional small chalk fragments (803). These three deposits appear to be more ancient riverine deposits.

Deposit (803) was sealed by c. 0.35m of mid brown slightly sandy silt with occasional lenses of yellow brown clay and small river gravels (802). This was sealed by c. 0.45m of mid brown slightly sandy silt with occasional small river gravels (801). Both of these deposit were heavily root disturbed and appeared to be a deep, settled subsoil and topsoil respectively. These were sealed by c. 0.4m of modern crushed stone and re-deposited/levelling material (800).

Top right: Working shot Excavation 8.

Above: Figure 5 / Plate 10: Representative section from Excavation 8 (1:20) and corresponding plate. Approximate location TQ 04511 80370.
