**LAND AT BATTLEFLAT LODGE FARM, STANTON UNDER BARDON, HINCKLEY
AND BOSWORTH BOROUGH, LEICESTERSHIRE**

Archaeological Evaluation Report

January 2017

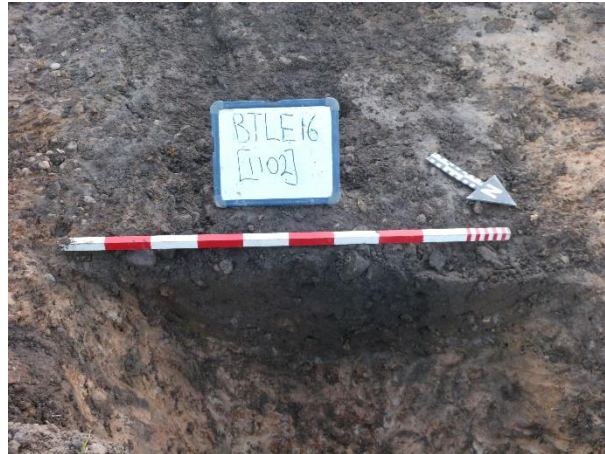
Plate 1: Ditch [1102] (looking SW)

The ditch/gully, [1102], was orientated approximately N-S, had fairly steep sides and a relatively narrow concave base. It contained a single black silt fill, from which no finds were recovered. Although the geophysical survey flagged the area as being archaeologically negative, a number of land drains identified to the north would potentially continue southwards through this trench. No land drain was seen in this feature.

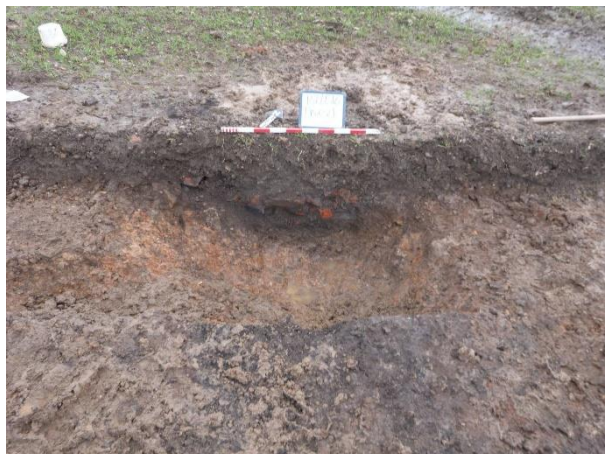
Plate 2: Ditch [3502] (looking NW).

The boundary ditch, [3502], orientated approximately NW-SE had gradually sloped sides, a concave base and contained two fills, both of which incorporated modern bricks, and general waste, indicating a recent date. This ditch, seen on modern OS mapping, was also observed in Tr. 35, 29, 27 and 19.

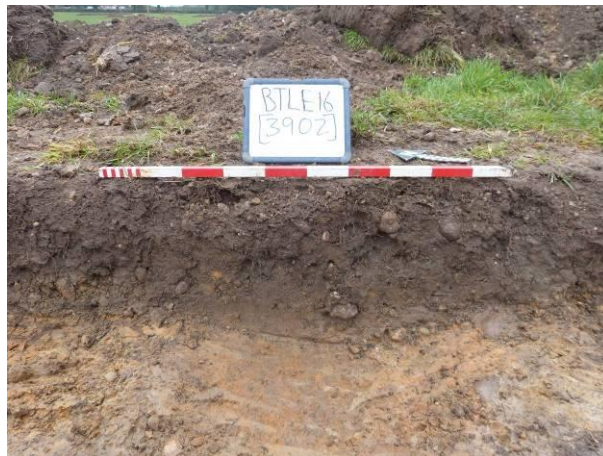
Plate 3: Gully [3902] (looking NE)

The gully, [3902], was orientated NE-SW, had fairly shallow sides and a concave base. It contained a single fill, which produced no finds.

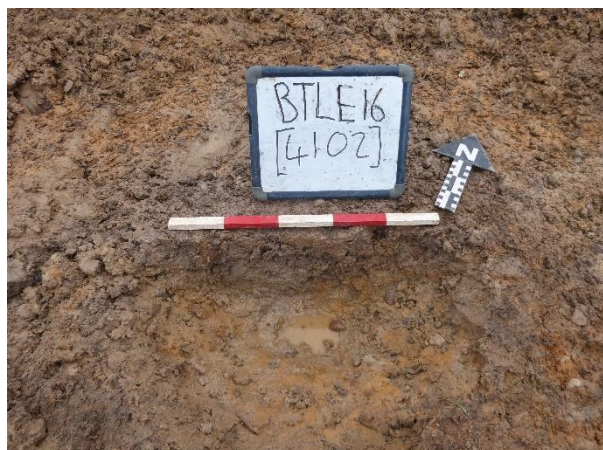
Plate 4: Pit [4102] (looking NW)

The pit, [4102], was circular in plan, with fairly regular sides and a narrow concave base. It contained a single clay silt fill, which produced no finds.

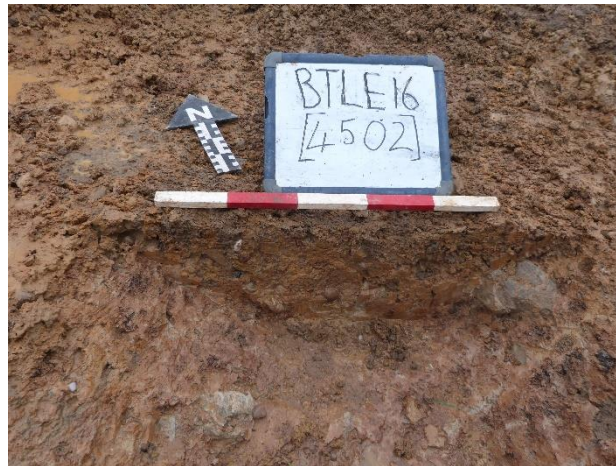
Plate 5: Gully [4502] (looking NE).

The gully, [4502], as seen in Trench 39, had shallow, rounded sides and a concave base. It contained a single silt clay fill, which produced no finds.

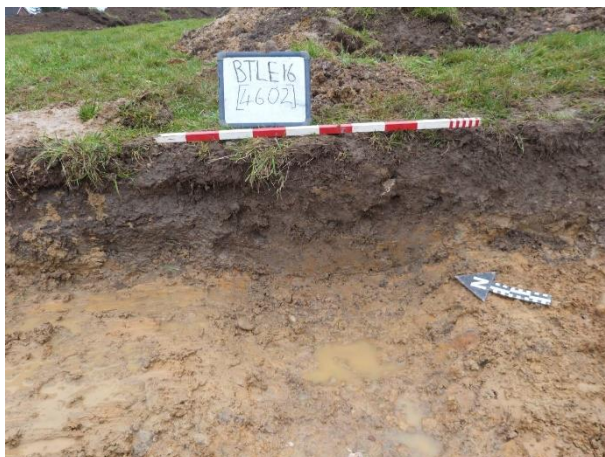
Plate 6: Gully [4602] (looking NE).

The gully, as in Trenches 39 and 45, had relatively shallow sides and a concave base. It contained a single silt clay fill, which produced no finds.

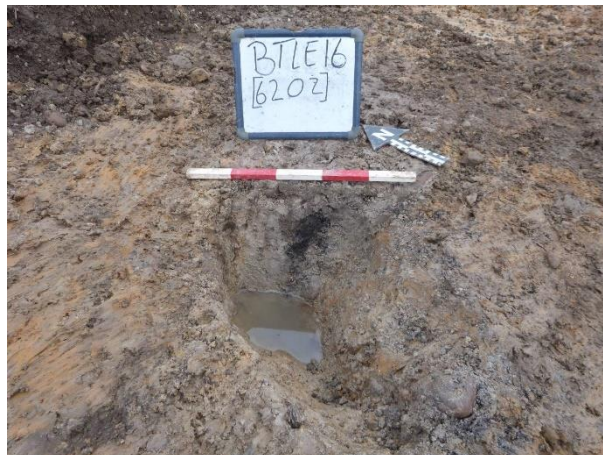
Plate 7: Pit [6202] (looking NE)

The pit was oval in shape with fairly diffuse edges. It had steep sides and an uneven concave base. It contained a single silt clay deposit that produced no finds.

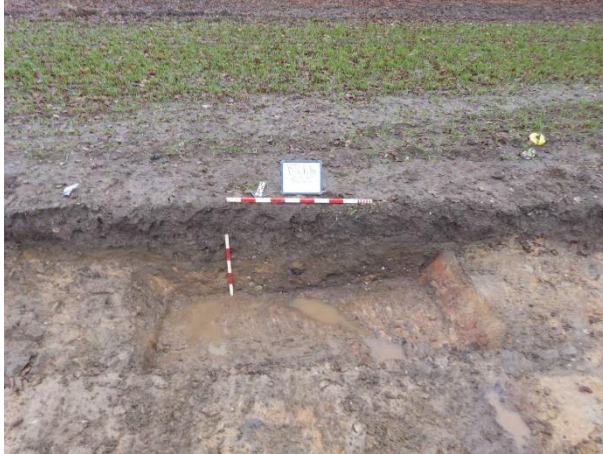
Plate 8: Pit [8002] (looking S)

The larger of the two pits, [8002], was circular in plan, with steep but shallow sides and a very flat base. It contained three fills, none of which produced any finds. There was some evidence of burning towards the edges of the feature, and it may be that this pit contained waste from industrial activity, however due to lack of finds, no date or certain use can be ascertained.

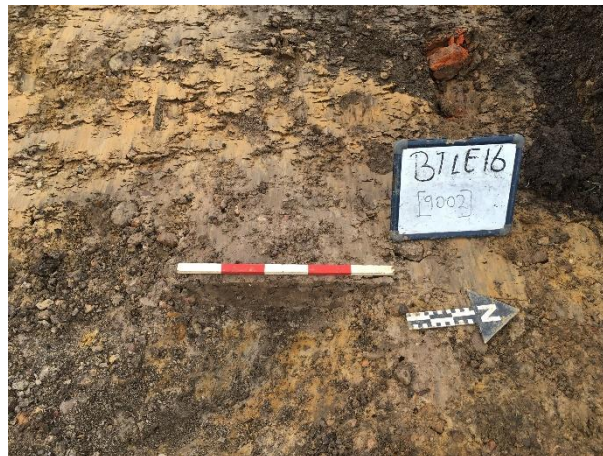
Plate 9: Pit [9002] (looking W)

The pit was an irregular circle in plan, with steep sides and a narrow concave base. It contained a single light grey silt clay fill that contained no finds.

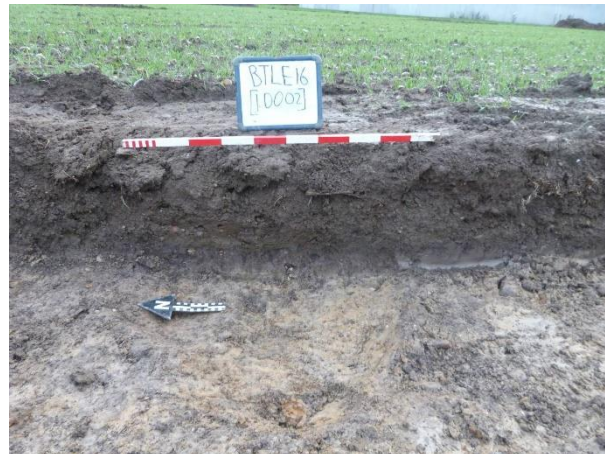
Plate 10: Pit [10002] (looking E)

The pit, [10002], which partially lay outside of the trench, appeared to be circular in plan, with shallow sides and a fairly uneven base, suggesting a possible natural origin. It contained a single fill that contained no finds.

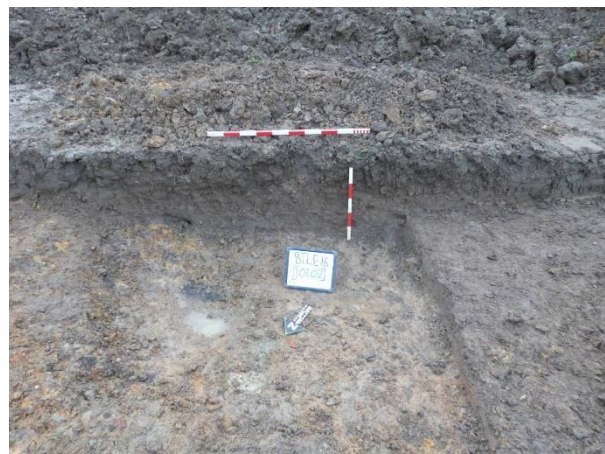
Plate 11: Pit [10202] (looking SE)

The pit, approximately 4.5m in width, had very shallow sides and a broad, uneven, but predominantly flat base. It contained a single silt deposit, which produced no finds. The poorly defined sides and uneven base suggest this feature may be a natural hollow or could potentially be a watering hole for livestock.

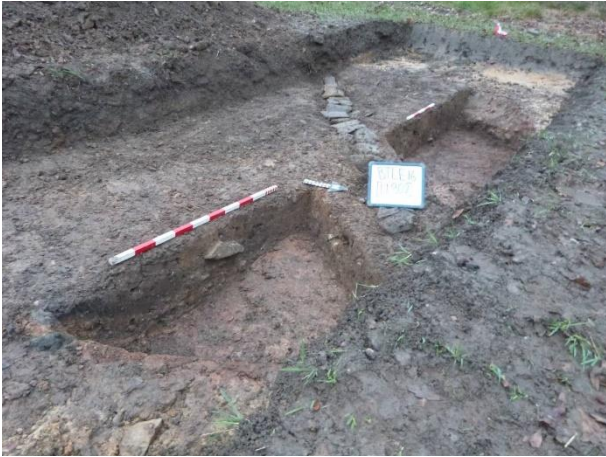
The largest of the three pits, [11902], was similar in form to the large pit seen in Trench 80. It was circular in plan, had steep but shallow sides and a flat base. There was also evidence of

burnt material within, which may also point to industrial activity. The pit contained three deposits, one of which produced a fragment of post-medieval CBM.

Plate 12: Pit [11902] (looking WSW). Note the land drain running through centre of pit.

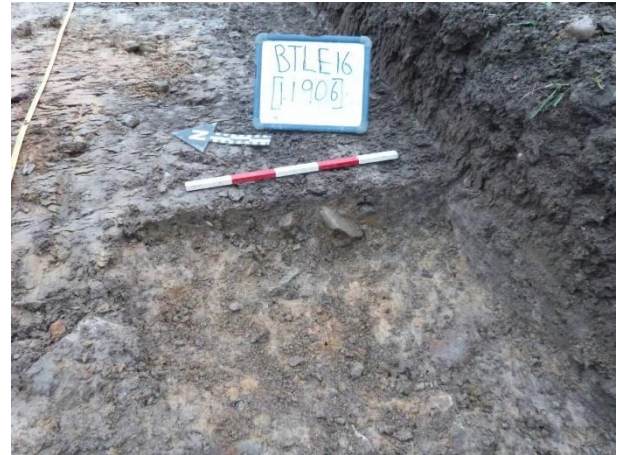
Plate 13: Pit [11906] (looking E).

The other two pits were to the east of the large pit. Both features were only partially exposed, had shallow sides, uneven bases, and contained single fills. Neither produced any finds.
