**RUNWAY REFURBISHMENT, RAF WADDINGTON,  
NORTH KESTEVEN, LINCOLNSHIRE**

**SCHEME OF ARCHAEOLOGICAL MONITORING  
AND RECORDING**

Report prepared for  
Carillion Construction Services

November 2016

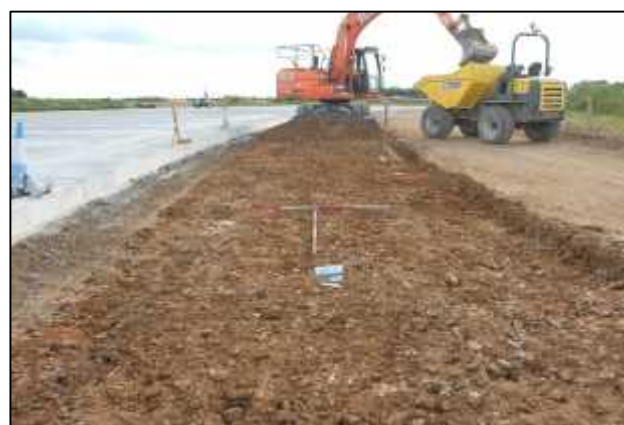
**Plate 1:** Working shot of the strip along the north side of the existing runway, looking south-west.

trenching. The monitored zone extended to 70m either side of the projected centre line of the Roman road, and the strips varied from 5m to 14.5m in width. Excavations were carried out using a wheeled 360° excavator fitted with a toothless ditching bucket (plate 1).

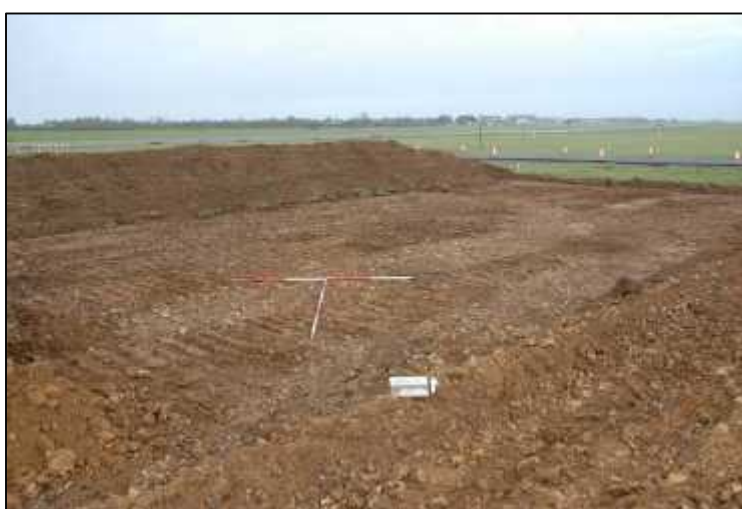
**Plate 2:** Topsoil strip at the beginning of groundworks on the taxiway, looking north. The break in the line of trees on the horizon, almost directly on the line of the north arrow, shows the course of Roman Ermine Street. The abundant stone in the topsoil strip proved on deeper excavation to be natural in origin.

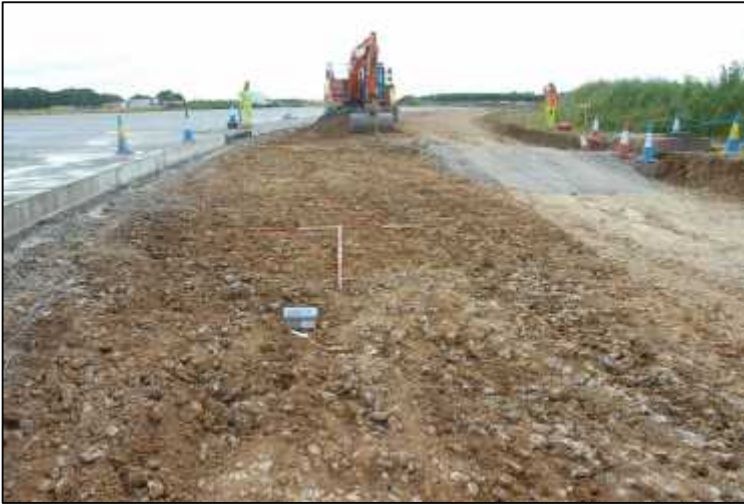
**Plate 3:** Excavation at the north side of the taxiway, looking southwest, showing the natural stone.

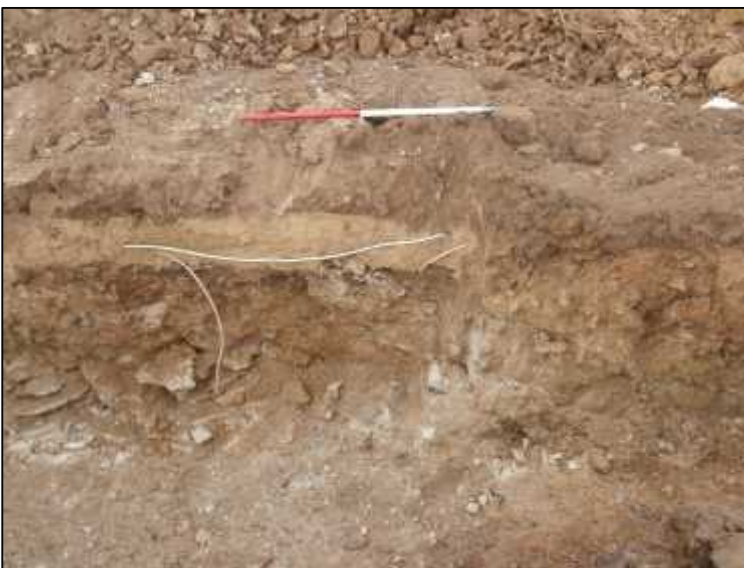
The natural limestone bedrock 004 was exposed at the base of the deeper excavations. Along the north side of the runway, this was overlain by modern deposits: made ground and concrete 003 and brick rubble 105, with the existing runway surface above. On the south side of the runway and along the taxiway, only subsoil 101 and topsoil 100 were recorded. Abundant stone was observed in the subsoil during the initial strip of the taxiway groundworks, but excavation to greater depths showed that this stone was derived from the underlying natural bedrock and did not constitute the remains of a road surface (plates 2 and 3). Buried services, such as drains and electric cables, were frequently encountered throughout the groundworks (plate 4).

**Plate 4:** View of the excavations at the north side of the runway, showing the disturbance caused by modern services.

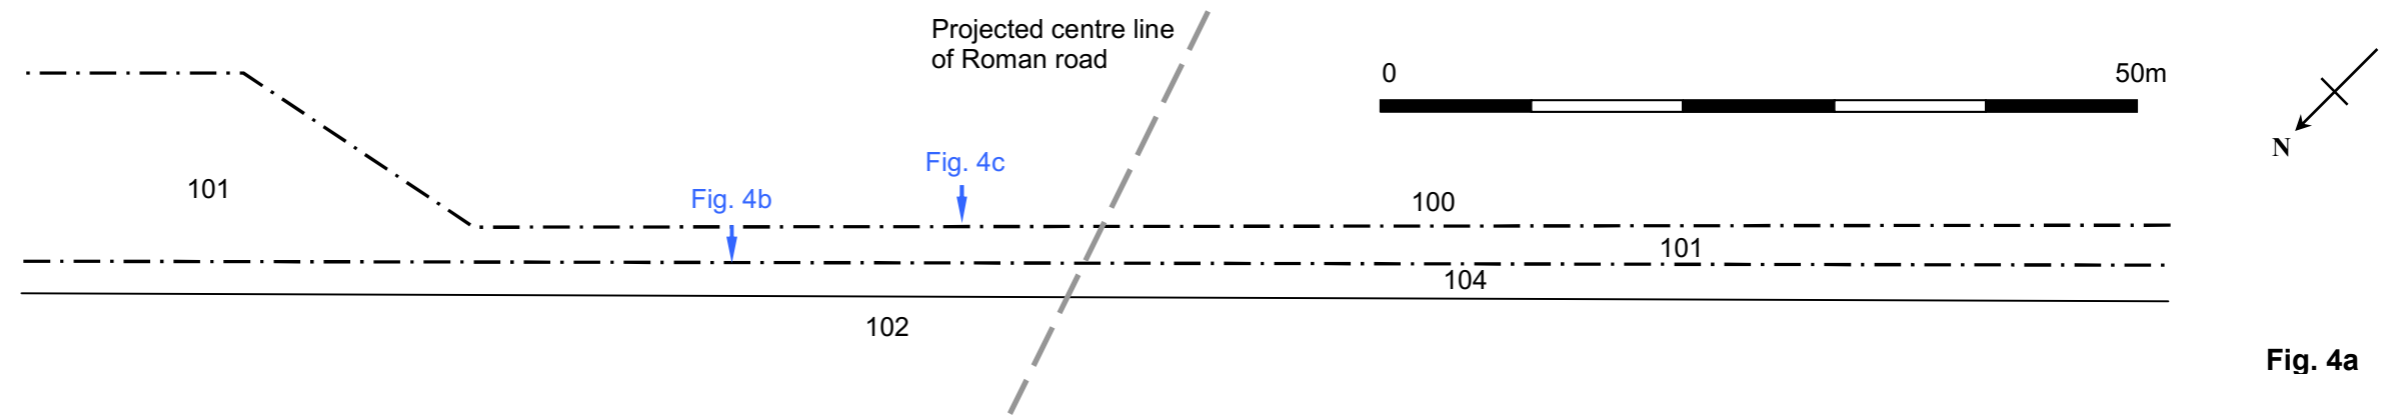
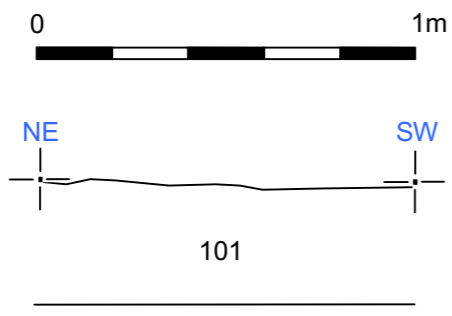
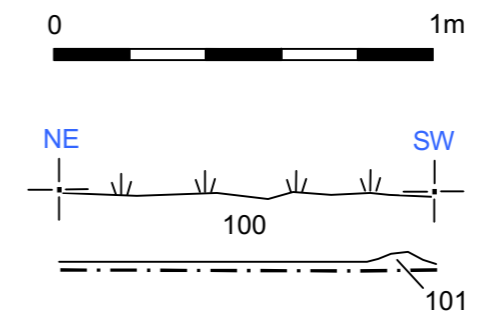
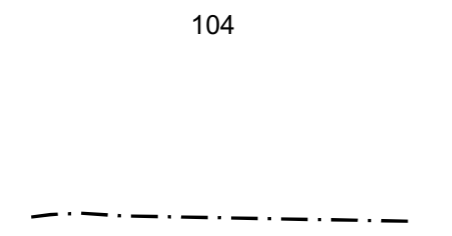
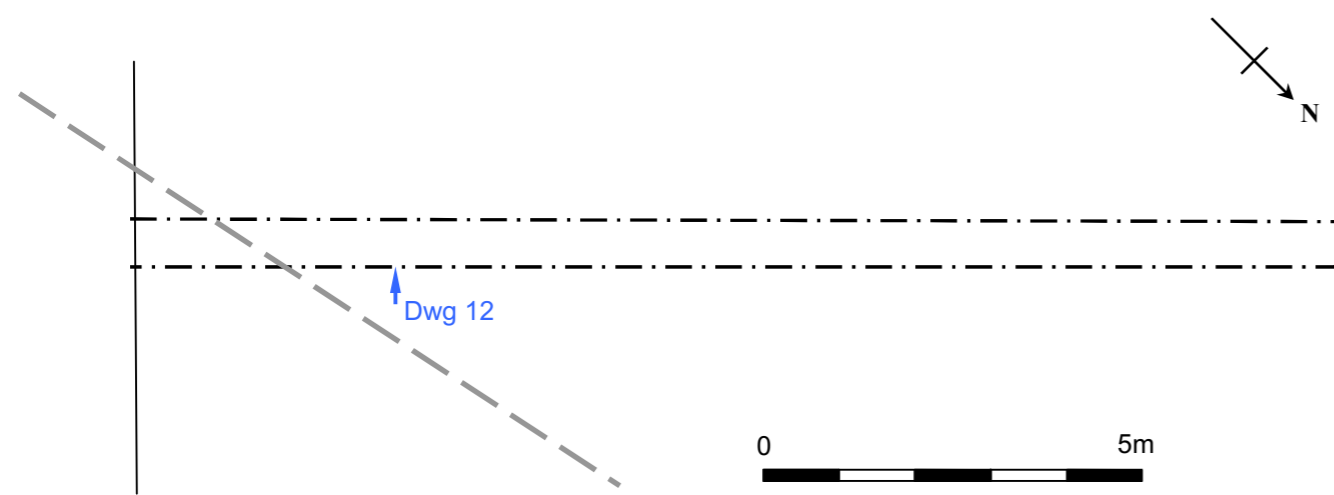
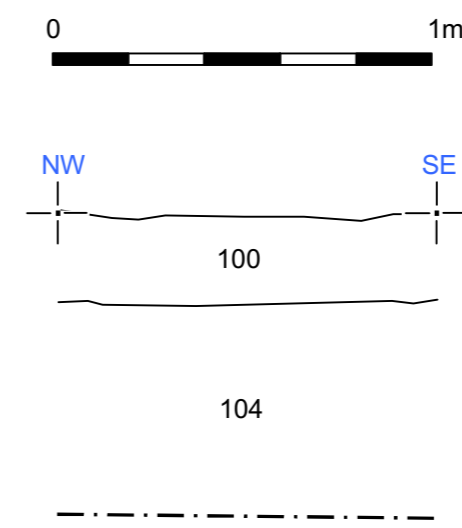
**Figure 4:** Sections drawn within the monitored area on the south side of the main runway, at scale 1:20, with location plans at scales 1:500 and 1:100.

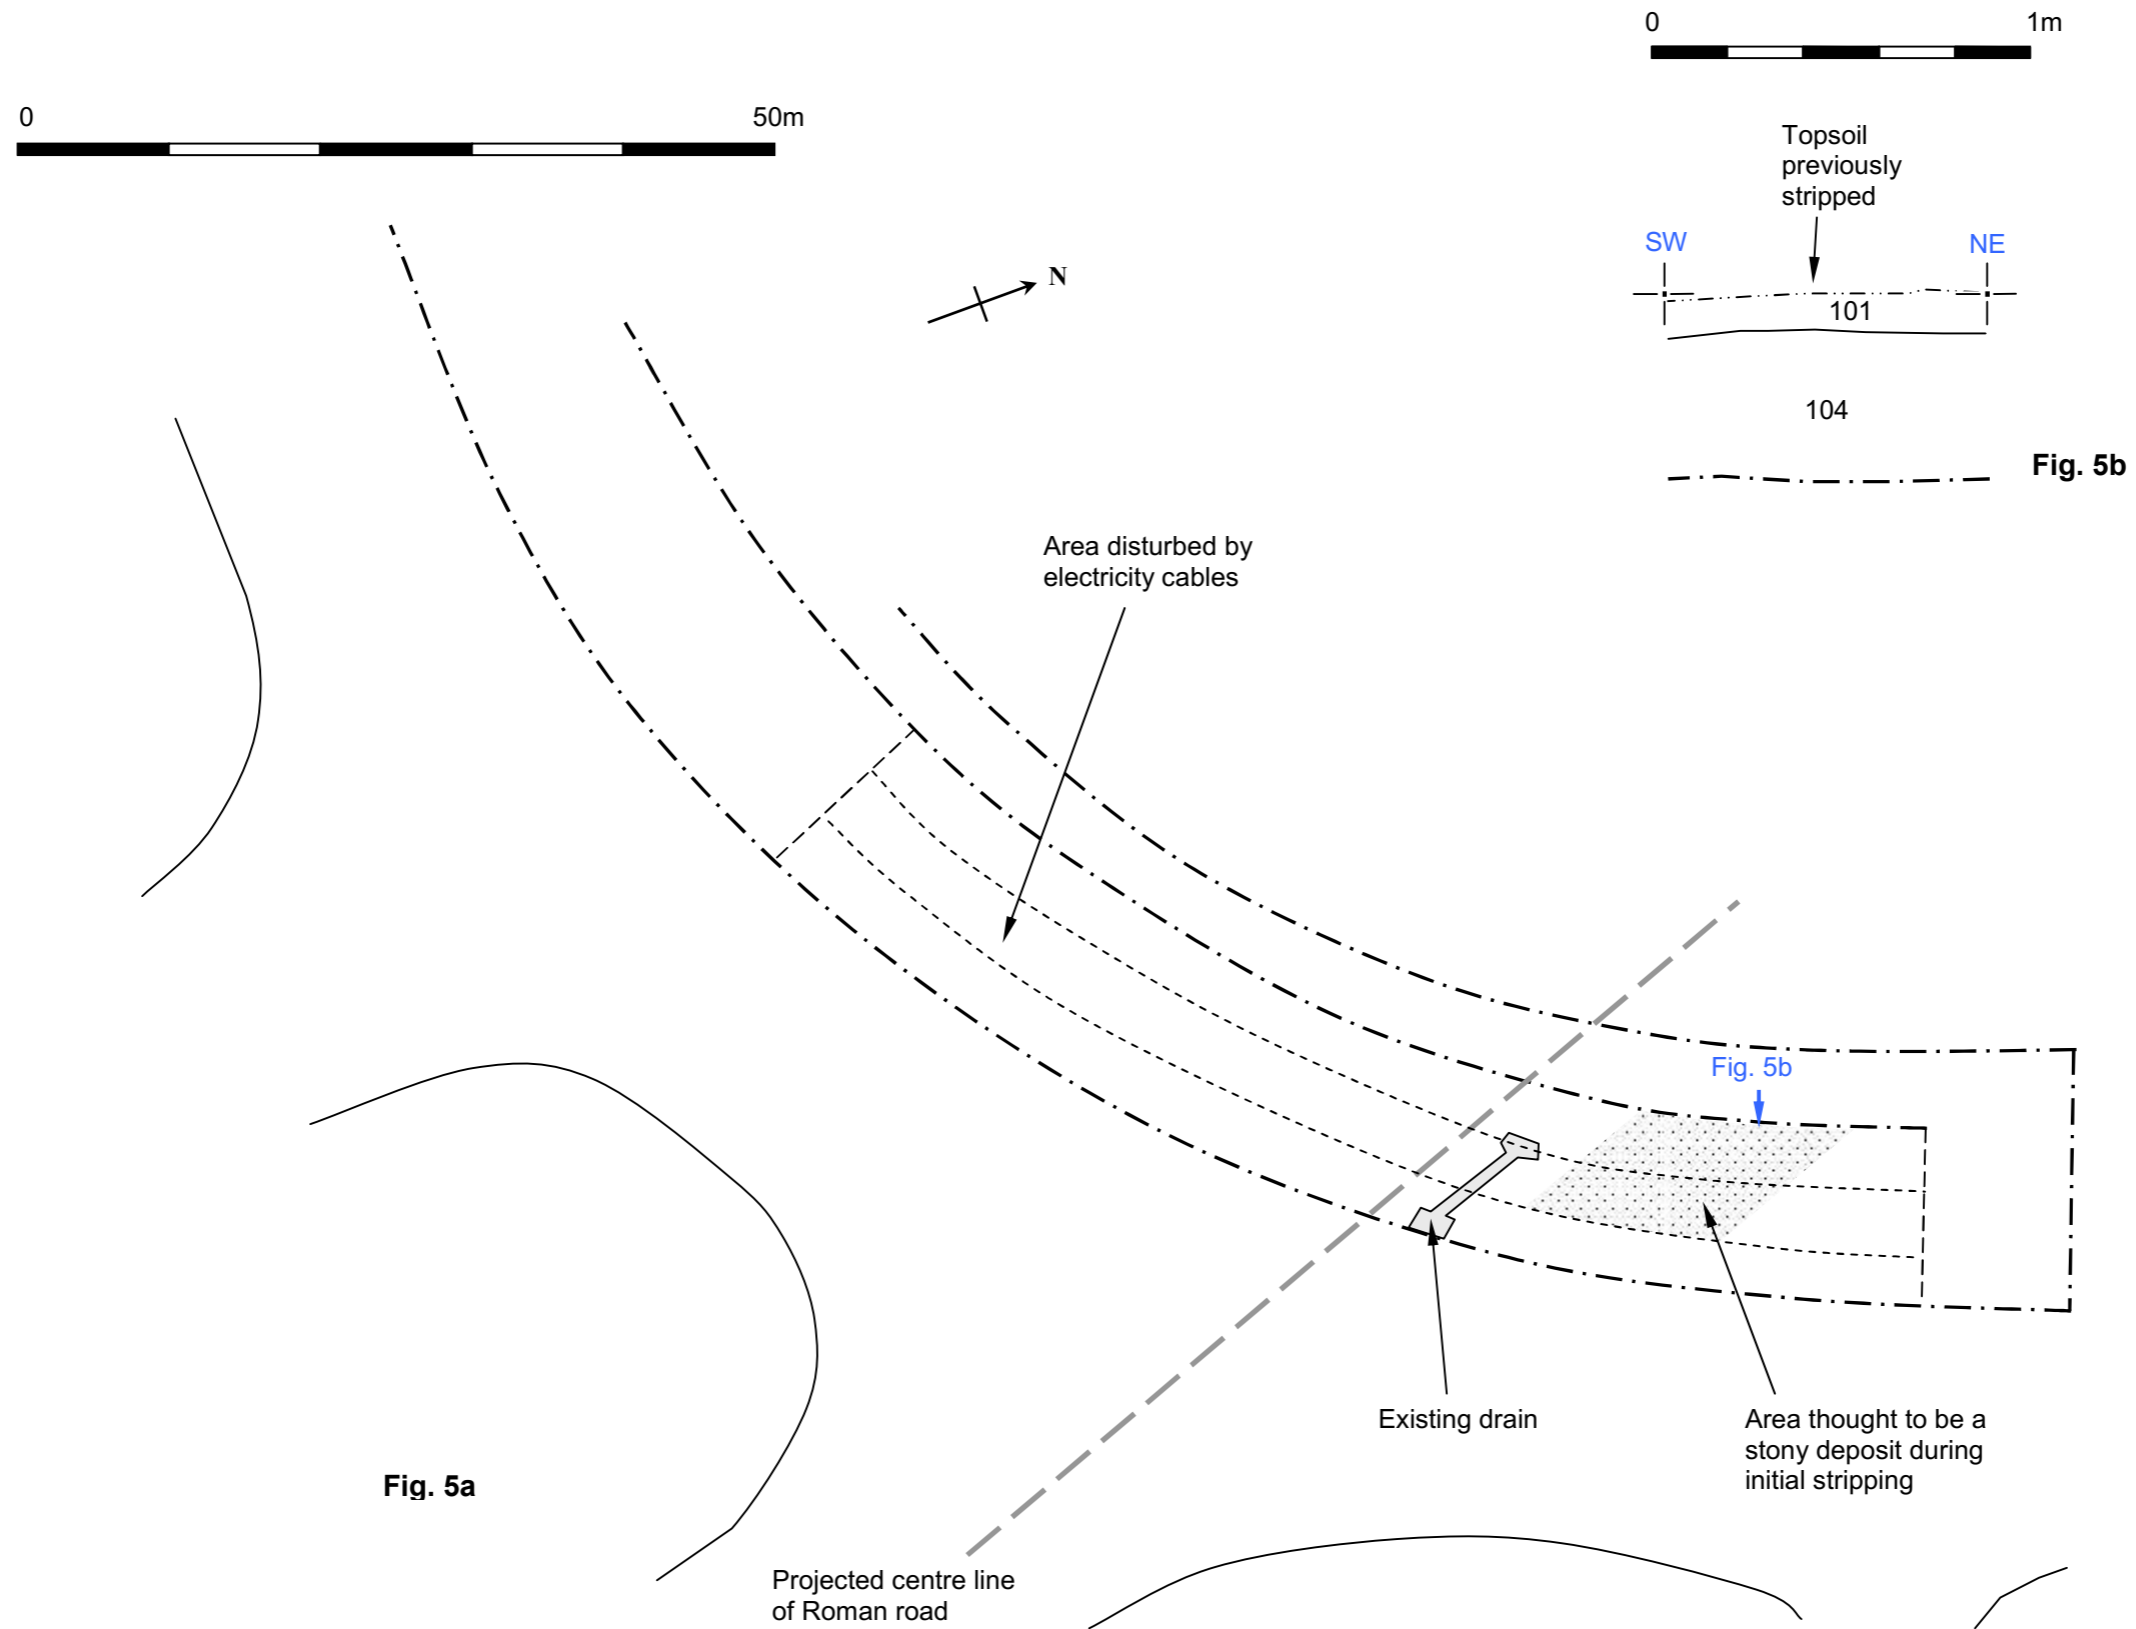
**Figure 5:** Plan of the monitored area of taxiway at scale 1:500, with sample section at scale 1:20.
