**CABLE TRENCHING ON LAND AT STANTON HALL,
STANTON LE VALE, WEST LINDSEY, LINCOLNSHIRE**

**SCHEME OF ARCHAEOLOGICAL MONITORING
AND RECORDING**

NGR: TF 16518 94744
Planning ref.: 134481
PCAS Job No.: 1753
Site code: SLVM 16
Archive acc. code: 2016.132

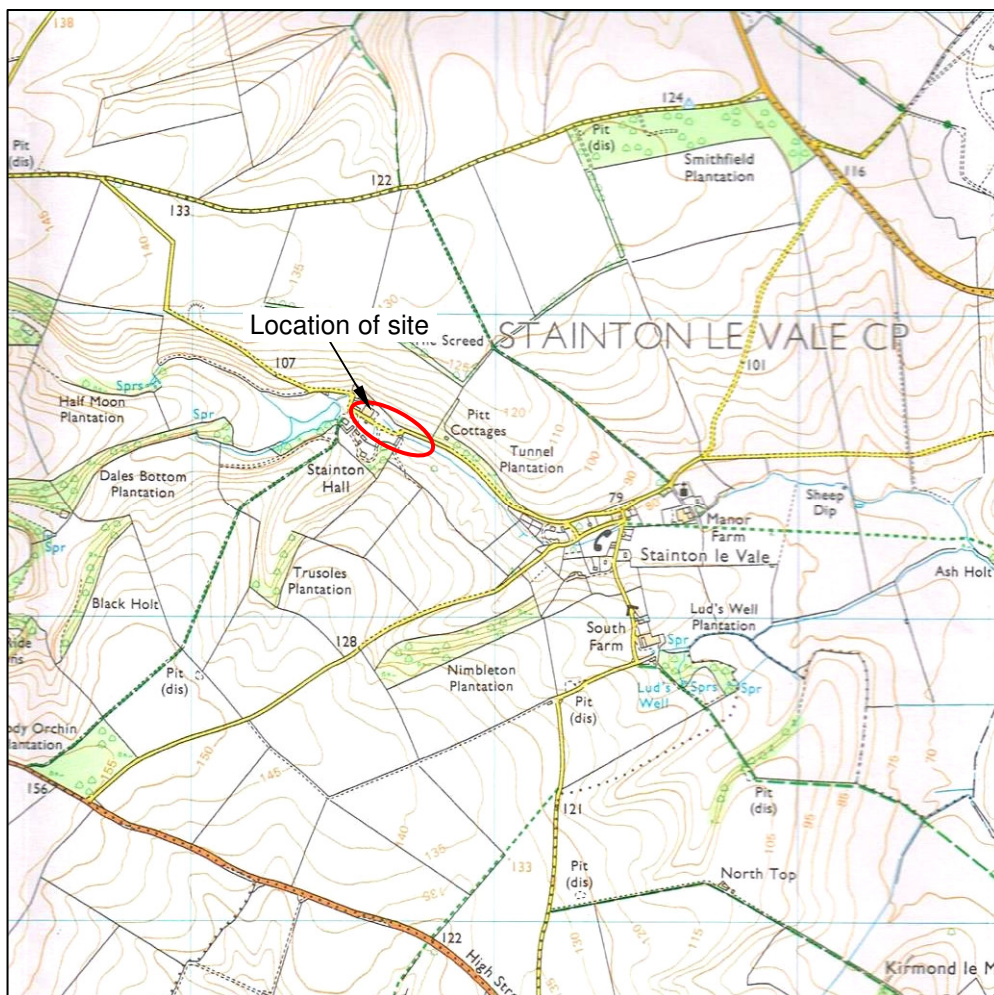
Figure 1: Location plan of the project at scale 1:25,000. The area of works is ringed in red. OS mapping © Crown copyright. All rights reserved. PCAS licence no. 100049278.

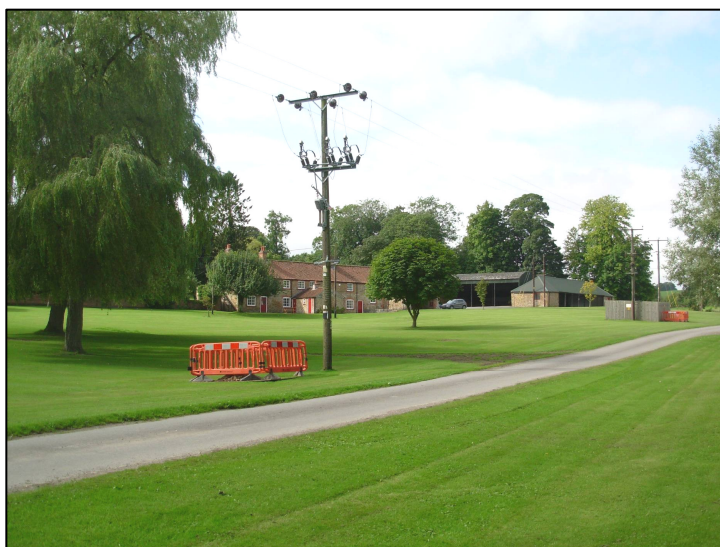
Plate 1: General shot of the farmstead buildings with the sites of Test Pits 2 and 3 (surrounded by orange fencing), looking west from the far side of the road, near the crossing over the Waithe Beck.

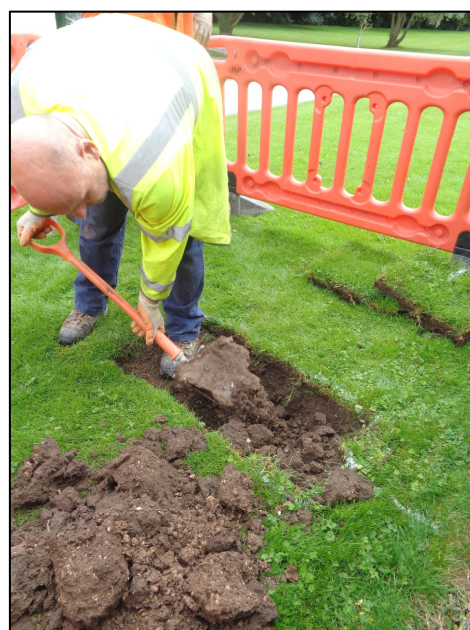
Plate 2: Hand excavation of Test Pit 3.

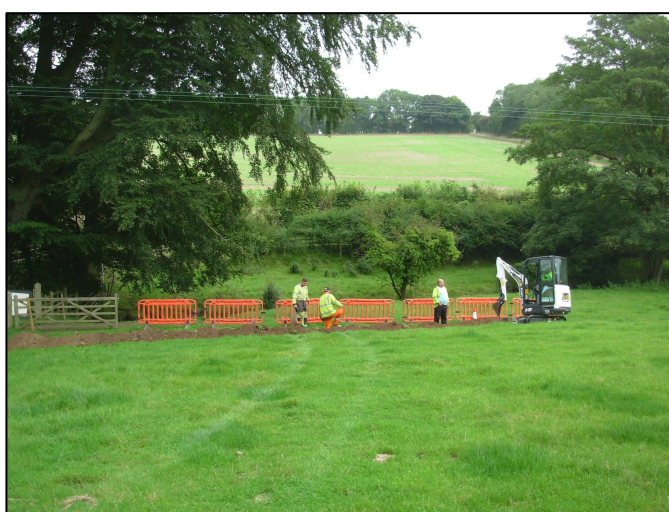
Plate 3: Working shot during trenching into the field, looking north-east: the trees to the rear mark the course of the Waithe Beck.

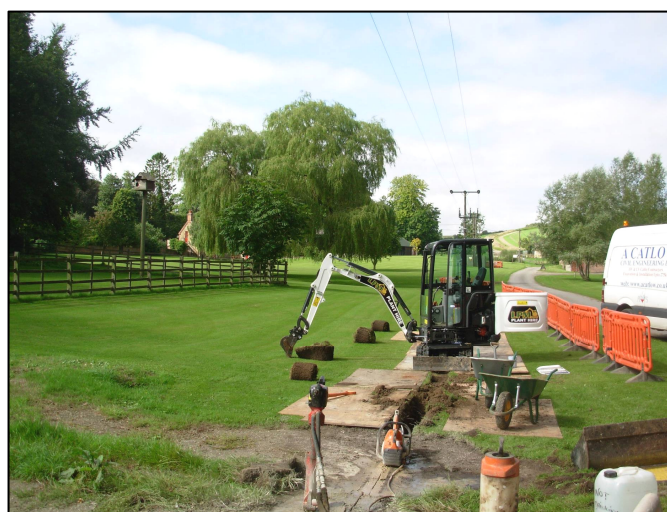
Plate 4: Working shot during trench excavation along the road, looking west-north-west from the area of concrete hard-standing.

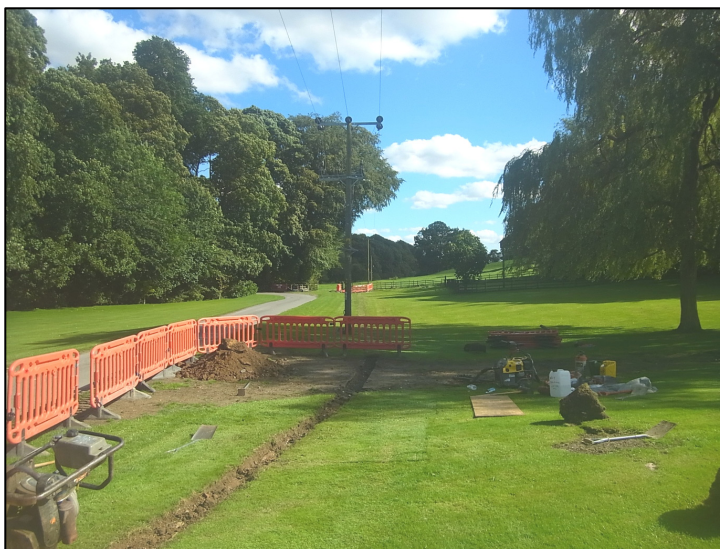
Plate 5: The excavated cable trench, looking east from a point a short distance to the west of Test Pit 2.
