LAND AT WESTBROOKE ROAD, LINCOLN

SCHEME OF ARCHAEOLOGICAL MONITORING AND RECORDING

B. P. Hobbs and R. D. Savage

March 2017

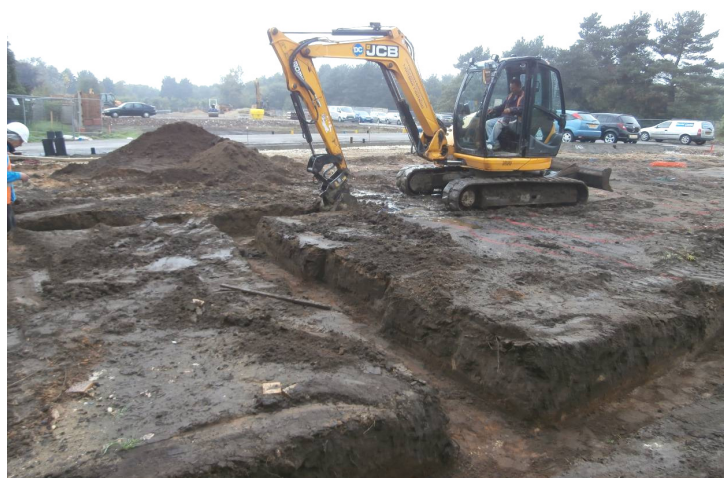
Plate 1: General working shot at the beginning of house plot excavations: work in progress on the garage of HP1, looking NW towards Tritton Road.

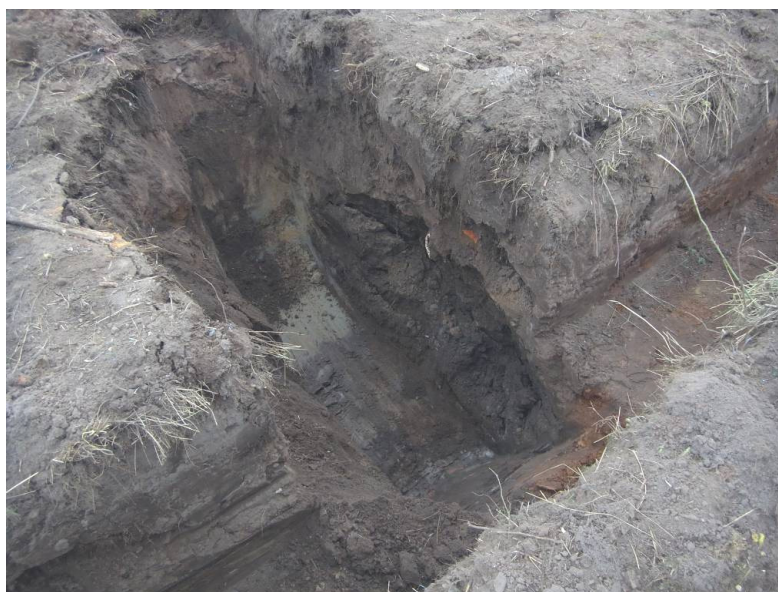
Excavations in the area of new apartments at the north-east corner of the site revealed the line of a major drain or dyke, **2003**, at least 2m wide and over 2m deep, running in a projected curve north-west to south-west (plate 2). This direction appears to be away from the line of the Catchwater dyke approximately 35m to the north-east, although it may have fed a supplementary drain running along the north-west boundary of the site.

The fill of this feature was dark grey sand silt clay, **2004**, indicating it had not been active for many years, although some of the upper part of the fill could be tentatively be identified as re-deposited material in nearby deposit **2001**. No dating evidence came from the lower part of the fill of the dyke (the base was not exposed during the monitoring) although there were individual modern bricks and a land drain within the upper part of fill, around 0.50m down from the current ground surface. The dyke is not marked on the 1889 OS map of the area, nor on later maps up to the present. This may either suggest the original dyke has an early to mid 19th century date at the latest and silted up before the 1880's, or that it was not as important a drainage feature as the Catchwater dyke.

Plate 2: South-west facing section of dyke feature **2003**

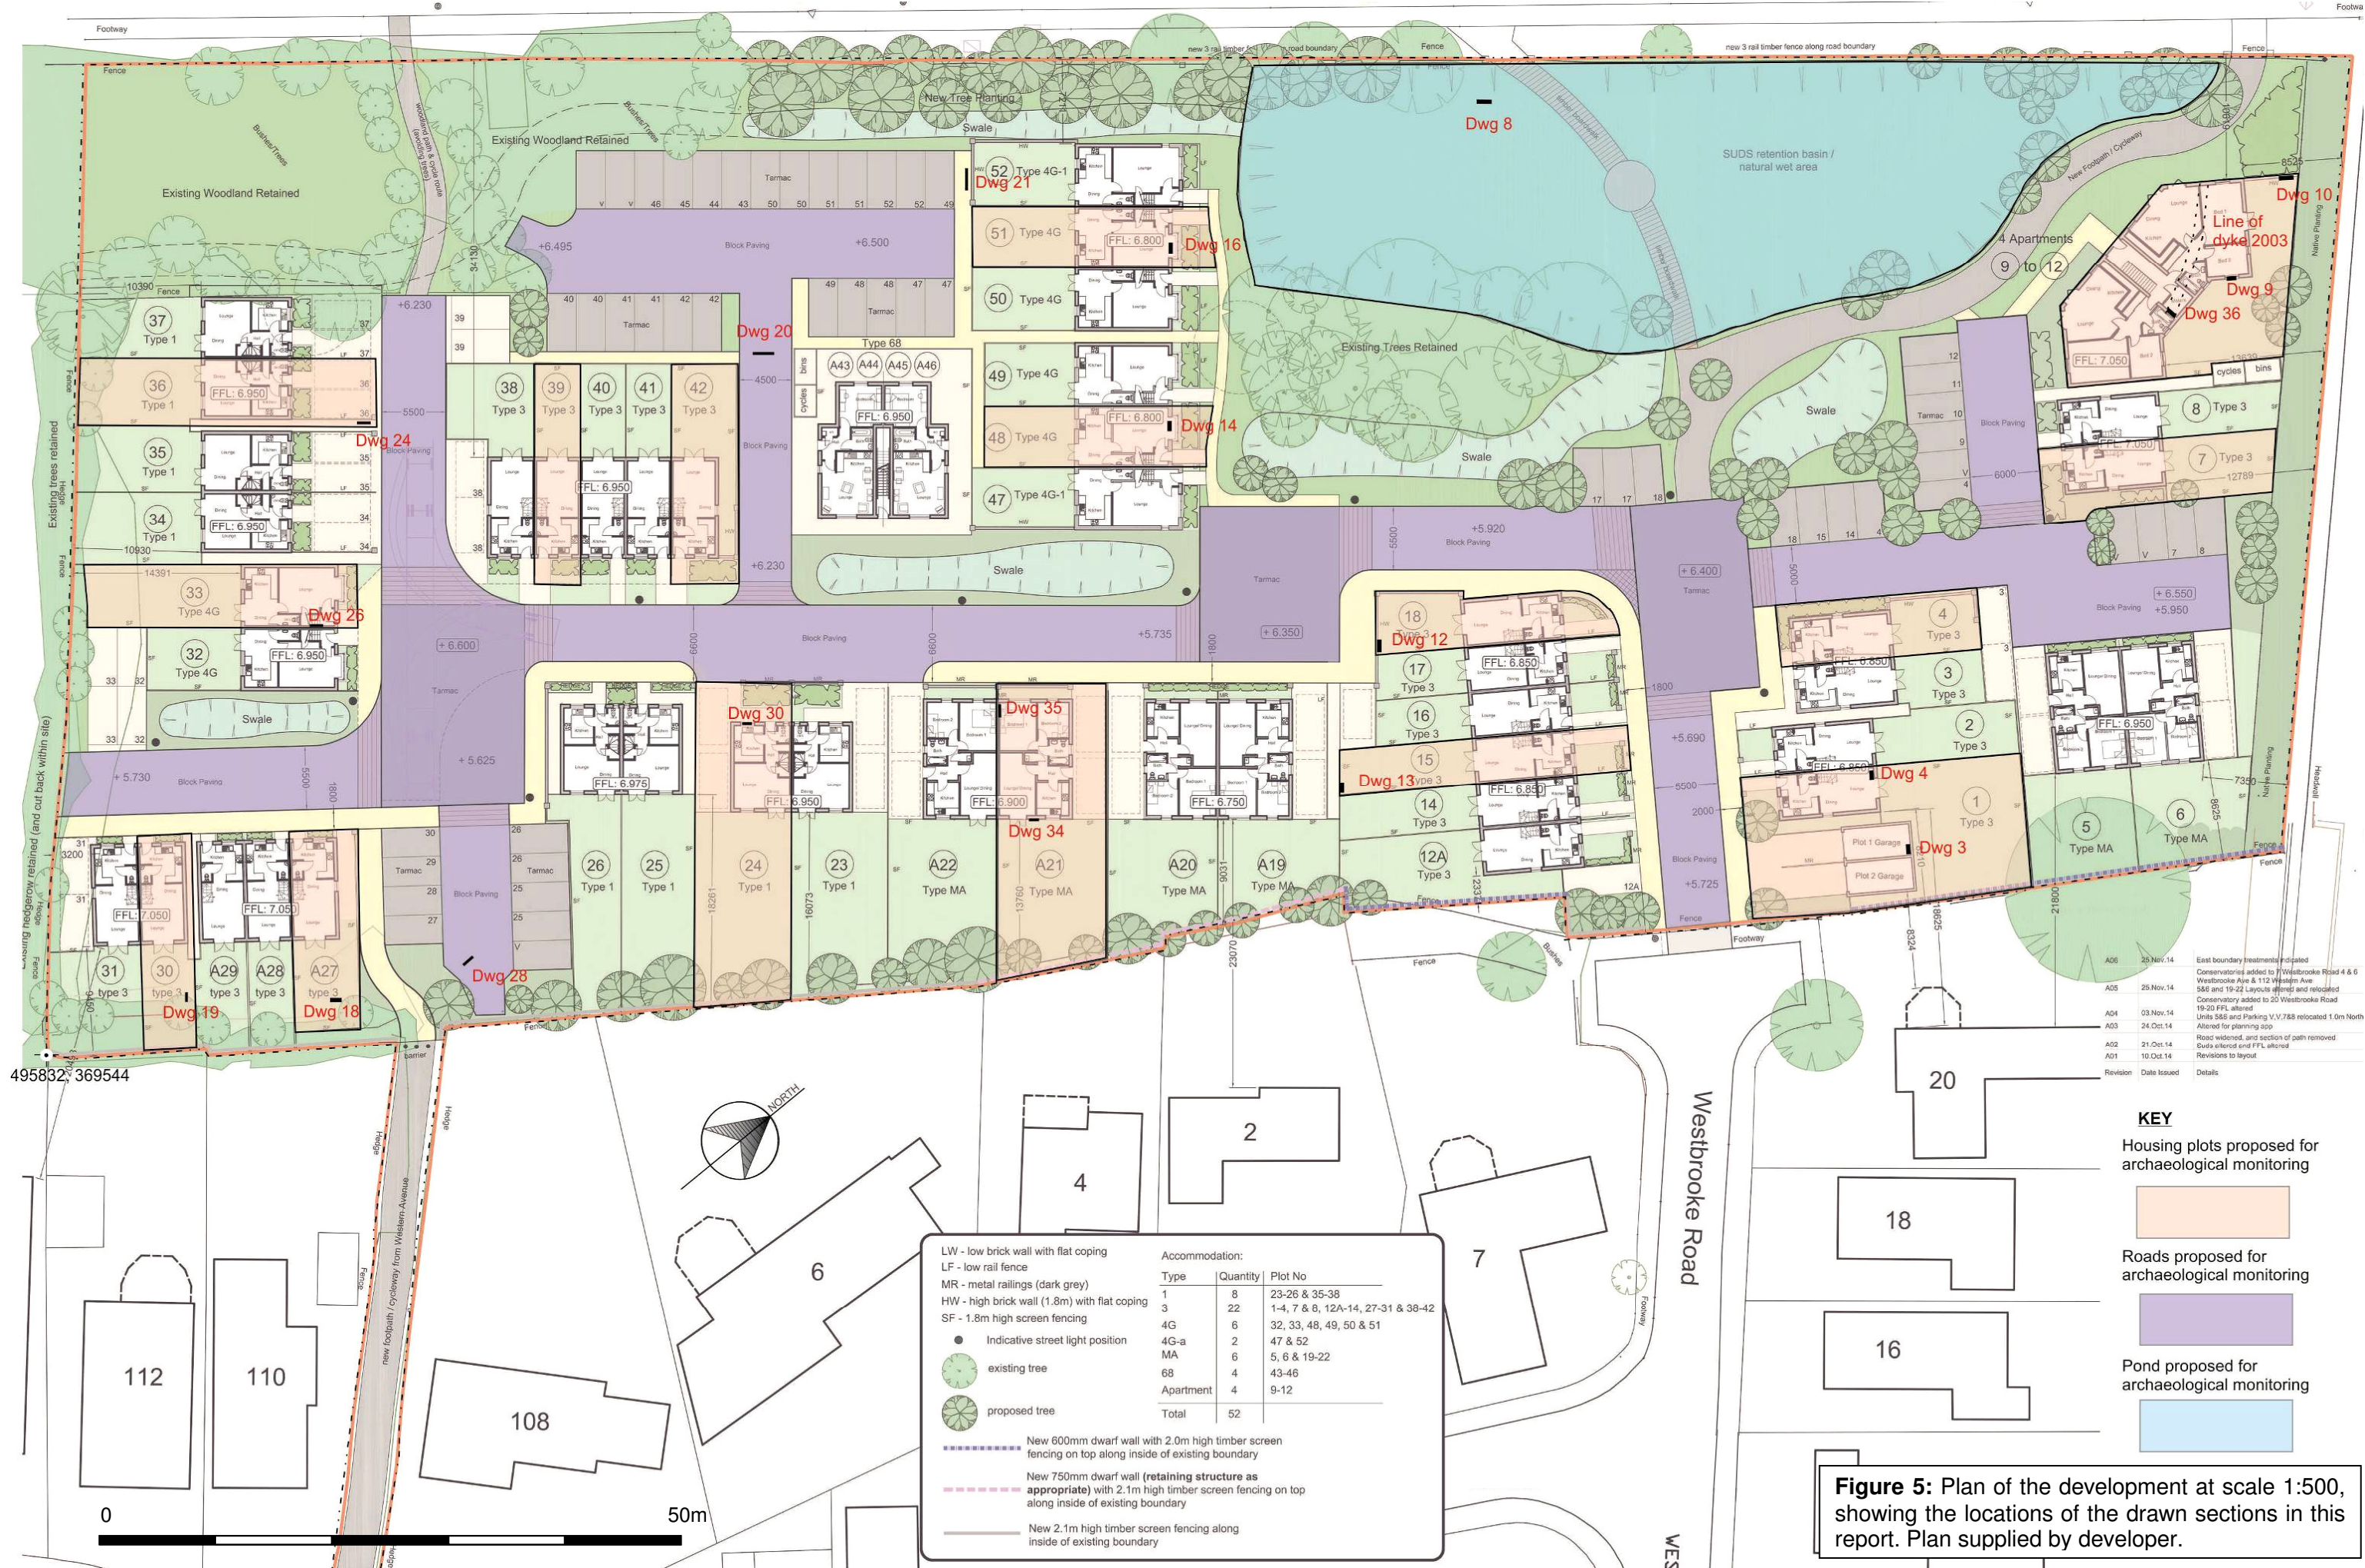
7.0 Results (figs. 5-7)

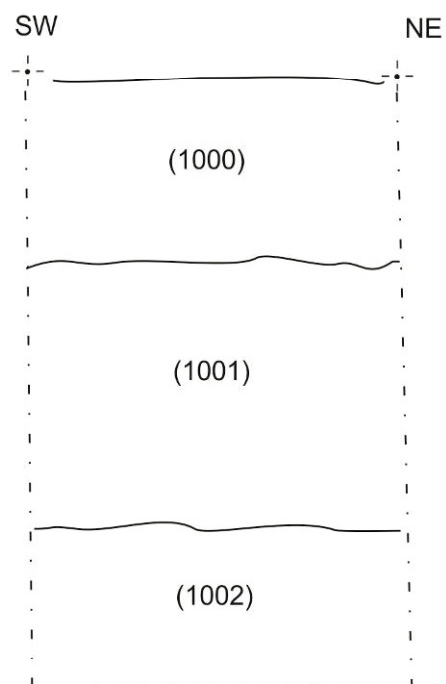
Dwg 8: North-west facing Lagoon

The excavation of the lagoon area to the north-west of the site held a fairly high expectation of encountering archaeological evidence, both with the location towards the area of previously discovered Roman kilns and the increased depth of excavation of the feature. The results, however merely identified re-deposited soils of an average depth of 1.2m covering the underlying geological sands and clays (plates 3 and 4). This may indicate a previous disturbance to this depth in this area.

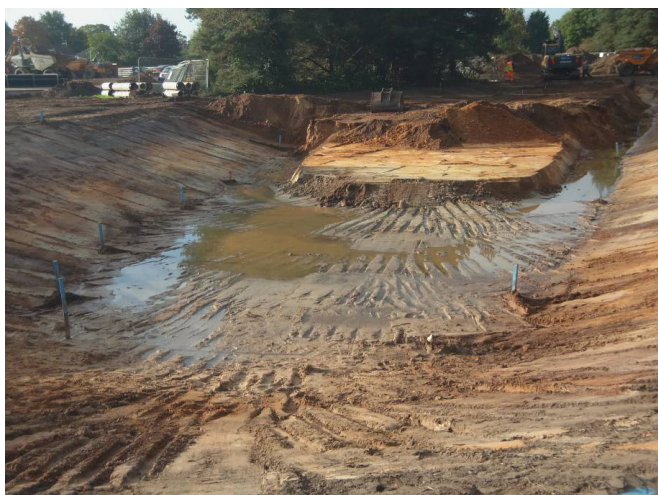
Plate 3 (above): Area of Lagoon excavation facing south-west

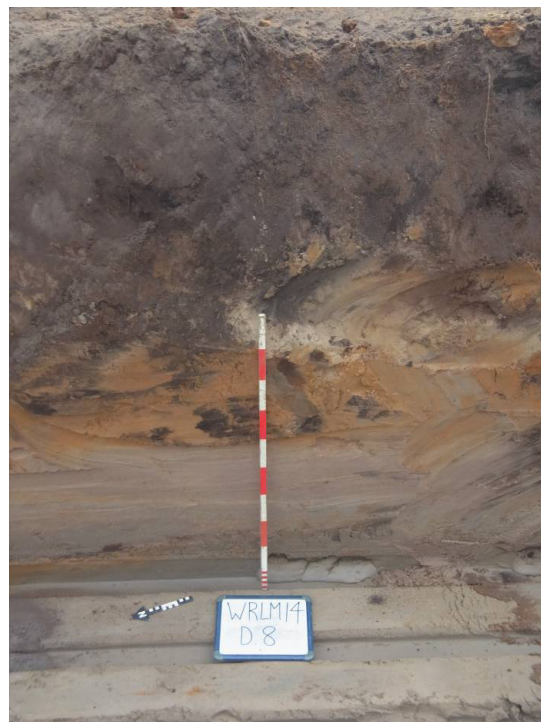
Plate 4 (right): North-west facing section no. 8 of Lagoon area
