**OBAM STAIRLIFT, TILLBRIDGE ROAD, STURTON BY STOW, LINCOLNSHIRE,  
LN1 2PB**

**ARCHAEOLOGICAL MONITORING REPORT**

NGR: SK 89318 80232  
Planning Authority: West Lindsey District Council  
Planning Ref.: 130005  
PCAS job no. 1265  
Site code: STRM 14  
Archive acc. code: LCNCC 2014.150  
Oasis Report ref: preconst3-286877

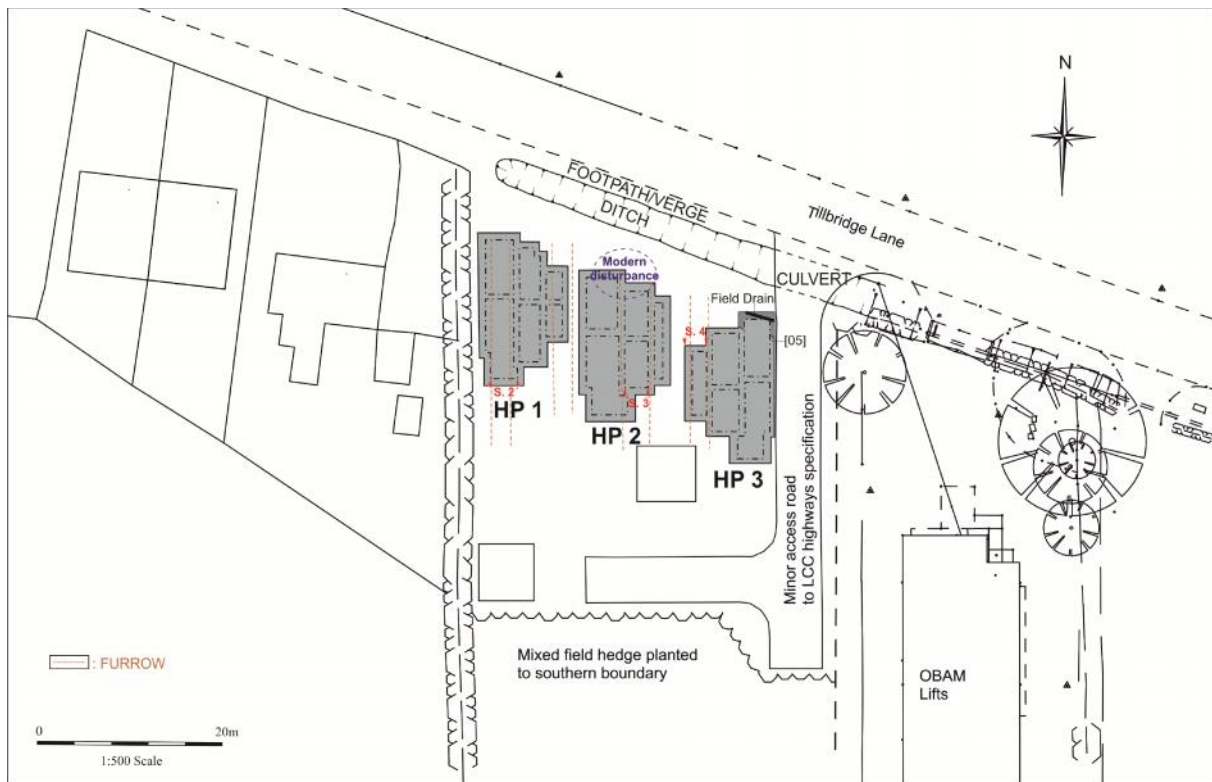
**Figure 2: General plan of excavation areas. 1:500@A4**

Figure 2: General plan of excavation area. Site layout plan supplied by client. 1:500@A4

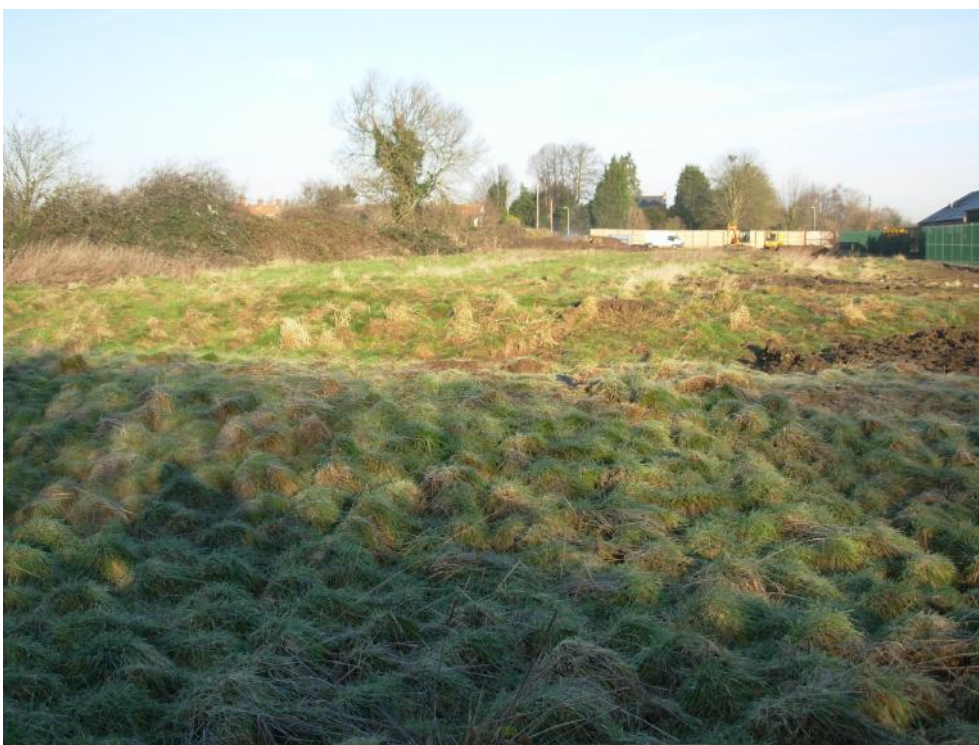
Prior to stripping the topsoil, the topography of the site was uneven and slightly undulating representing the remnants of agricultural ridge and furrow earthworks running north to south with what appeared to be a low headland and east-west ridges at the south end of the site.

**Plate1:** Site topography prior to topsoil strip, facing north

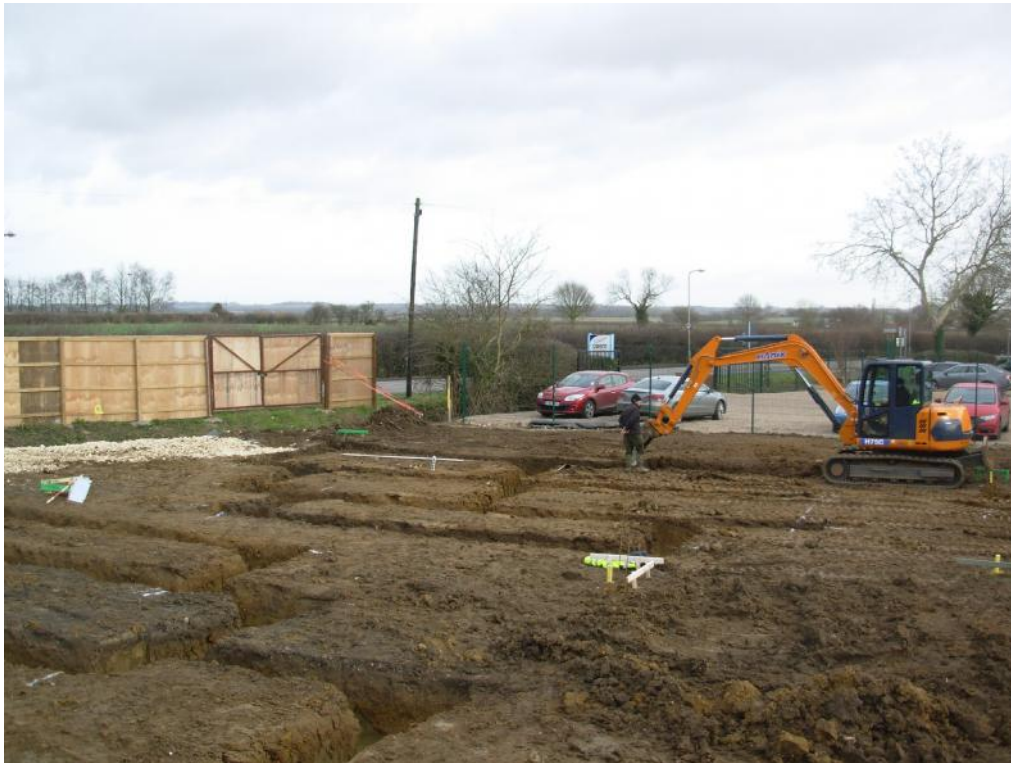
**Plate 2:** Site after topsoil strip and during excavation of footing trenches, facing north-east

The hedge-line along the north edge of the site was removed and the ground levelled and covered with Terram and type 1 stone for vehicle parking. Natural sandy clay **02** containing occasional small stones was exposed after stripping of the topsoil **01**.

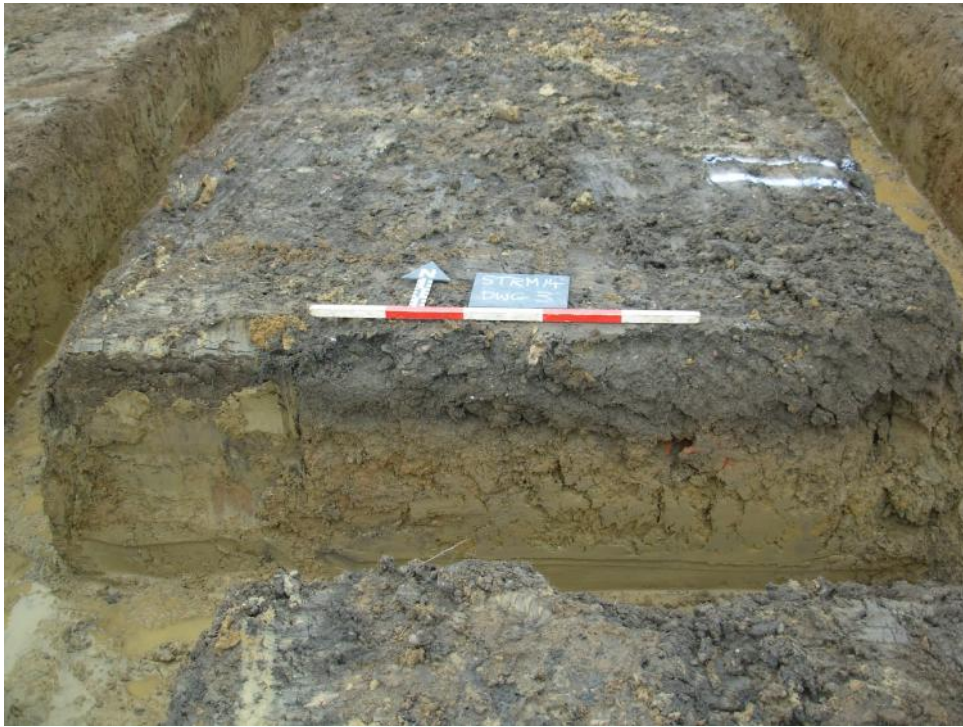
**Plate 3:** Section no. 3

A series of probable ridge and furrow earthworks was observed running north to south across the site prior to the commencement of construction trenching. The greater depth of these appeared to be removed in the topsoil strip and there was little indication of the features in trench sections (drawings 2, 3 and 4; fig.4). An extra depth of topsoil was observed in one of the north-south footing trenches in house plot 2 and this was interpreted as the line of a furrow. A corresponding layer of topsoil was seen in the eastern-most baulk of house plot 1, indicating a recognised spacing between furrows. No dating evidence came from the furrow deposits.

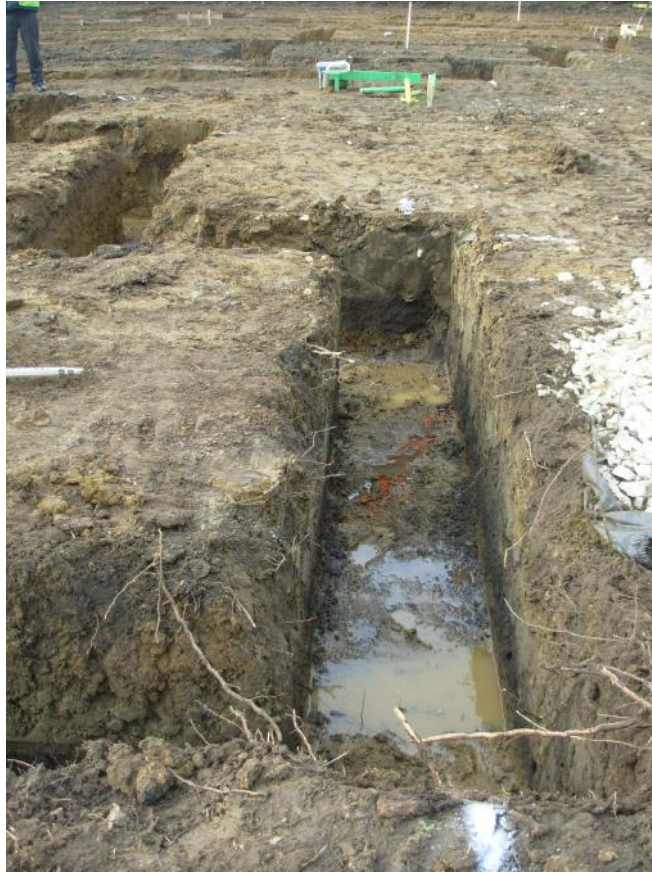
A post-medieval or early modern field drain, **05**, was observed in one of the footings of house plot 1, running parallel in the direction of the furrows. The line of a post medieval or modern ditch or drain cut through the north-east corner of house plot 3, running parallel to Tillbridge Road it may have been an earlier roadside ditch: This contained a field drain pipe running north-west to south-east at the base of the trench.

**Plate 5:** Ditch feature 05 with land drain, facing west
