**LAND ADJACENT TO PLAYGROUND, YARBOROUGH ROAD,
KEELBY, WEST LINDSEY, LINCOLNSHIRE**

**ARCHAEOLOGICAL MONITORING
REPORT**

NGR: TA 1634 1024
WLDC Planning Ref.: 128542
PCAS job no. 1456
Site code: YRKM 15
Archive acc. no.: 2015.94
Oasis Report No.: 288818

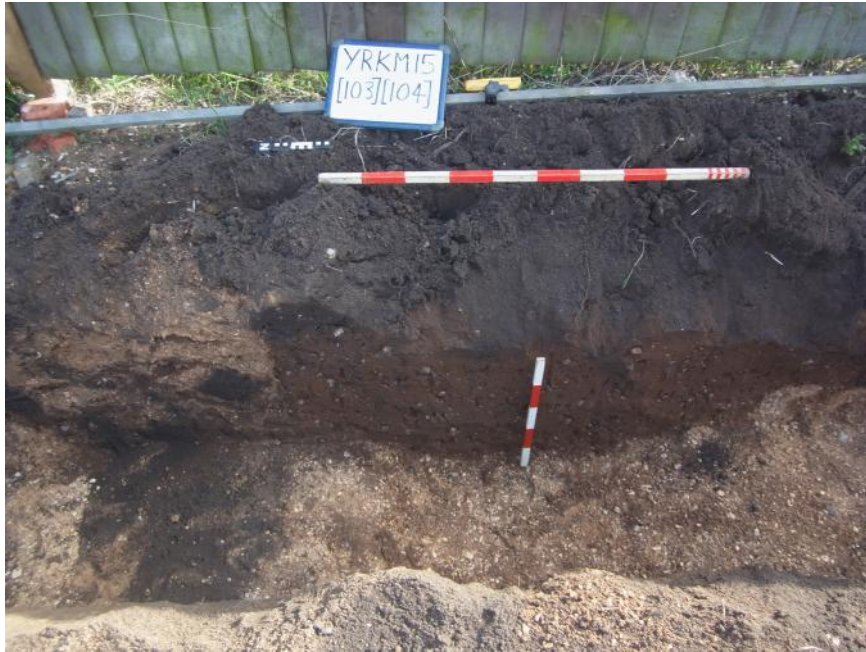
Plate 1: Ditch **104**, west facing section

During the excavation of footing trenches for the eastern house plots, a modern construction cut, **103**, was observed running east to west in the footings of house plot 5. This appeared to cut a north-east to south-west shallow ditch feature, **104**, (drawing number 4, figure 4). The east-west line of this feature was also observed in one of the footings on the west side of the plot. The single fill of this feature was a mid-brown sandy silt, **106**, containing frequent small stones but with no artefactual evidence for dating being recovered.

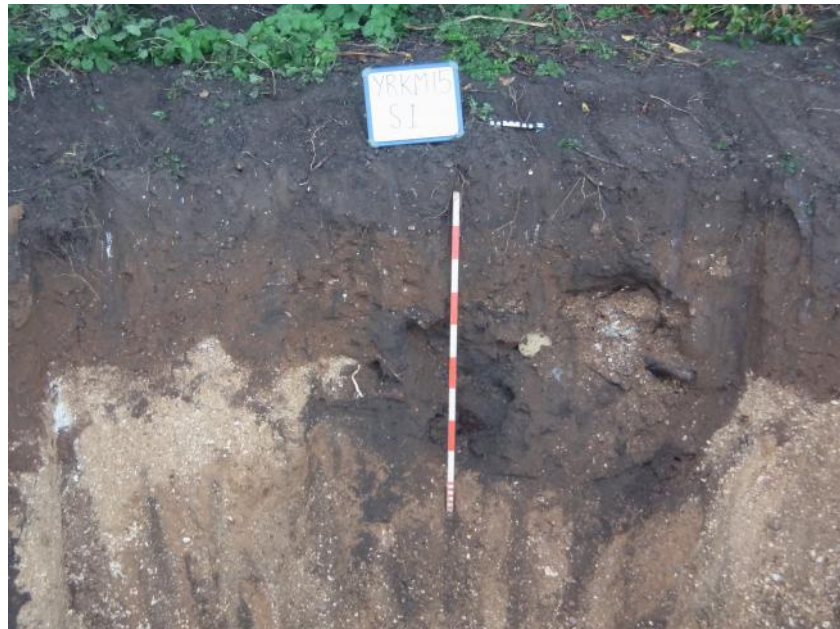
Plate 2: Soakaway no. 1, modern pit **108** east facing section

Six soakaway pits were machine excavated across the site in relation to the five housing plots; one in the south-west corner of the site, two to the south-west of house plot 1 in the north portion of the site and three on the east side of the site. The latter three were not recorded as they were observed to be excavated through the hardcore of the previously monitored road. The two soakaway pits to the north of the site were photographed and the one to the south-west was recorded in section (drawing number 7, figure 4). The cut for a modern rubbish pit, **108**, was observed in the section of soakaway no. 1. Its single fill, **109**, was a mixed dump deposit of grey-brown silt-sand incorporating modern ceramics and metal debris.

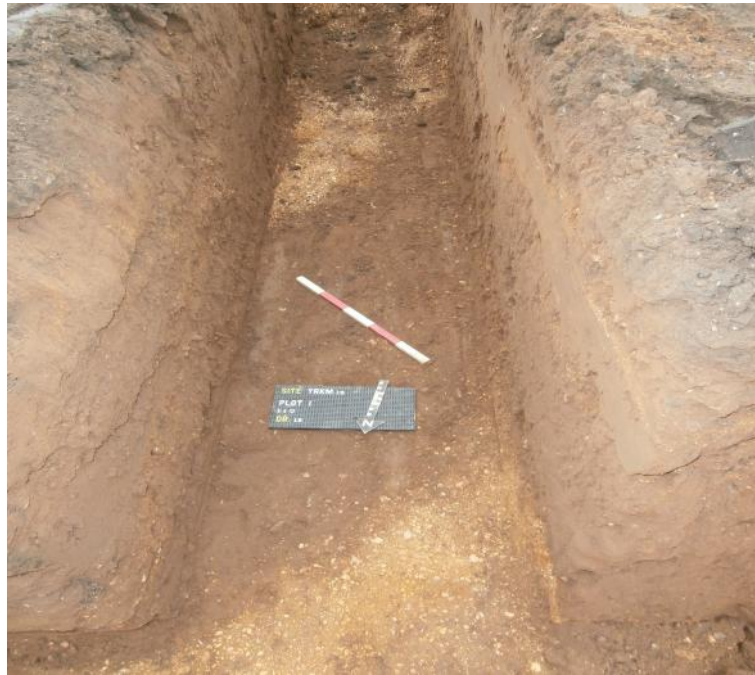
Plate 3: Ditch **110** plan, facing south

A ditch feature, **110**, was observed in the footings of house plot 1 running NE to SW with a single mid brown sandy silt fill, **111**, similar to the subsoil **102**. The ditch was shallow with concave sides with a depth of 0.20m to 0.30m cut into natural sand deposit **107**. Several sections of the line of this feature were observed in the footings of the house plot with the same fill, recorded as **112** and **113**, but with varying sizes of pebble inclusions. This feature was interpreted as a possible drainage channel from which no dating evidence was recovered (drawing number 11, figure 4).

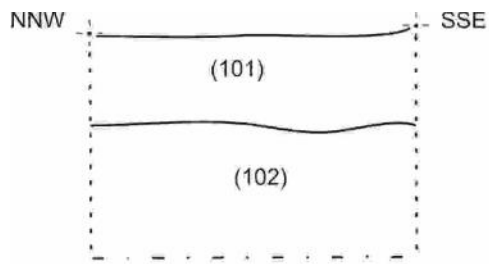
Dwg 1: WSW facing section of drive

Initial site work involved the stripping of topsoil, **101**, to average depths between 0.35m and 0.40m to create road access. This process was not required to be monitored due to the shallow aspect of the stripping. Beneath the topsoil was a mid-brown sandy silt subsoil, **102**, with an average depth between 0.46m and 0.66m. Geological deposits were a mid-yellow brown loose gravelly sand, **107**, with an irregular undulating interface with the subsoil.
