CLIFF HOUSE, CLIFF LANE, WADDINGHAM, LINCOLNSHIRE

HISTORIC BUILDING SURVEY

Report prepared for Mr. H. Blandford

November 2017

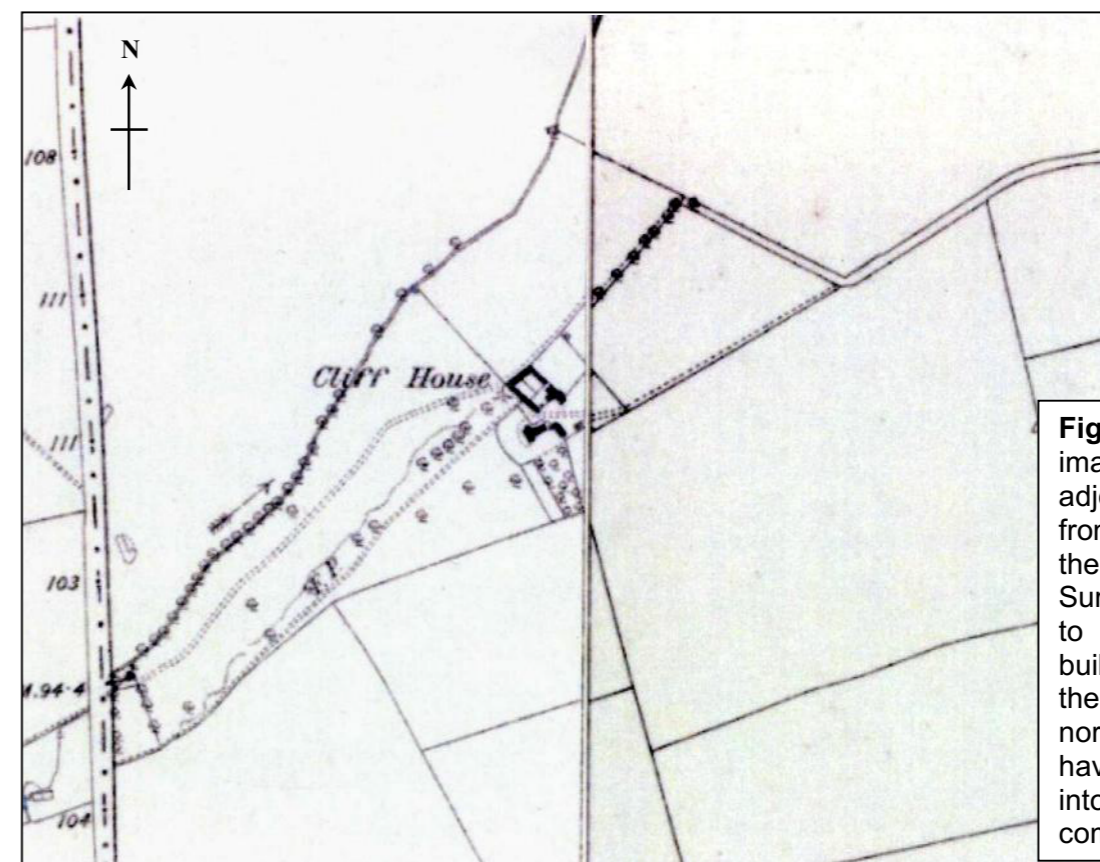
Figure 5: Composite image from two adjoining map sheets from the 1885-6 6" to the mile Ordnance Survey 1st edition (not to scale), showing a building to the east of the farmhouse. The northern outbuildings have been extended into a U-shaped complex.

The group of outbuildings shown in the earlier mapping had been extended and consolidated by the time of the 1st edition Ordnance Survey mapping of 1855-6 into a U-shaped range around a partitioned crewyard, in the style typical of the High Farming movement (fig. 5). It appears that the western range has remained unchanged, but the eastern range has been rebuilt further to the east, increasing the size of the crewyard, and a building has been added at the north side, linking the ranges. The phase 1 building has also been added to the east of the farmhouse. The first listing for Cliff Farm that could be identified in 19th-century business directories was in the Kelly's Directory of 1889, when it was being run by Mrs. Mary Kirby (p.466). However, a Thomas Kirby and a William Kirby are both listed as farmers in Waddingham by two earlier directories, one compiled only five years after Cliff Farm was put up for auction (White, 1856, p.607; Kelly, 1868, pp.326-7), and it seems probable that one or the other of these men had bought Cliff Farm at the sale of the Kelsey estate and remodelled the farmstead along High Farming lines, and that Mary Kirby was his widow.

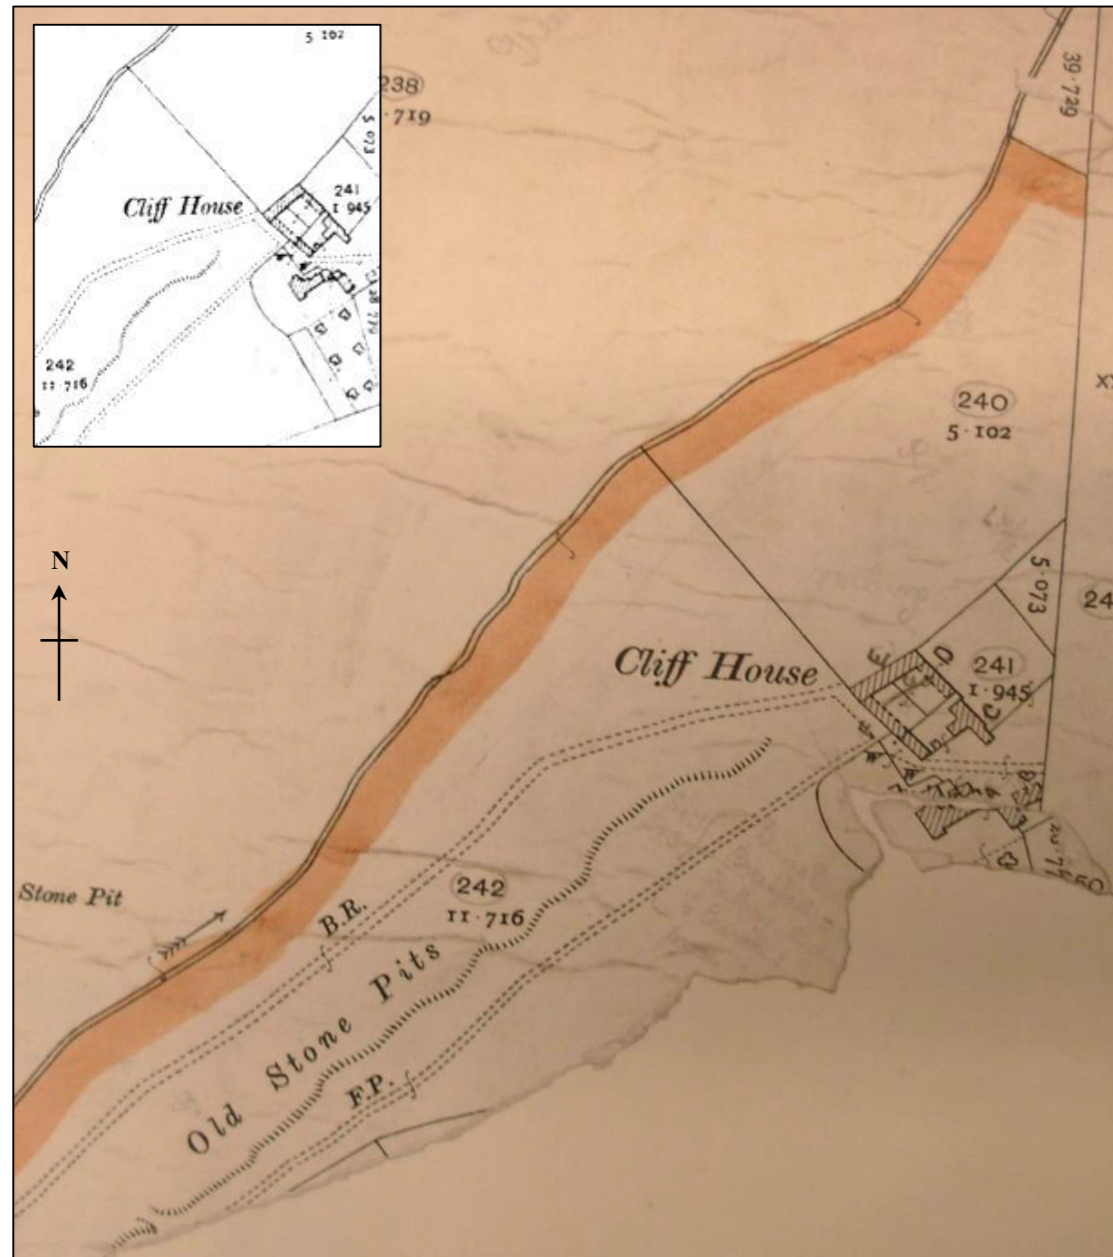
Figure 6: Photographic extract (not to scale) from the surveyors' field plan from the 1910 Land Tax assessment, with the surveyors' notes overwritten on a sheet of the 2nd edition 25" to the mile Ordnance Survey mapping from 1906. The original map has been heavily damaged and a fragment has been inaccurately placed during restoration: the inset shows an extract from the original map sheet, in which the buildings can be seen in correct proportion. Broken lines as part of a building's outline indicate that the building was open-fronted on this side.

documentation for the 1910 Land Tax. The Land Tax assessment plan showing Cliff House has been damaged, with a corner torn off and a tear going through the southernmost buildings of the farmstead (fig. 6). Unfortunately, although the document has been restored, the fragment showing the historic buildings has not been replaced quite accurately, and the majority of the surveyor's notes, handwritten on the map, are missing. Enough of the map sheet survives to show that the building to the east of the farmhouse – labelled 'B' by the surveyor – was open-fronted on the north side, towards the access track, while the building at the south-east corner of the farmhouse, shown as part of the same block on earlier and smaller-scale mapping, was a discrete structure, open-fronted on the east side. The only portion of the notes remaining refer to the farmhouse, recording that it was of stone with roofs of both slate and tile, and that it included a dining room, a breakfast room, six bedrooms, a scullery, a wash-house and possibly a drawing-room (the remainder of the list was too fragmentary to identify). The adjoining map sheet was consulted, but no further notes had been made on it; the Lincolnshire Archives do not hold, or cannot locate, the relevant Land Tax record book.

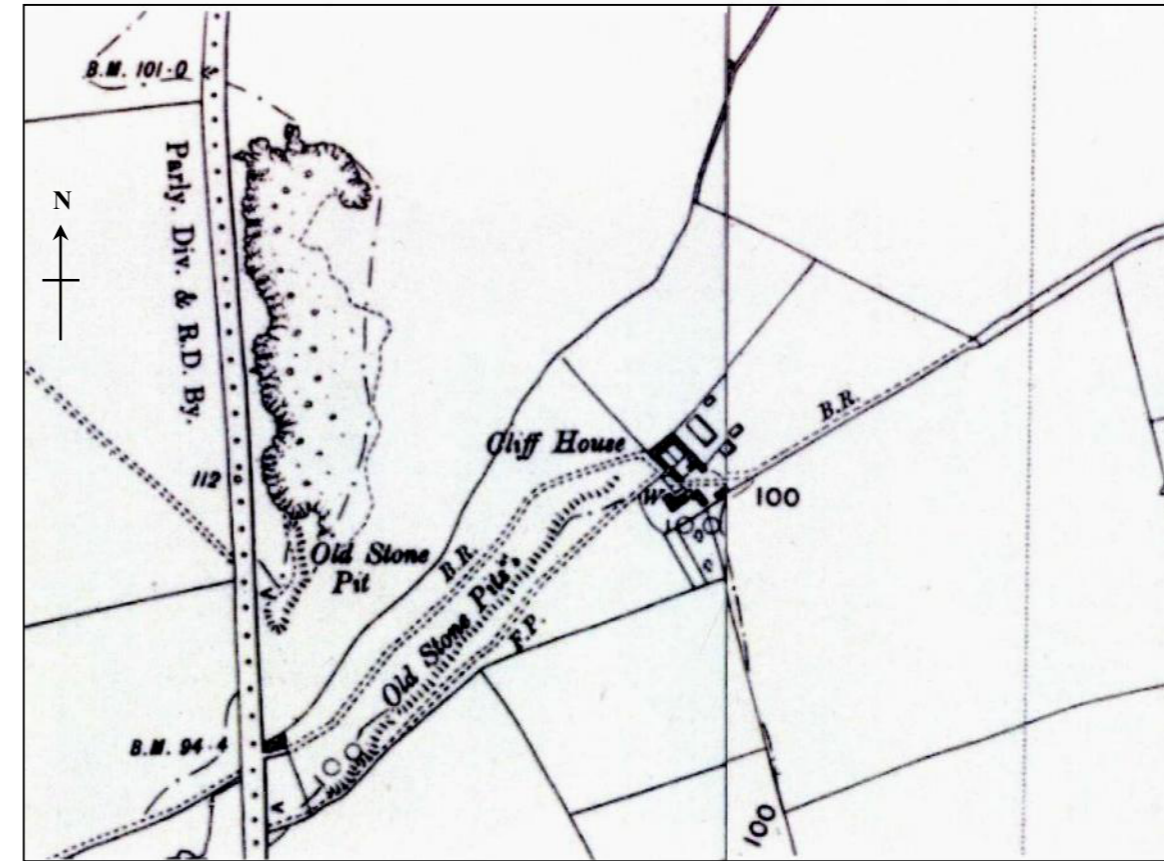
Figure 7: Extracts from two adjacent map sheets of the 1948 revision of the Ordnance Survey 6" to the mile mapping, published in 1950 (not to scale). The buildings surveyed in 1906 are uncoloured; new buildings, differentiated from the previously surveyed buildings by being uncoloured, have been constructed to the north-east.

Cliff House or Farm cannot be identified in county business directories during the first quarter of the 20th century, as it is not listed by name and the surnames previously identified do not appear. In the Kelly's Directory of 1926, Albert Hedley Lingard is listed as a farmer at Cliff House, while the 1930 edition lists Joseph Smith in this position, and the last of these directories to be produced, the 1937 edition, continues to list Joseph Smith as the farmer at 'Waddingham Cliff' (Kelly, 1926, p.634, 1930, p.609 and 1937, p.605). The farm appears to have been extended, but not remodelled, during this period: 6" Ordnance Survey mapping surveyed in 1948 and published in 1950 shows the same layout as was surveyed in 1906, down to the partitioning of the crewyard, with a number of additional buildings to the north-east of the outbuilding complex (fig. 7).

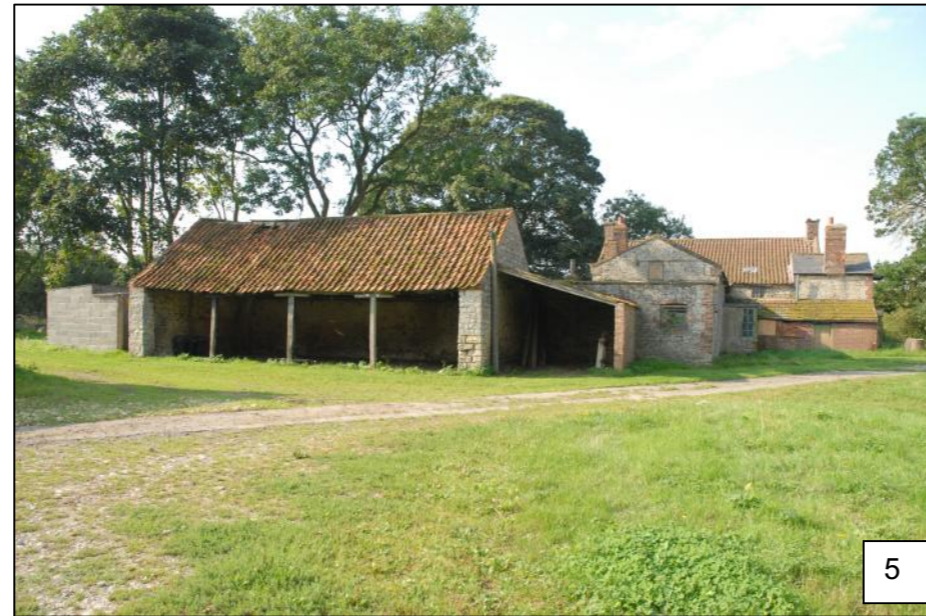
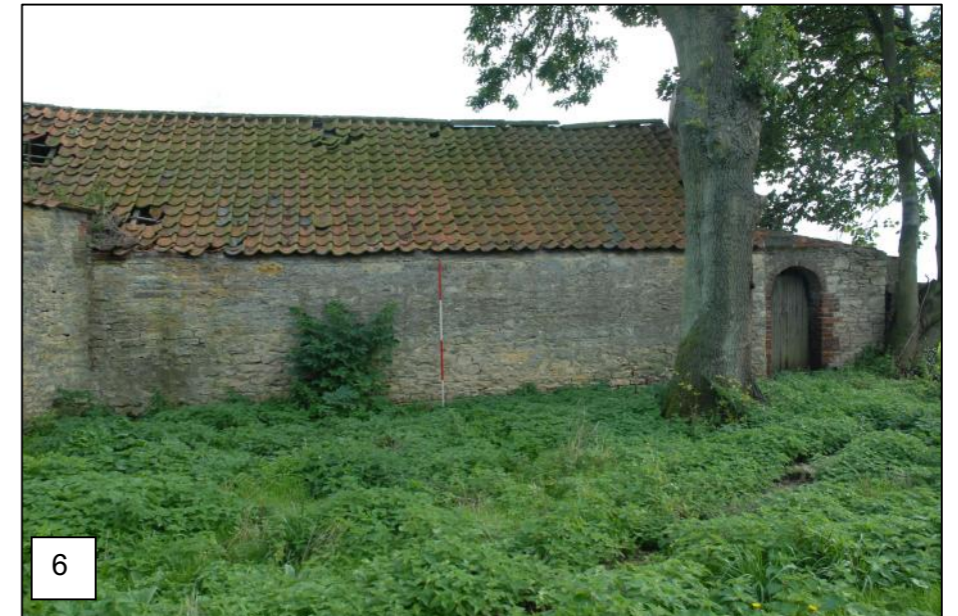
Building B

A single-storey open-fronted cart or implement shed with a lean-to shed at its north side is present to the immediate east side of the farmhouse, at the south west side of the outbuilding group.

The building is of four bays, separated by timber posts and is constructed of roughly coursed limestone rubble with a pitched roof of pantiles. Its west side forms the eastern boundary of a garden area to the south of the farmhouse, and is joined at its northwestern corner to the outbuildings of the farmhouse. Its close proximity to the farmhouse suggests that this building may have comprised a stable and trap house in the early incarnation of the farm.

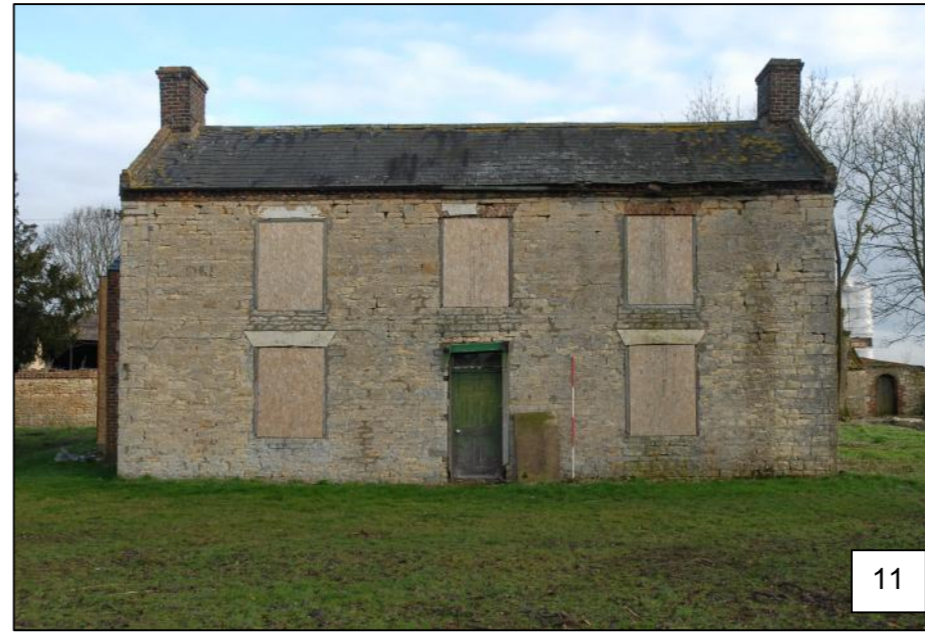
The formal western elevation is of three bays, with a central door with a fanlight present in a panelled timber doorcase with fluted pilasters and a bracketed porch over. The door is flanked by sash windows with stucco lintels (applied over cambered brick lintels), with three windows at first floor level; none of the windows have sills.

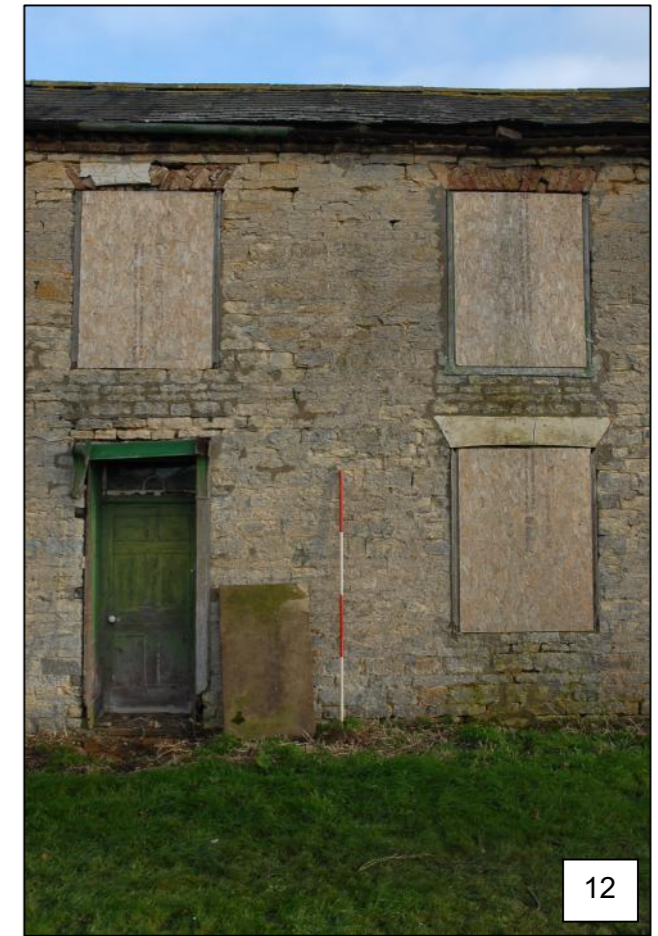
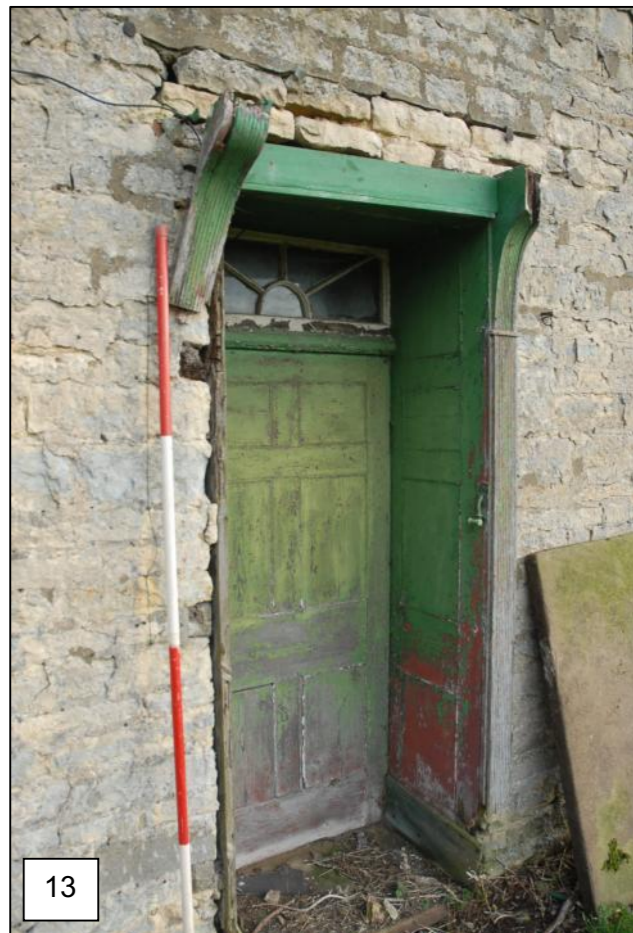
West Elevation

This is the front elevation of the building and faces the open area to the west of the main farm outbuilding group, looking towards Ermine Street.

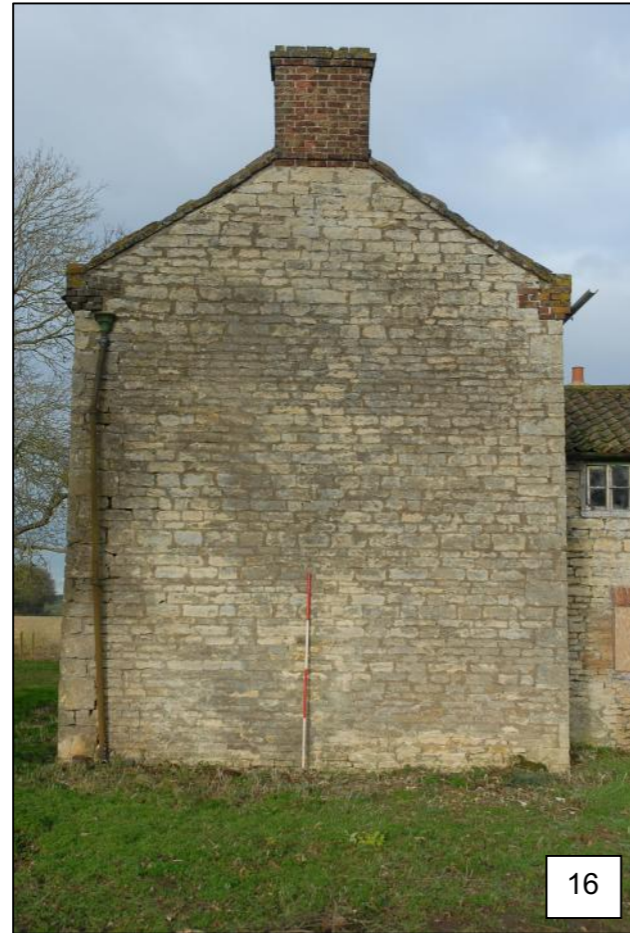
The south elevation is blind; it has a brick verge and brick kneelers, and a simple two-flue gable stack with a two-course brick cap. The surviving rainwater goods are of cast iron: a rainwater hopper and downpipe are present at the west side.

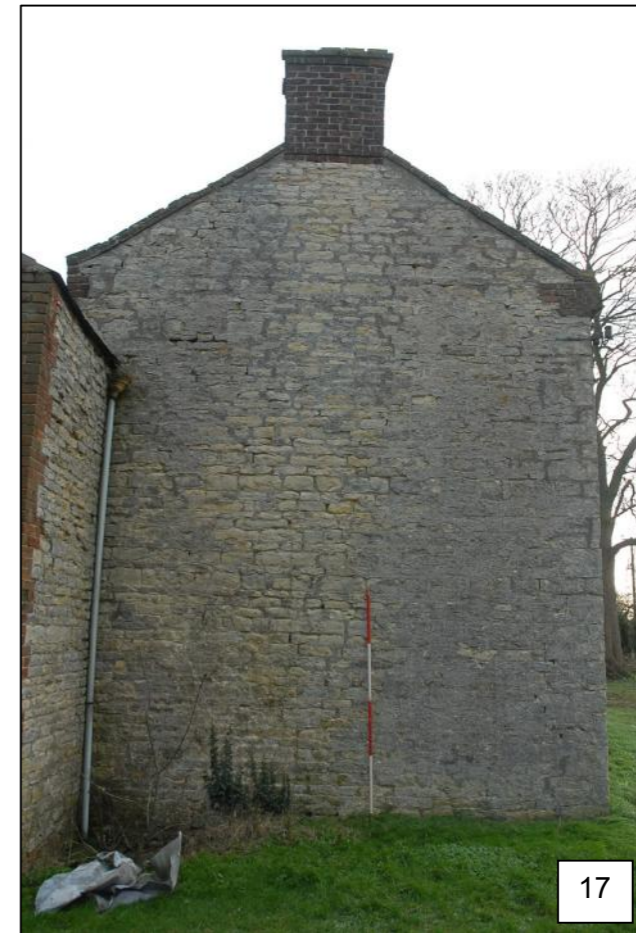
The north elevation is also blind, with similar brick details to those seen at the south side. A later two-storey extension abuts the east side and a cast-iron rainwater hopper with a plastic downpipe is present at the junction of these elements.

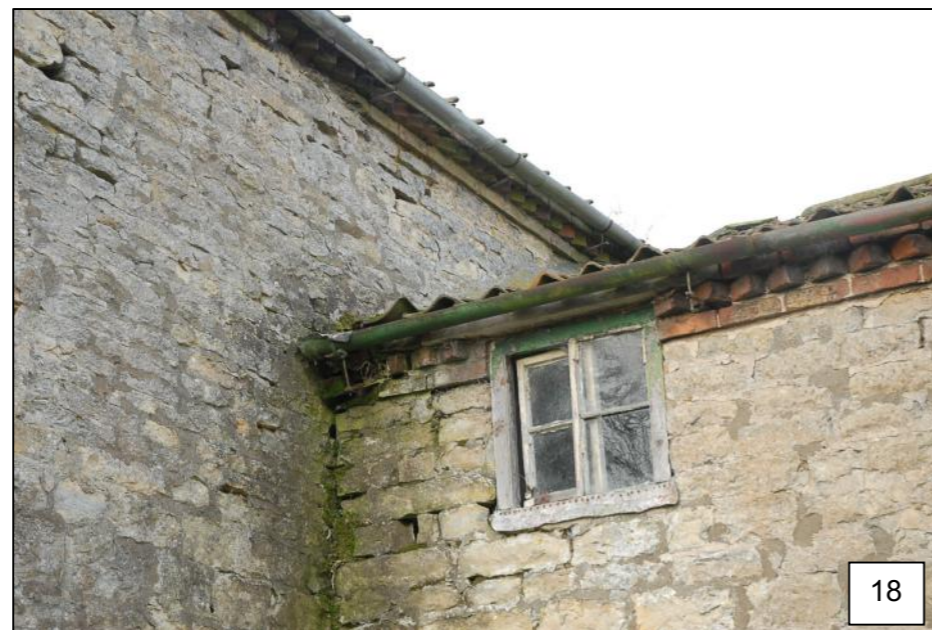
The east side of the main block is largely obscured by the service wing and subsequent extensions built at its north side. No openings are present here.

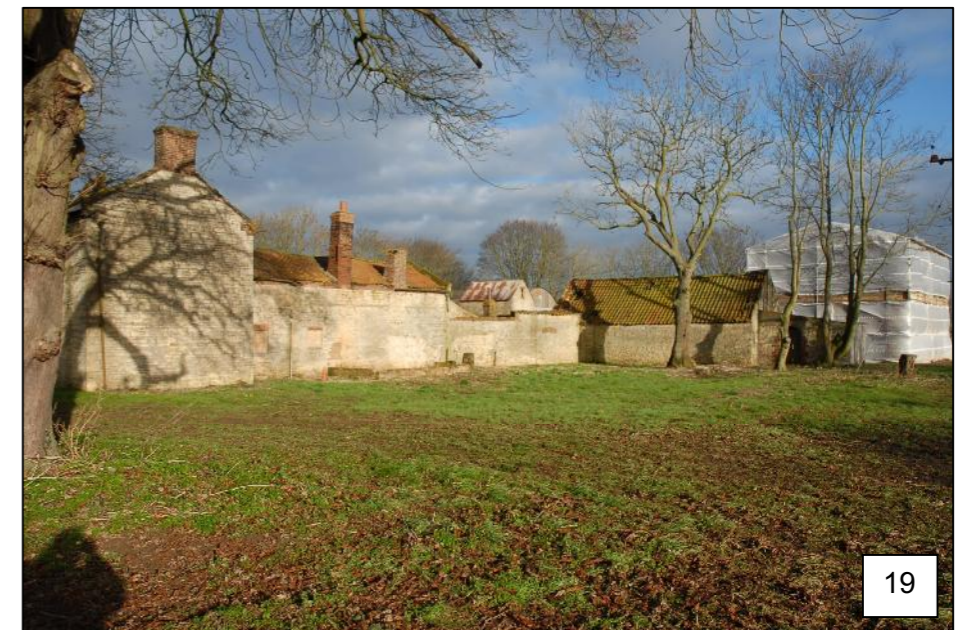
The area to the south of the buildings is now largely open with several mature trees. On historical mapping, the area to the south of these trees is shown as woodland, which would have obscured any view from the house in this direction beyond the lawn here.

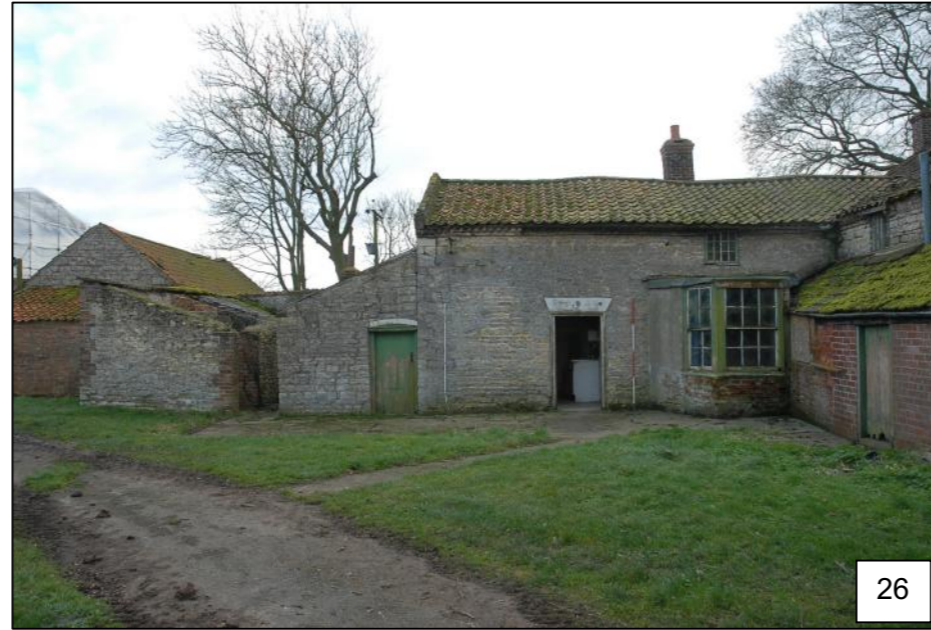
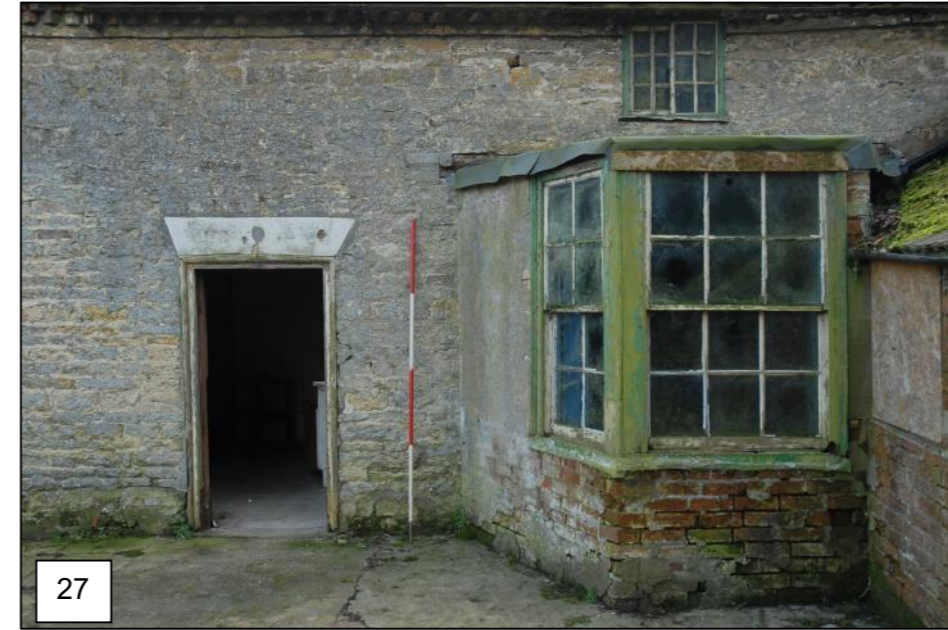
A later large, ground-floor projecting, flat-roofed bay with single-hung sashes is present at the north side of the rear wing adjacent to the rear door of the building: this is constructed of 2¾" brick in stretcher bond and is partially obscured behind a later pantry extension to the main block.

A single door opening with a rendered cambered lintel is present at the east side, containing a framed and ledged plank door. At first floor level a four-pane Yorkshire sash is present immediately below the wall-plate.

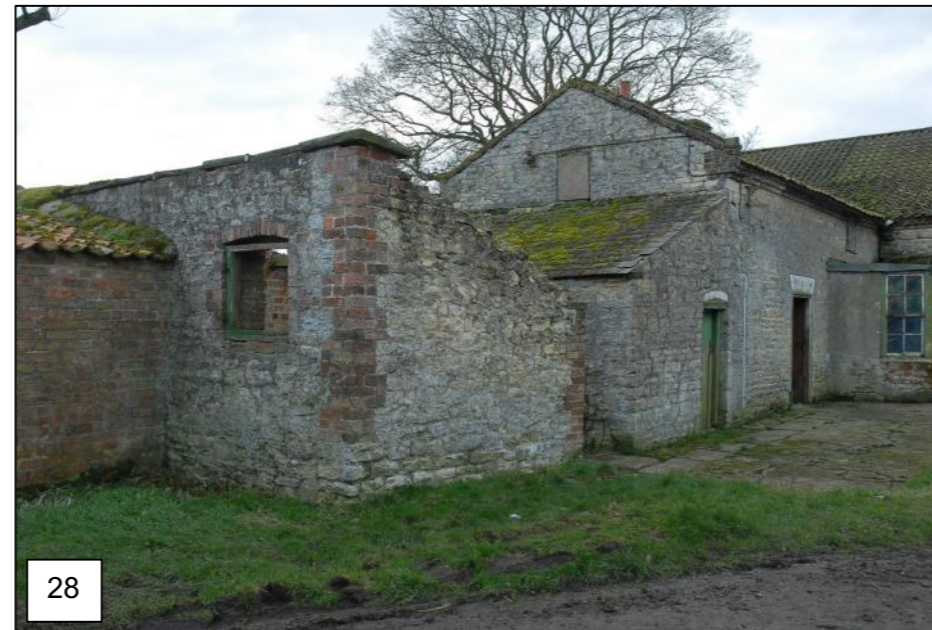
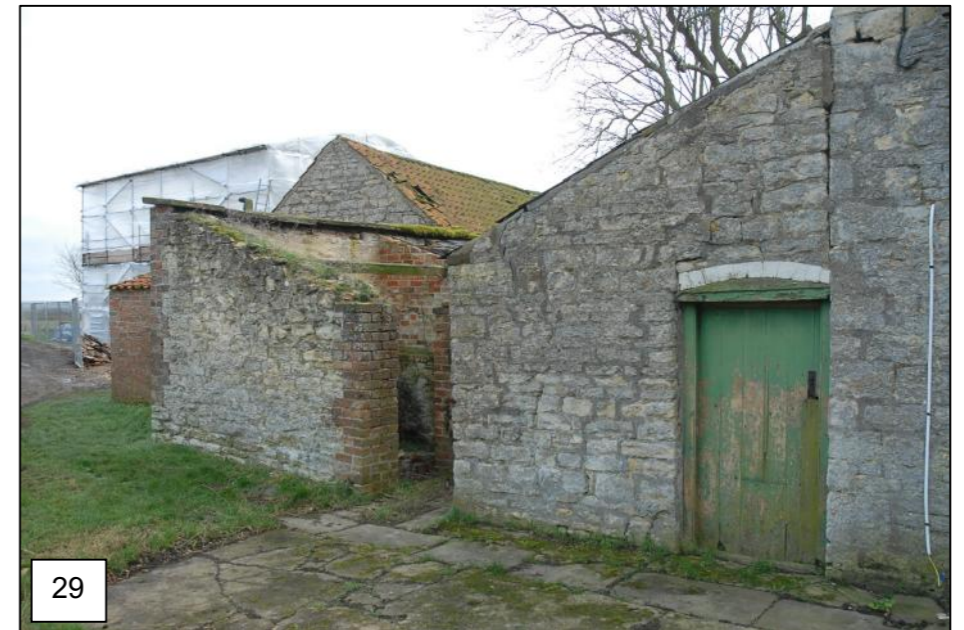
A single-storey outshut is present against the east gable of the building, with a narrow door opening with a segmental brick lintel. The area between this later extension and the neighbouring open-fronted cartshed is occupied by a group of outbuildings now in a ruinous condition.

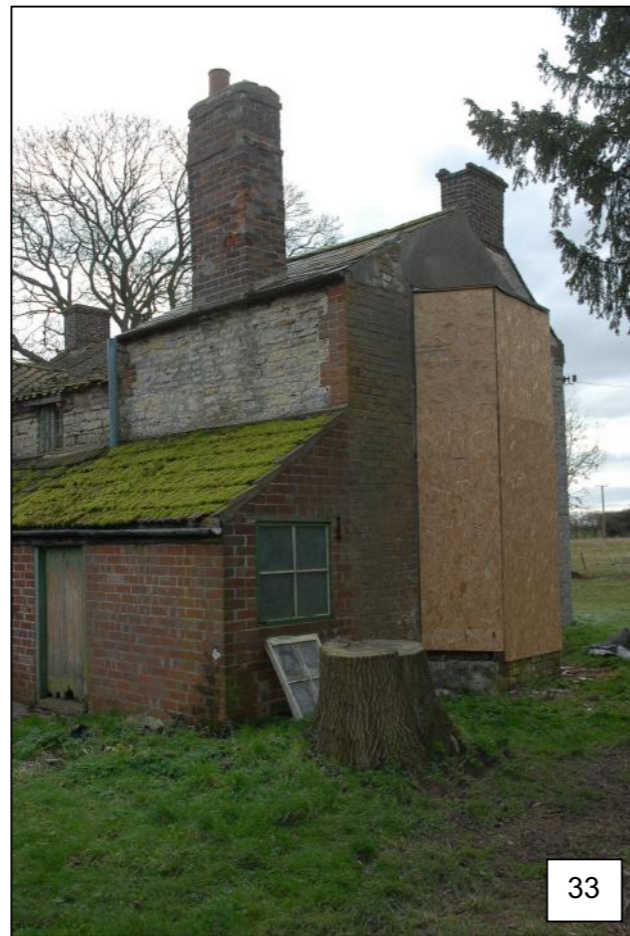
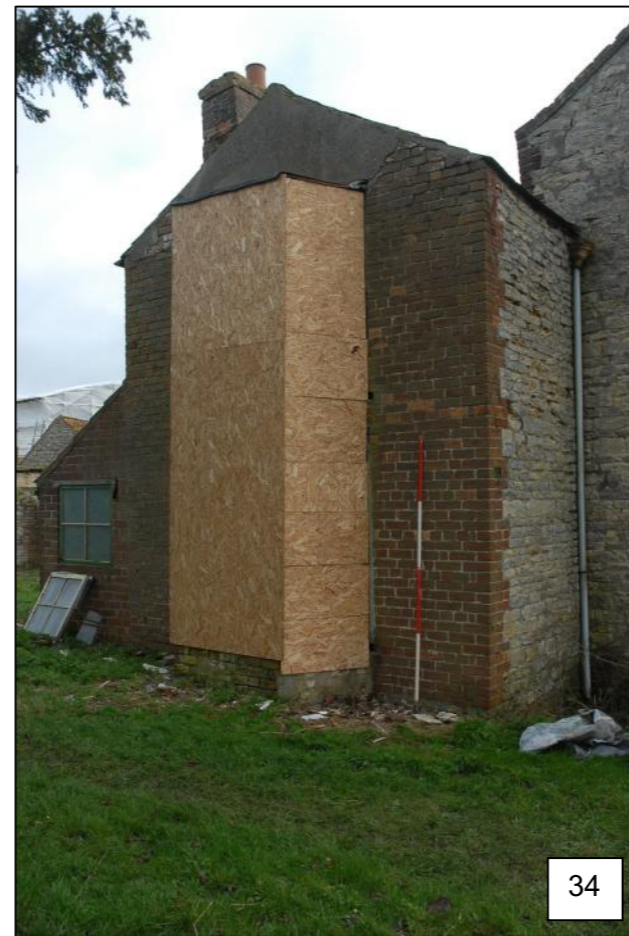
A further later two-storey extension is present at the north side of the building, lit by a two-storey projecting bay at its north side. This building has its own pitched roof of slates, independent of the original structure.

It is built of coursed larger blocks separated by 5-8 courses of limestone rubble between. (Blocks 0.3-0.45m x 0.13m and rubble 0.2m x 65mm); this extension has brick dressings at its corners and the north face is entirely brick (brick size: 8³/₄" x 4¹/₄" x 2⁵/₈", 3 courses = 9") in 3-course EGW bond, cement rendered above wall-plate level.

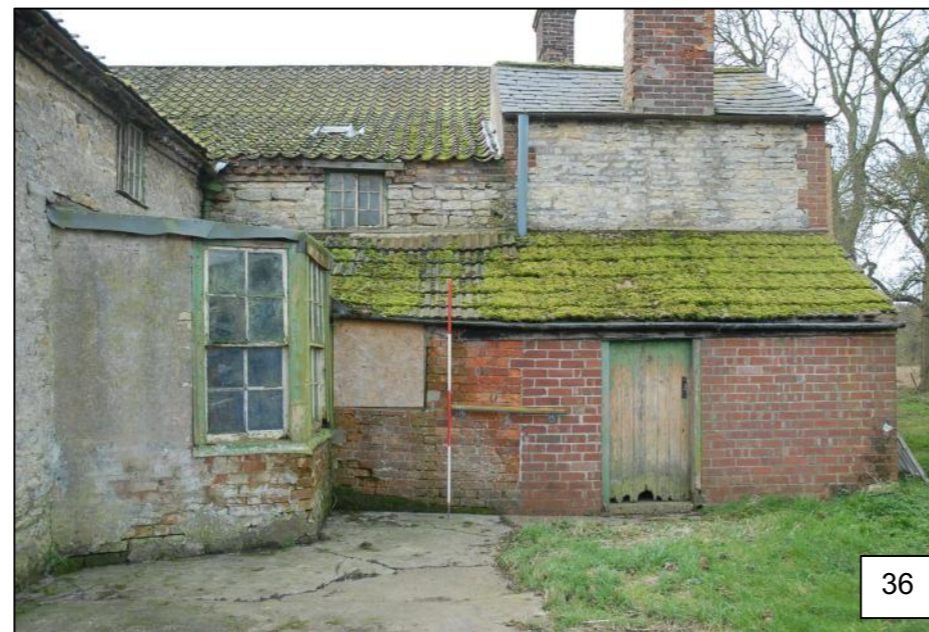
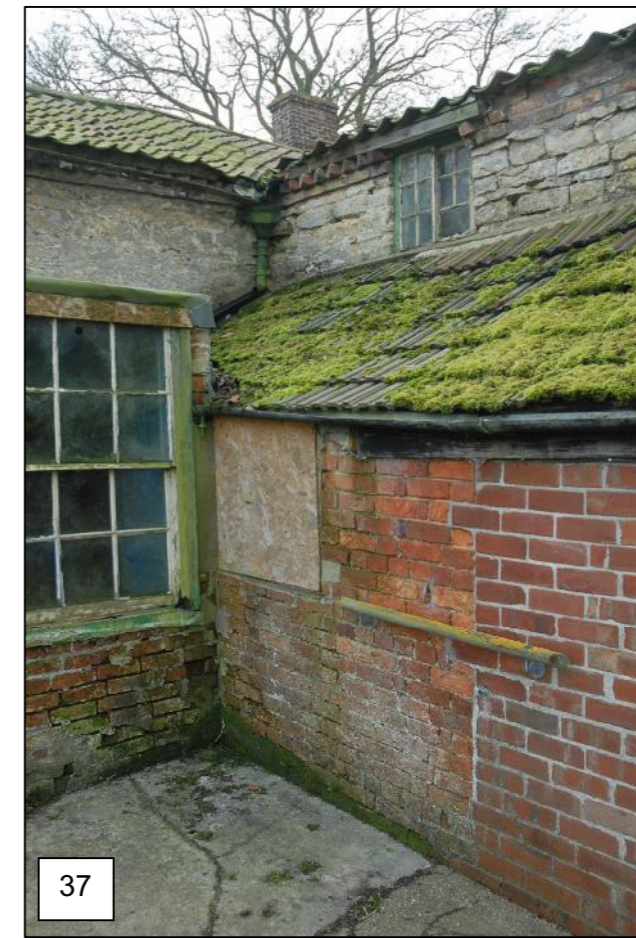
Further extension has taken place along the rear of the main block and includes a pantry in 2³/₄" brick in 3-course EGW bond, further extended for an outside toilet in a salt-glazed 3" brick in stretcher bond.

At the rear of the main block, the dog-toothed eaves cornice seen throughout the original structure does not extend beyond the small first floor window, suggesting that the building has been altered here when the two-storey extension was added.

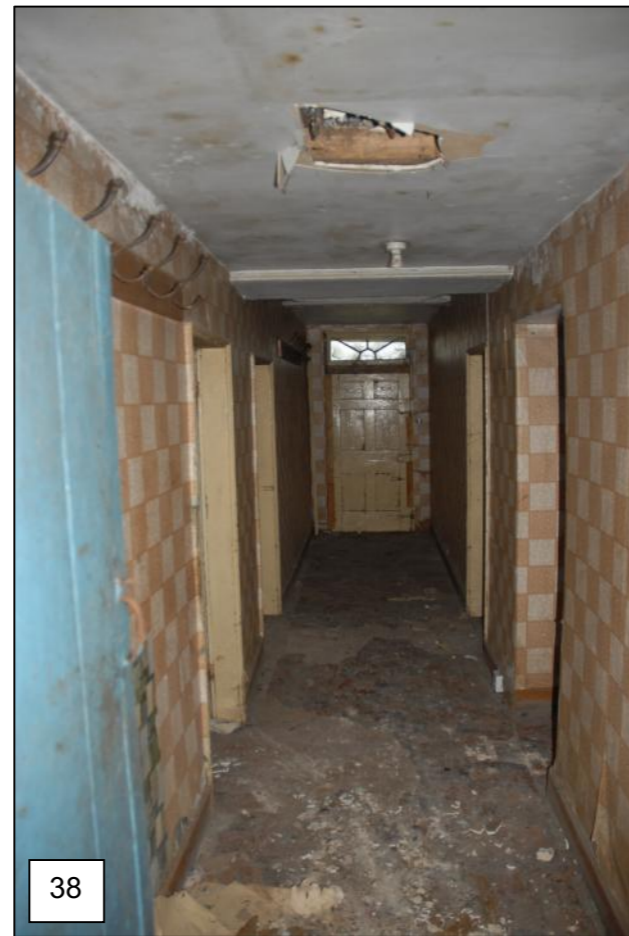
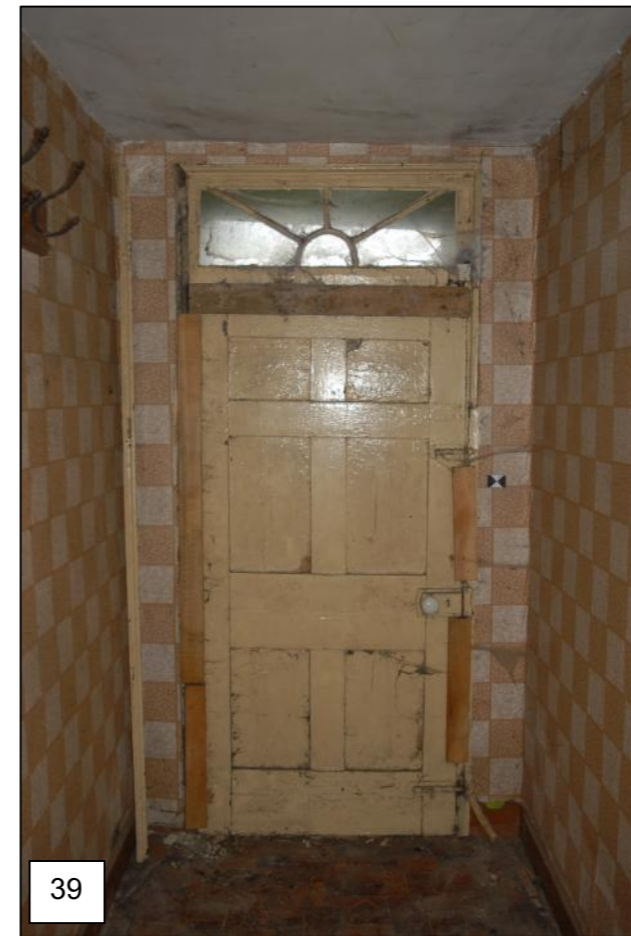
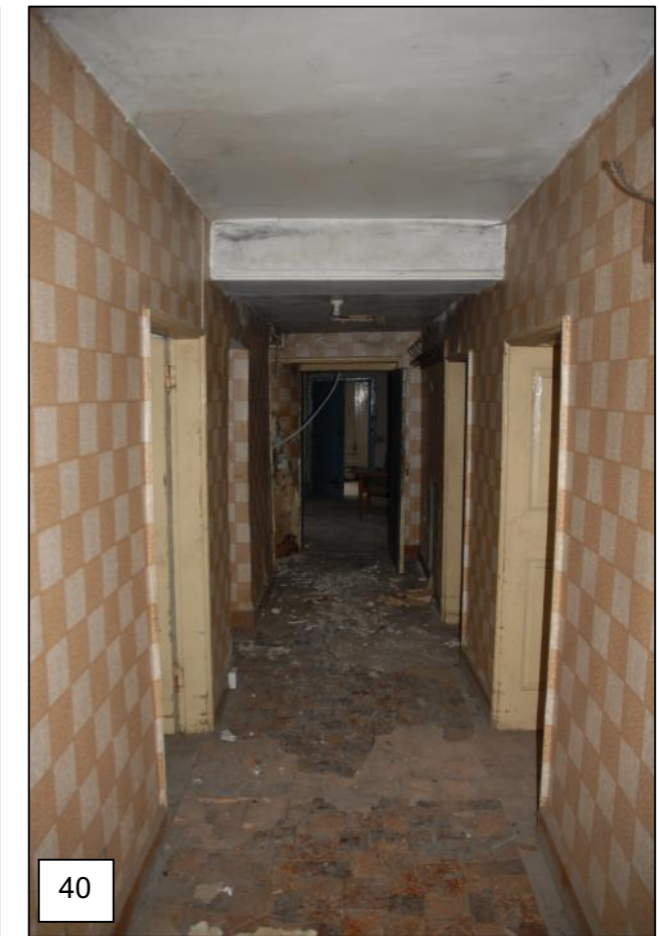
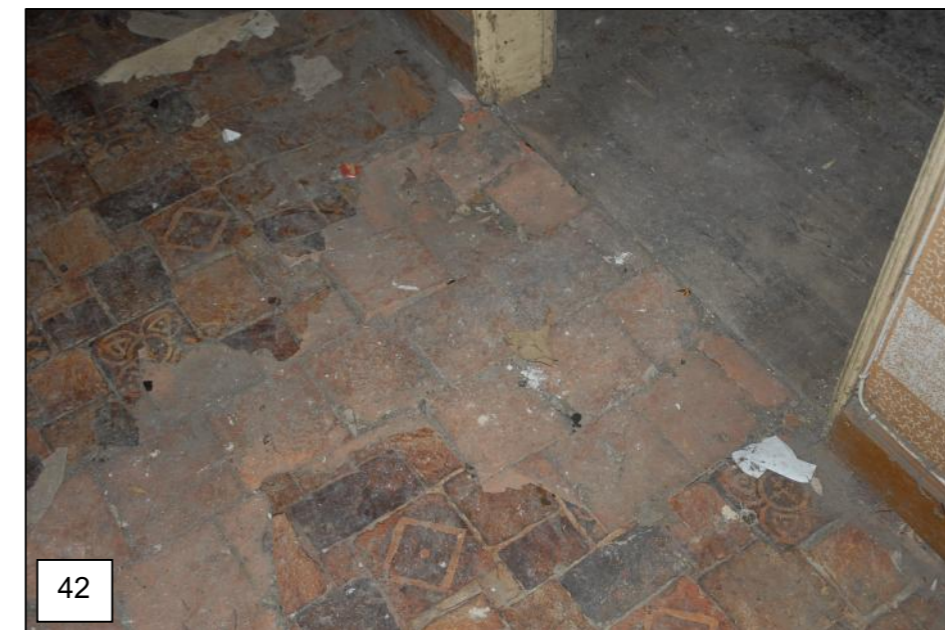
Ground Floor – Room 1

This entrance hall (Room 1) has a floor of 6" quarry tiles, and the reception rooms have four-panel doors in panelled doorcases; a 5½" bead-topped skirting is also present here.

The six-panel front door has a fanlight with an ogee and chamfer head.

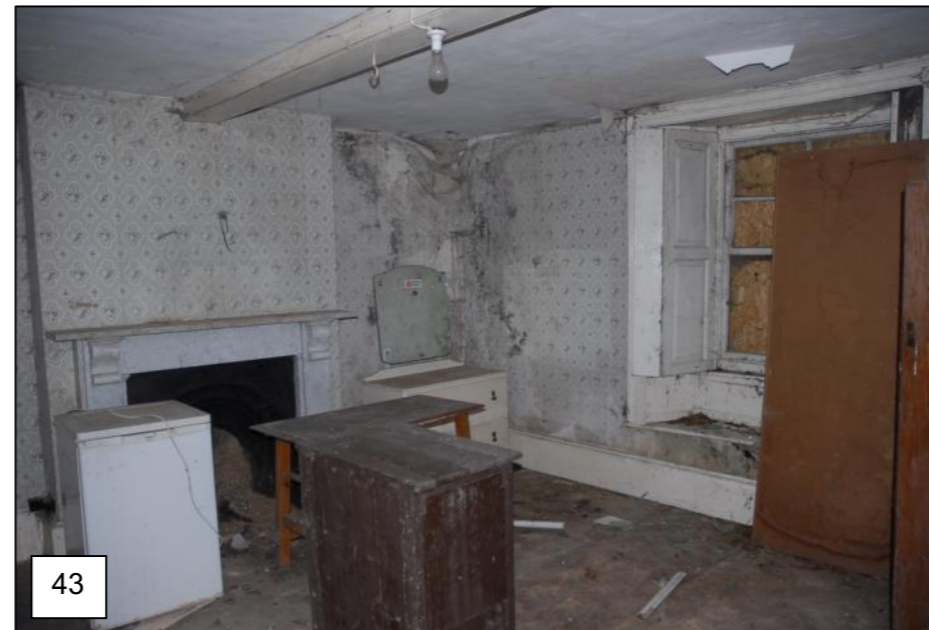
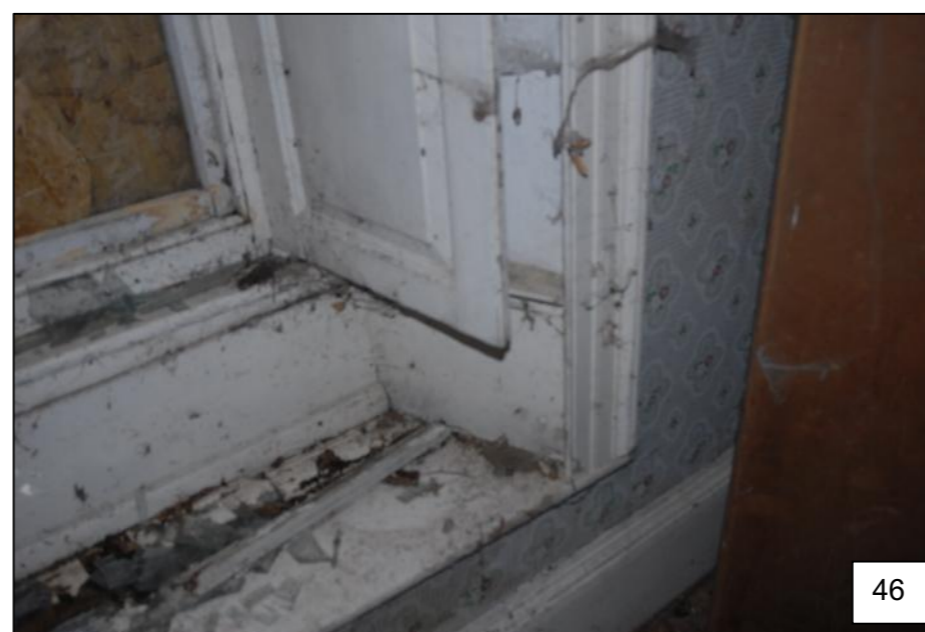
This is the main reception room of the house, located to the south of Room 1. It retains an original plaster-lath ceiling bisected by a central north-south beam with a return-bead soffit. It has a double-hung sash window in the west wall, which retains its four-panel shutters and shutter-boxes. Room 2 was clearly the formal reception room with a larger skirting (9½" torus-bead); it retains its original arched cast-iron fireplace and marble fire surround.

Doors throughout the main block are 4-panel raised and fielded interior doors with ½" ogee panel mouldings. Room 2 retains a 'press' in the east wall, here with an arched opening and shelves inserted. Both ground floor reception rooms have floors of 6½" floorboards running east-west.

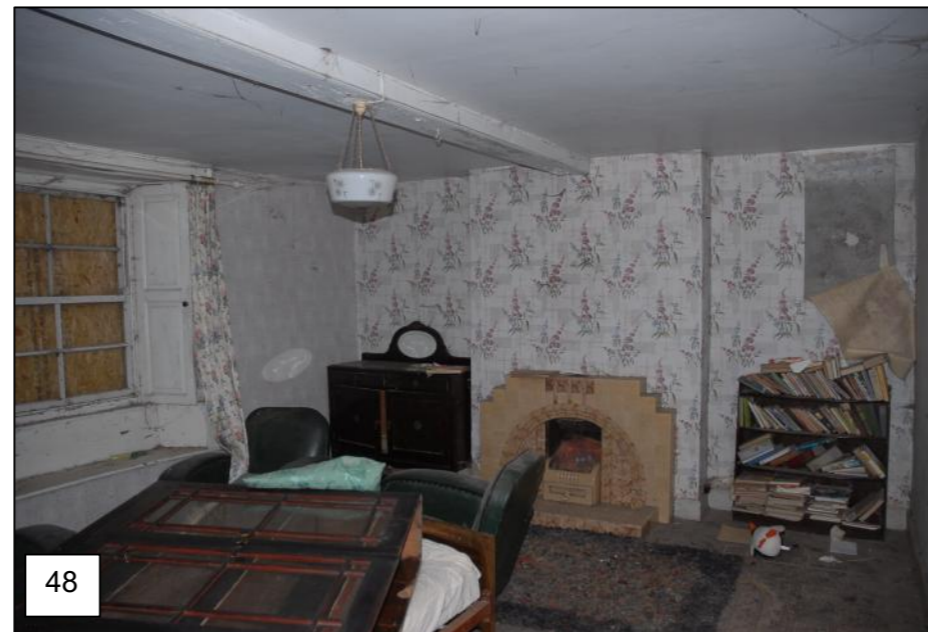
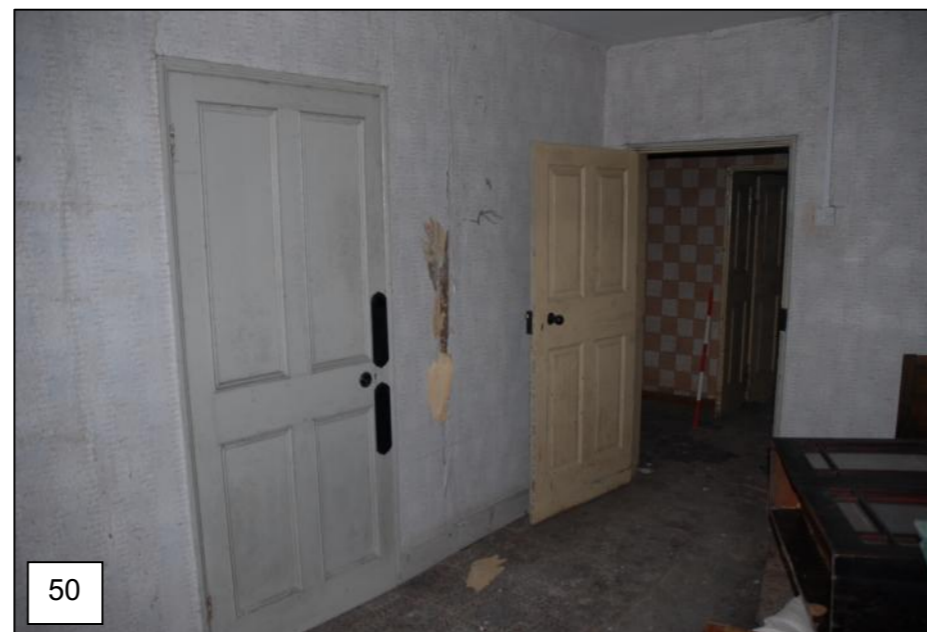
This is the 'living room', located at the north side of Room 1. Like Room 2, it has an original plaster-lath ceiling bisected by a central north-south beam with a return-bead soffit. It has a double-hung sash window in the west wall, which retains its four-panel shutters and shutter-boxes. The fireplace has been renewed with a 1930s style tile surround and enamelled grate. The room has only 5" torus-bead skirting.

Room 3 also has a 'press' in the east wall, here with a plain four-panel door with bolection panel mouldings.

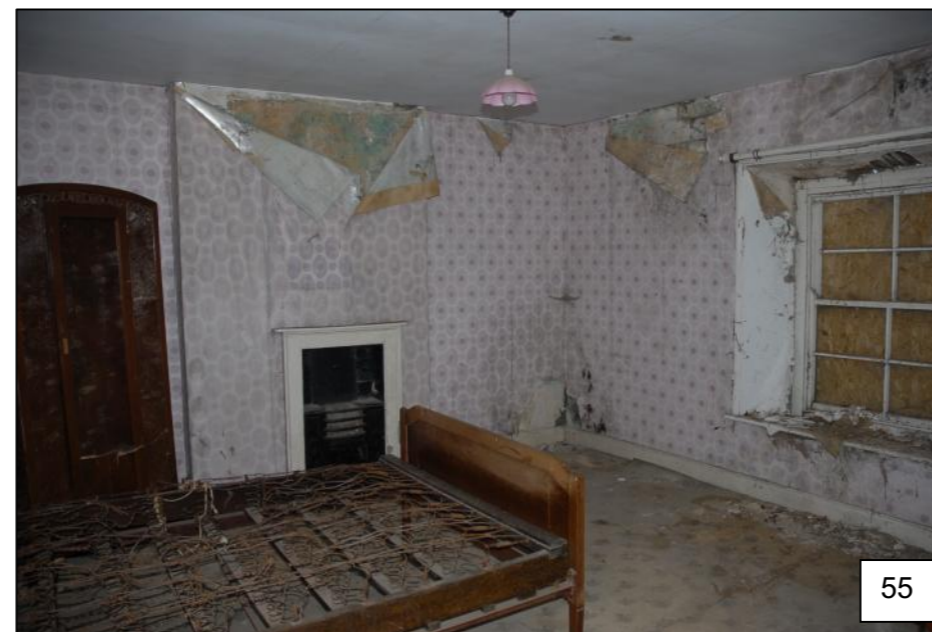
The first floor remains largely unaltered, and Room 12 has a plain plaster/lath ceiling and a 5¾" bead-topped skirting, with 1¼" ogee and chamfer-moulded architraves to its door and window openings. The floor is of 10" tongue-and-grooved floorboards which run north-south.

Room 12 has a door typical of the main block - a 4-panel raised and fielded interior door with 1/2" ogee panel mouldings. It retains an original fireplace in the south wall with a cast-iron hob grate and simple timber surround.

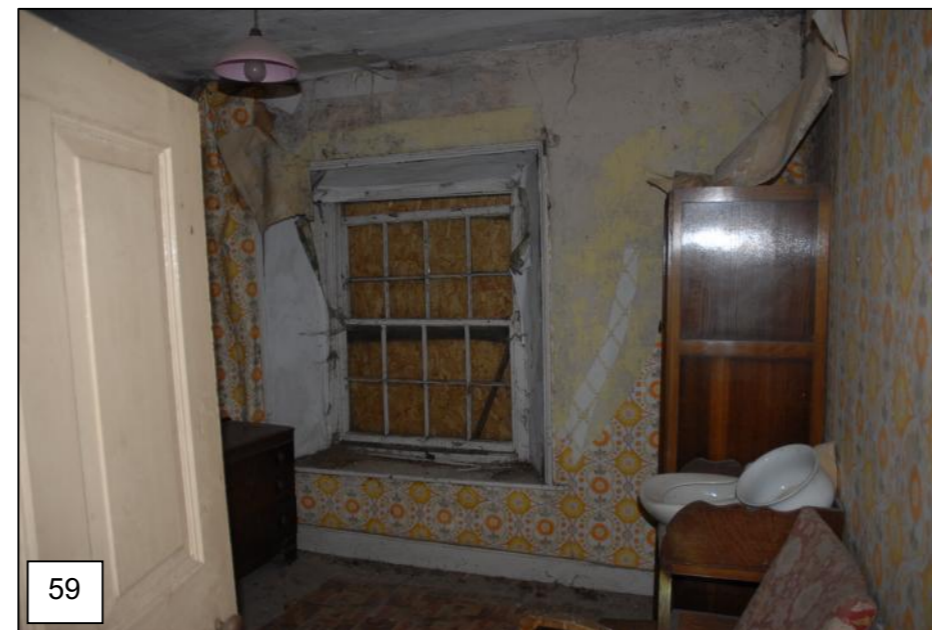
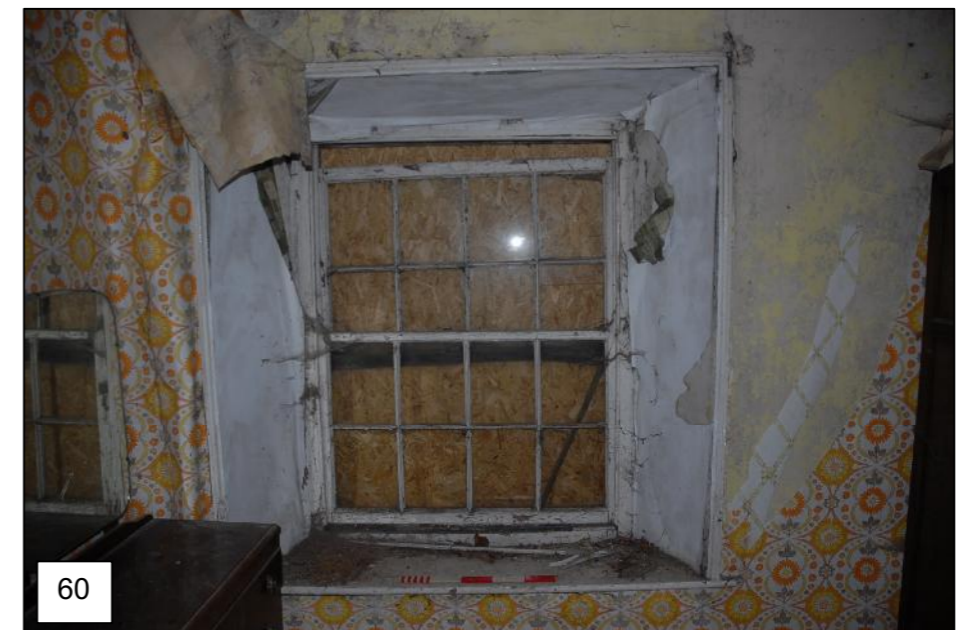
Room 13

The central room (Room 13) has the only example of an unaltered sash window in the west elevation. It is otherwise similar in fixtures and fittings to Room 12, but has no fireplace.
