CLIFF HOUSE, CLIFF LANE, WADDINGHAM, LINCOLNSHIRE

HISTORIC BUILDING SURVEY

Report prepared for Mr. H. Blandford

November 2017

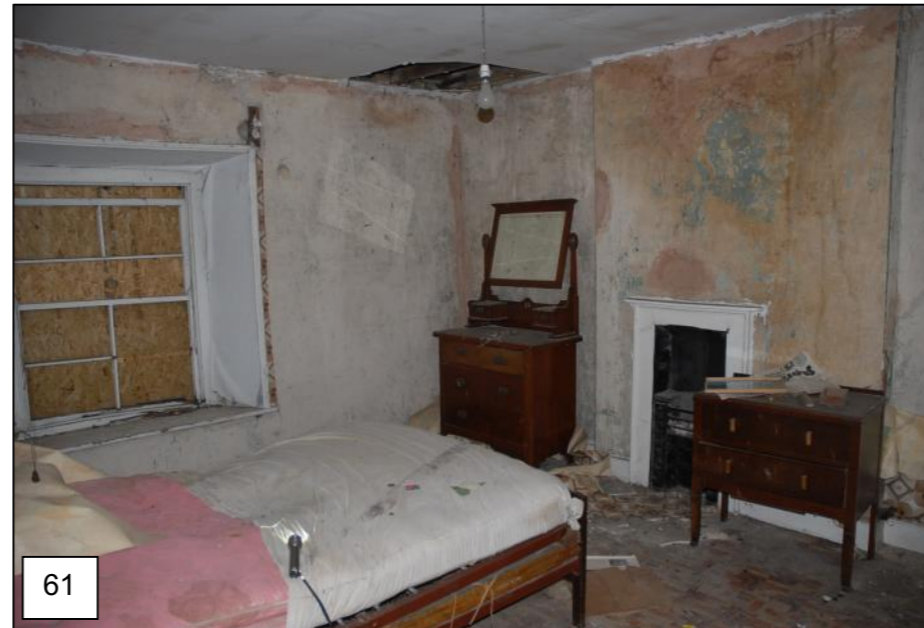
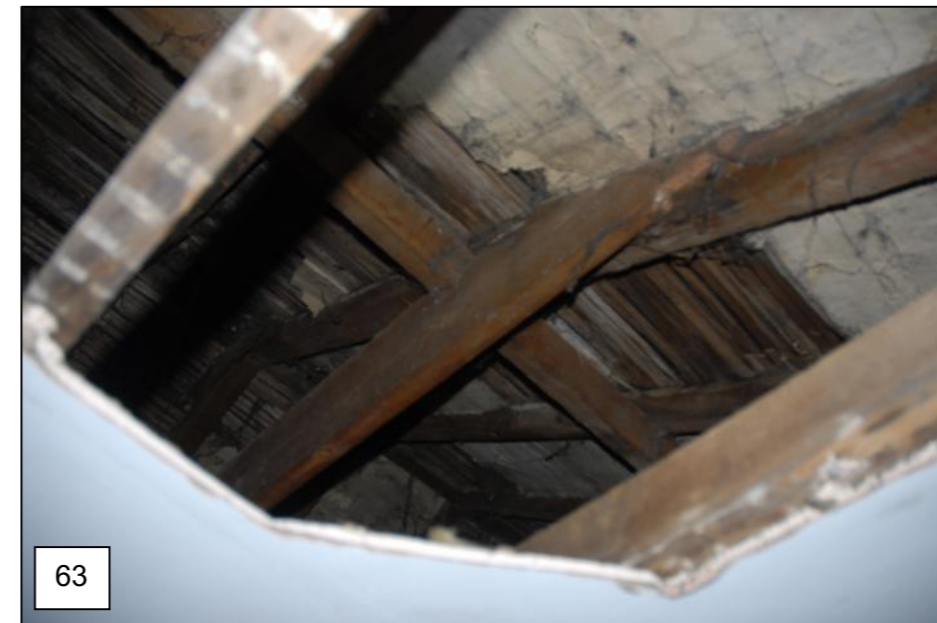
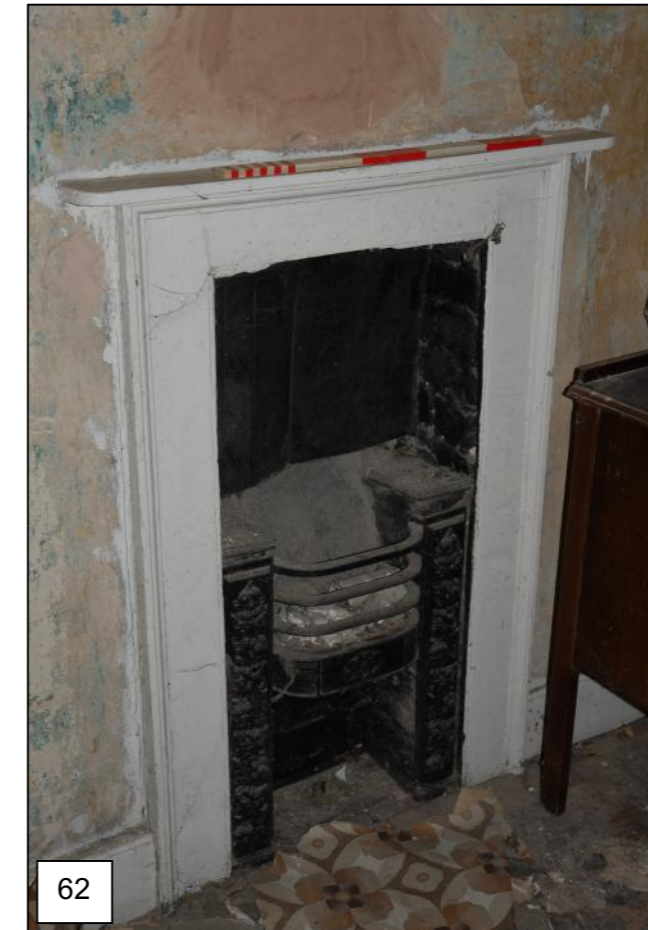
Room 14

This room occupied the northern part of the first floor of the main block. It is identical in fixtures and fittings to those described above in Room 12, with an identical fireplace and grate – here in the north wall. The floor here is of similar floorboards, but on 3" x 3" joists at 14½" centres.

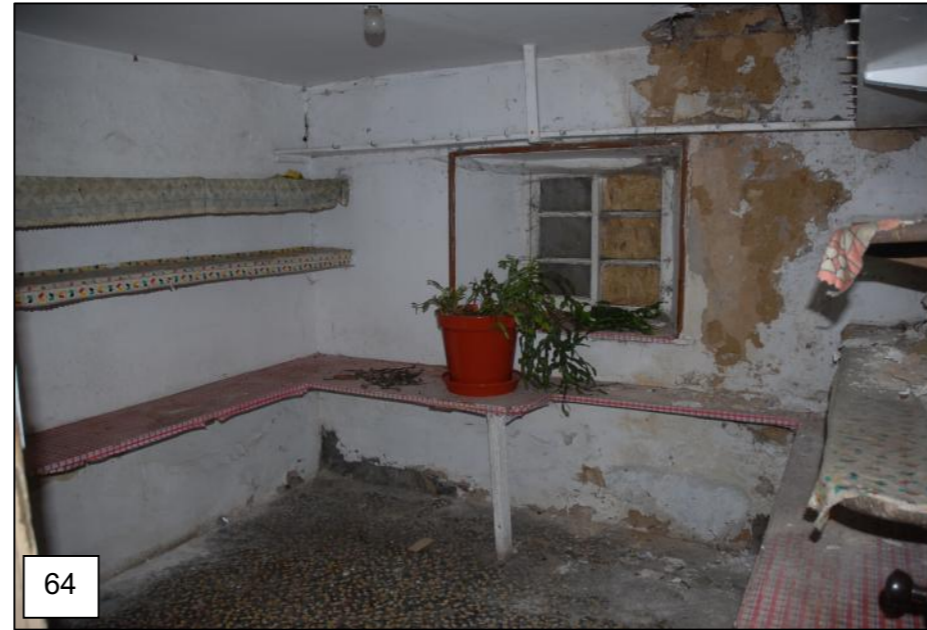
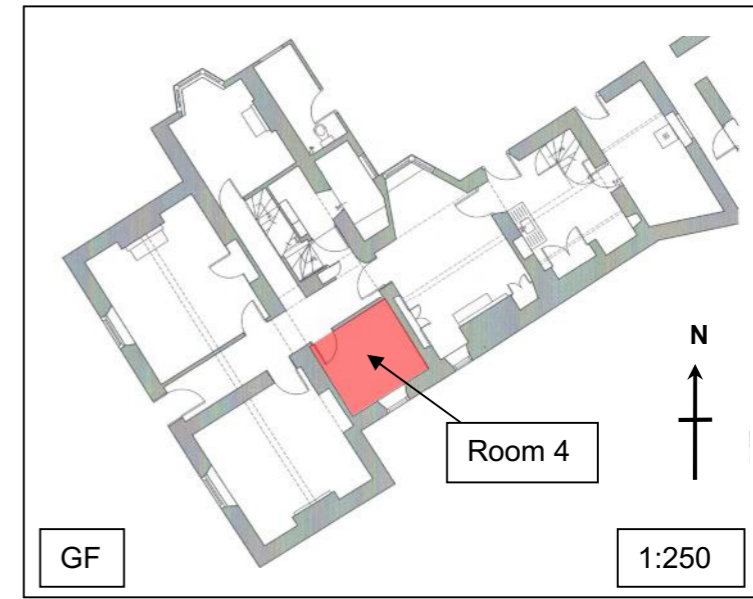
Ground Floor - Room 4

To the east of Room 2, Room 4 has most recently served as a pantry or storeroom – it has timber shelves on three walls and is lit by a Yorkshire sliding sash window in the south wall (this has been altered in the same way as the west windows). Room 4 retains a floor of worn brick in half- overlapping east-west rows.

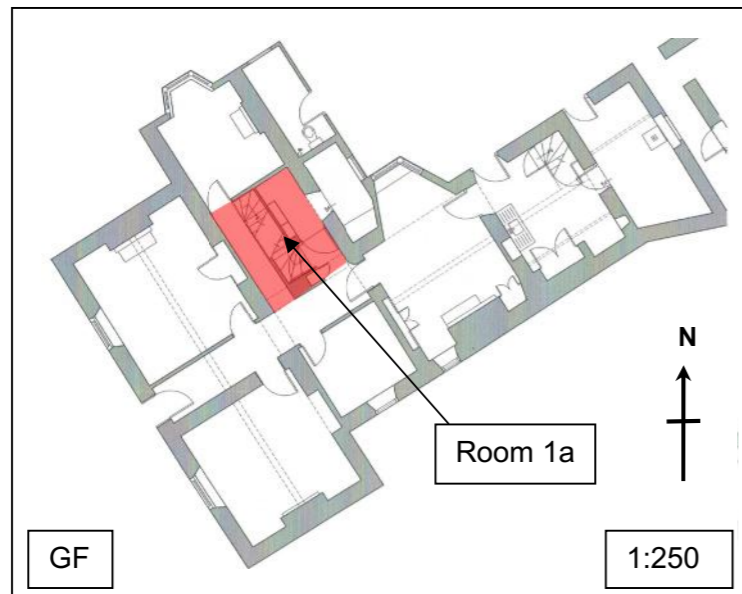
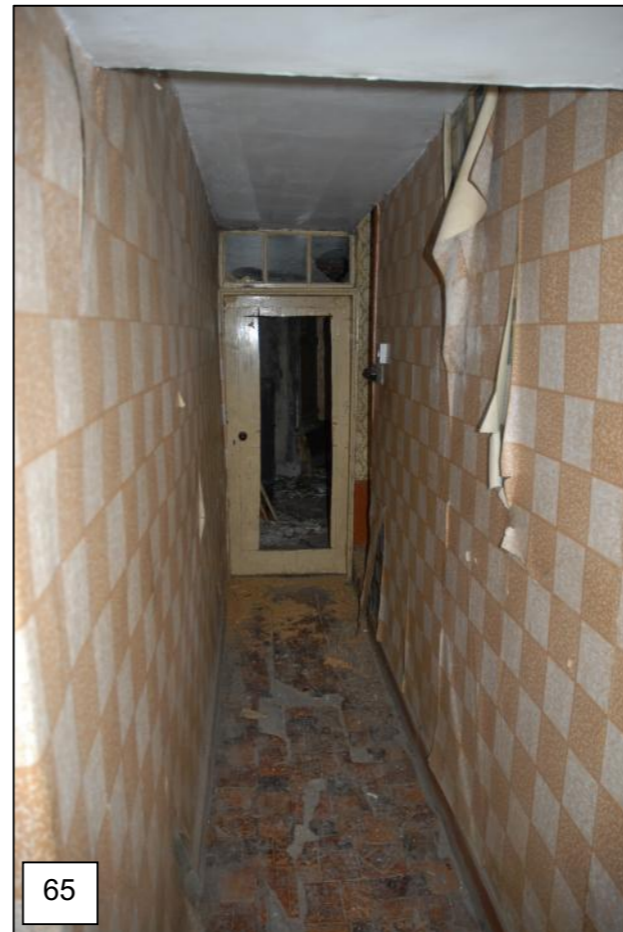
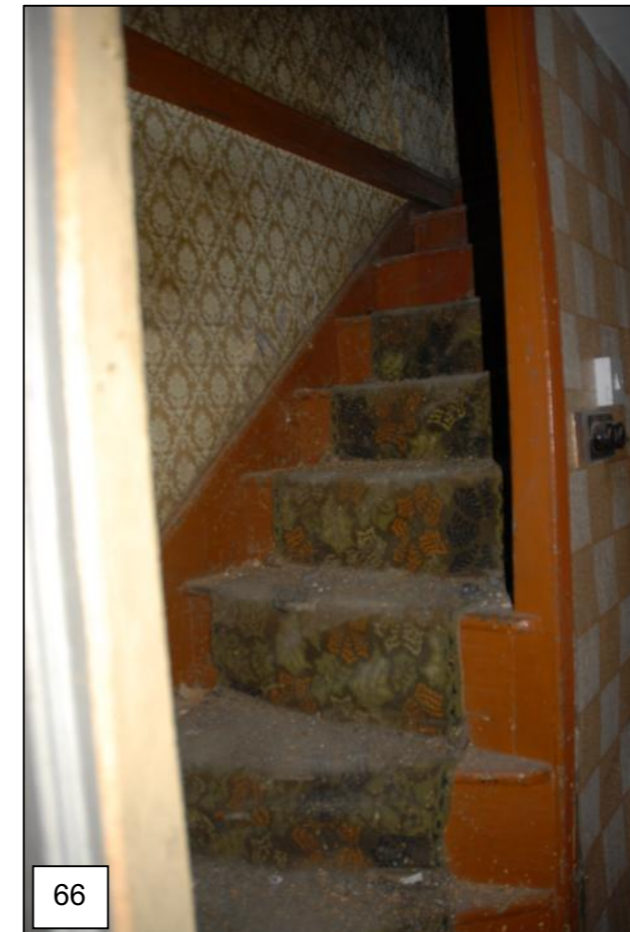
Room 1a

At the rear of the reception rooms, at the north side of the entrance hall, a corridor gives access to the staircase (stairs go 9", rise 8 1/4" with 3/4" stick balusters, 2 1/2" newel and handrail 31" high) and beyond to Room 5, the ground floor room of the northern extension.

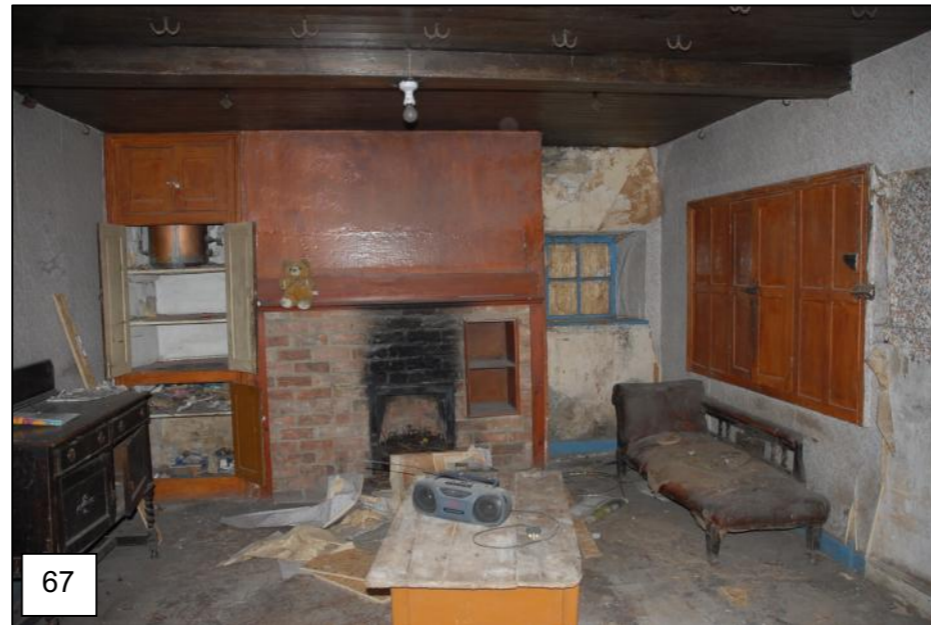
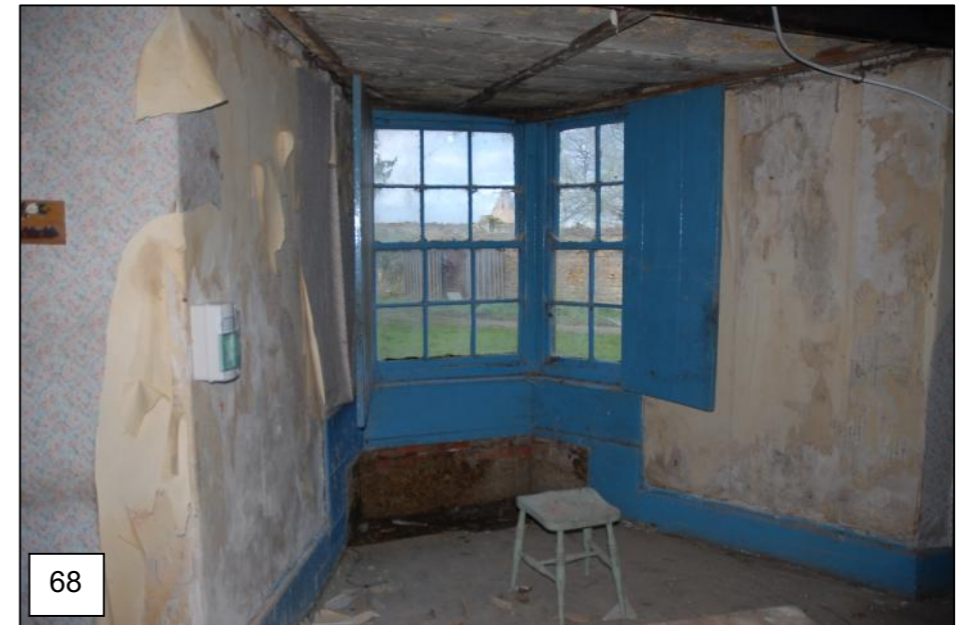
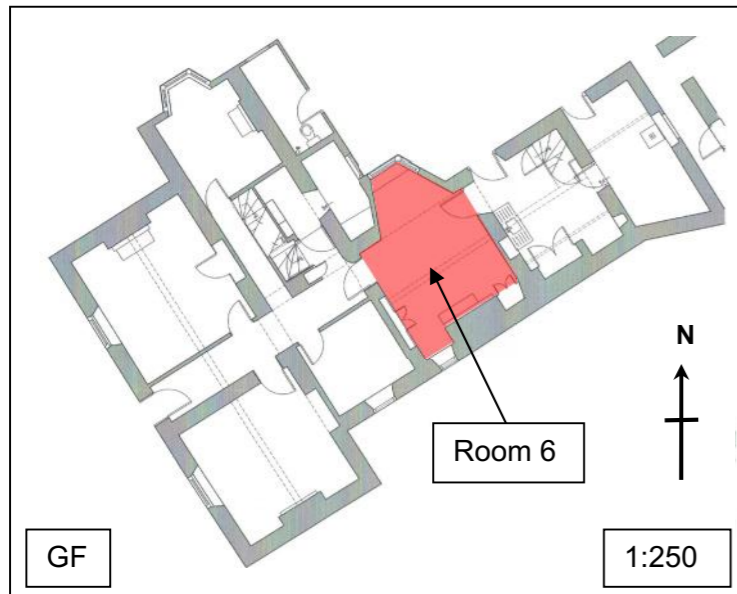
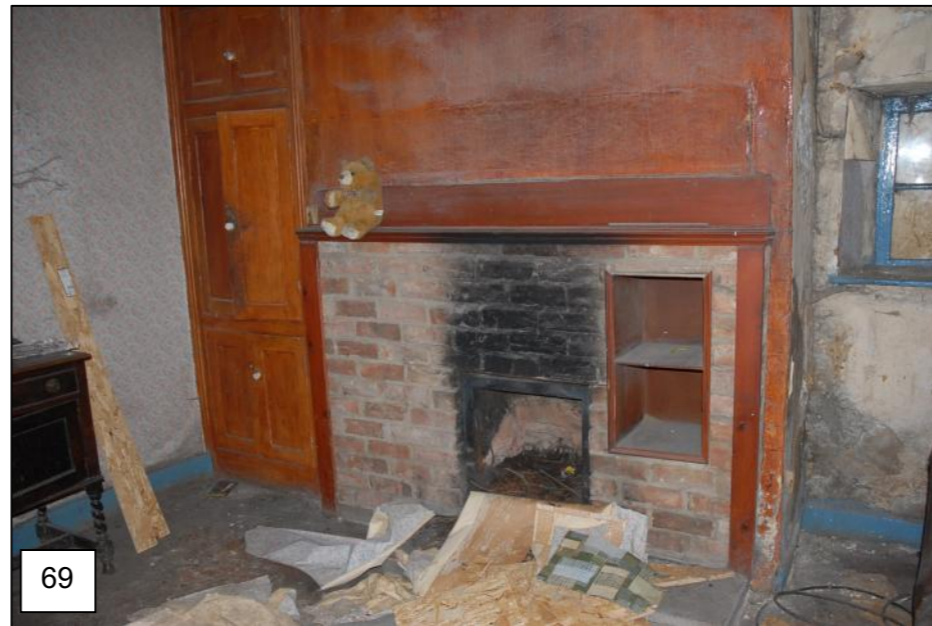
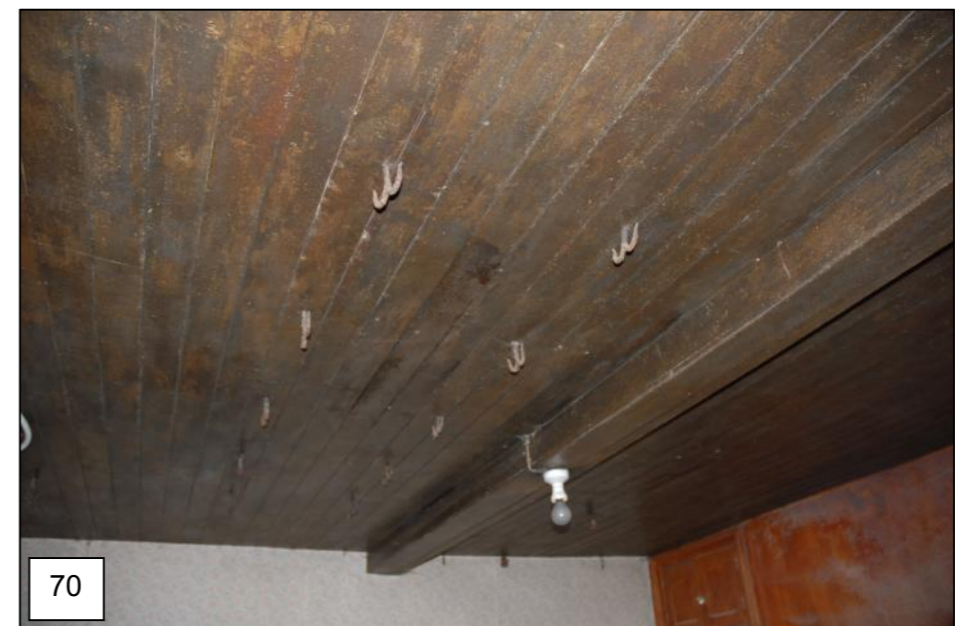
This is the central room of the service wing. It has a recent ceiling of 3¾" matchboard with a single east-west boxed beam. The room is accessed from the entrance hall (Room 1) at the west side, and a door opposite gives access to Room 7. Room 6 has a floor of poured concrete and 5½" skirting. It is lit by a large bay window in the north wall which has a single-hung 6-over-6 pane sash and 4-over-4 pane side window with plain 4-panel interior shutters; this bay has a 9½" torus-bead skirting. No openings in this part of the building have architraves, and the doors here are of ledged vertical 7" bead-edged planks.

A heavy chimneybreast with a modern flue and timber panelling is present at the south side of the room. To the west is a small 4-pane window.

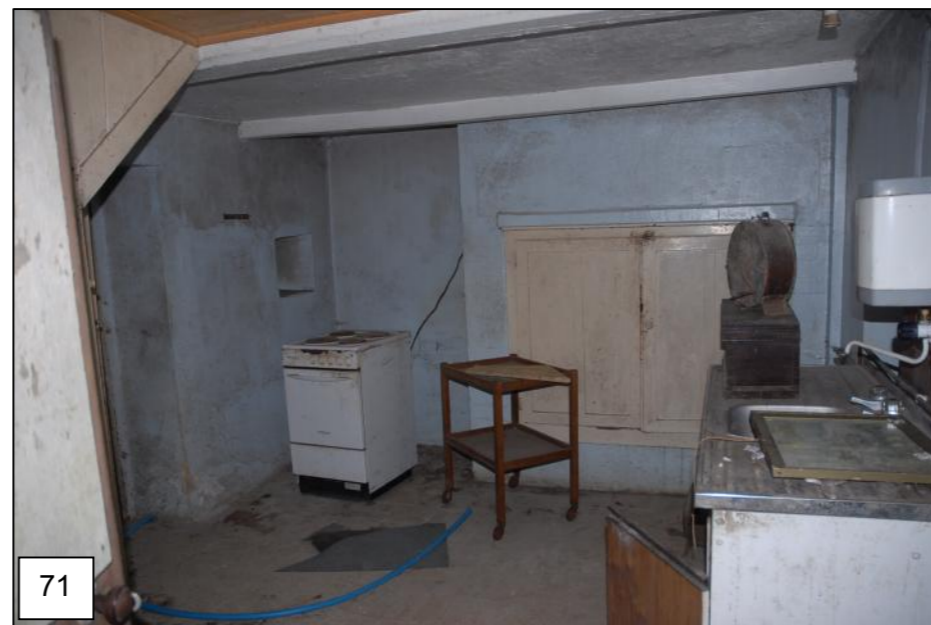
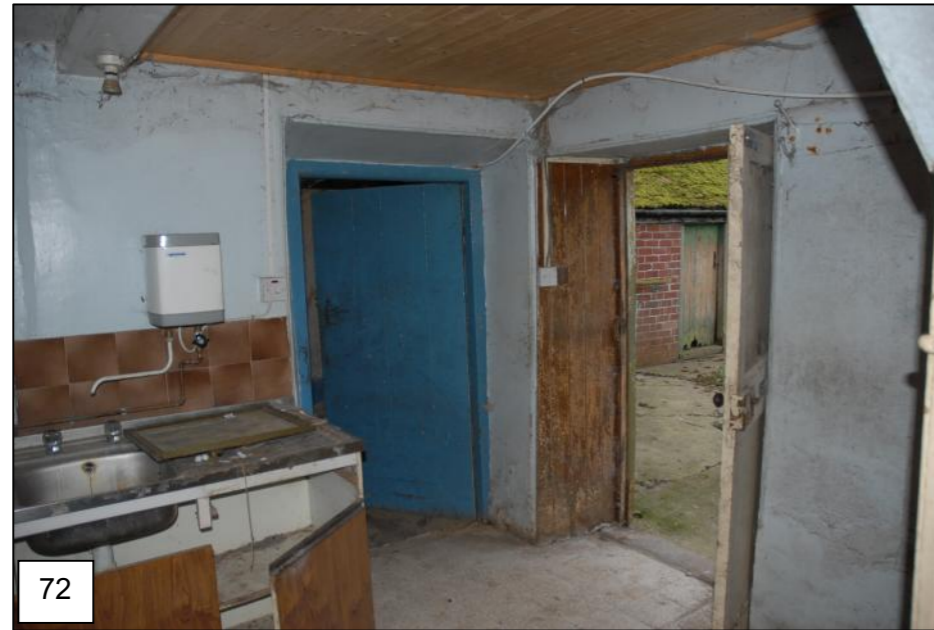
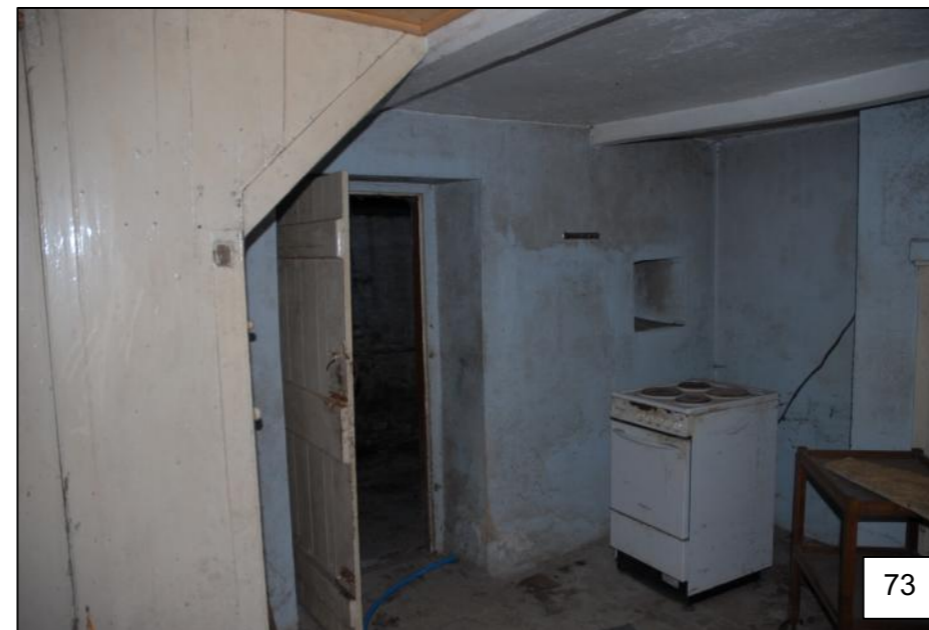
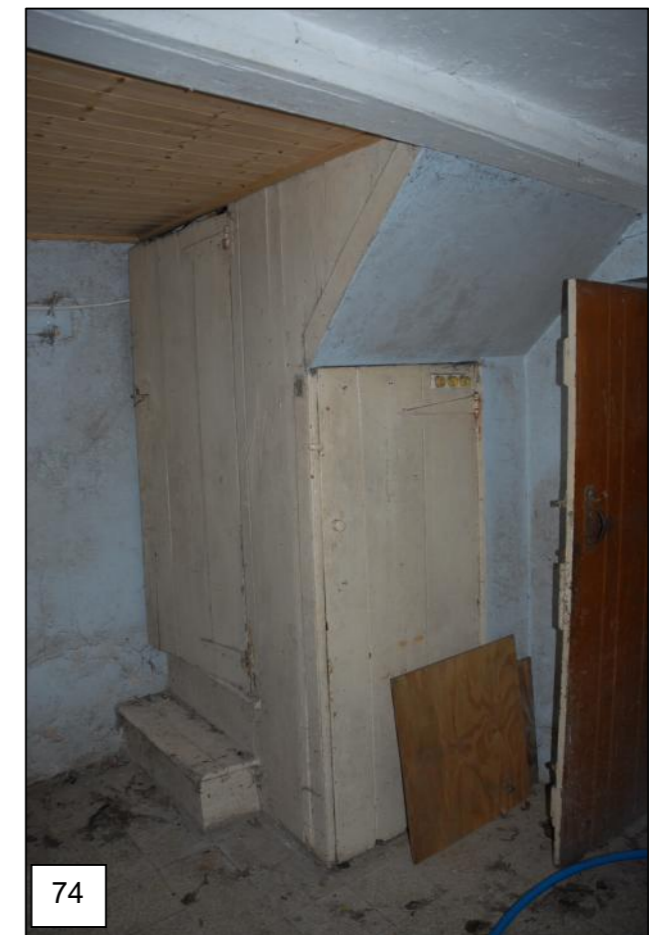
Room 7 has a ceiling of 3½" pine matchboard on two east-west chamfered beams. It has no windows; an exterior door is present at the west side of the north wall, while a winding timber staircase rises in the northeast corner (rear stairs: go 9¼", rise 9¼"; and wind to east and south). It has a floor of 9" terrazzo tiles. A chimneybreast with a large cupboard now let into it occupies the south wall.

The exterior door has timber-panelled jambs, while the panelling to the staircase is of wide vertical bead-edged tongue and grooved planks. A small alcove is present at the south side of the west wall.

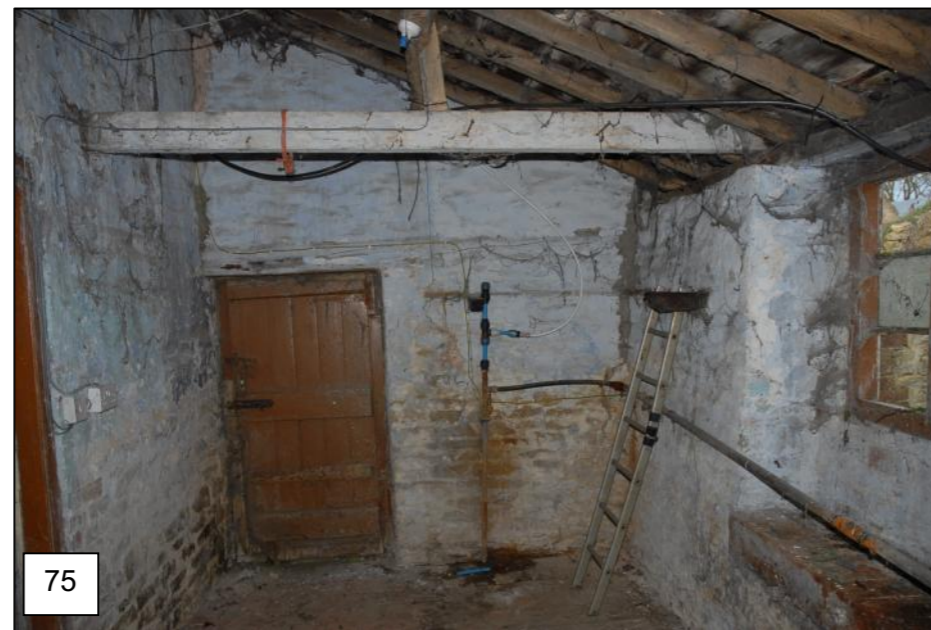
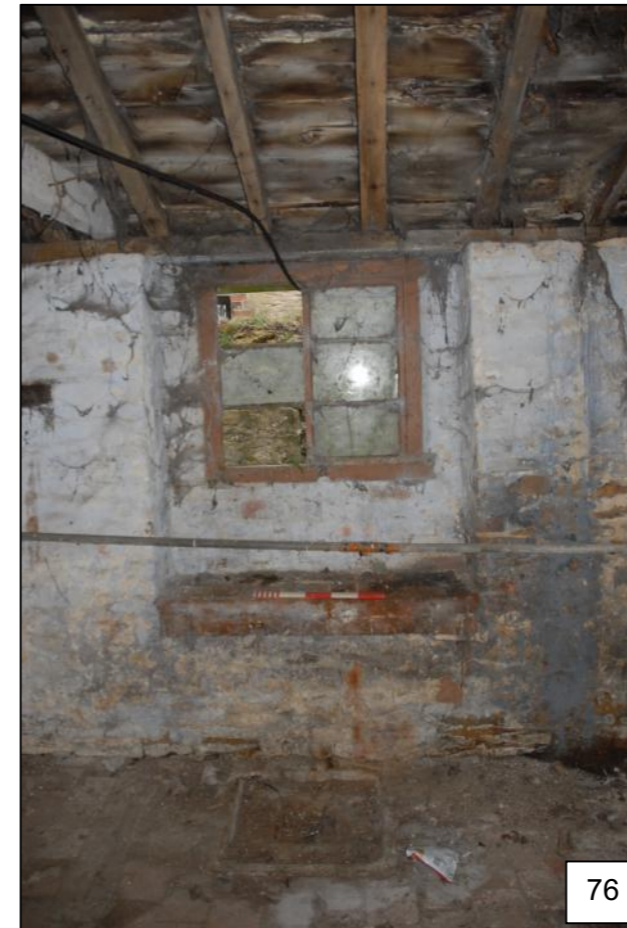
Room 8 occupies the lean-to extension at the east end of the Service Wing.

Its ceiling consists of the exposed timbers of its monopitched roof: a 5½" x 3" beam and purlin support 3" x 2½" common rafters at 16" centres. It has a small Yorkshire sliding sash in the east wall, each element of three enlarged panes (similar to the west elevation). The floor is of 6" quarry tile, laid in half-overlapping east-west rows.

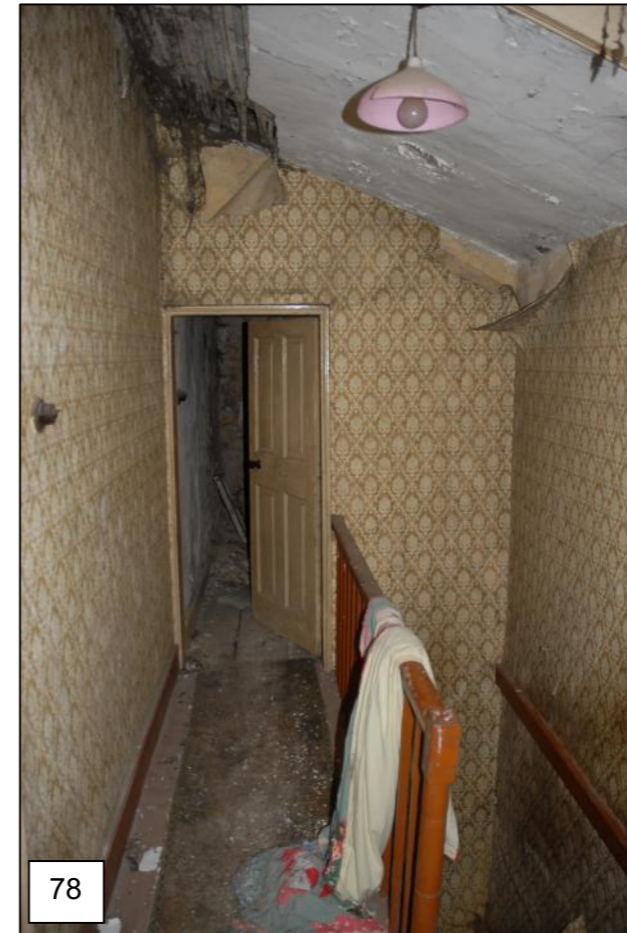
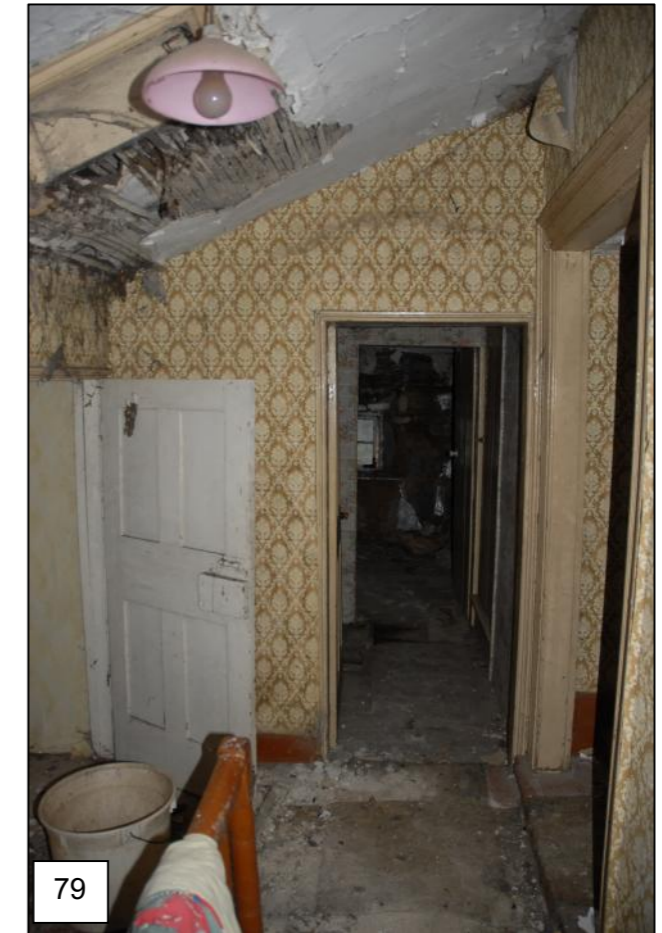
First Floor - Room 1b

This is the first-floor landing within the service wing of the building.

The staircase has a simple safety rail with a turned newel and stick balusters. The ceiling is of plaster lath, with a rooflight near the head of the stairs.

A narrow toilet is accessed from a small four-panel door to the east.

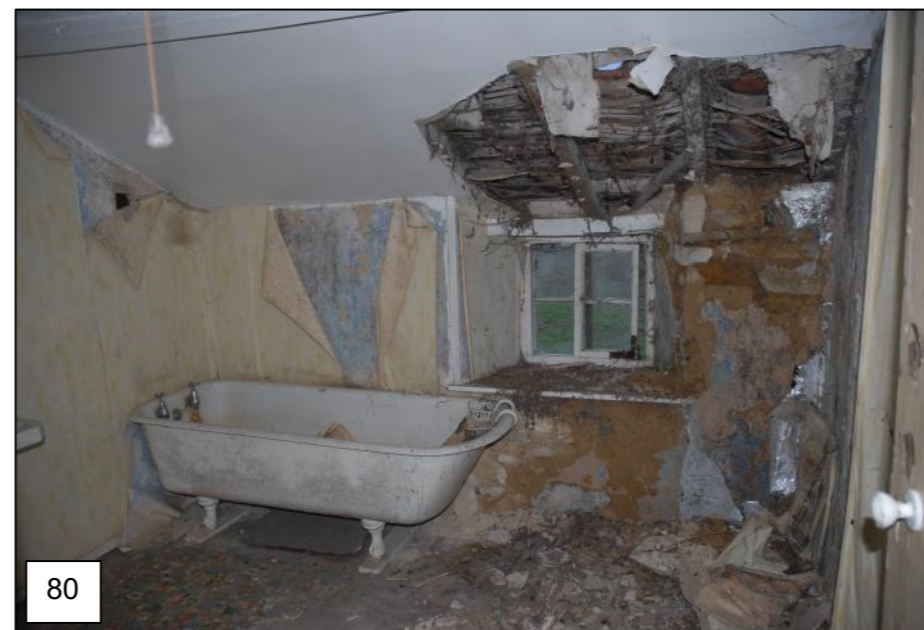
Room 15

This room occupies the area above Room 4, separated by a stud partition from a corridor giving access to the main rooms of the service wing.

It has a plasterboard ceiling and is lit by a small four-pane Yorkshire sliding sash in the south wall.

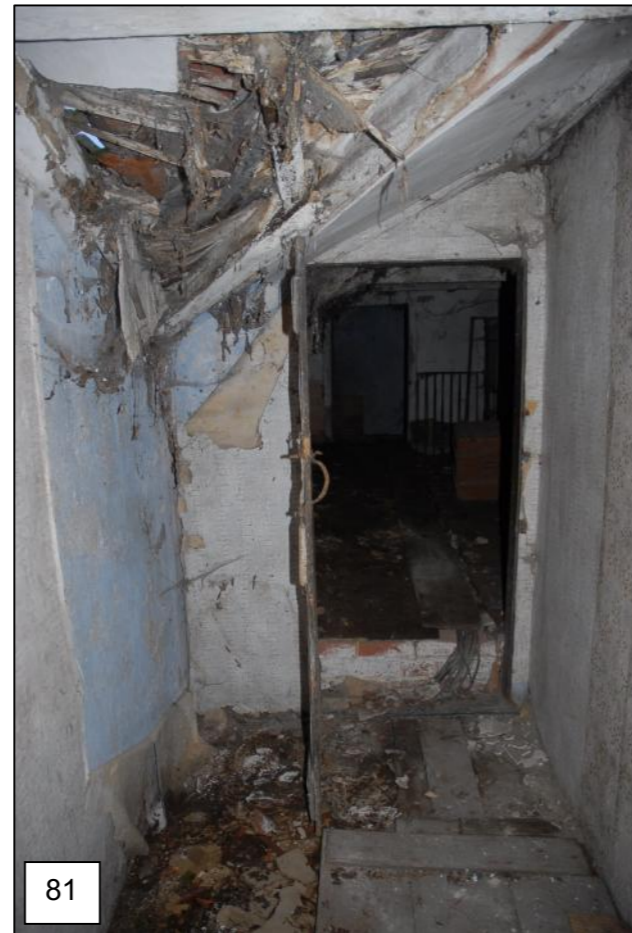
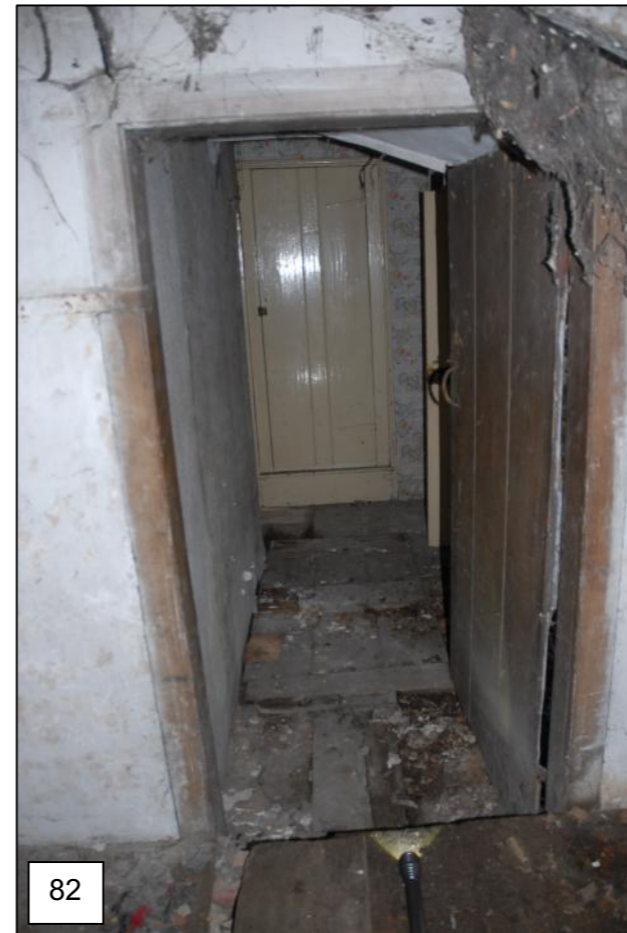
Room 15a

This is a narrow corridor linking the landing to the service wing along the north side of Room 15. This room arrangement is fairly recent, having plasterboard ceilings and a stud partition.

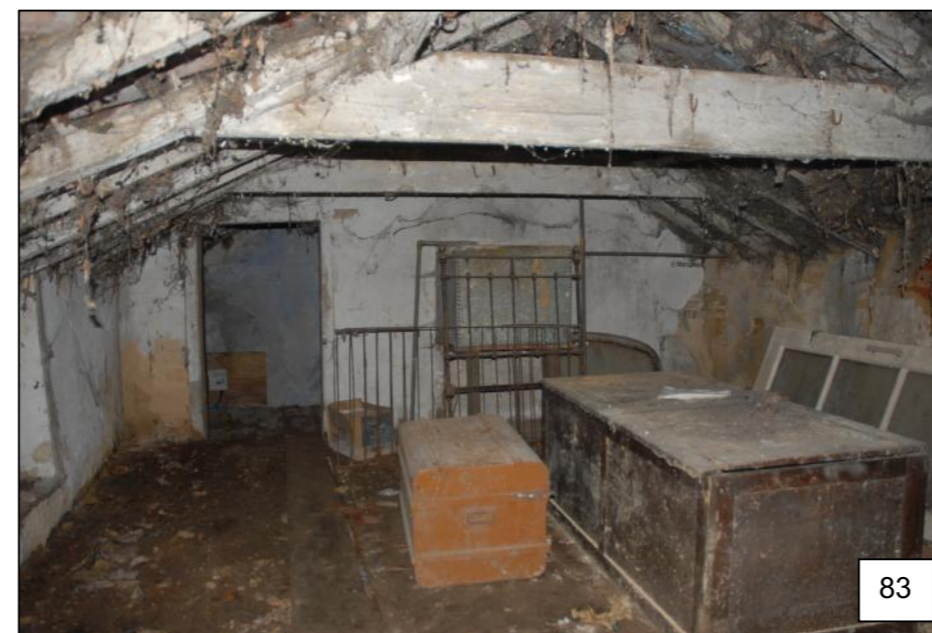
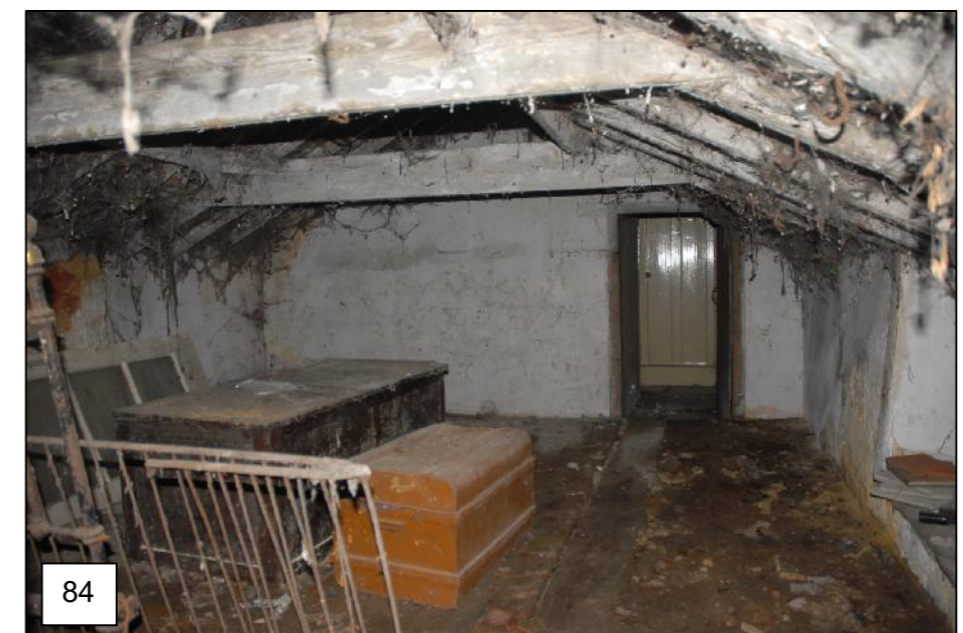
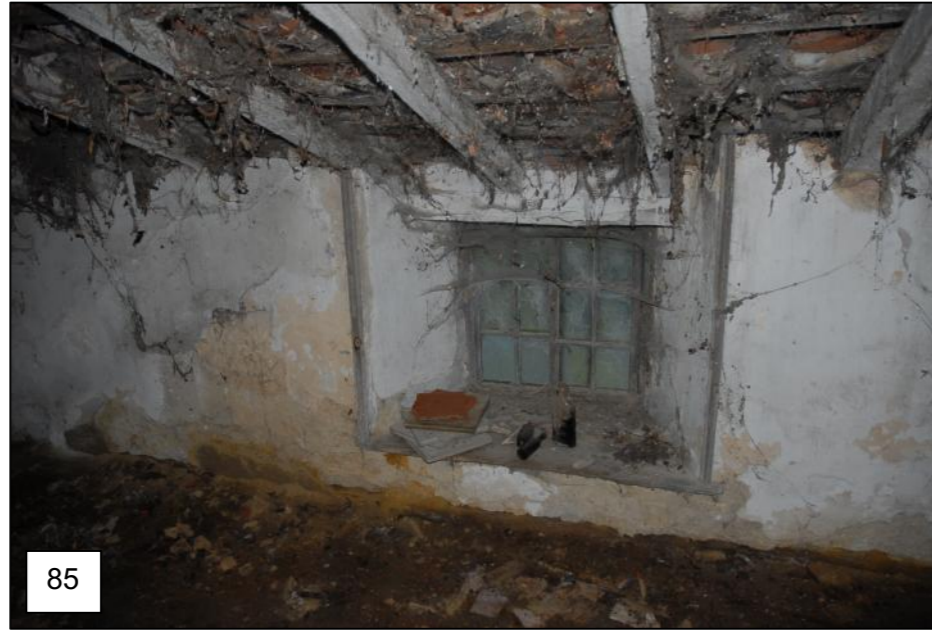
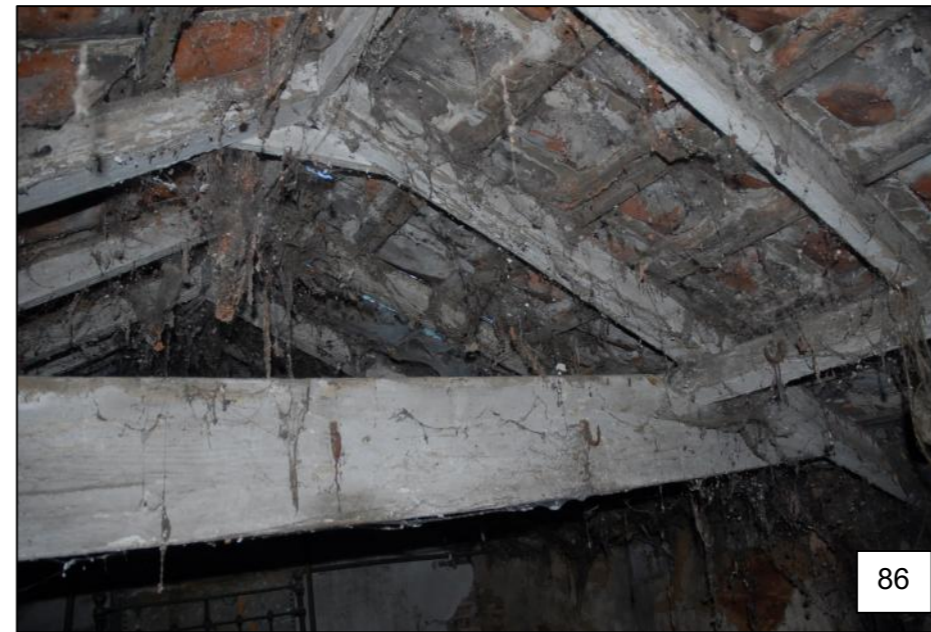
This Room is located at first floor level, above Room 6. It has a floor of 10¼" tongue and grooved floorboards running east-west. It is lit by a small Yorkshire sash in the north wall (each element of six small panes). The floor level in Room 17 is higher than that of Room 18; in both rooms, the timbers of the collar-rafter roof are exposed, with only the remains of a plaster/lath ceiling surviving between the rafters.

The collar-principal rafter roof has clasped through-purlins, ridge collars and a ridgeboard.

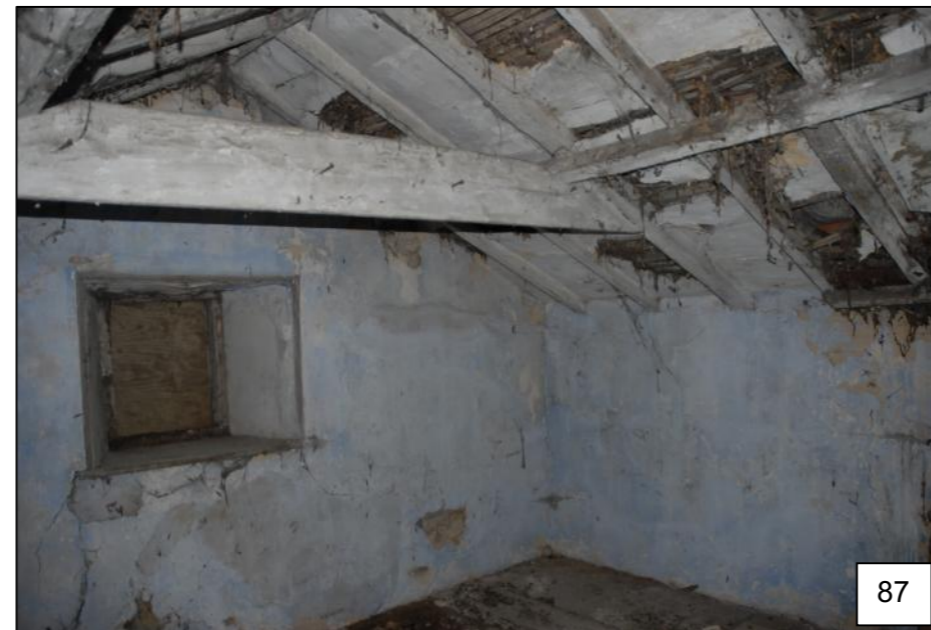
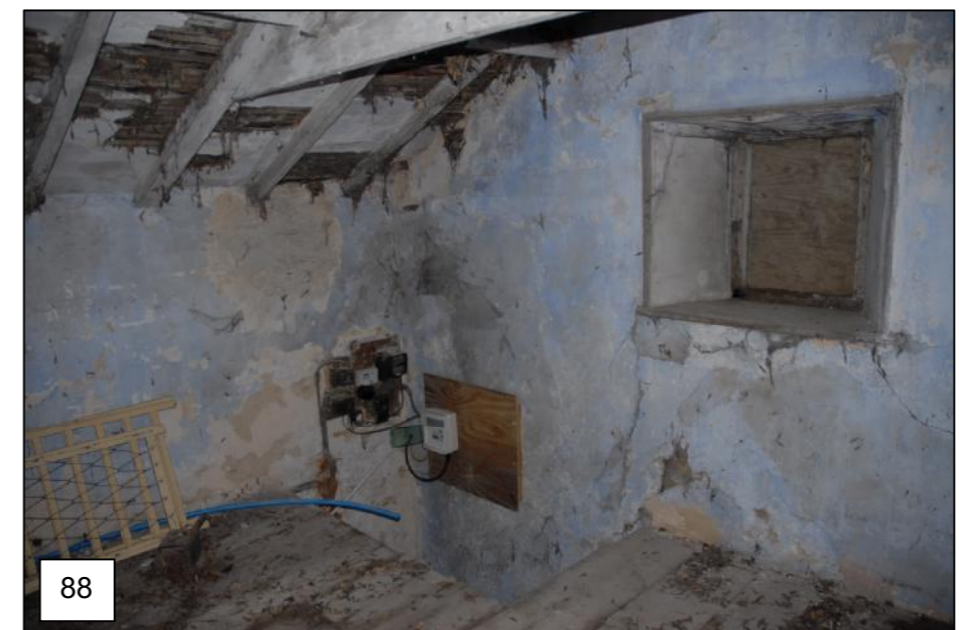
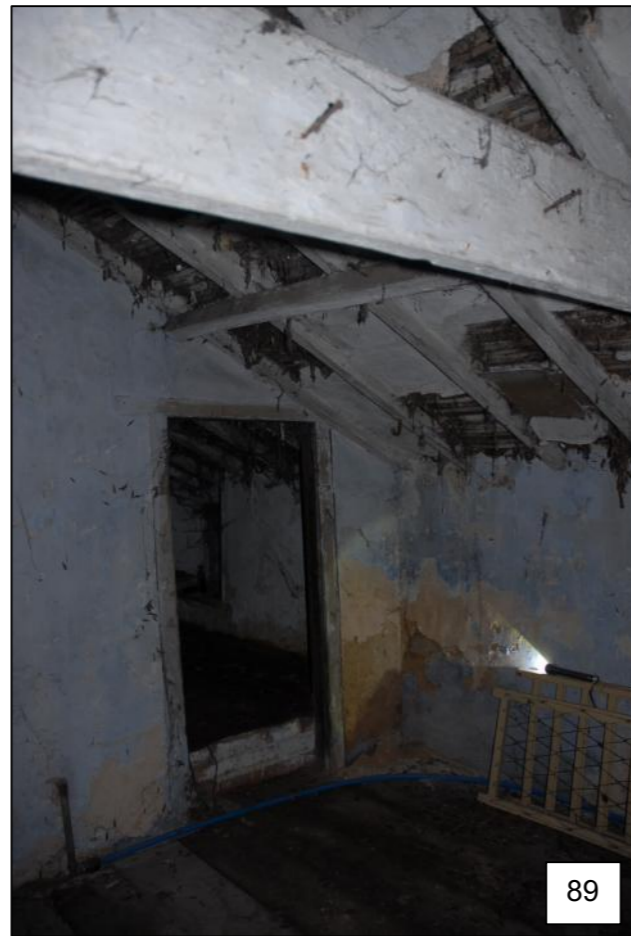
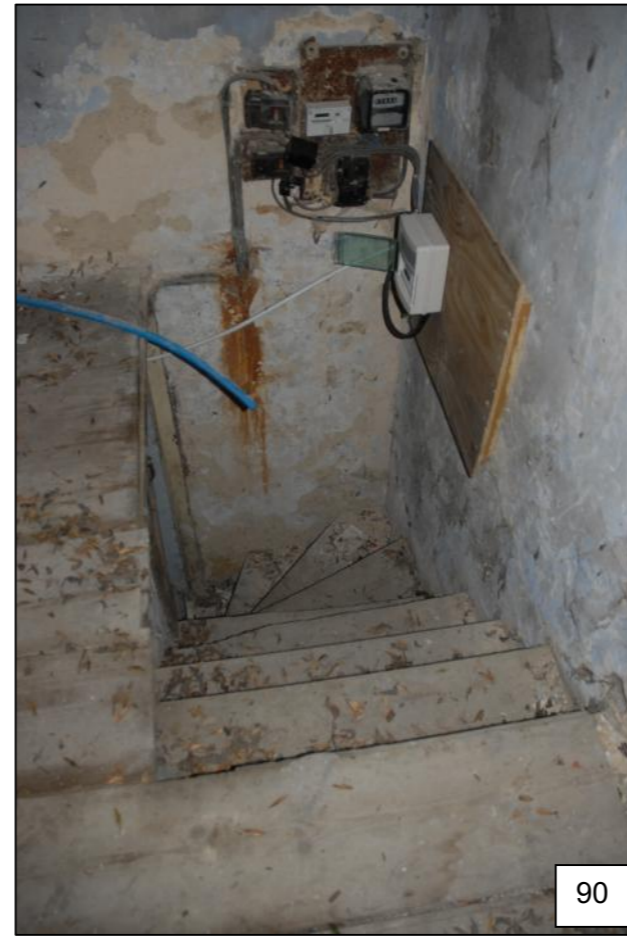
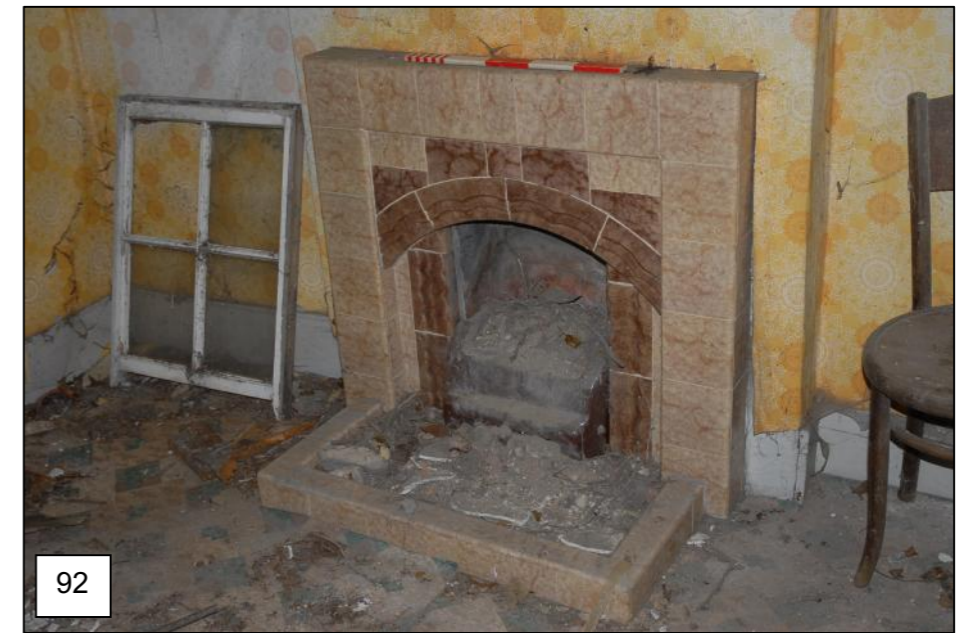
Room 18

This room is located above Room 7 at the east end of the first floor of the service wing. Its ceiling is composed of the exposed timbers of the collar-rafter roof, with only the remains of a plaster/lath ceiling surviving between the rafters. It is lit by a small boarded window in the east wall and has a floor of 10¼" tongue-and-grooved floorboards running east-west.

The winding timber staircase rises from Room 7 rises in the northeast corner (rear stairs: go 9¼", rise 9¼"; and wind to east and south), but has no safety rail. The room is whitewashed throughout.

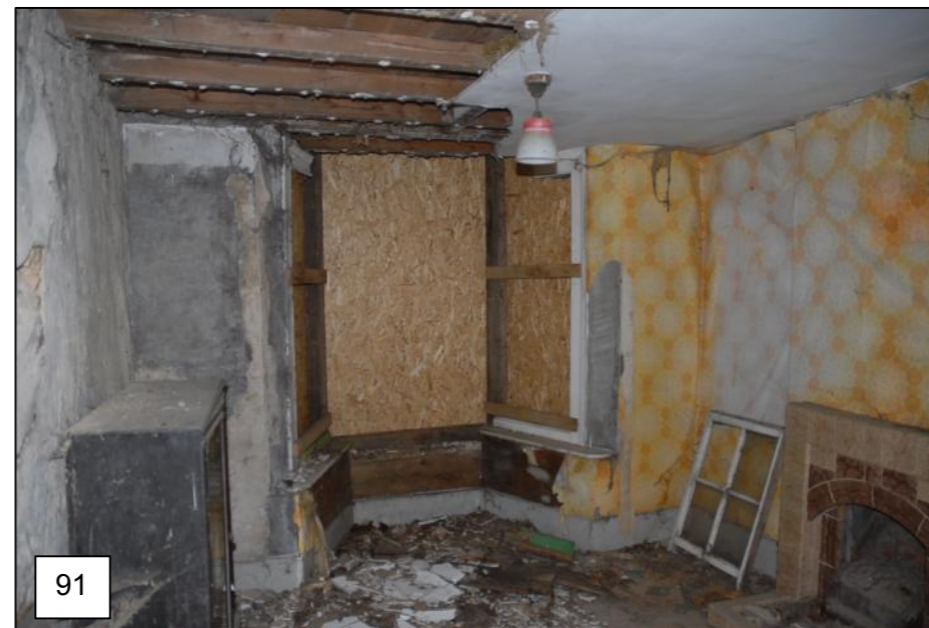
**Two-storey Northern Bay
Room 5**

This is the ground floor room of the two-storey northern extension. It has plaster lath ceilings and a similar floor to the Georgian wing but with 7½" skirting; it is lit by a bay window at the north side with a 2" sunk-bead architrave, and the plain four-panel door has a 1½" ogee and fillet architrave. The bay window itself has collapsed and is now boarded. The fireplace at the north side of the room has been renewed with a 1930s style tile surround.

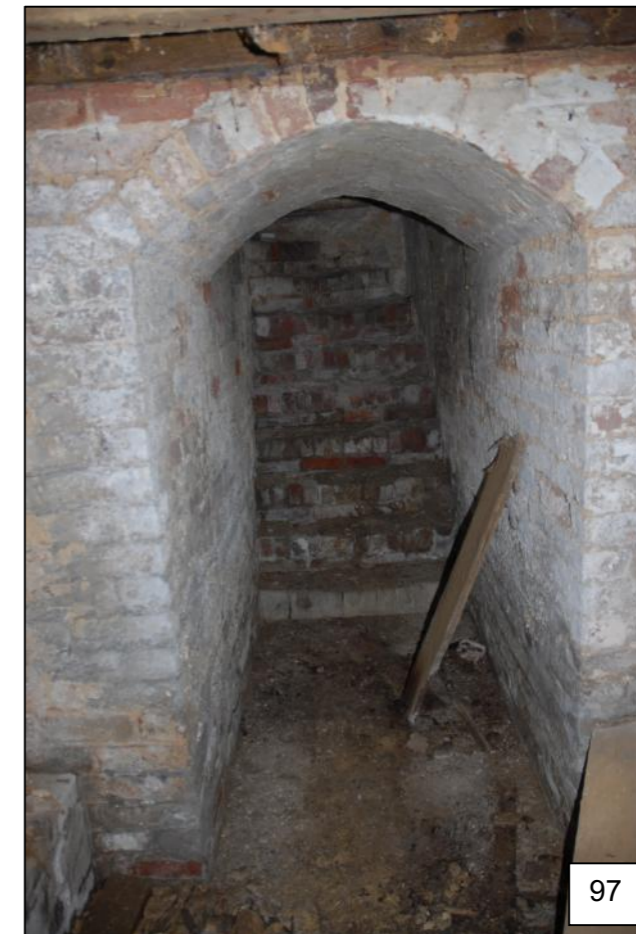
Cellars below Room 5

A cellar is present below the northern extension, built of similar brick to the north wall of the building. It has a brick bench around three sides, but the exterior access at the west side has been blocked in brick. It has a ceiling composed of the exposed east-west joists of the floor of Room 5 above, and is accessed down brick steps situated below the main staircase.

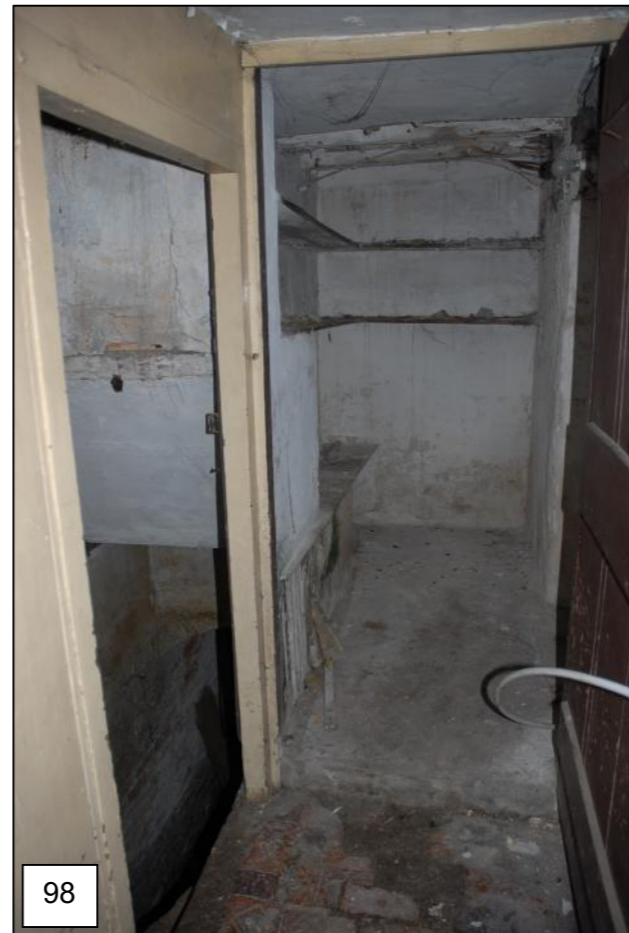
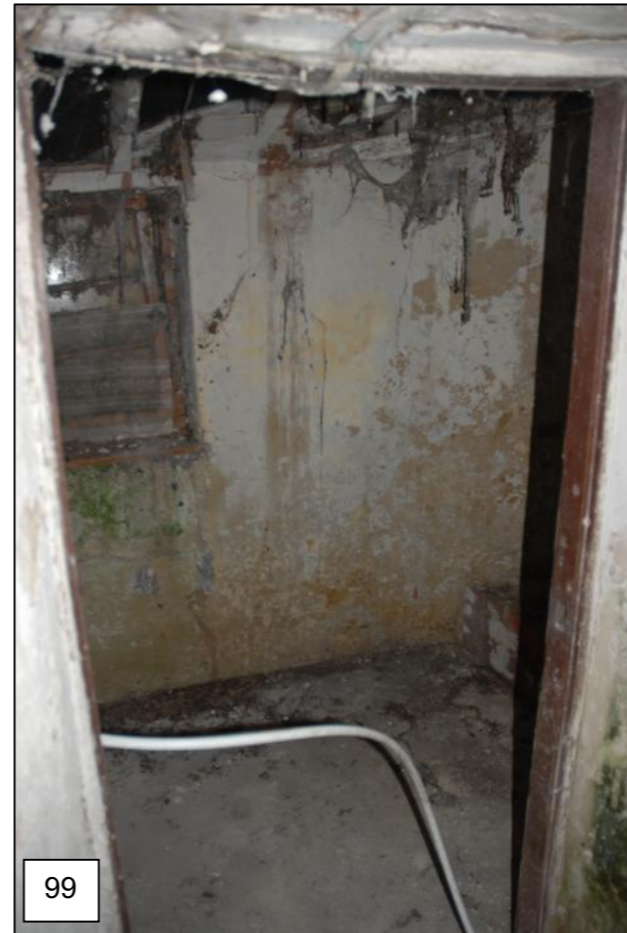
Room 9 has a concrete floor, whitewashed walls and is lit by a Yorkshire sliding sash window in the south wall (also with the glazing altered in the same way as the west windows). A brick built platform is present at the south side of the room, three courses in height.
