CLIFF HOUSE, CLIFF LANE, WADDINGHAM, LINCOLNSHIRE

HISTORIC BUILDING SURVEY

Report prepared for Mr. H. Blandford

November 2017

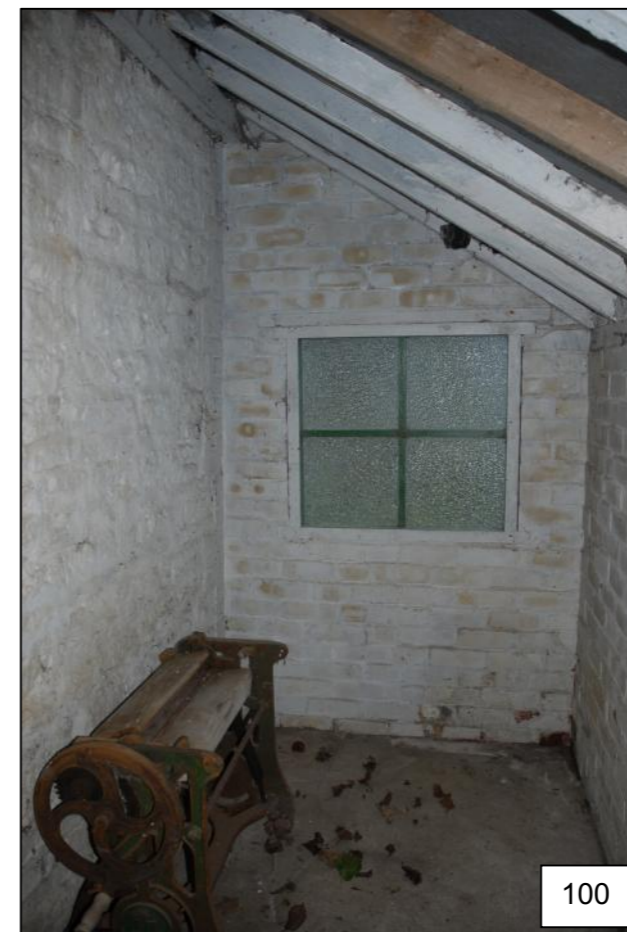
Room 10

This room has whitewashed 4" brick walls, a poured concrete floor and a simple four-pane window in its north wall. Its ceiling is the exposed timber joists of a felted monopitch roof.

It is accessed from a plank door in the north wall.

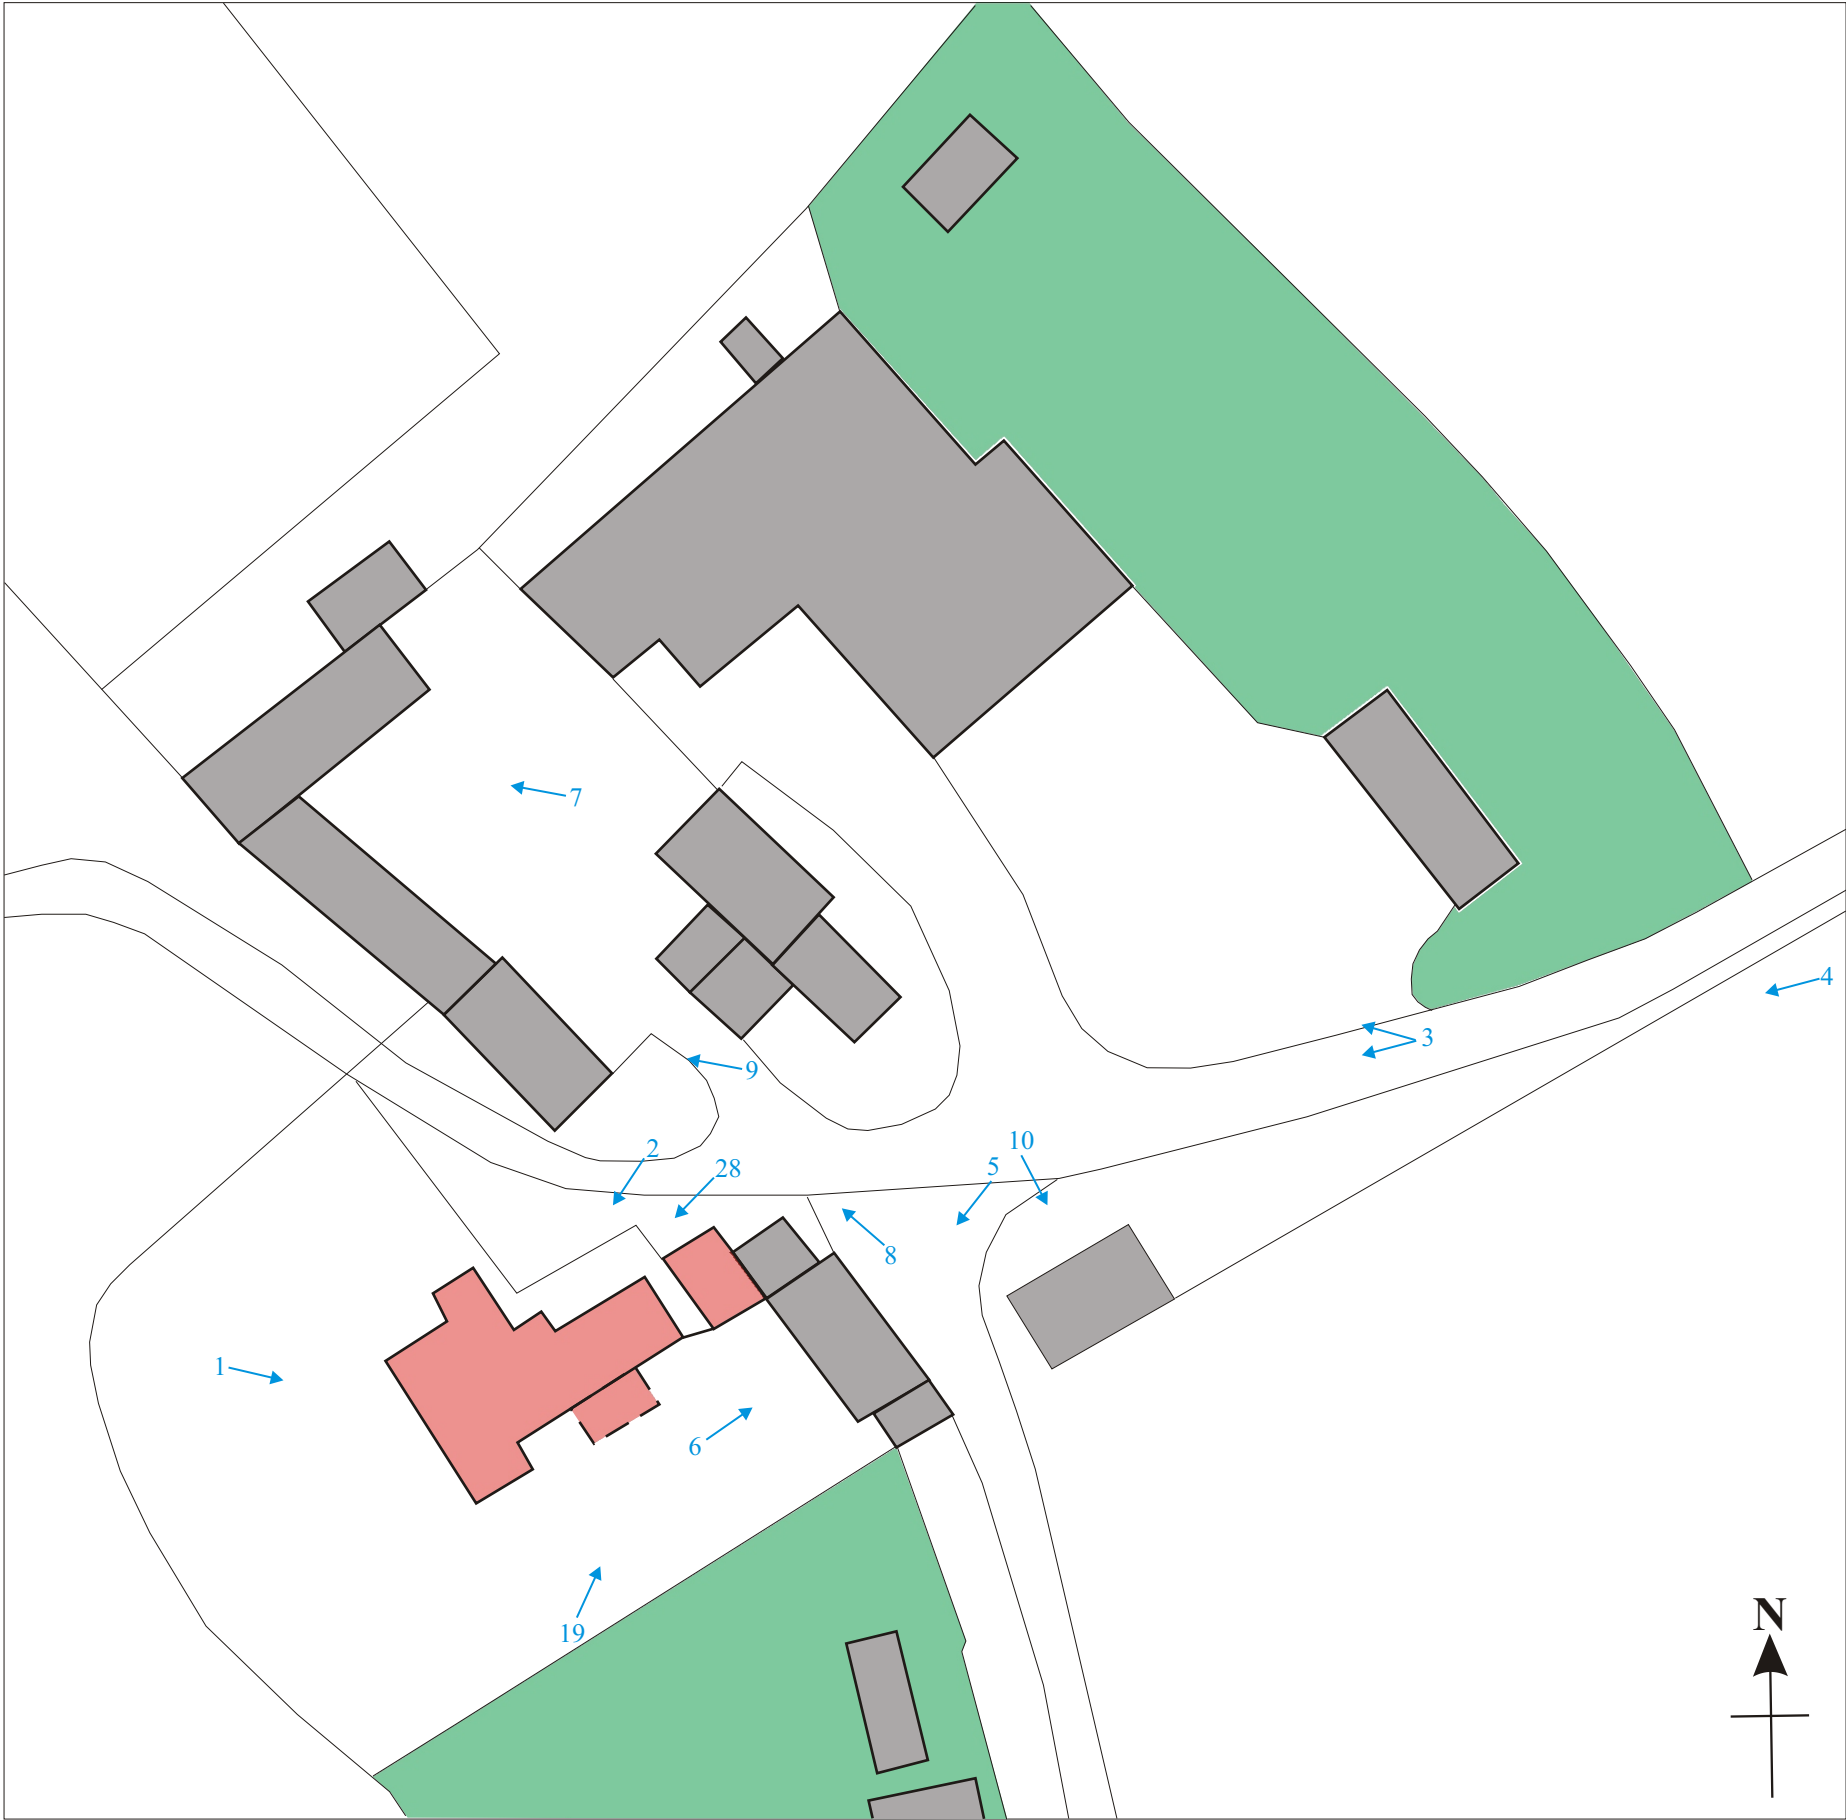
Plan showing the layout of the site at scale 1:500. The position and direction of general and settings photographs is shown in blue. (Plan supplied by client)

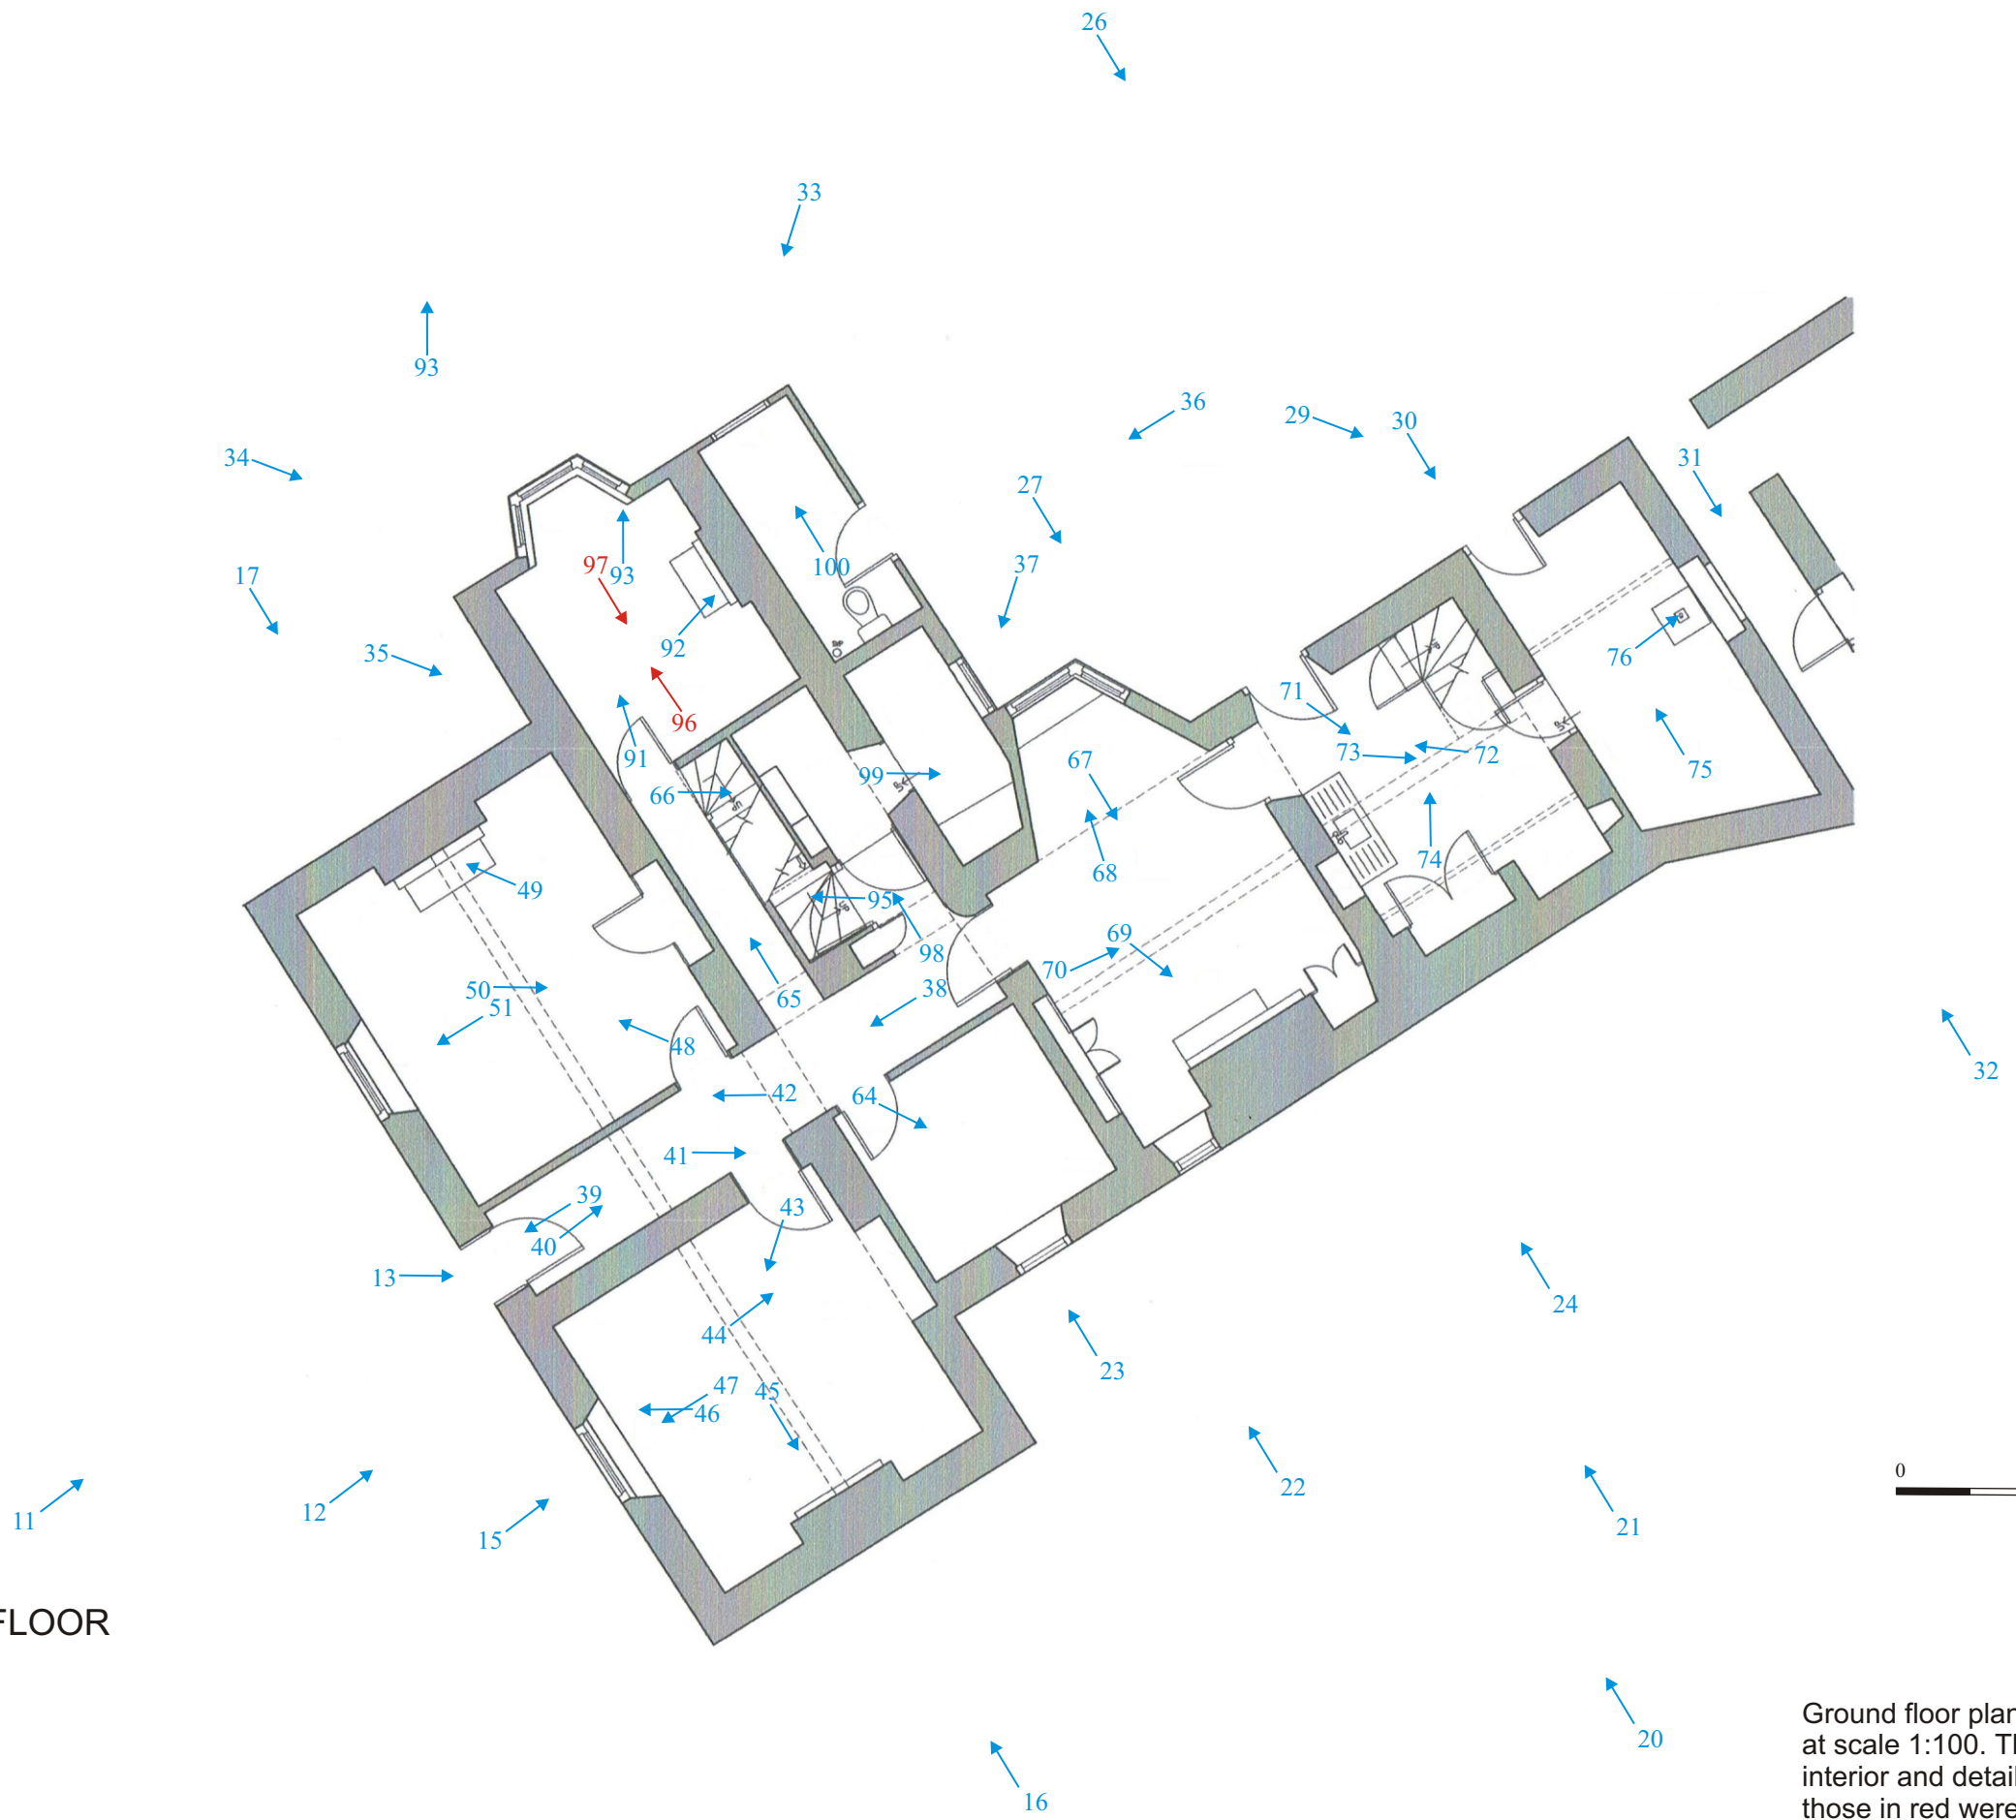
GROUND FLOOR

Ground floor plan of Cliff House, Waddingham at scale 1:100. The position and direction of interior and detail photographs is shown in blue; those in red were taken at cellar level. (Plan supplied by client)

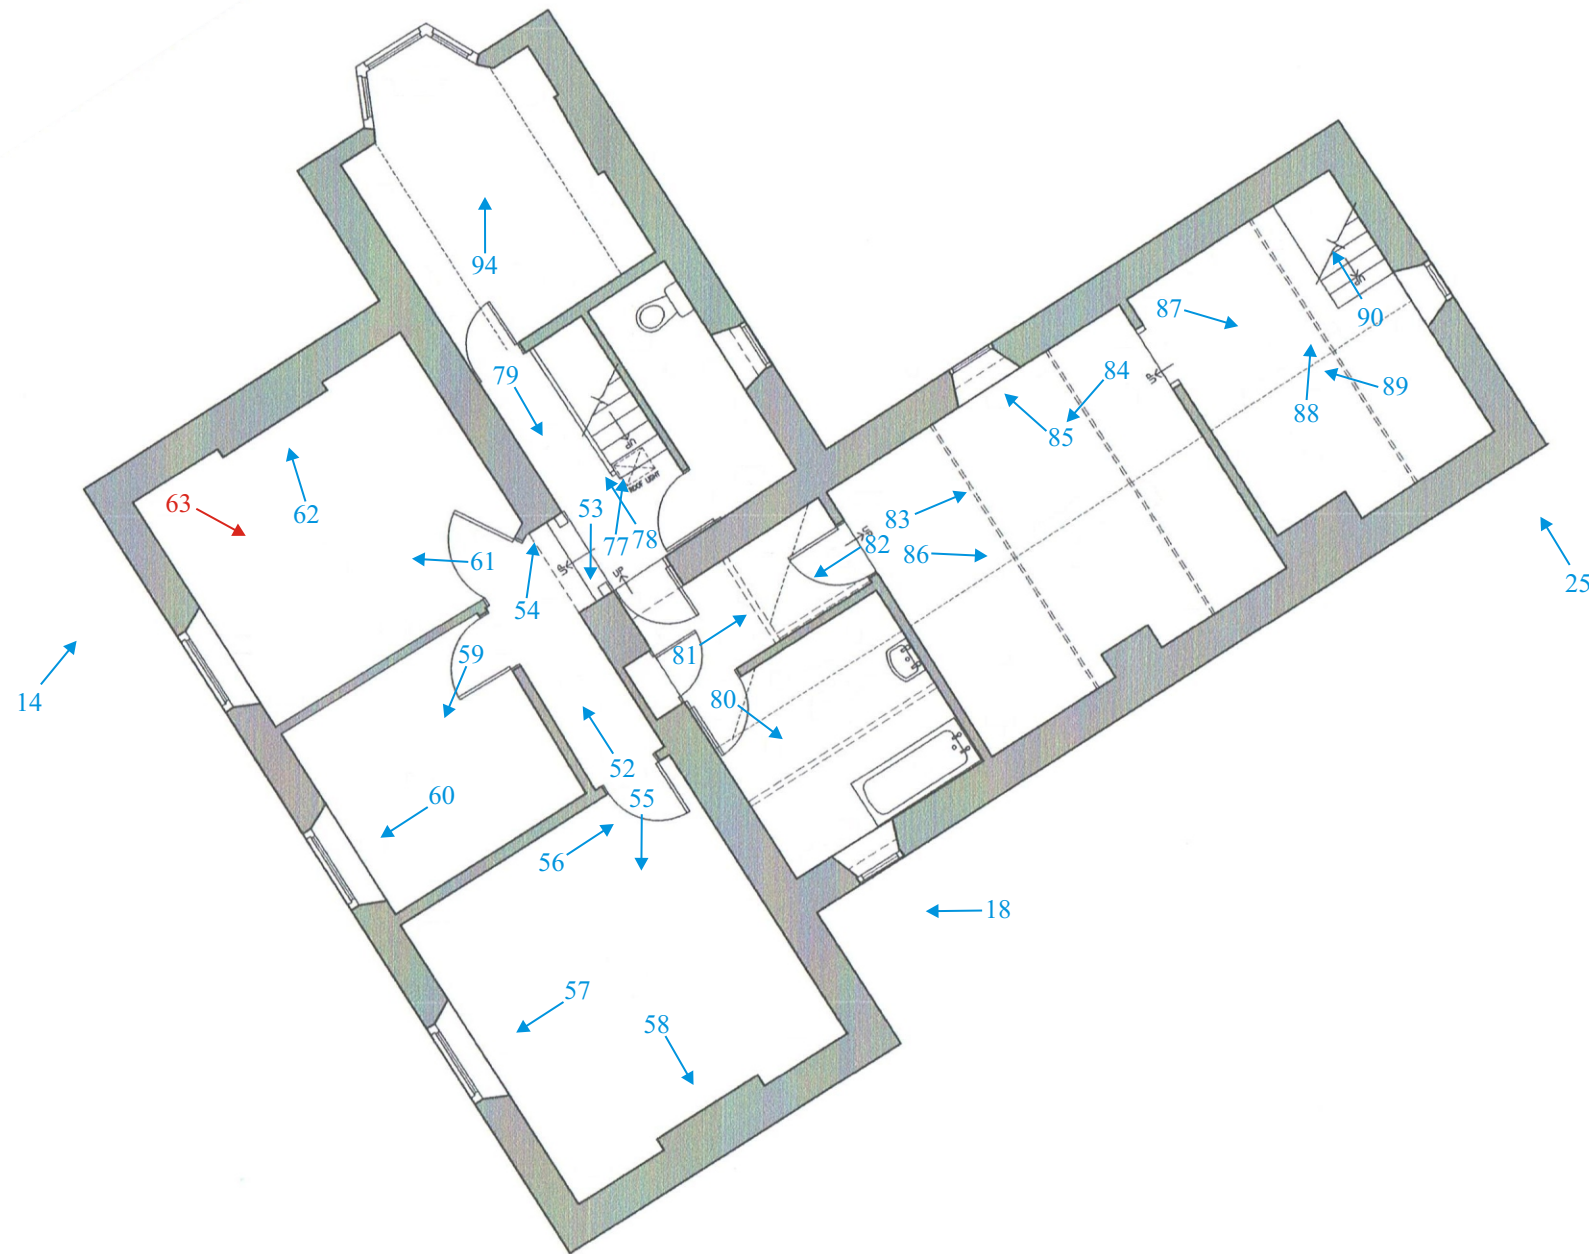
FIRST FLOOR

First floor plan of Cliff House, Waddingham at scale 1:100. The position and direction of interior and detail photographs is shown in blue; the one in red was taken at roof level. (Plan supplied by client)

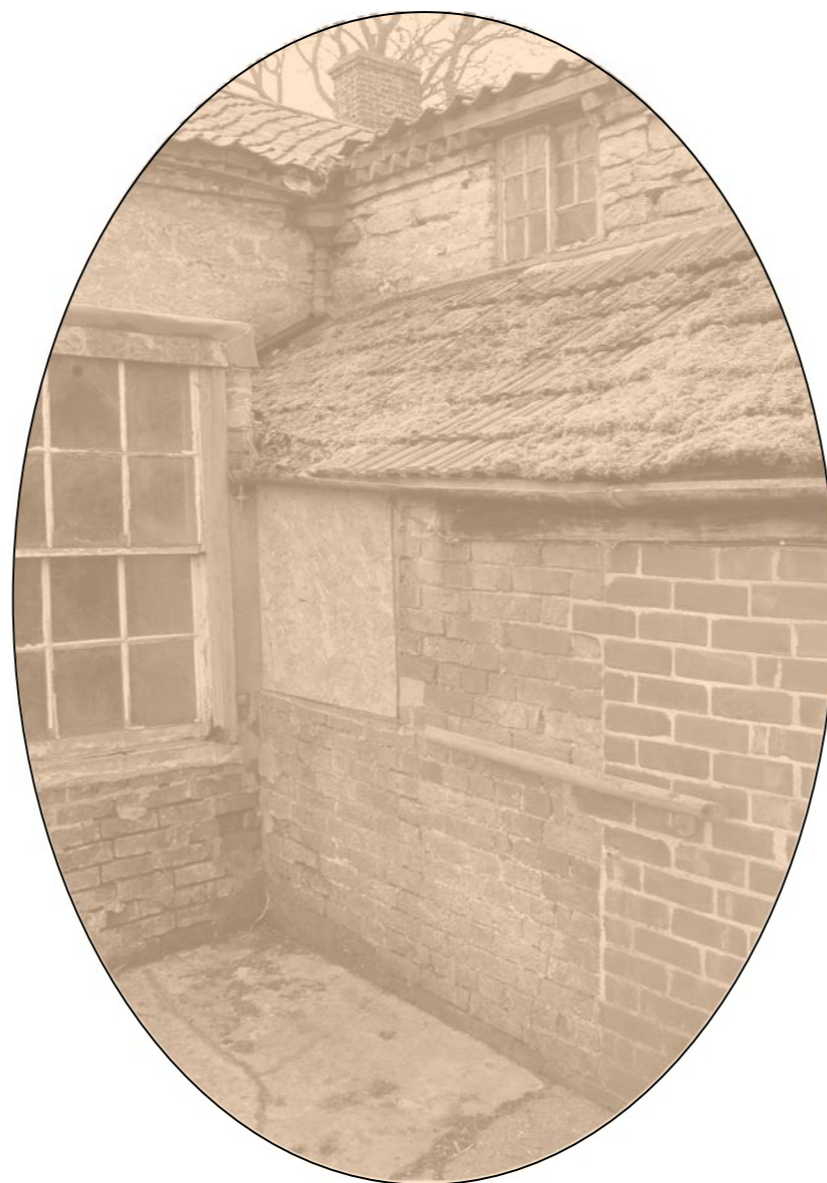
Front Cover Photograph: General view of the site from the north-west.
