**LAND AT NOS. 37 AND 39, SNELLS NOOK LANE, NANPANTAN,
LOUGHBOROUGH, LEICESTERSHIRE**

**SCHEME OF ARCHAEOLOGICAL MONITORING
AND RECORDING**

NGR:	SK 50421 17455
Planning ref.:	P/16/0033/2
PCAS Job No.:	1976
Site code:	SNLM 17
Archive acc. no.:	X.A118.2017

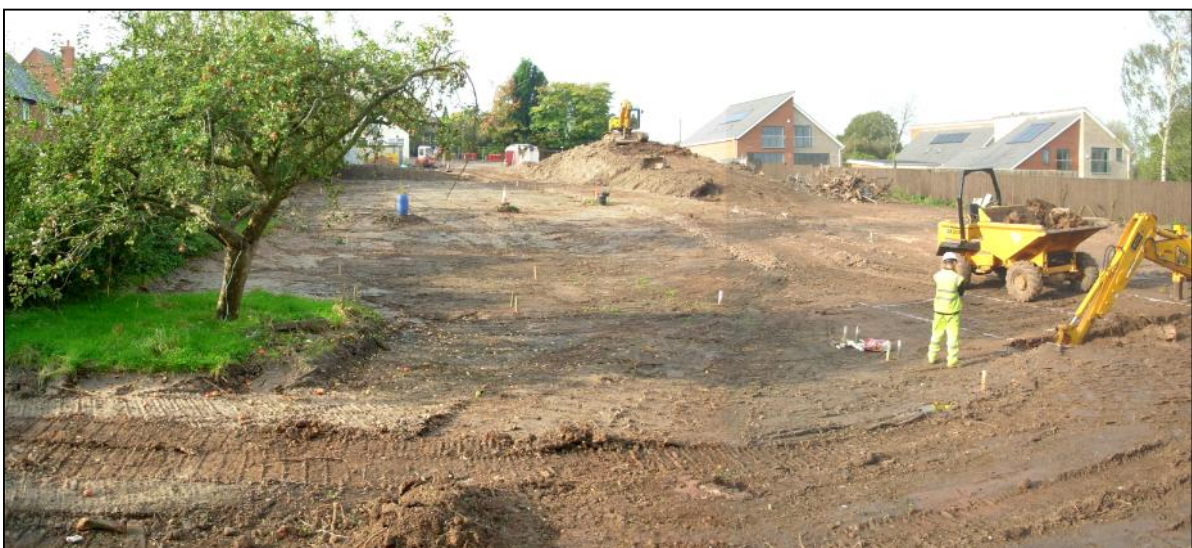
Plate 1: Composite view of the site looking W and NW from its SE corner at the start of monitoring. The house at the N side of the street frontage has been demolished, leaving only a fragment of standing wall.

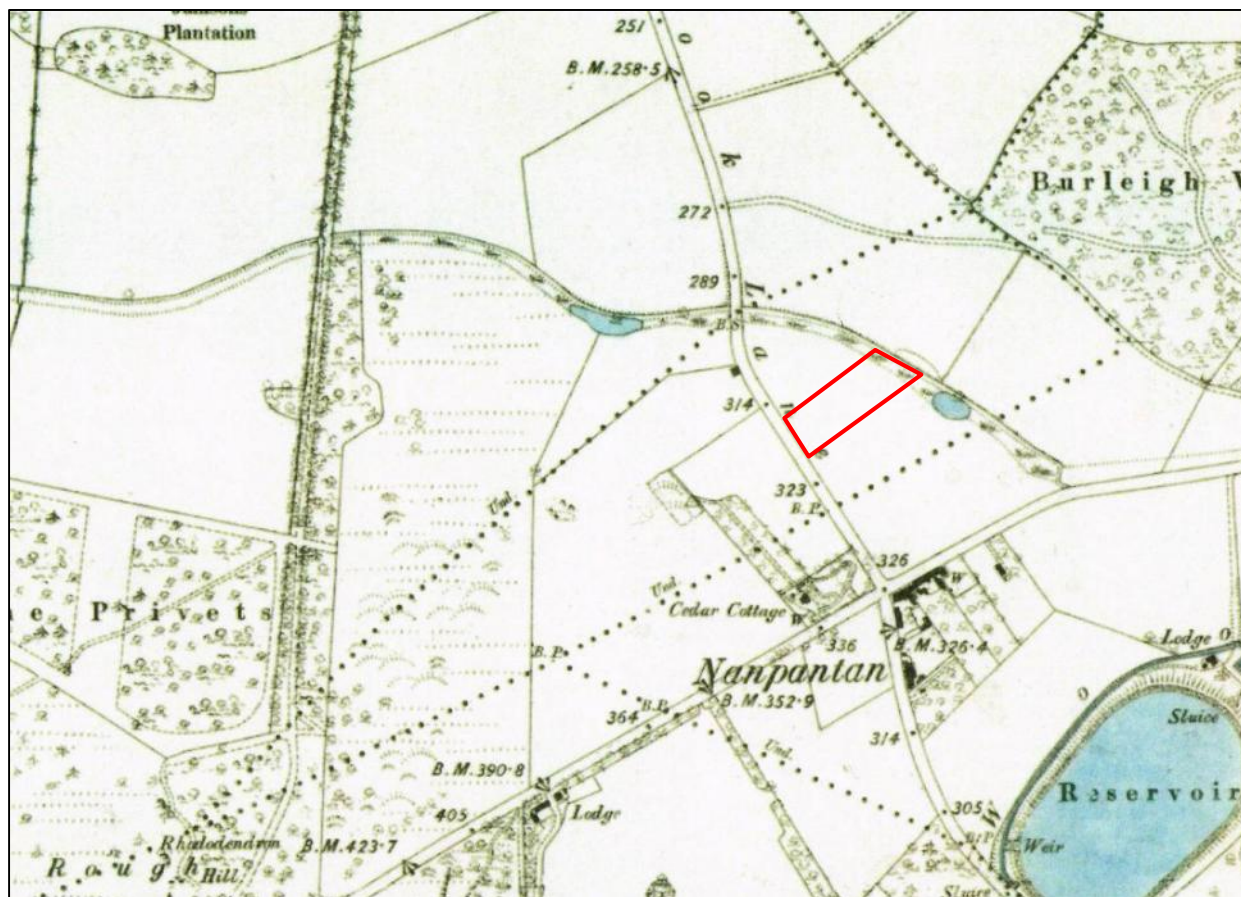
Figure 3: Extract from the 1st edition 6" to the mile Ordnance Survey map of 1884 (not reproduced to scale). The route of the Charnwood Forest Canal is marked, running west to east in a sinuous line, but it no longer holds water: the canal head can be seen adjacent to the eastward road out of Nanpantan. The approximate position of the development site, then part of a field, is marked in red.

The Charnwood Forest Canal was opened in 1791 as part of an integrated transport system for moving goods and materials such as coal and quarried stone. The eastern end of the canal was at Nanpantan, and was connected by a tramway to another stretch of waterway at Loughborough Wharf. The triple-handling of loads required by this system made it uneconomic, and the canal remained in use for only a few years: the Leicester Canal Company took up the rails and sleepers of the tramway in 1820, and let the land along the canal from 1826. The land across which the canal, now a dry earthwork, had run was sold to the adjacent owners in 1848 (*ibid.*). The 1st edition 6" to the mile Ordnance Survey map of 1884 shows the route of the former canal as a narrow, sinuous strip of marshy land, with only occasional pools of water: at the time, the site lay within a triangular field defined by Snells Nook Lane, the eastward road to Forest Gate and the course of the canal (fig. 3).

The course of the Charnwood Forest Canal was confidently identified, running across the east end of the development site. The canal is shown on historic mapping to have lain open as a dry earthwork feature for many years after it went out of use (Whiteley, 2016; fig. 3), and natural weathering processes, as well as the possible removal of revetting structures, have reduced it to a broad, shallow, irregular linear depression under a deep layer of naturally accumulated topsoil. The upper fill, mixed deposit 002, was probably deliberately infilled as ground levelling when nos. 37 and 39 were built in the mid-20th century and the canal bed was incorporated into their rear gardens.

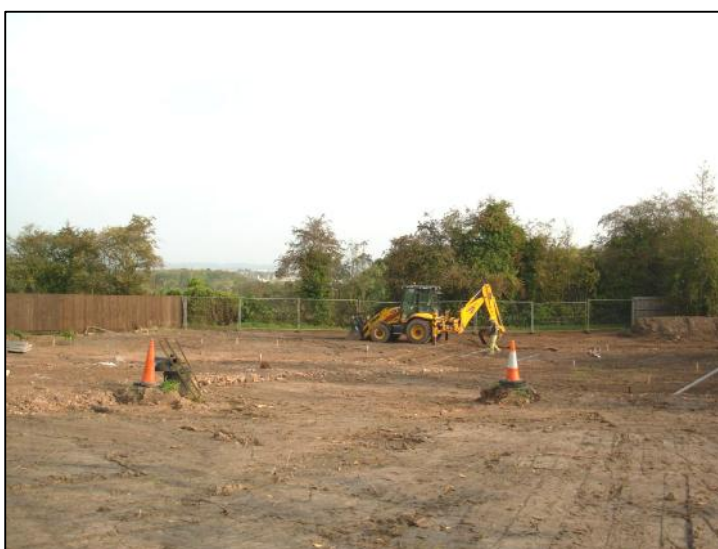
Plate 2: General shot of the area of monitoring during machining, looking ENE, showing the topography of the lower end of the site.

Nanpantan village is situated on a north-east facing hillside above the town of Loughborough, which lies in the valley of the River Soar. The site generally slopes down from 105m above Ordnance Datum sea level at its western boundary to 95m OD at the east side (Flitcroft, 2017), but levels out at the eastern edge, with the area of the former canal being completely flat (plates 1 and 2).

The programme of archaeological monitoring was targeted on the archaeologically significant area: the east end of the site, where the course of the canal was expected to run. This area, hatched red on Figure 4, contained two house plots, one with an integral garage and one with a detached garage. Site logistics required groundworks to begin with the excavation of foundation trenches for the detached garage (the building lying furthest within the projected canal route). The trenches, which were 0.70m wide and up to 1.70m deep, were excavated under archaeological supervision, using a 180° back-acting 3CX mechanical excavator, fitted with a toothless bucket (plate 2).

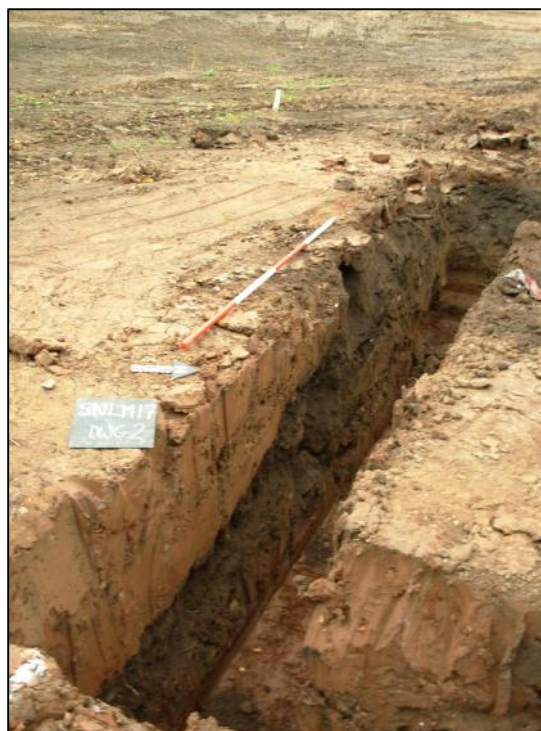
The canal cut was clearly visible running across the garage plot (plate 3). Cut **004** was up to 1.40m deep where it was exposed in the foundation trench. Only parts of the west bank and the base were exposed within the 6m wide section: the edge of the cut was difficult to ascertain on the ground, as the dark layer 003 was similar in appearance to the remnants of topsoil on the site, but the total width of the cut appeared to be approximately 16m. The exposed portion of the cut was shallow and irregular in profile: the sides had presumably slumped and weathered once the canal was dry, and had been heavily disturbed by tree rooting. It is also possible that the sides of the canal had been revetted, and further disturbed by the removal of revetting structures when it went out of use.

The lowest deposit in canal cut 004 was layer 003, a dark brownish-grey organic fine-sandy silt that appeared to be a buried topsoil. Layer 003 covered the whole of the exposed portion of the canal side and base to a depth of up to 0.70m, and could indistinctly be seen on the ground surface at the edge of the cut, indicating that it covered the entire cut. This deposit seemed likely to be material that had built up on the sides and base of the disused canal bed after it had been left lying empty, eventually forming a natural topsoil. Few inclusions were observed, although a scatter of fragments of unworked stone (sample size 120mm x 120mm x 50mm) near the south-east corner of the foundation trench may bear out the suggestion that the banks were originally reinforced or revetted. Occasional artefacts were retrieved: all were industrial-period or modern, including a small electric light bulb and two machine-moulded screw-top glass jars, one of which was stamped 'Heinz'.

Plate 3: North-facing section of the garage footings, looking south-west, showing the modern infill of the canal and the dark layer of topsoil that had previously accumulated on the sides of the empty canal bed.

The canal had been infilled above topsoil-like layer 003 with mixed material 002, which was generally light pinkish-brown in colour (plate 3). This deposit was up to 1.0m deep within the
