**LAND ADJACENT TO NO. 18, WASHDYKE LANE, OSGOBY,  
WEST LINDSEY, LINCOLNSHIRE.**

**SCHEME OF ARCHAEOLOGICAL MONITORING  
AND RECORDING**

NGR: TF 07291 92785  
WLDC Planning ref.: 134383  
PCAS Job No.: 1935  
Site code: OWLM 17  
Archive acc. code: 2017.155

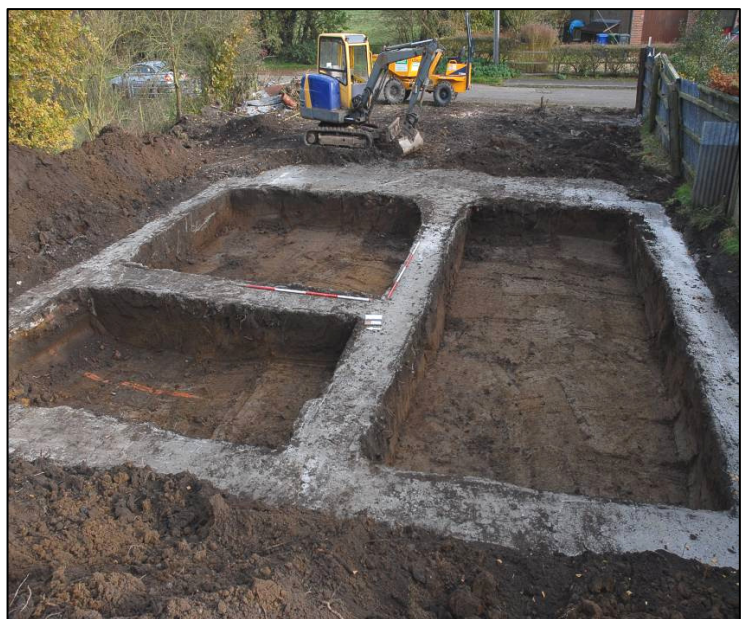
**Plate 2:** The completed building plot footings after the removal of material from between them, looking east north east.

A mini dumper and excavator were employed, initially, to clear contaminated area to the front of the plot to a depth of 600-800mm and move this to where the plot was thin. The site was also cleared of a former shed/workshop to the east of the site and a former piggery to the north west. The footings to the building were excavated to a depth of 600mm throughout, and a soakaway trench measuring approximately 18m x 2m, occupying almost the whole width of the site, was excavated along its western edge. After the footings had been concreted, the ground within the footings was lowered to 600mm depth (plate 2). Further contaminated soil was removed from the area of the east boundary up to 600mm deep and was placed between the building footings (figs. 3 and 4).

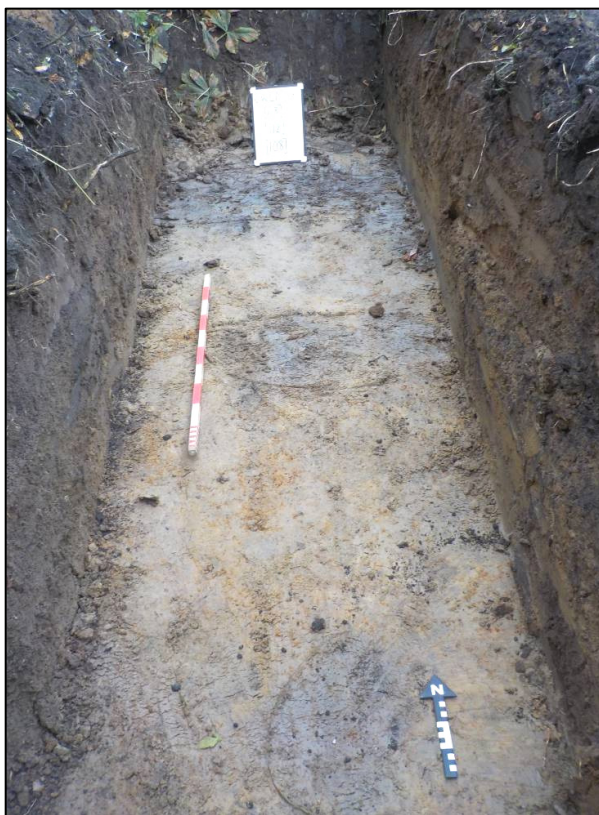
**Plate 3:** Features [108], [112] and [113] looking north.

A total of four possible features were noted during the monitoring. Three of these were observed close together in the north end of the soakaway, cut into natural sand (110) (plate 3). Feature [112], aligned roughly east west, may have been a possible gully terminal. To the north of this feature [113] also aligned east west was thought to be a further gully. To the south of both of these features a possible post hole [108] was located. All three features were filled by mid blue grey sandy silty sand and were sealed by the possible alluvial deposit 102, which covered the whole of the works area to a depth of some 0.40m. Due to the constraints of the groundworks, none of these features could be closely investigated; their diffuse edges and the appearance of their fills suggest that they may in fact have been natural channels and hollows in the surface of the sand. The fourth feature [107] (Plate 4), was located in the north west corner of the building footing, an area in which the natural was not reached. Only a small portion of this feature was exposed in the footings trench: it

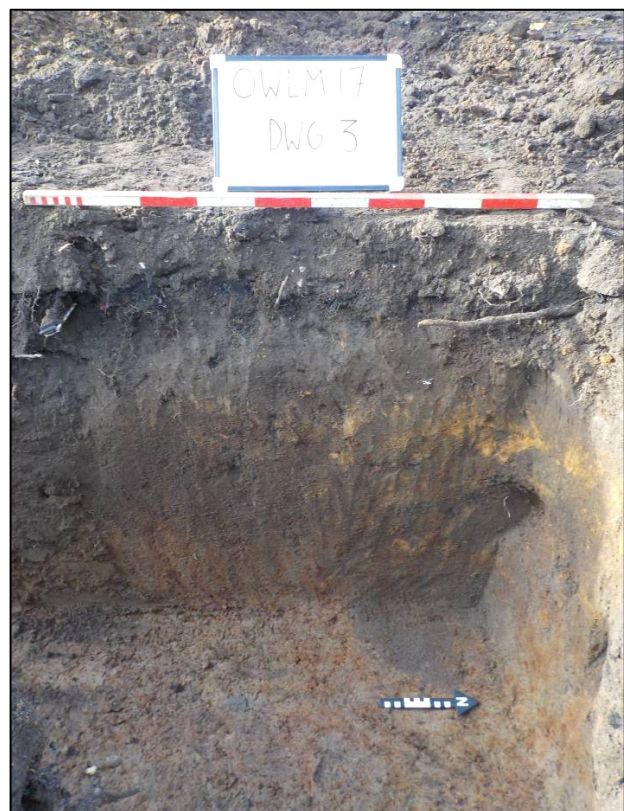
**Plate 4:** Representative section and Feature [107] looking west.

appeared to be small, sub-circular and steep-sided, and was cut into the surface of the possible alluvial layer (102) (fig. 5b). It was thought to be a possible post hole filled by (106) a mid grey-brown friable loamy sandy silt. Post hole [107] was overlain by (105), a possible buried soil and in turn by (104) a mid grey brown silty sand with patches of redeposited clay sand, which may have been a recent levelling deposit. These layers were only seen in this part of the site: elsewhere in the groundworks, layer (102) was overlain by a thin layer, no more than 0.10m deep, of light brown sandy silt subsoil (101). The most recent layers were (100), up to 0.30m depth of modern topsoil (present only in the western half of the site), and the recent demolition layer (103), which overlay all stratigraphy.

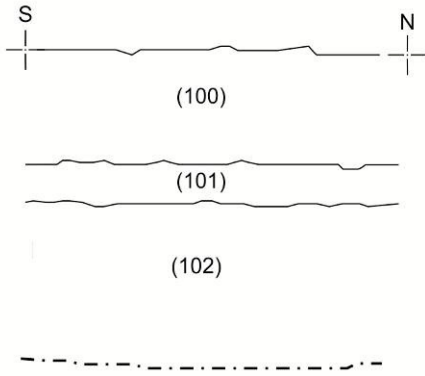
**Figure 5a:** Representative section of plot  
 Scale 1:20

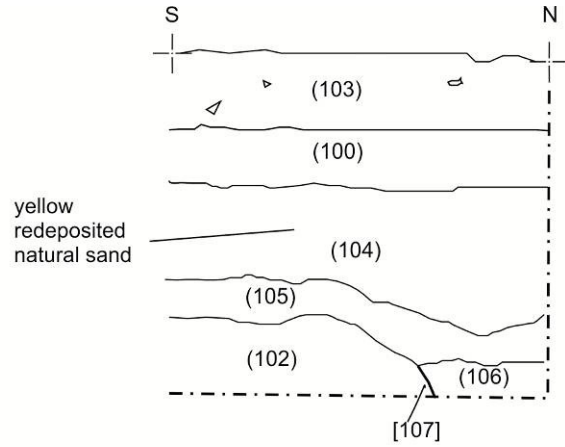
**Figure 5b:** Representative section showing possible post hole [107]  
 Scale 1:20.

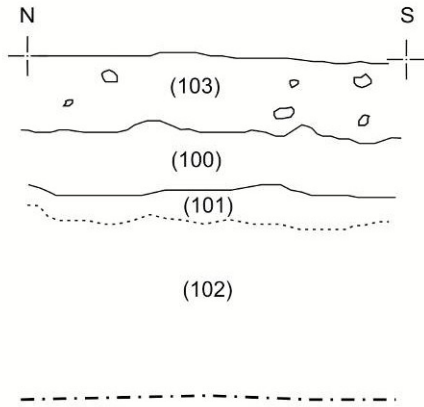
**Figure 5c:** Representative section of soak away  
 Scale 1:20

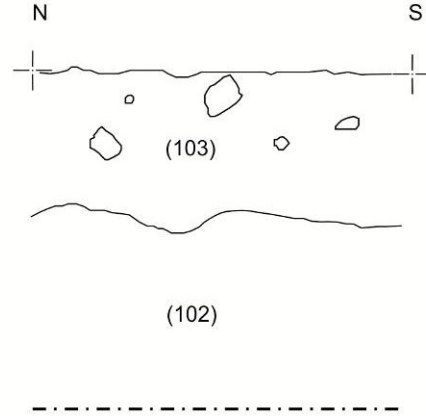
**Figure 5d:** Representative section at east end of plot  
 Scale 1:20

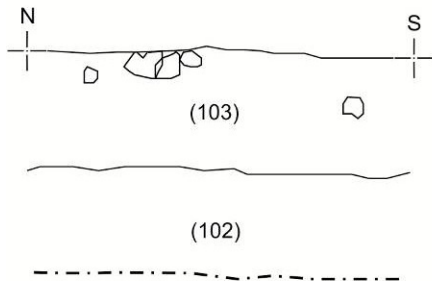
**Figure 5e:** Representative section east side of contaminated strip  
 Scale 1:20
