**Land adjoining Firsdale, Tattershall Road, Kirkby on Bain,
Lincolnshire, LN10 6YN**

Archaeological Monitoring and Recording Report

Planning Application No.: S/094/02024/13
NGR: TF 24086 62160
PCAS Site code: KBFM 14
PCAS Job No.: 1251
Archive Accession code: LCNCC 2014.130
OASIS ref.: preconst3-322308

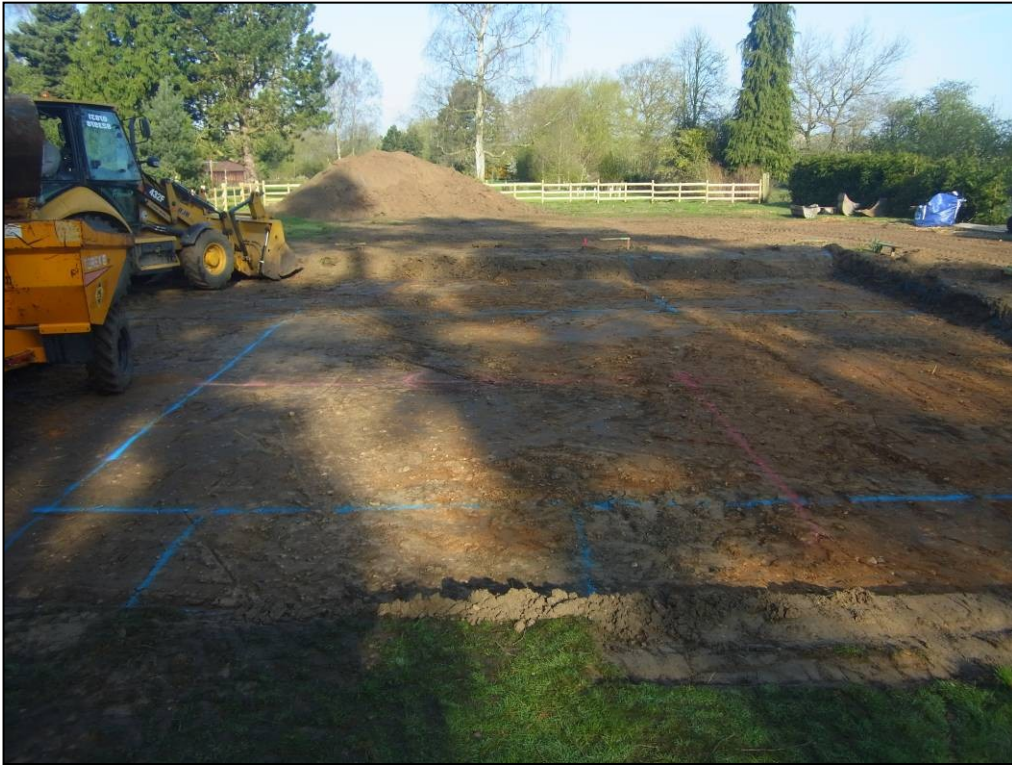
Above: Site on arrival

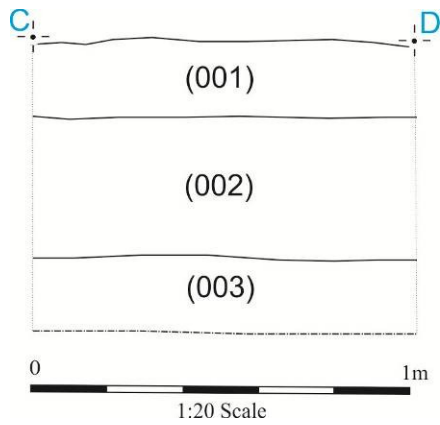
Figure 3 C-D

Foundation trenches were excavated to a depth that varied between 0.75m (south side of site) to 0.95m (north side of site), revealing a consistent stratigraphy of topsoil (001) covering subsoil (002) and natural geology (003) (Fig 3C-D). The natural geology was described as fine orange sand, probably river deposits from the nearby River Bain.

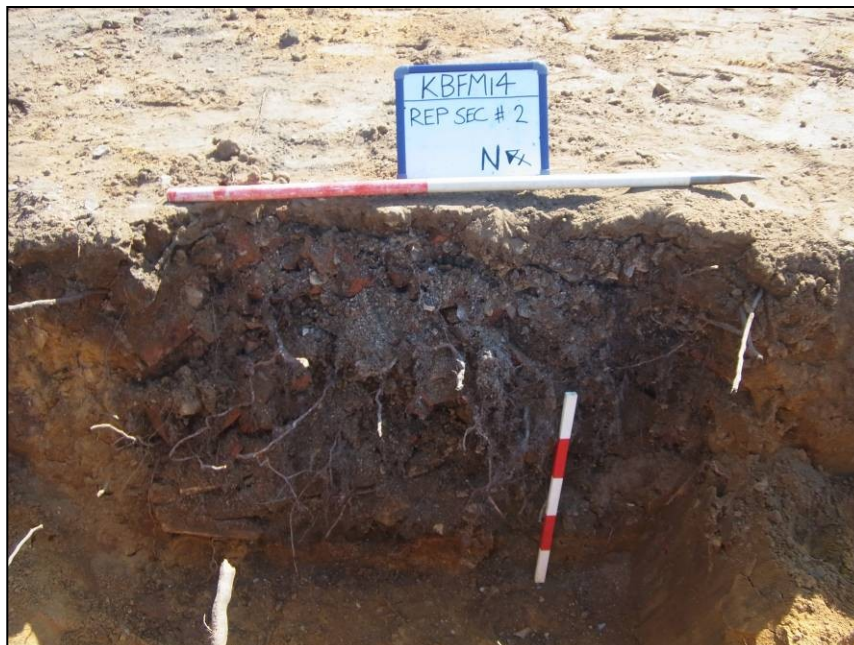
Figure 3 E-F

The only exception to this sequence was a pit towards the northern end of the footings [004], a steep sided pit c. 1.50m in diameter that was cut through the subsoil. It contained a single fill (005) which was heavily rooted, and in which modern rubble, plaster and brick were noted (but not retained) (Fig 3E-F).
