**LAND ADJACENT MAPLE LEA, GAINSBOROUGH ROAD, KIRTON IN LINDSEY, NORTH
LINCOLNSHIRE**

ARCHAEOLOGICAL EVALUATION REPORT

NGR: SK 93369 97951
PCAS job no. 2160
Site code: GRKE 19
Planning Authority: North Lincolnshire Council
North Lincolnshire Museum code.: KLBV

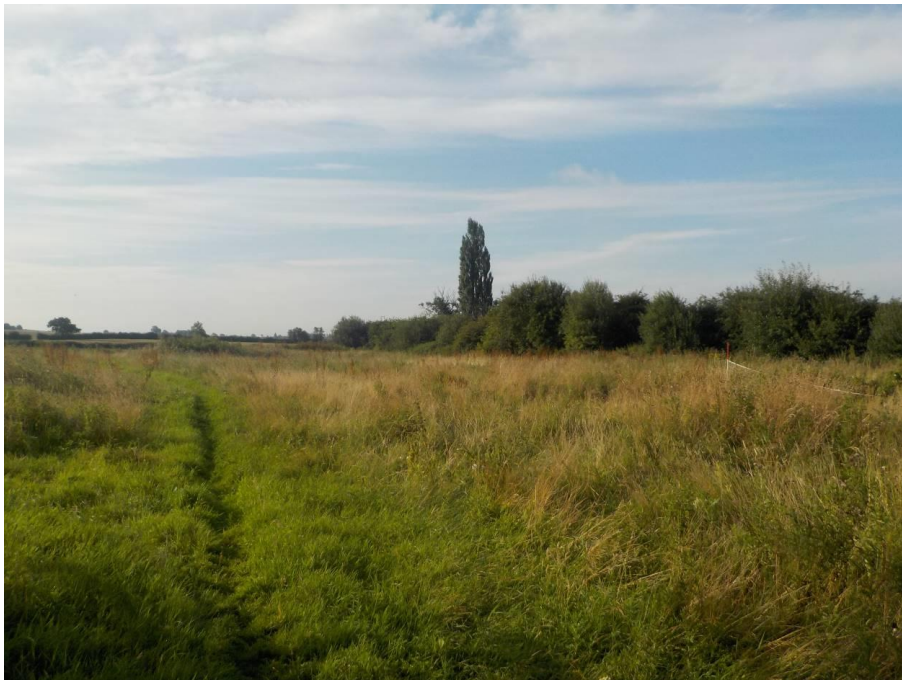
Plate 1: Site prior to excavation of trenches (looking S)

The site is located on the south side of Gainsborough Road, to the west of the junction with Grayingham Road, at a central National Grid Reference of SK 93372 97955; it lies outside the southwestern border of the Kirton in Lindsey Conservation Area. It consists of a sub-rectangular plot of grassland to the rear of properties fronting onto Grayingham Road; the rear boundaries of these properties form its eastern border, while open paddocks lie to the south. It is located at the edge of the settlement and contains evidence of medieval agriculture in the form of ridge-and-furrow earthworks.

The site contains ridge and furrow earthworks of former medieval cultivation strips. The earthworks are visible from aerial imagery but the HER has no further information about their state of preservation.

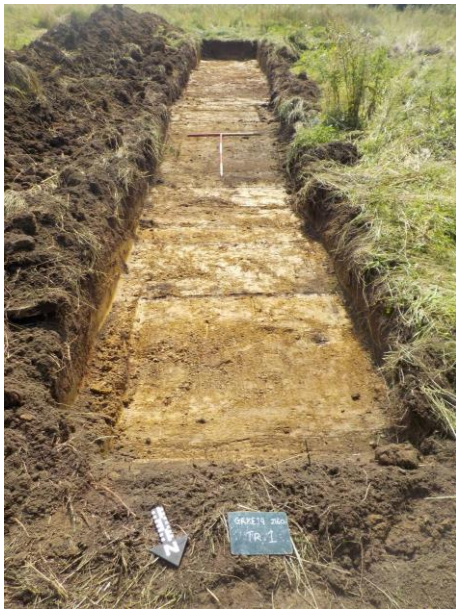
Plate 2: Trench 1 (looking SSW).

The only other features seen during the evaluation were a row of three modern post holes seen at the northern end of Trench 1.

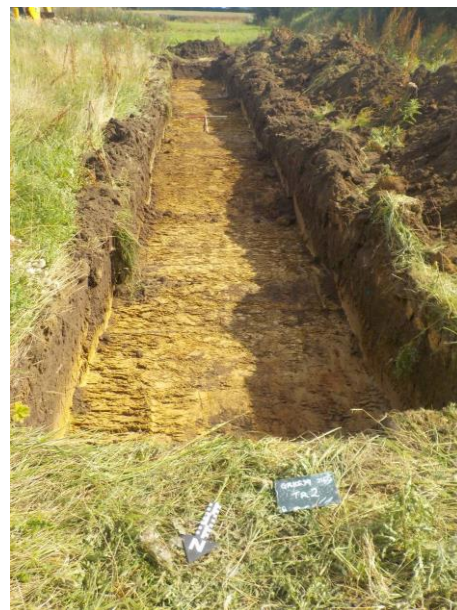
Plate 3: Trench 2 (looking SSE).

All trenches exhibited the same stratigraphic sequence of natural clay overlain by subsoil and ultimately topsoil, the depths of these deposits being consistent throughout at 0.35m and 0.3m for subsoil and topsoil respectively. All the furrows were sealed by the subsoil deposit. The only variation in this deposition was that a layer of re-deposited natural and topsoil were seen in the sequence in Trench 2. These layers were seen above the topsoil (201).

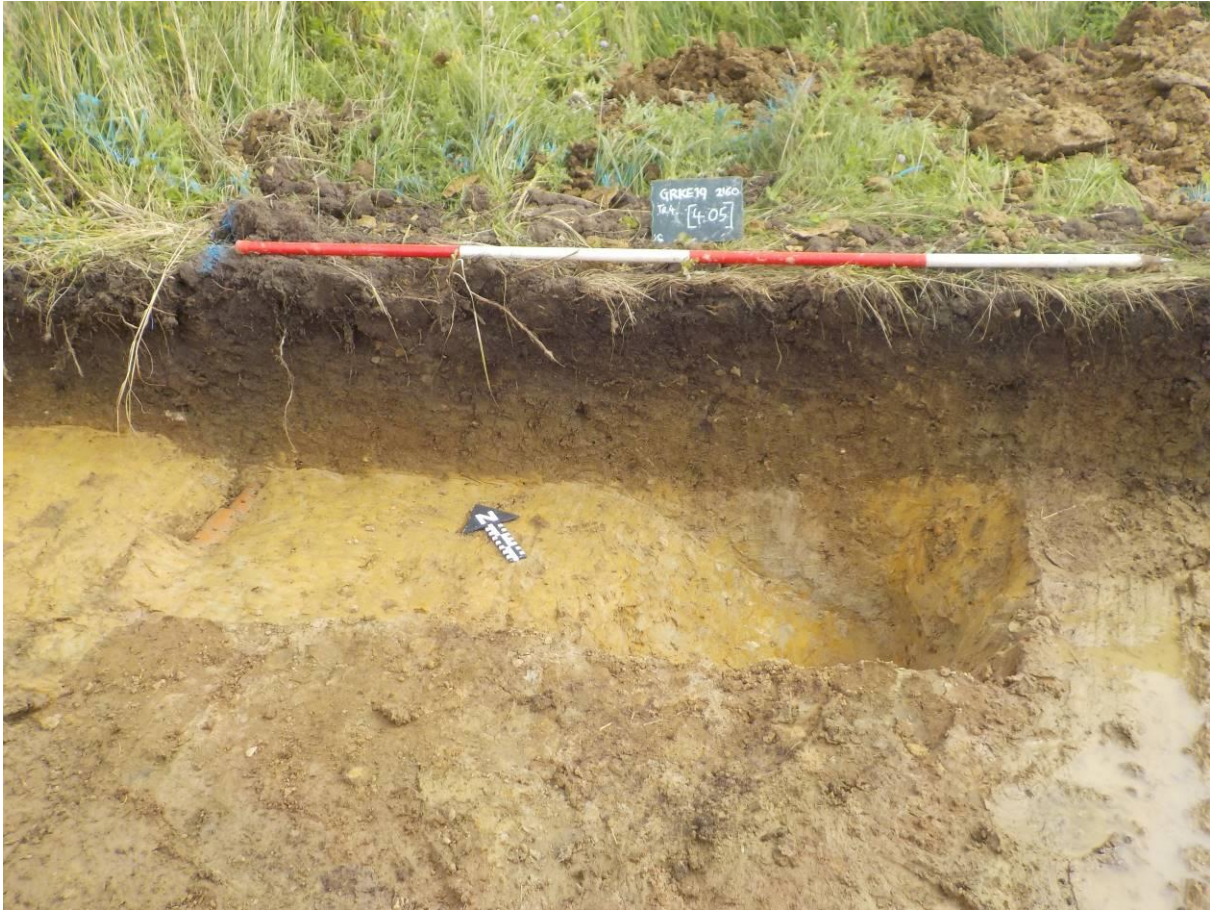
Plate 6: Furrow [405] (looking NE).

Each furrow was approximately 2m to 3m wide, evenly spaced and orientated approximately NE-SW, indicates that they were most likely part of the same field system. No dateable finds were recovered from any of the features, so the precise date of this agricultural activity is unknown (although likely medieval to early post-medieval). A single fragment of burnt hare or cat bone was recovered from furrow [405] in Trench 4 (pers comm J. Curl).

404	Fill	of furrow [403]. Light greyish brown sandy clay. Occasional small limestone fragments.	
405	Cut	Furrow. Orientated NE to SW. 2.4m wide.	
406	Fill	of furrow [405].	Bone
407	Cut	Furrow. Orientated NE to SW.	
408	Fill	of furrow [407].

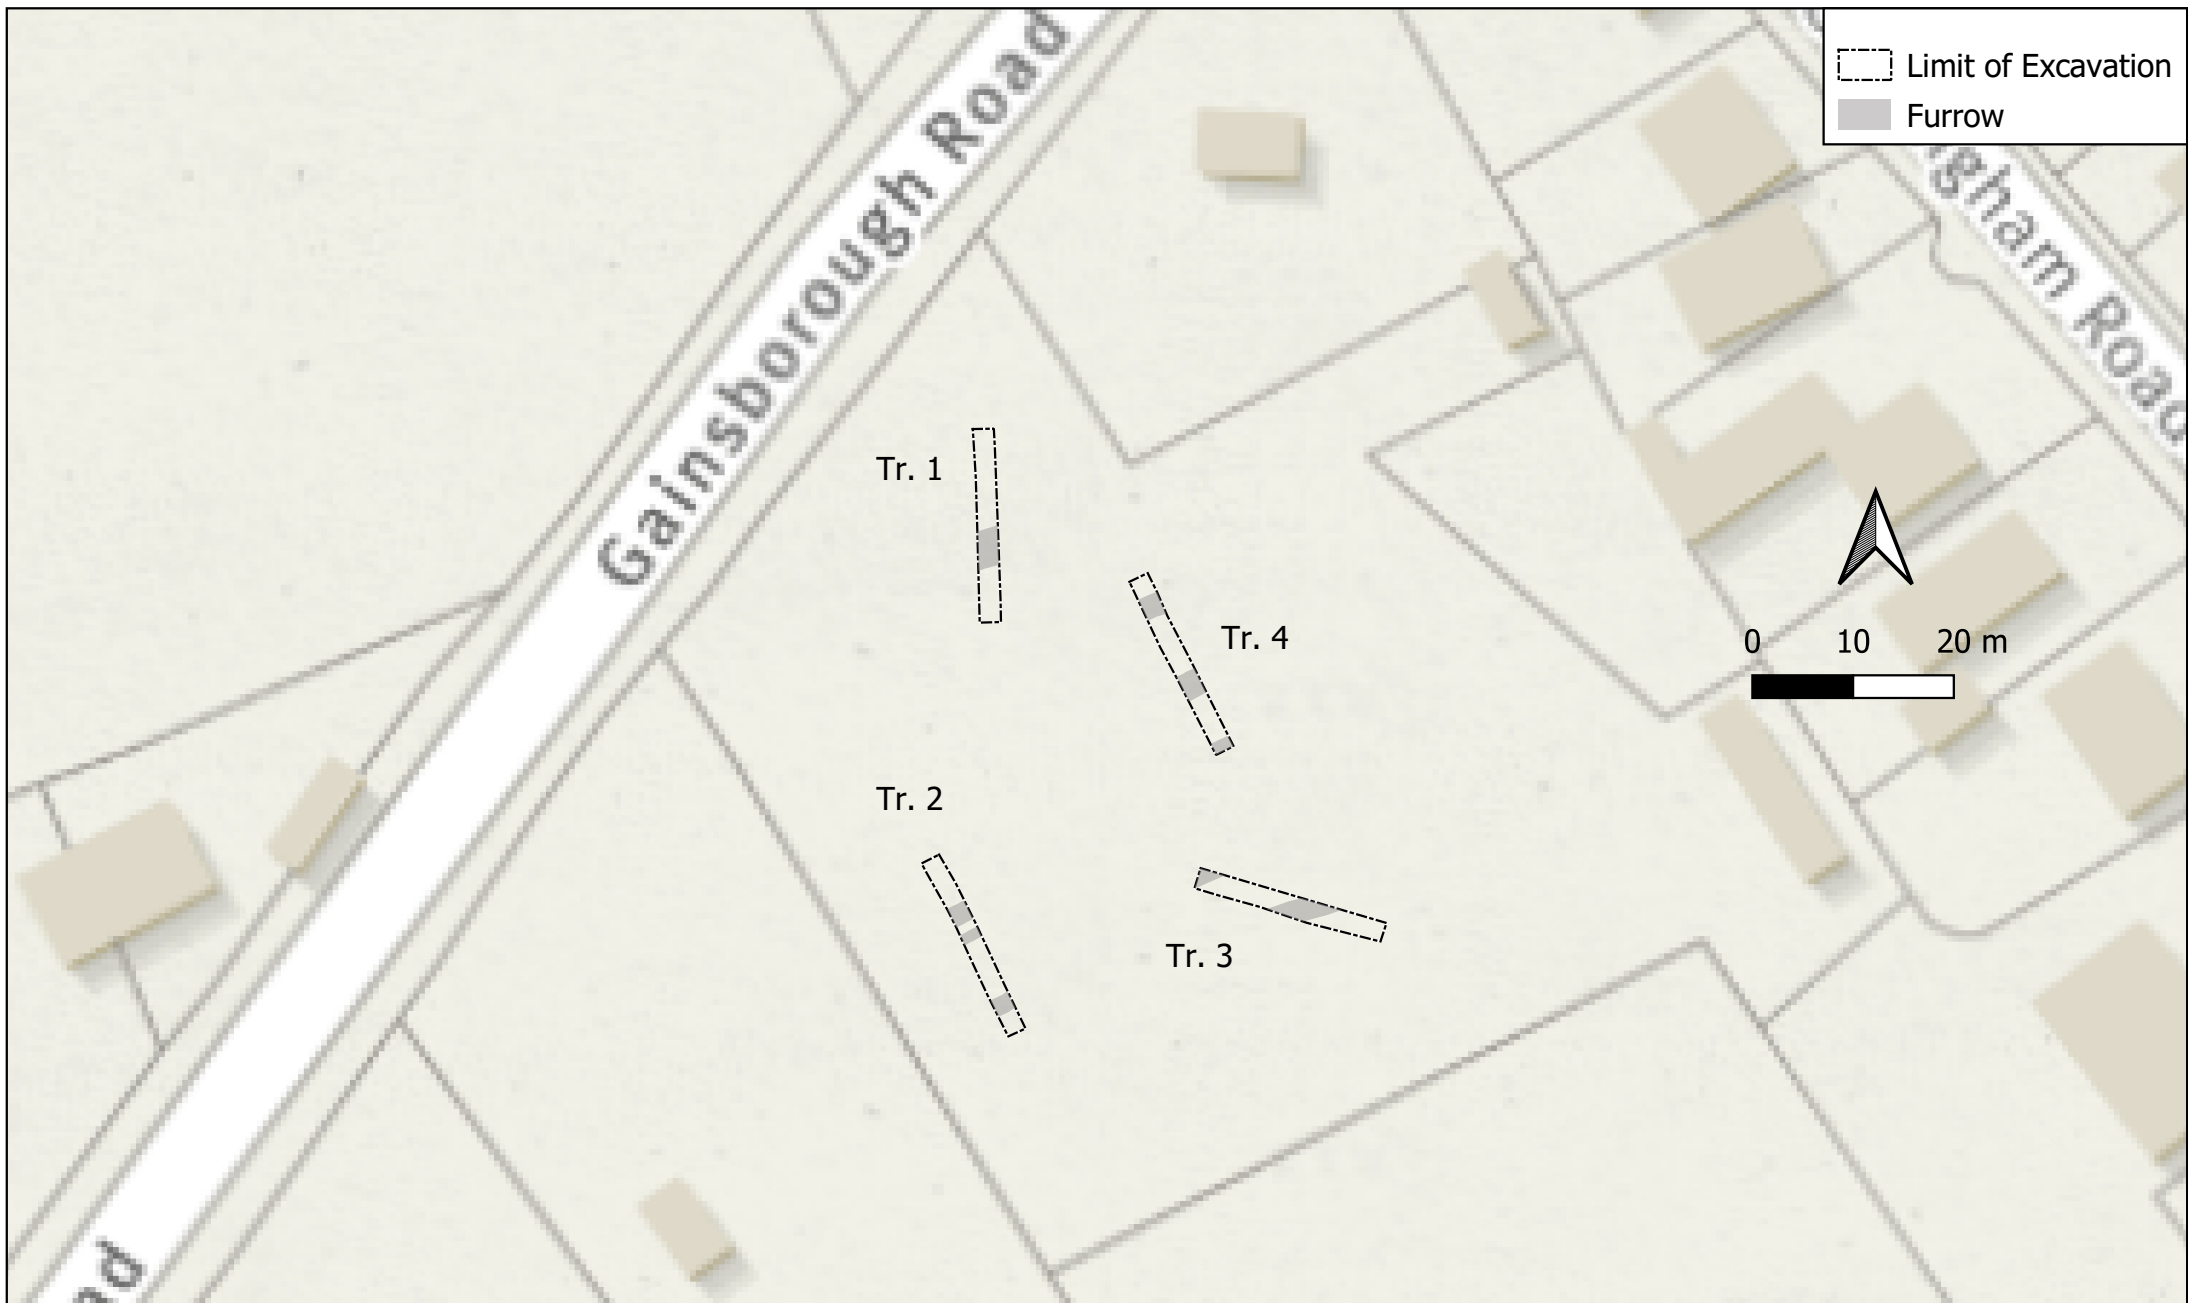
Figure 7:
Plan of furrows identified
(1:750)

All trenches excavated contained at least one furrow, with a total of nine being identified across the site. Each one was on an approximate NE to SW alignment and, for the most part,

evenly spaced. They ranged between 2m and 3m wide and each one contained a mid-grey brown silt clay deposit within it.
