TWYFORD RISING MAIN, ASHBY ROAD, TWYFORD, LEICESTERSHIRE

**SCHEME OF ARCHAEOLOGICAL MONITORING
AND RECORDING**

Report prepared for
NMCN/Severn Trent Water

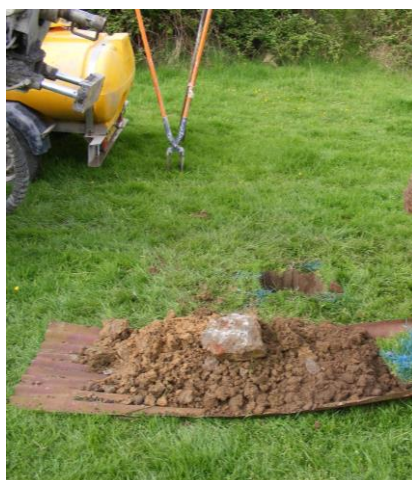
PI. 1: Borehole, looking N

At the base of the excavated borehole was a natural mid-yellow-brown sand layer 004, at the depth of 1.1m. Above this was layer 003, similar to subsoil 002 with more medium stone inclusions, only 0.10m thick. The subsoil layer 002 was a mid-red-brown clayey silt with occasional stone fragments and cobbles, 0.60m thick. The sealing deposit was topsoil 001, a mid-red brown slightly sandy silty loam, thought to be redeposited over an artificial platform, 0.40m thick.

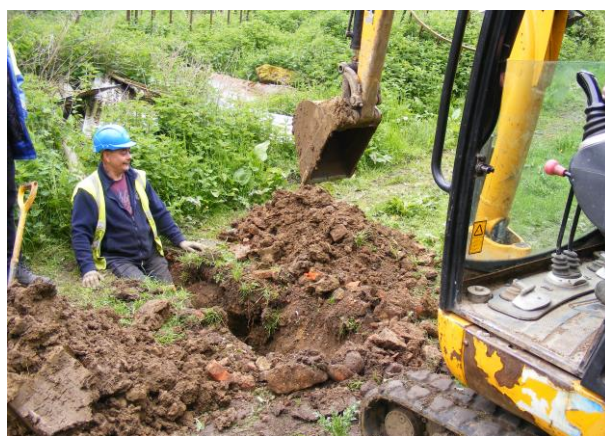
PI. 2: Working shot, Test Pit 2, looking W

With the test pits being located on a farm track, the construction consisted of a subsoil layer 101, a slightly sandy mid-red-brown clayey silt, 0.80m thick, overlaid with a hardcore of brick rubble with frequent stones and brick inclusions, 0.20m thick.

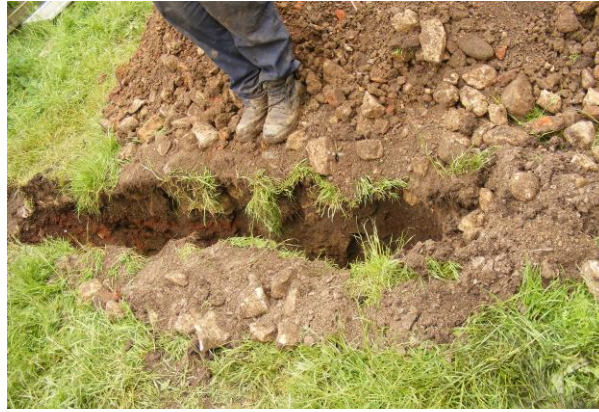
PI. 3: Post excavation of Test Pit 2, looking W

At the base of Test Pit 2 was a mid-grey-brown silt layer 203, at 0.45m deep. Above this was a hardcore layer 202 (same as 100), with brick rubble inclusions, covered by a redeposited soil and shale mix 201. These deposits were sealed by a hardcore layer 200, incorporating imported materials of crushed stone hardcore, 0.20m thick.

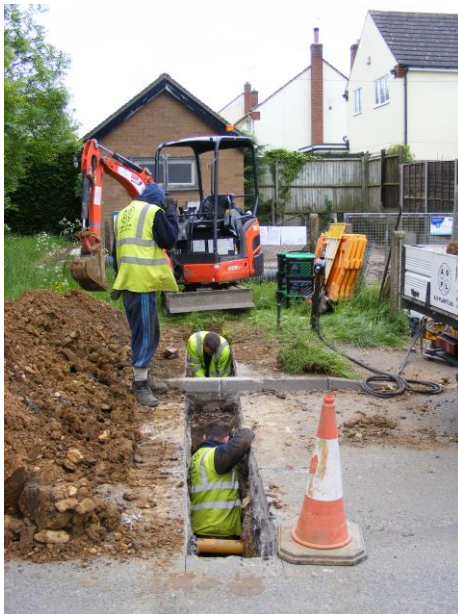
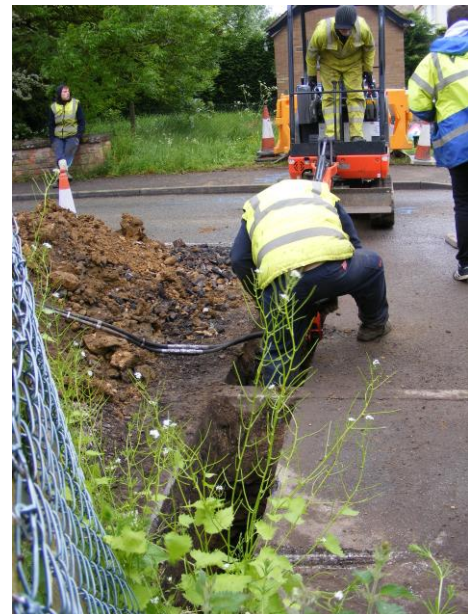
As this trench crossed the Main Road within Twyford village, it exposed a variety of road and pavement surfaces, as well as two late 18th to early 20th century red brick structures.

PI. 4: (left)
Working shot of
Trench 3,
looking SE

PI. 5: (right)
Working shot of
Trench 3,
looking SE

At the base of the south eastern trench end was a likely natural layer of mid-red sandstone 306, reached at the depth of 1.50m. Above this was a mid-brown natural alluvial silt 301, likely to be the same as alluvial silt layer 308 seen at the north western end of the trench. Related to layer 308 was a slightly clayey alluvial silt layer 309, which contained frequent small stone inclusions and was 0.50m thick. Both were covered by a former topsoil layer 307

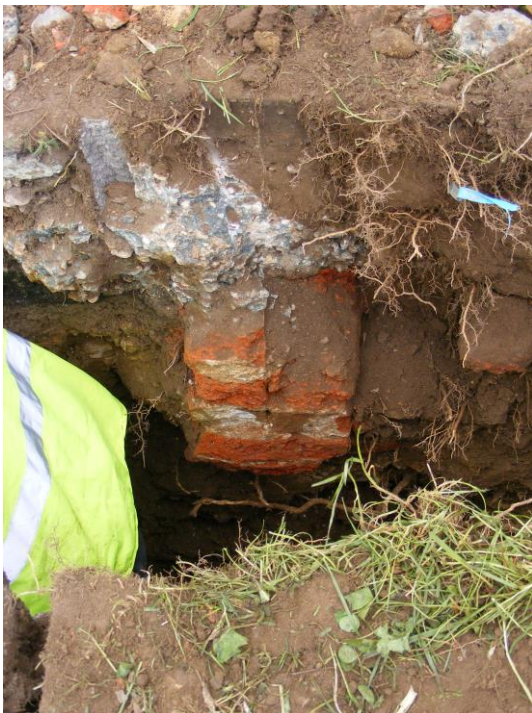
PI. 6: Structure **303**, looking NE

at the northwest end of the trench. Cut into alluvial silt 301 was a north east to southwest aligned red brick wall structure **303** (see PI.6), running parallel to the road and pavement. Just four courses of brick survived, a single brick wide and bonded with a light grey lime mortar. This structure was truncated by the pavement surface 302 and had also been disturbed by modern services to the northwest: only a 0.30m long, 0.20m wide and 0.55m deep section of the wall survived. A possible brick floor to the southeast was observed, suggesting that the walled structure **303** was possibly a small building, likely to be domestic as the bricks were handmade and made of local materials. The bricks used were similar to the adjacent 18th century Grade II listed Lewin's Bridge, possibly confirmed by the sample bricks taken from **303** being dated to a similar period, 19th century to early 20th century (*Appendix 2*). Slightly above and to the southeast of **303** was a 0.20m thick mid-brown silty sand demolition layer 304 which incorporated frequent brick fragments and modern bottle glass. At the southeast end of the trench, directly above layer 304 was redeposited landscaped soil 305, 0.35m thick.

Both of the brick structures exposed within Trench 3 were of late 18th to 20th century date, so are either contemporary with or built just after the construction of the adjacent Grade II listed Lenin's bridge. As only very small sections of these structures were exposed, it is difficult to fully conclude. Possibly structure **303** was part of a small building with a brick floor. It is considered unlikely this was associated with the bridge itself (eg a small tollhouse), and its use was probably more likely to have been of a domestic nature, possibly a dwelling.

Recovered from wall (303) was an abraded complete handmade brick in a coarse sandy poorly mixed fabric with common iron rich grains and some calcareous material. The brick has mortar on all faces, uneven arrises and is possibly slop moulded. Also recovered was approximately half a brick in the same fabric. It also has mortar on all faces and uneven

arrises. The header is burnt, possibly intentionally, to a deep purple colour. They are likely to be typical local products. They possibly date between the 19th and early 20th century. Their poor condition precludes any closer dating.

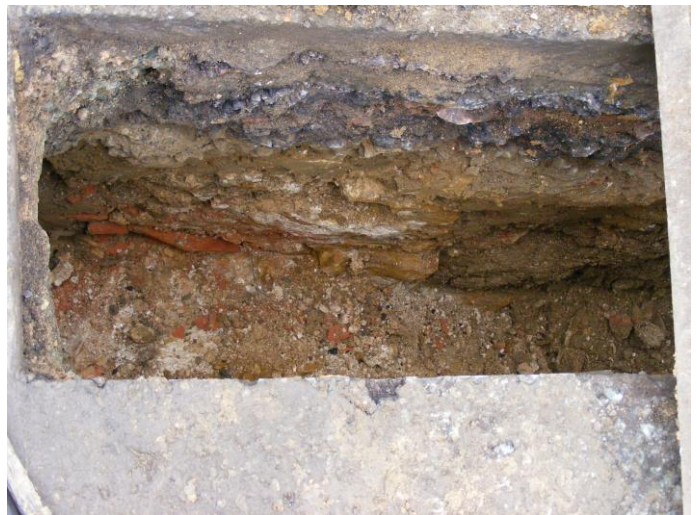
PI. 7: Structure **310**, looking NE

Towards the north western end of the trench was a red brick structure **310**, of four surviving courses (see PI.7). This was east north east to west south west aligned, diverging from the north east to southwest alignment of the road. This large brick wall was bonded with a yellow brown sandy mortar and was built on natural sandstone blocks. The dimensions of the wall were 0.60m wide and 0.40m high, with the footing being 0.10m wide and 0.50m deep. Sample bricks taken from this structure possibly date between the late 18th to the 19th century (*Appendix 2*). The site archaeologist suggested that **310** was possibly associated with a bridge predating the existing one. Alternatively, it could be that **310** has associations with the existing bridge – difficult to prove or disprove given the very narrow exposure.

Structure **310** was very different. This could have been associated with the original ramping leading to Lenin's bridge, adding additional support. As both structures have been truncated during the construction of the modern road, a full conclusion is not possible.

A complete brick and a partial brick were recovered from wall (310). The complete brick has mortar on all faces, is sand bedded, sand moulded, has uneven arrises and a stacking scar. It is a light orange relatively fine sandy oxidised fabric with a moderate amount of iron rich grains and occasional voids. It appears to date between the late 18th century and 19th century. A partial brick also recovered from this structure is a pale brown sandy fabric with occasional iron rich grains, occasional mudrock, occasional red clay pellets and relatively common voids. It is similar to the complete brick but not exactly the same size or fabric. It also possibly dates from the late 18th to the 19th century.
