**PHASE TWO, TEMPLE FARM, TEMPLE BRUER
LINCOLNSHIRE, LN5 0DG**

**REPORT ON A SCHEME OF ARCHAEOLOGICAL
MONITORING AND RECORDING**

O. Darnault

January 2022

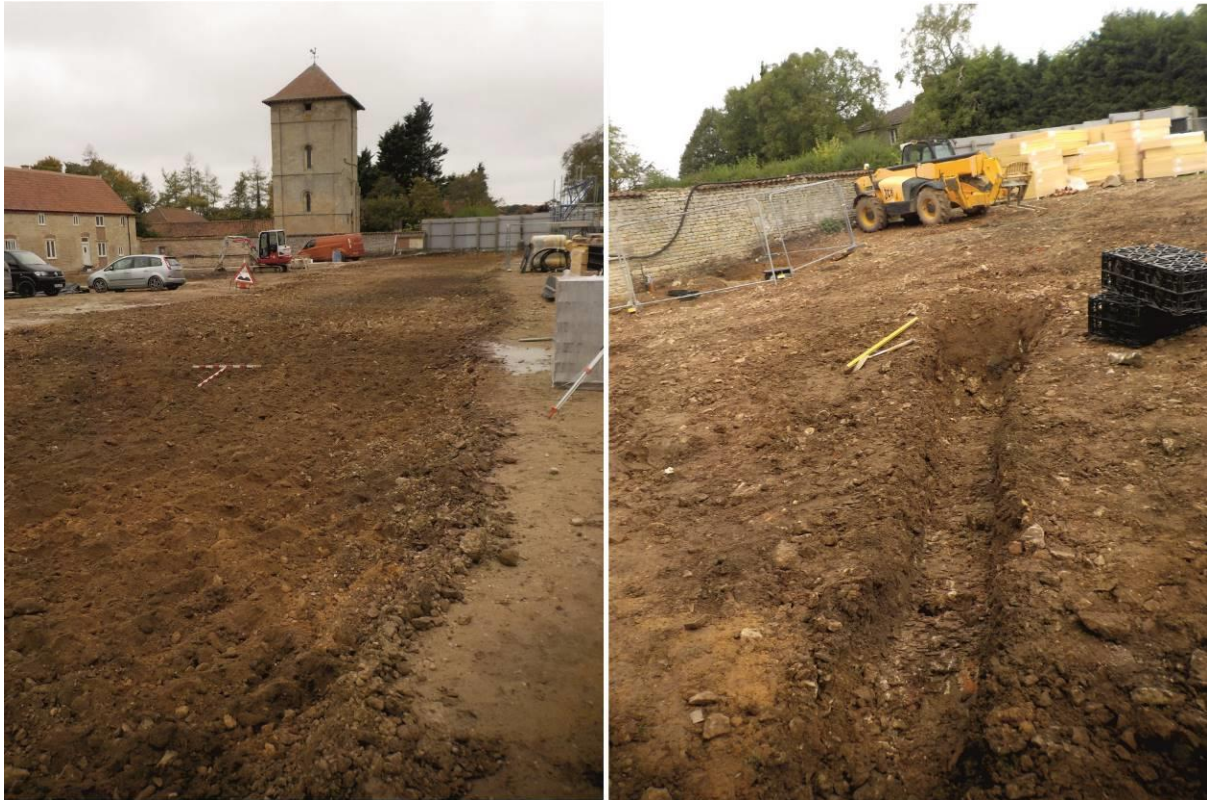
Plate 1: Working shot looking west, showing finished excavation monitored on 13/10/2020.

Plate 2: Working shot looking northwest, showing service trench excavated on 04/09/2020.

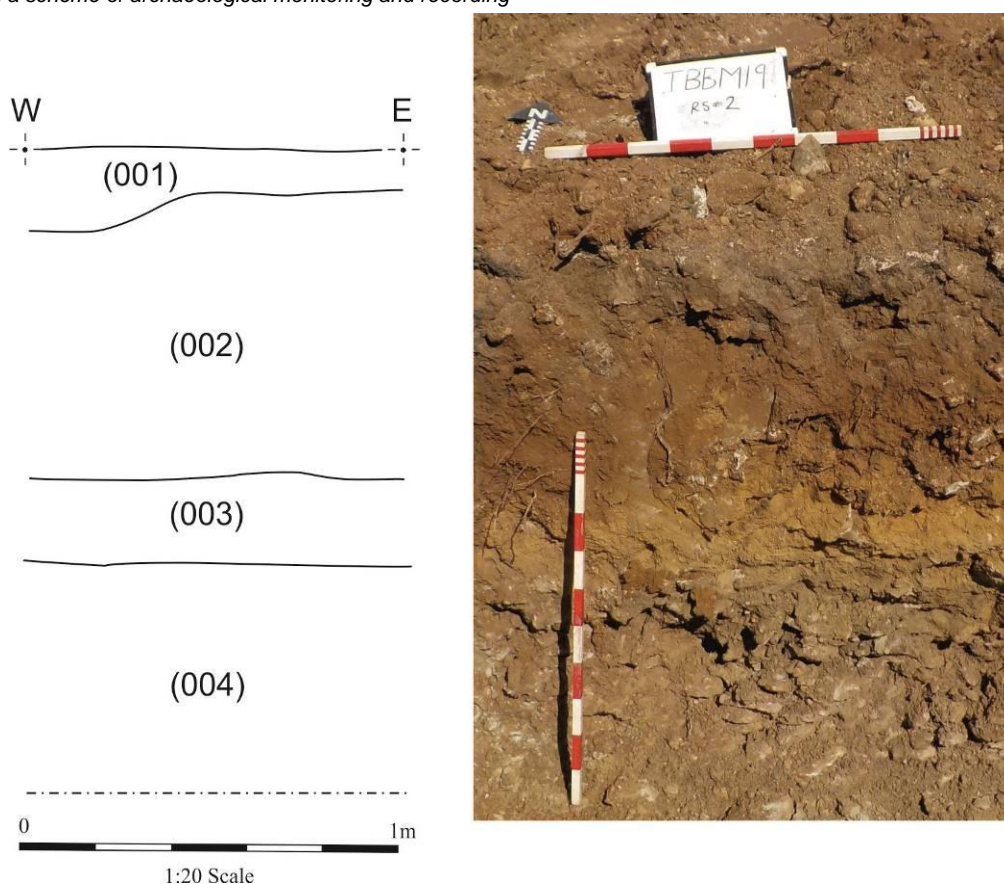
Four layers were identified and recorded:

- (001): **Modern disturbed rubble level.** Disturbed brick/gravel/concrete rubble present across site (0.20-0.80m. thick).
- (002): **Natural deposit** of light orange loose silty sand, small limestone fragments inclusions (0.40-0.60m. thick).
- (003): **Natural deposit** of creamy white silty sand with frequent limestone inclusions, slightly more compact than (002) but still rather light (0.10-0.20m. thick).
- (004): **Natural deposit** of compact creamy white limestone brash mix (80% limestone rocks and 20 % silty sand) (+1.30m.).

**Figure 4: Representative Section, facing South (plotted in red on excavation plan (fig. 3)).
Plate 3: Representative Section, looking North.**

No archaeological features were exposed during the monitoring, and no artefacts were recovered. Overall, only built-up rubble from previous demolition covering natural deposits was observed. No topsoil or subsoil layers were present in the area: the ground has likely been reduced and subsequently filled with rubble from a previous standing structure to develop the farmyard. This may have affected existing archaeology, had there once been any.
