Summary

- *Pre-Construct Archaeology (Lincoln) was commissioned by Scott Wilson Ltd on Behalf of AMScott to undertake a programme of archaeological works as part of the A1 North Muskham Drainage Scheme.*

North Muskham Archaeology Report – Addendum

Concrete Removal Monitoring around North Muskham Cross SAM

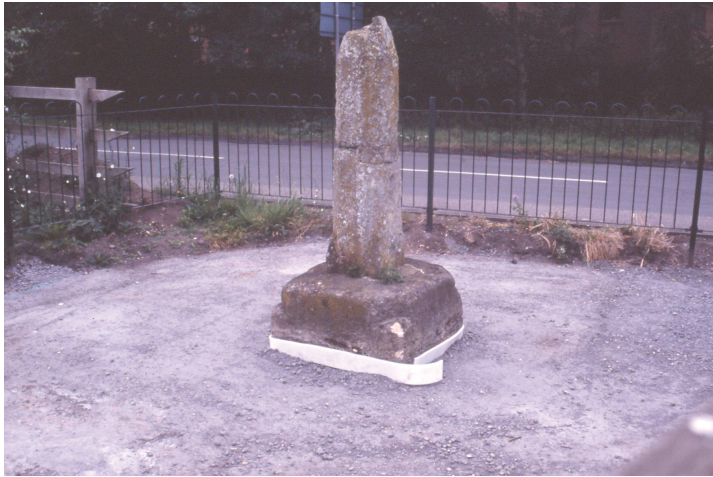
Plate 1: The cross shown surrounded by concrete. The damage to the base can be seen on the front right corner.

Following the completion of the archaeological works on site, the landscaping works around the cross commenced. The contractors did not follow the issued English Heritage approved specification written by Scott Wilson and instead of limiting the bedding layer of concrete to an outer ring starting 1.54m from the centre of the cross shaft, they instead laid the concrete in the entire hand-excavated area up to the base of the cross base. Strips of plastic were placed around the cross base to protect the fabric from the concrete.

Following consultation with English Heritage, Scott Wilson prepared a specification for the immediate removal of the concrete from the inner circle up to the cross base. This specification was approved by English Heritage. Pre-Construct Archaeology (Lincoln) was commissioned to oversee the removal of this concrete by the contractors and ensure that no damage occurred to the cross. The works took place from 29th-30th June.

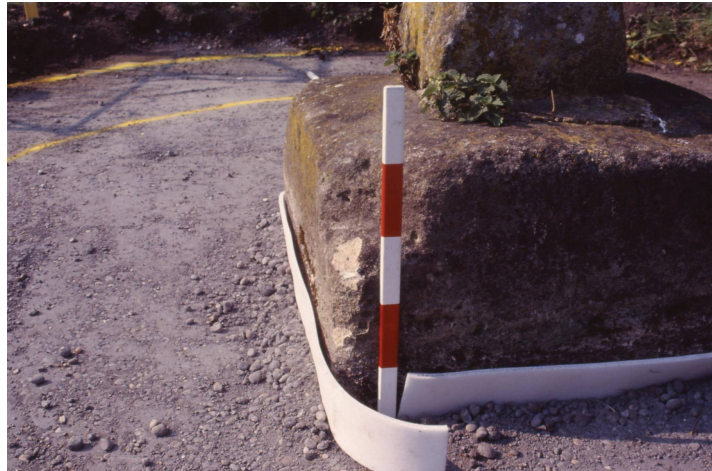
Plate 2: Close up of the cross base showing the damage. The concrete landscaping with the area marked out for removal can be seen in the background.

Photographs of the current landscaping and damage to the cross were taken prior to the 1.54m diameter circle for concrete removal being marked out by the contractors. A

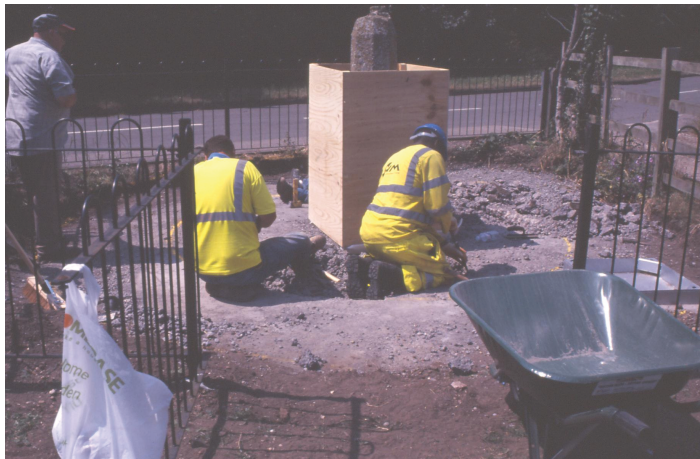
Plate 3: Remedial works being carried out by hand once the wooden shuttering had been erected.

wooden shuttering box was then erected around the cross to protect it from the forthcoming works. The inner circle of concrete was then removed as specified. An archaeologist remained on site until the concrete was removed and the galvanised angle and gravel infill situated around the cross base.

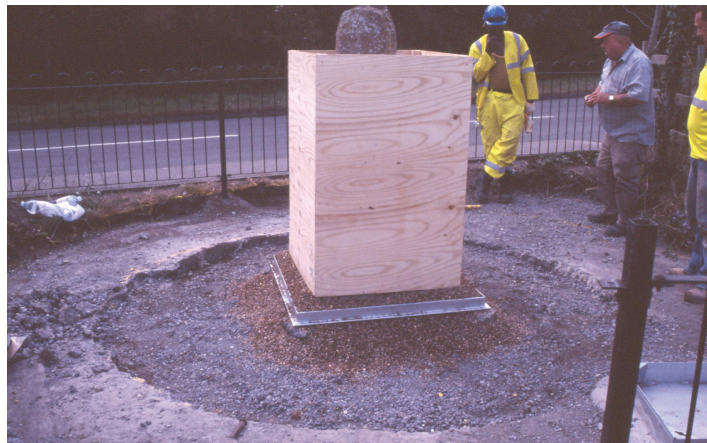
Plate 4: The inner circle of concrete has been removed and the galvanised angle and gravel infill has been situated.
