Pl. 1 Position of the evaluation trench within the proposed development plot (looking north-east past No. 19 Highfield Road).

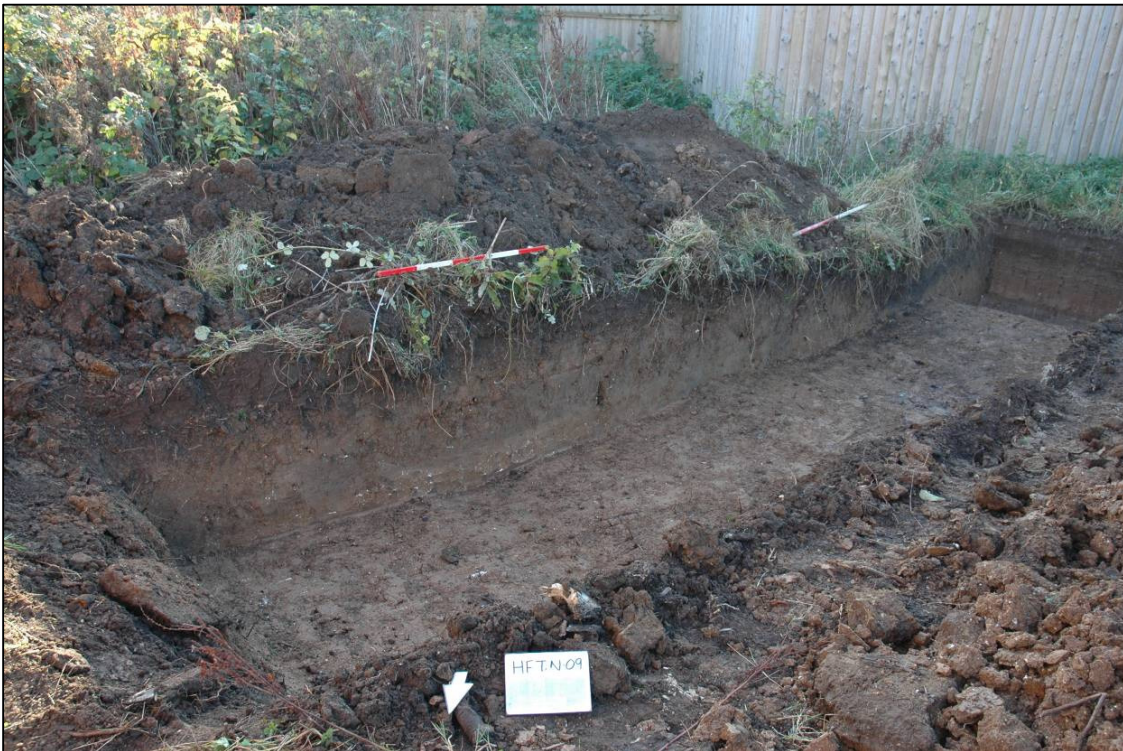
Pl. 2 The machine-excavated trench (looking south, scales 1m). Raised ground to the south-east of the trench is probably a spoil heap associated with development of the adjacent plots.

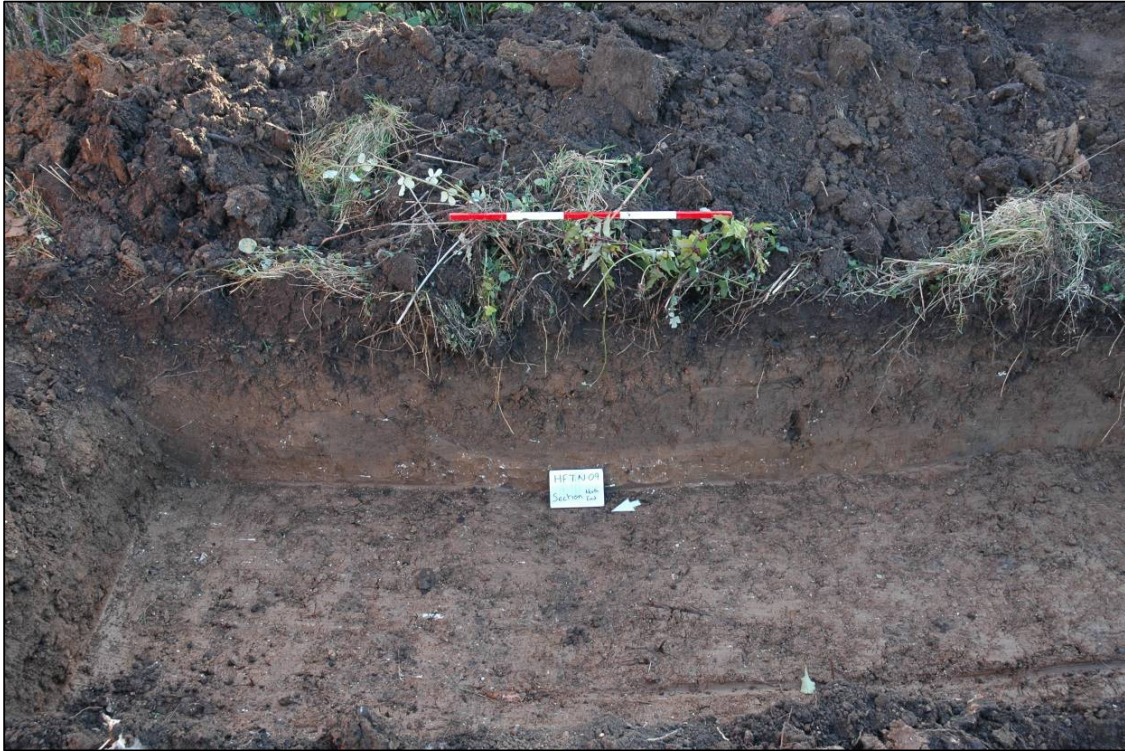
PI. 3 Deposits visible at the north-eastern end of the trench (looking south-east, scale 1m). The dark modern topsoil (100) covers a band of redeposited clay above the subsoil (101), indicating probable machined truncation in the past.

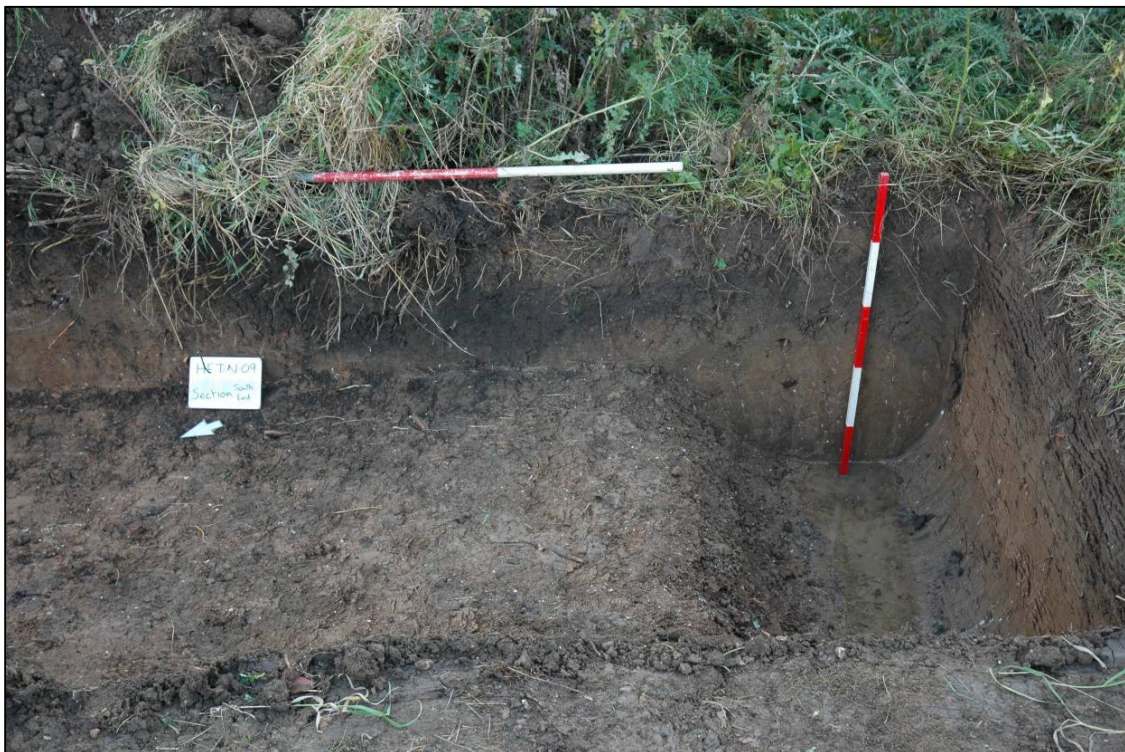
PI. 4 Close to the south-western end of the trench (below the horizontal scale), the modern topsoil dipped into a depression above a backfilled land drain [104]. At the end of the trench a machined scoop confirmed that underlying layers were undisturbed glacially deposited material (looking south-east; scales 1m).

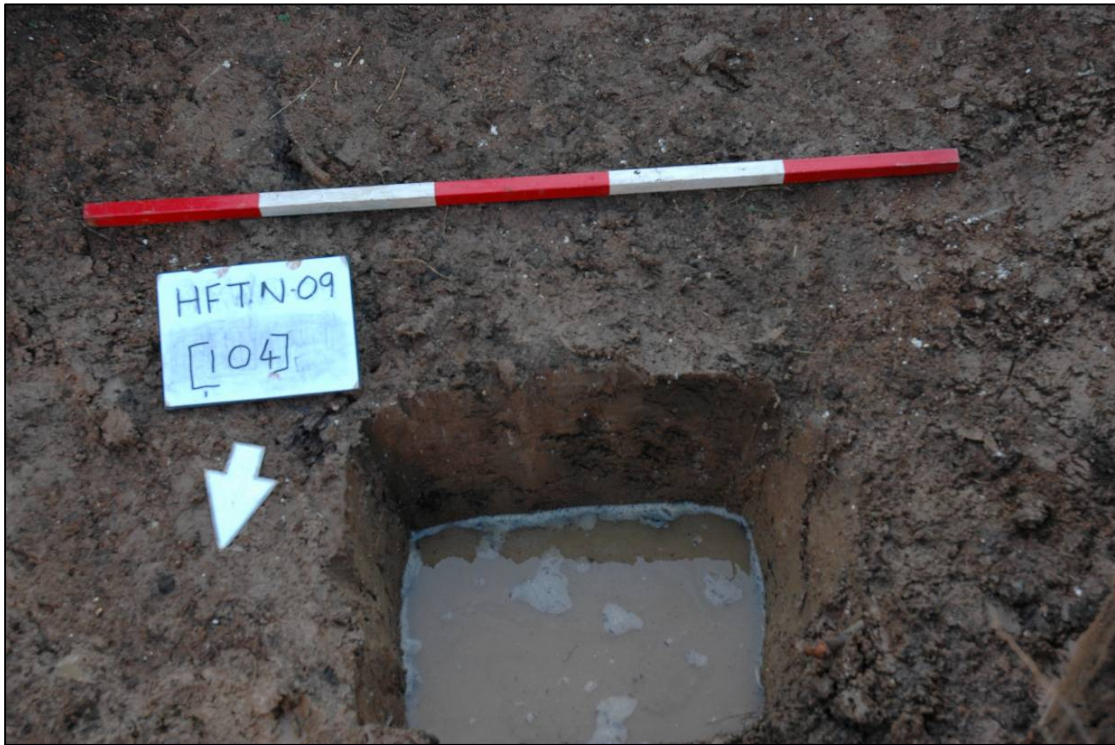
Pl. 5 Partly excavated post-medieval land drain cut [104]. The water is covering a horse-shoe type clay land drain. (Looking south, scale 1m).
