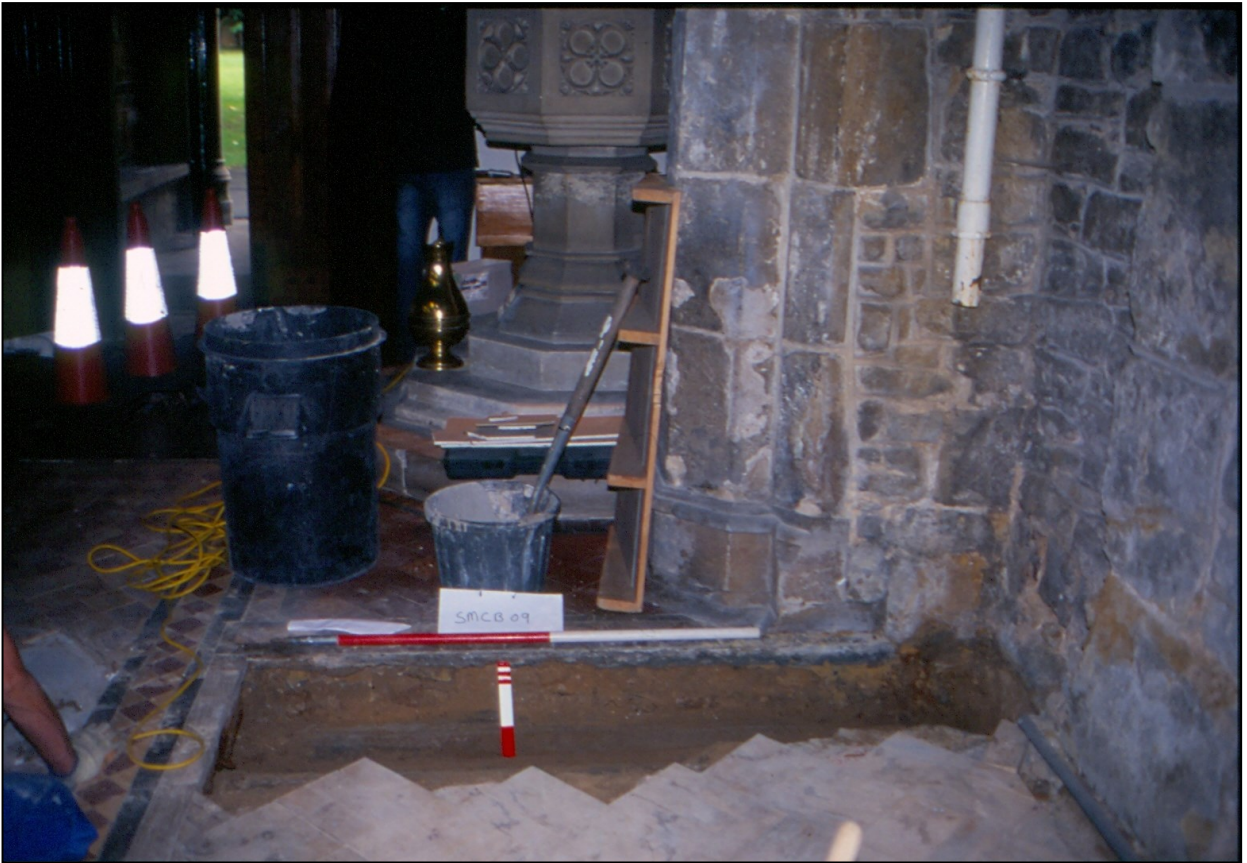
Pl. 1 Position of the monitored pipe duct (looking south towards the porch, with the east wall of the tower in the foreground, right. Scales 2m and 0.25m).

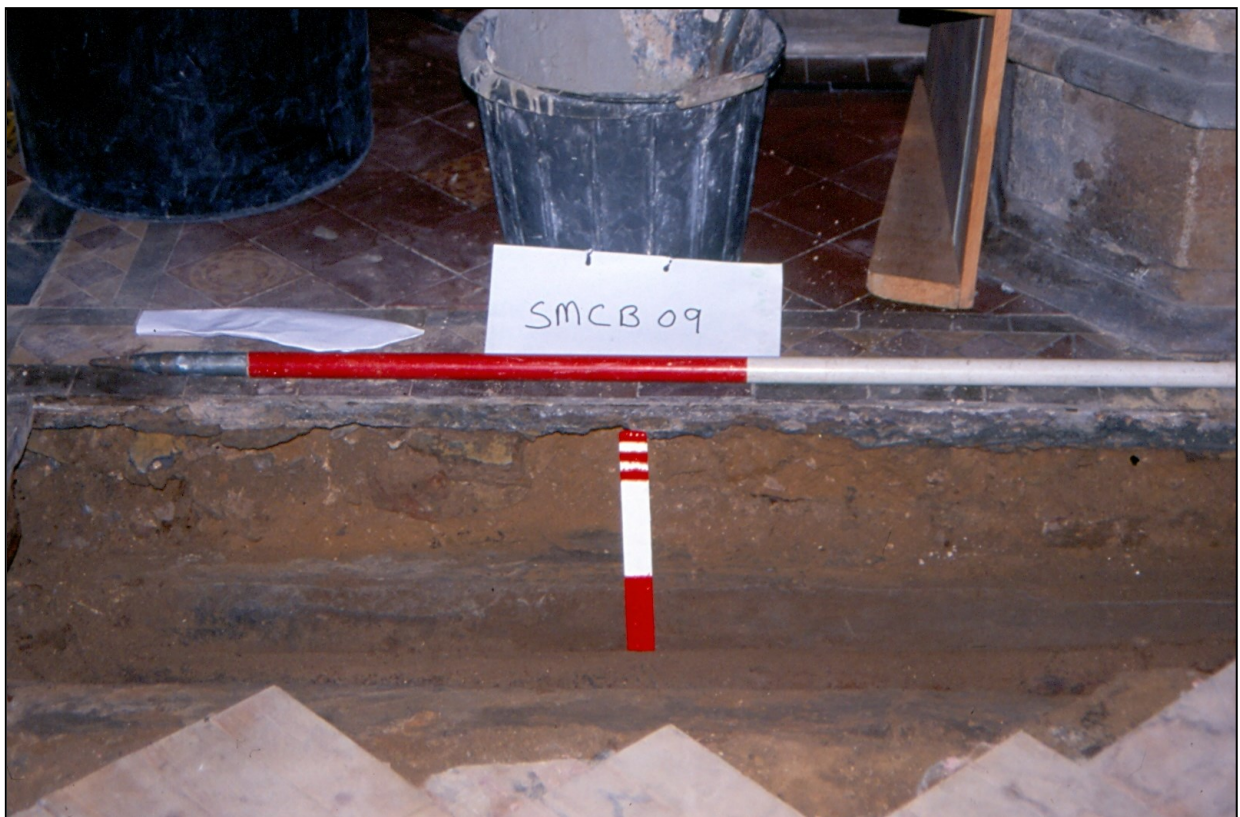
Pl. 2 South face of the re-excavated duct, with the low walls of the concrete lined duct visible at the base of the excavation. The 19th century floor tiles have been laid above a layer of demolition material (101), which may extend behind the duct. (Looking south, scales 2m and 0.25m).

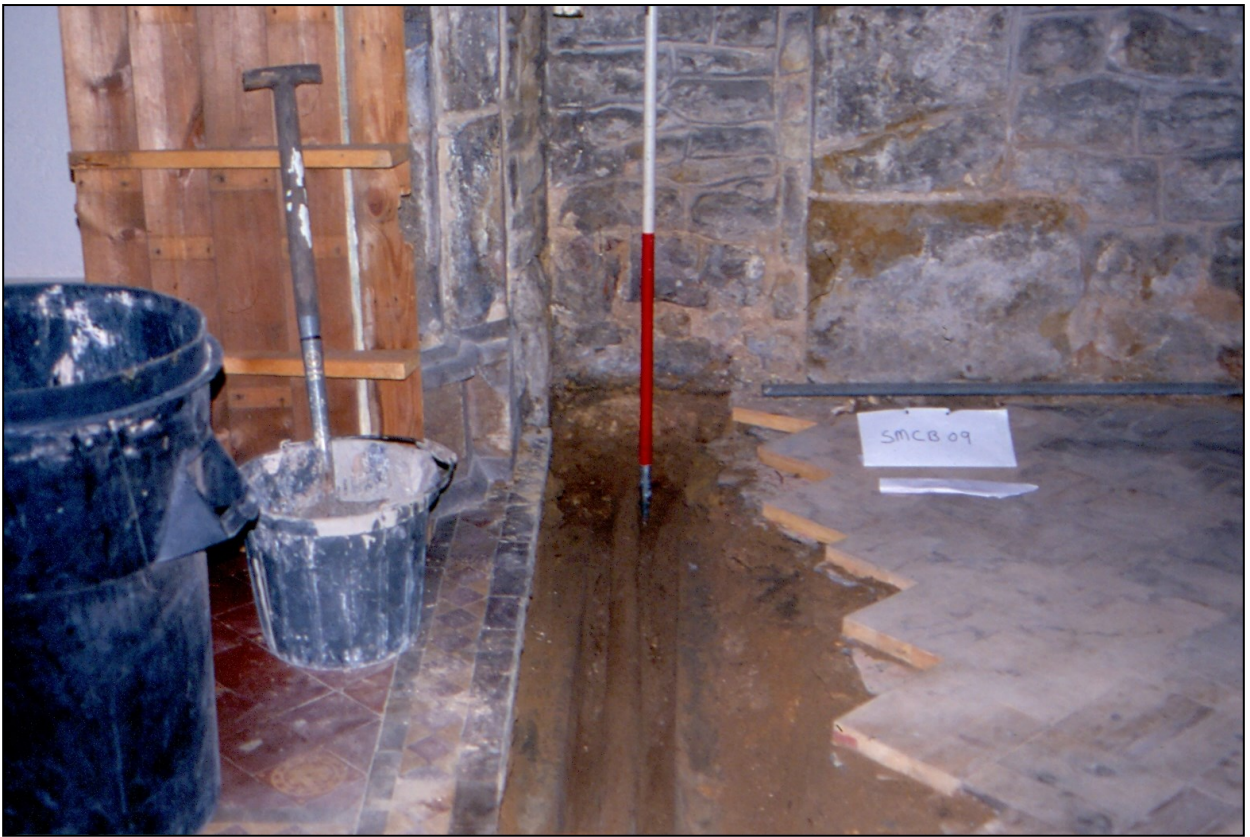
Pl. 3 The pipe duct extended to the west wall of the nave. To the north (right), the abrupt change in the stonework is at the south-east corner of the earlier east wall of the tower (looking west, scale 2m).
