CHURCH OF ST WYSTAN, REPTON, DERBYSHIRE

ARCHAEOLOGICAL WATCHING BRIEF

PCA Job No. 538
NGR: SK 3028 2717
Planning ref. n/a
Faculty: FI/DAC/2297A

March 2010

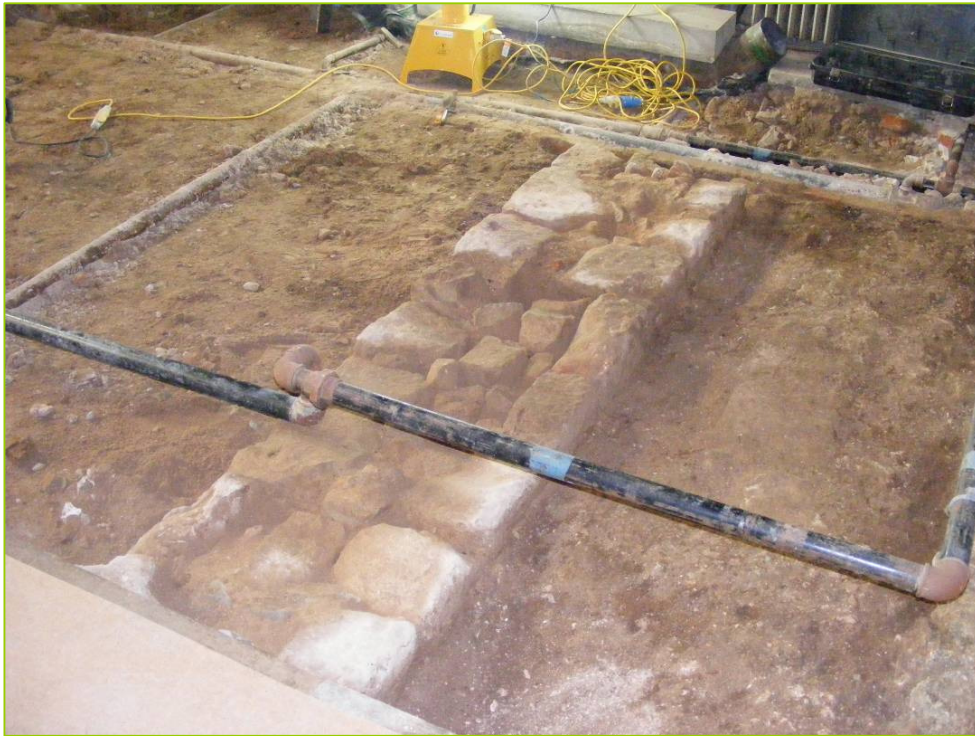
PI. 1 Outer vestry works following the removal of the floor surfaces and some underlying deposits. Wall (109) can clearly be seen as can the system of pipes that disturbed the area (looking south-west).

The monitored area lay within the extent of the former 'outer vestry', in the north-west corner of the church (Pl. 1). It extended to the edge of the western buttress of the tower, and between two arch pillars at the northern side of the central aisle. It measured 5.9m x 4.55m, with a maximum depth of 0.56m from the 2009 floor level. The 0.35m thick existing floor surface of wooden parquet blocks and stone flags (101) was lifted, revealing the 0.03m thick cemented sand bedding (102) for the

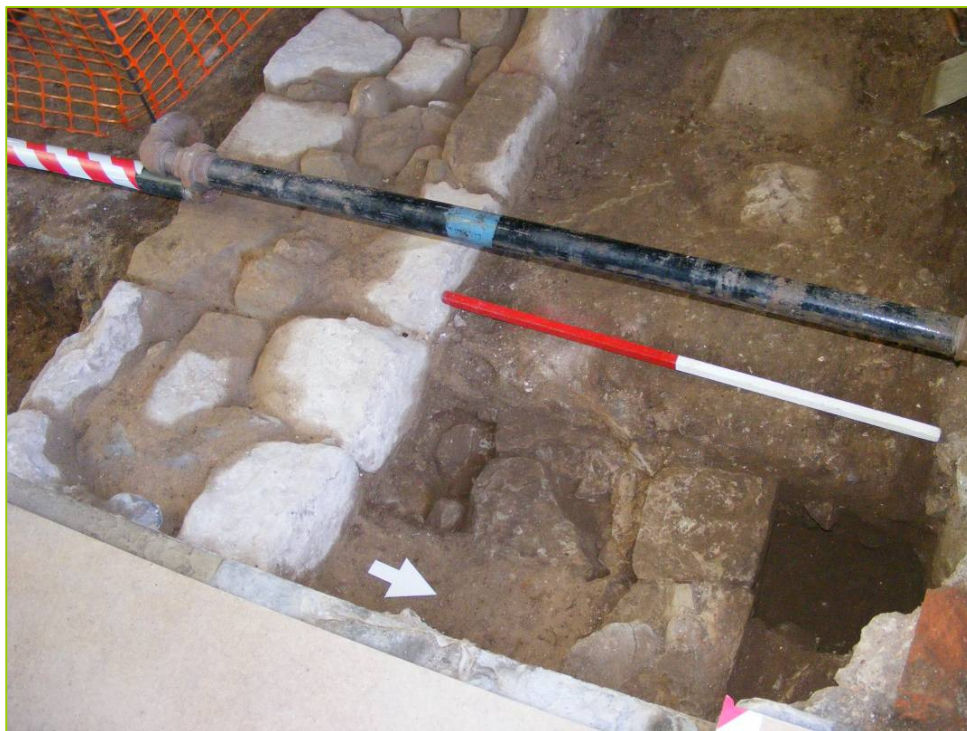
PI. 2 Stone wall (109) (left) cut through wall (113). Looking south-west, scale 1m.

A third parallel wall foundation (109) lay 1.2m from the standing north wall (Pl. 2). This had been cut through wall foundation (113) within a 1.2m wide construction trench [111] The 0.7m wide stone foundation was recorded as being constructed with mainly large hewn square limestone blocks (110), with some stone rubble within a matrix of light yellow/brown silty sand (112). The sand may have been decomposed mortar. A single course of faced blocks survived, on a rubble foundation which was offset 0.25m to the south, filling the construction trench. A single late 11th-12th century sherd of pottery was recovered during the 2008 archaeological evaluation from between the blocks of the northern face of this wall.

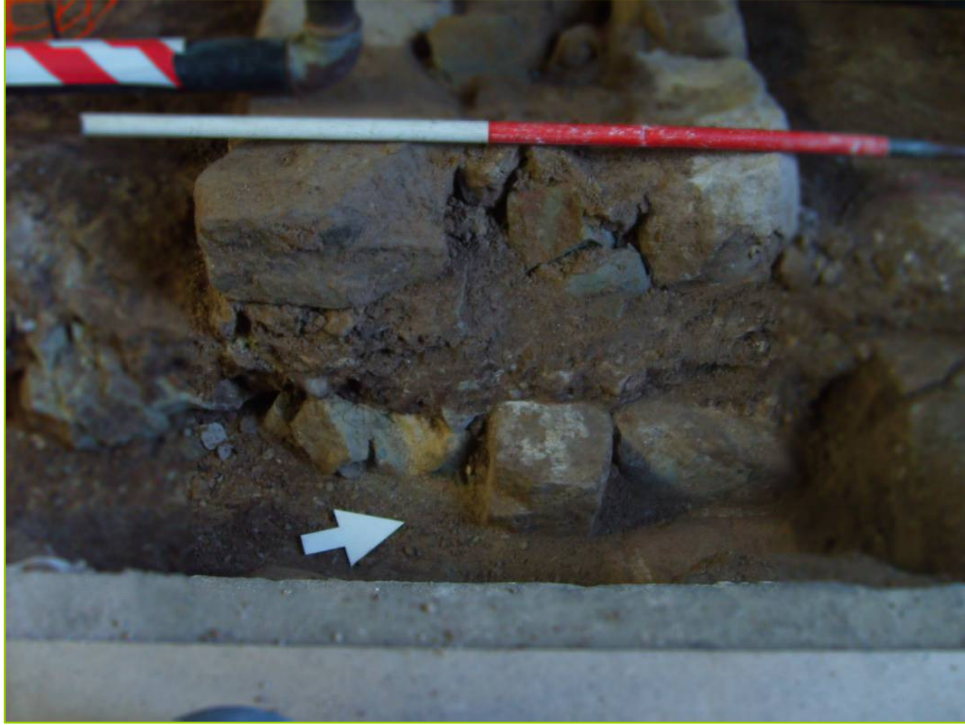
PI. 3. Section A. Slot through wall (109) showing foundation (110), looking north-west (1m scale).

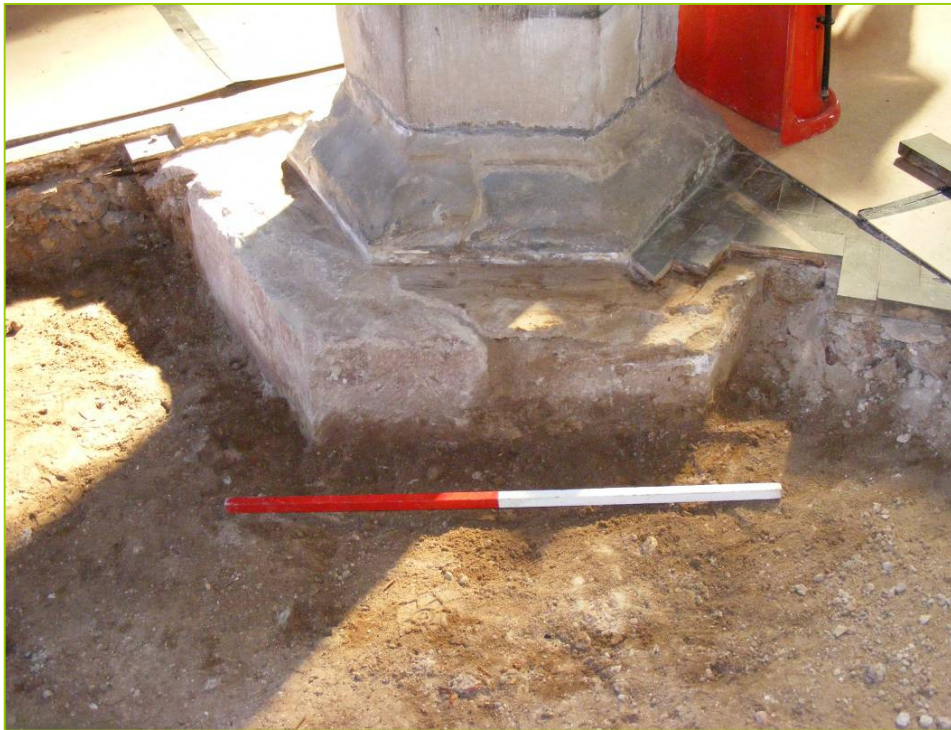
PI. 4 Mortared sandstone base (116) of the south-west arch pillar (looking south, scale 1m).

In the south-west corner of the outer vestry, the groundworks revealed part of the mortared sandstone base (116) of the south-west arch pillar (Pl. 4). No relationship was recorded between this and the soil layer (104).

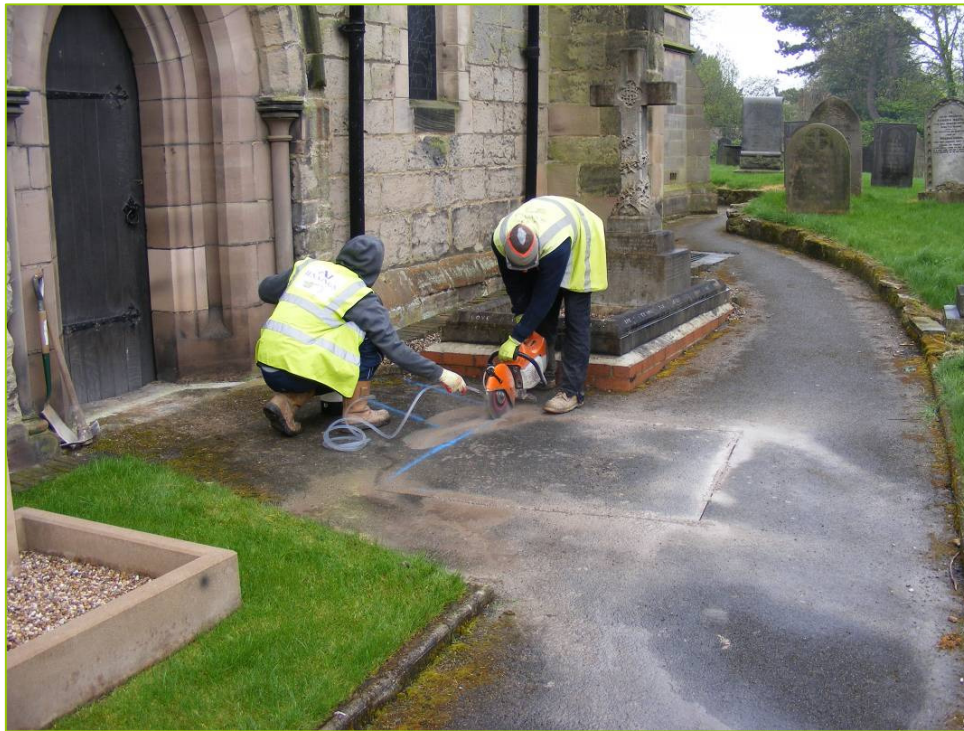
PI. 5 Location of the Pumping Chamber Pit outside the north door of the church (looking west).

A 1.5m square pit to contain a pumping chamber was excavated to a depth of 1.2m in the churchyard path, 3m north of the north wall (108). The pit was linked by a 0.65m wide and 1.5m long north-east/south-west aligned trench of the same depth from its south-west corner to the church wall.

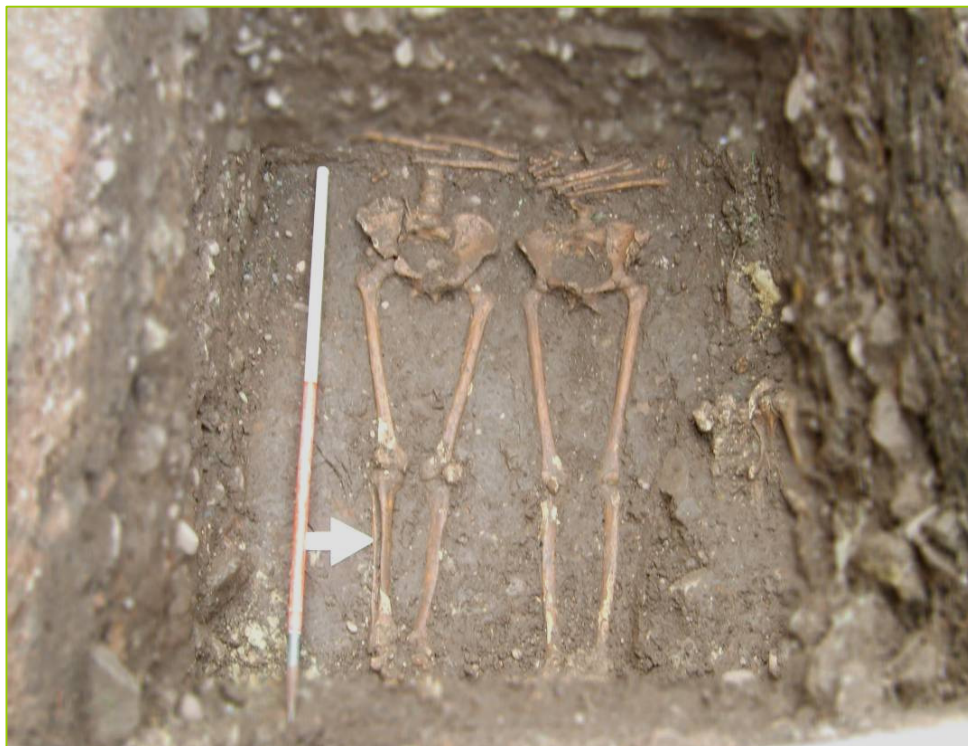
PI. 6 Double burial [207] (Sk 2 & 3) can be seen within the Pumping Chamber cutting through the grave of Sk 1 (right), looking west.

Parts of three articulated human skeletons were found within the Pumping Chamber Pit (Table 1). These comprised two (Sk2 and Sk3) within the fill (205) of a double grave [207], and part of an earlier Sk1 in fill (206) to the north of that burial. No grave edges were seen for Sk1. All three bodies were extended and aligned supine, with the head to the west. The skeletons Sk2 and Sk3 had their arms folded – at the western edge of the trench, but probably across their chests – and each had their feet together. The two occupants of the double grave were carefully positioned side by side, but the single skeleton was in a different row position and the remains had been disturbed by the later grave. No definitive evidence for coffins was recovered from either grave though a single nail was retrieved from the backfill of double grave [207], which was possibly a coffin nail disturbed from an earlier grave. The grave fill (205) contained three sherds of 5th-8th century pottery, and a late medieval floor tile showing signs of re-use was found in grave fill (206).

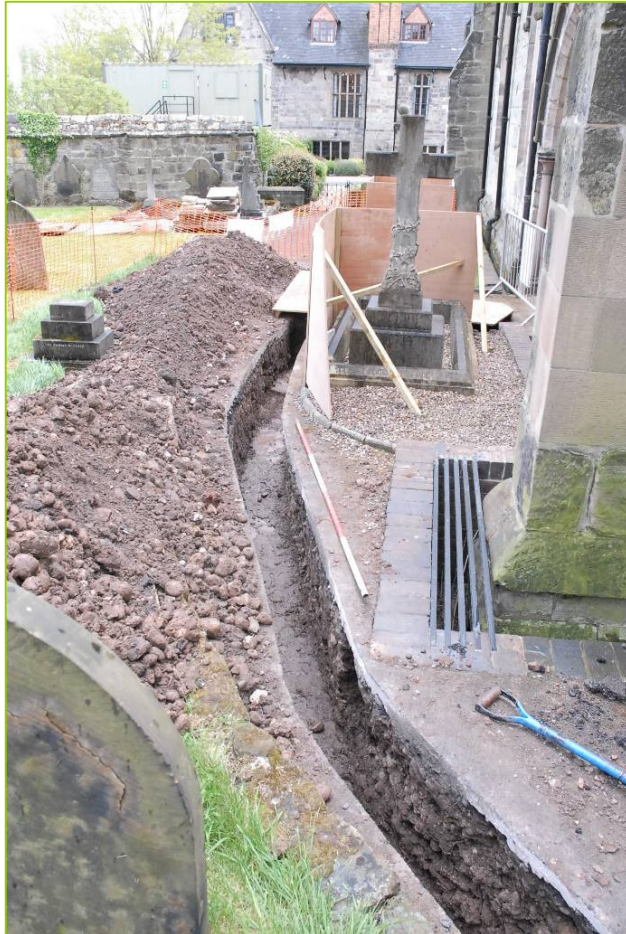
PI. 7 External pipe trench, to the north-west of the church (looking east, scale 2m).

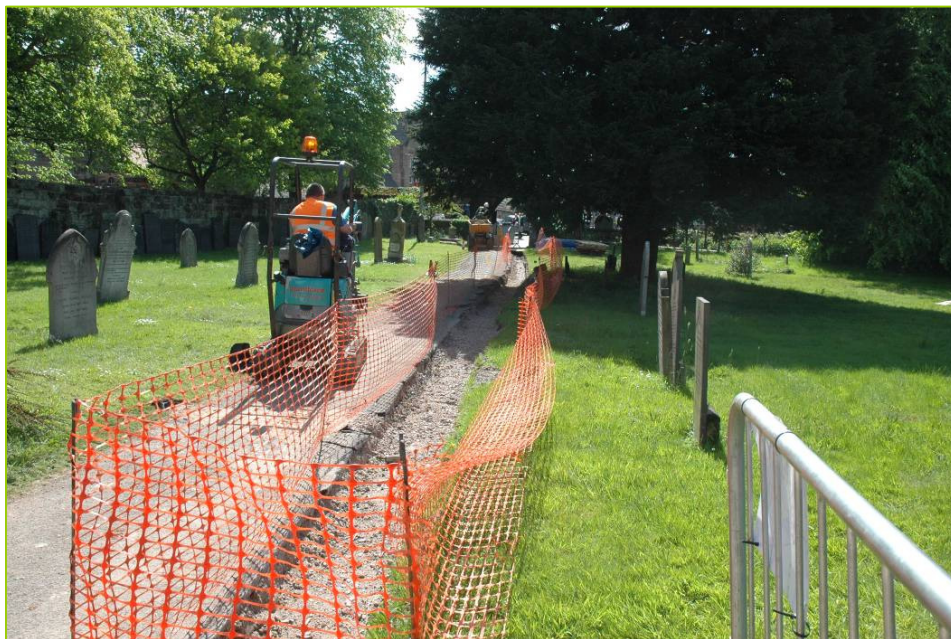
PI. 8 External pipe trench to the west of the church (looking west).

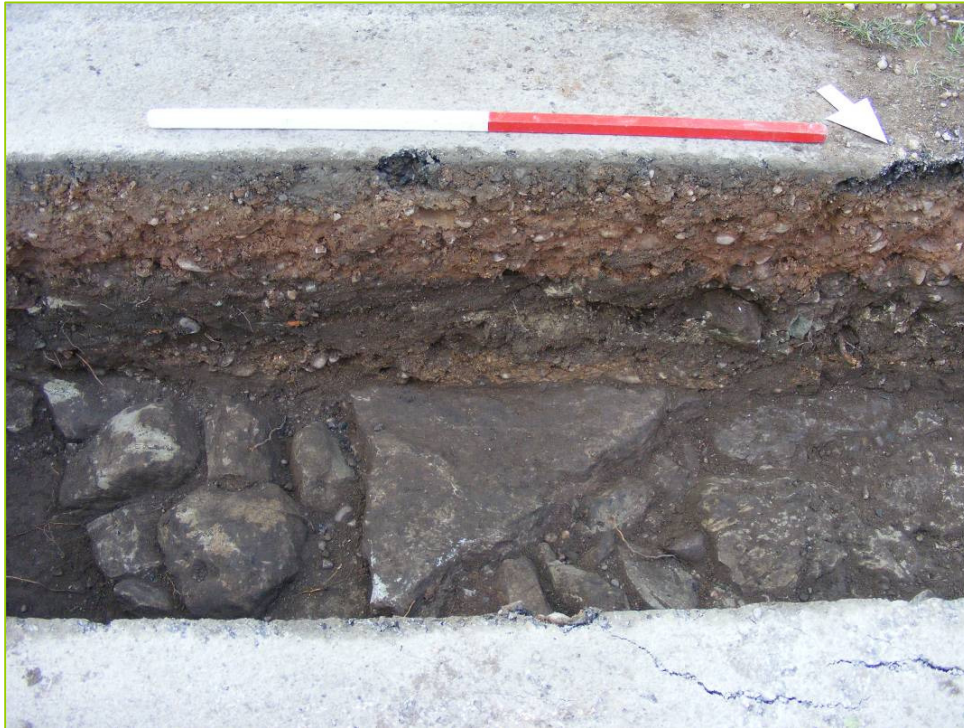
PI. 9 Stone wall/rubble (303) near the churchyard entrance, seen within the pipe trench. Looking south, scale 1m.

3m north of the present churchyard boundary wall, a 2.2m wide, north-south aligned, spread of sandstone rubble (303) was revealed 0.6m below the path surface, overlain by deposits of sandy gravel (302) and stony soil (301). Layer (301) contained fragments of medieval floor tiles, one glazed. The rubble was initially identified as a wall foundation but it may have been metalling of a path at the churchyard entrance (Pl. 11).

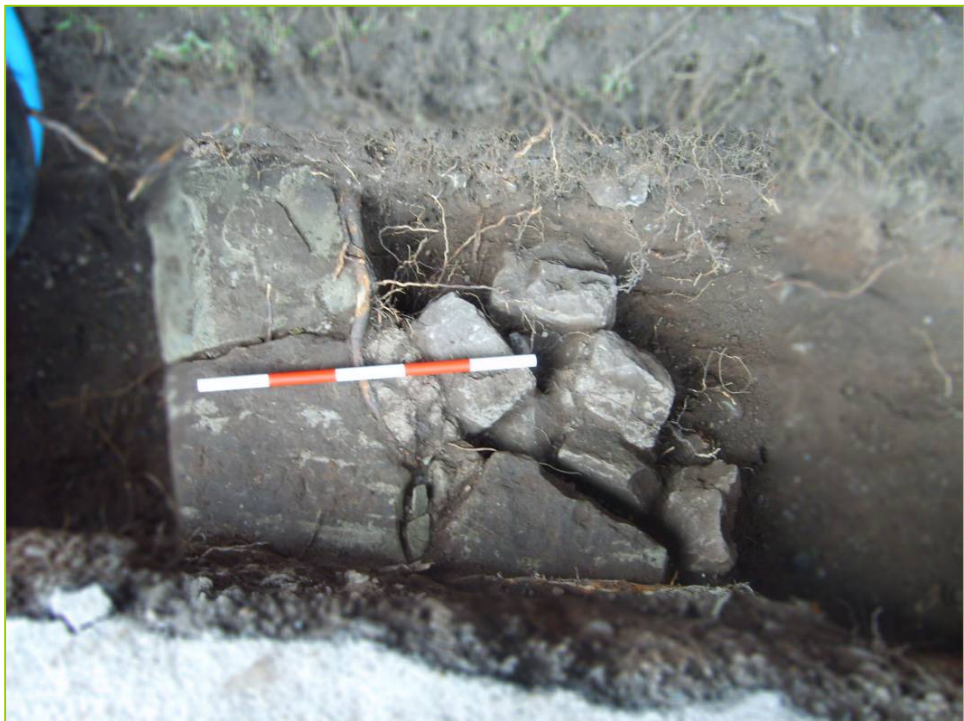
PI. 10 North-east/south-west aligned wall foundation of sandstone blocks (306), beside the churchyard path (looking south-west).

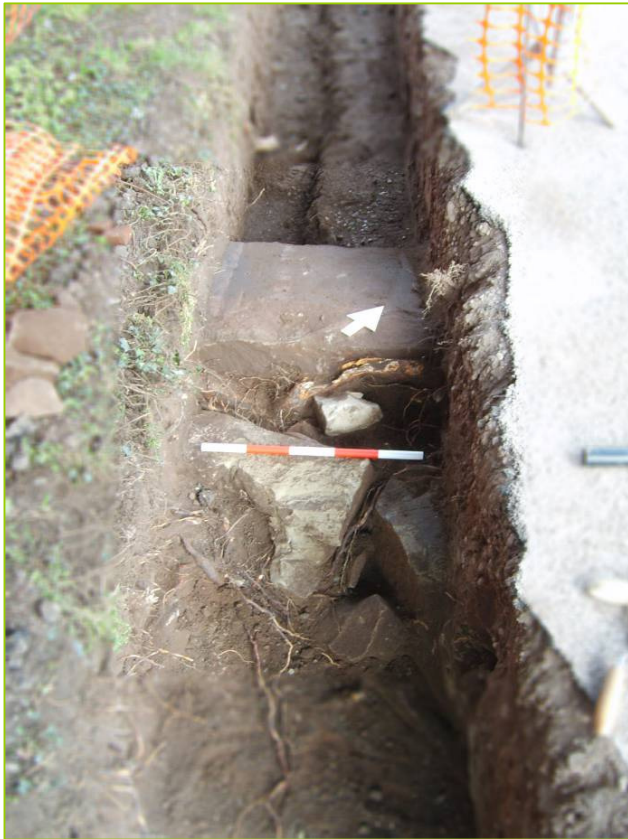
Pl. 11 Stone rubble (307) in the pipe trench (looking north-west, scale 0.5m).

A deposit of sandstone rubble and worked stone fragments with adhering mortar (307) was identified about 24m to the south-east of the south porch. Part of a 0.63m wide dressed stone slab, perhaps the lid of a monument, had been included with the rubble (Pl. 9). The deposit protruded up into the upper churchyard soil layer (204)/(305) as an uneven mound about 1.5m wide and at least 0.3m high. The only dating material here was in the overlying layer (305), which contained medieval floor tile fragments and a sherd of post-medieval pottery. There was no obvious reason for the rubble (307) at this location, although part of a 0.94m wide, north-east/south-west aligned wall foundation of sandstone blocks (306) was found beside the adjacent path 2.5m to the south. The yellow/grey dressed and mortared blocks of that foundation, ranging from 120mm x 100mm x 100mm to 530mm x 370mm x 250mm, survived as a single tightly packed course. There was some evidence of tumbled stone on the northern side (Pl. 10). This feature was not evident in a trench cut across the path to Lighting Hub 3, and its extent remains unclear. It could represent the base of a monument and not a wall foundation; one block was described as being shaped similar to a plinth base.

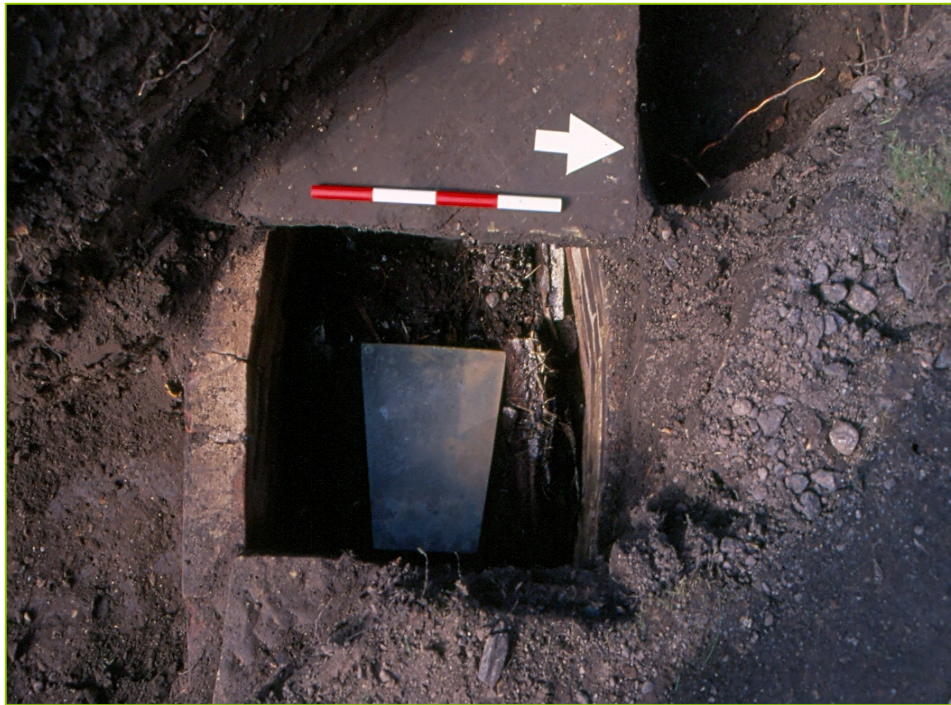
Pl.12 Brick lined grave (318), with capstones removed. The wood coffin and name plaque can clearly be seen within.

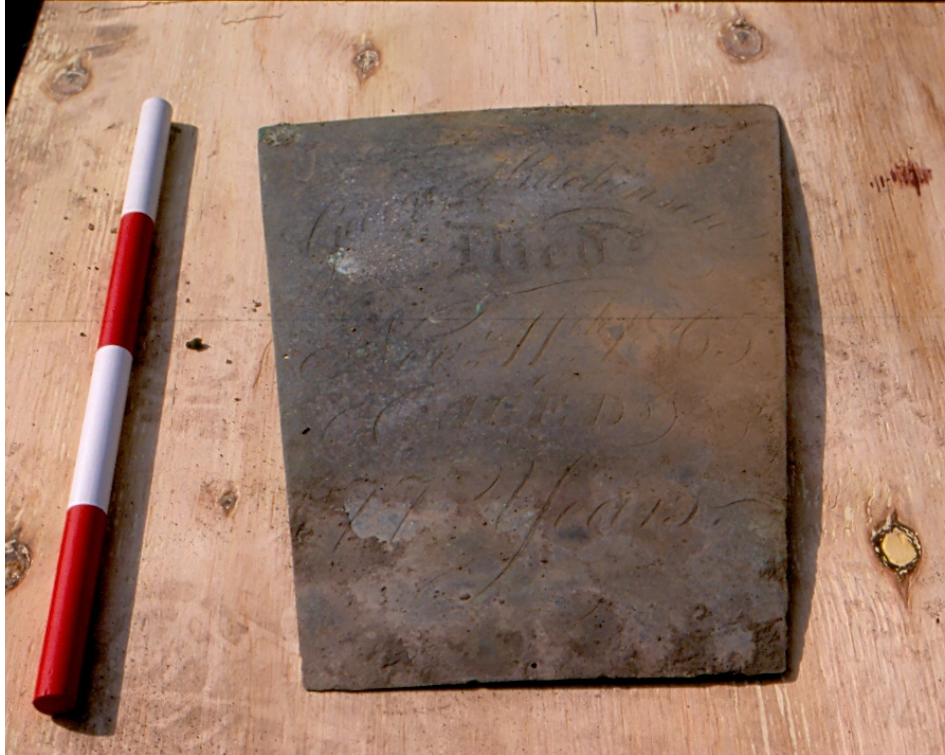
PI.13 Name plaque from within brick lined grave (318). Inscription reads 'George Hutchinson Died Nov 11th 1865 Aged 77 Years'.

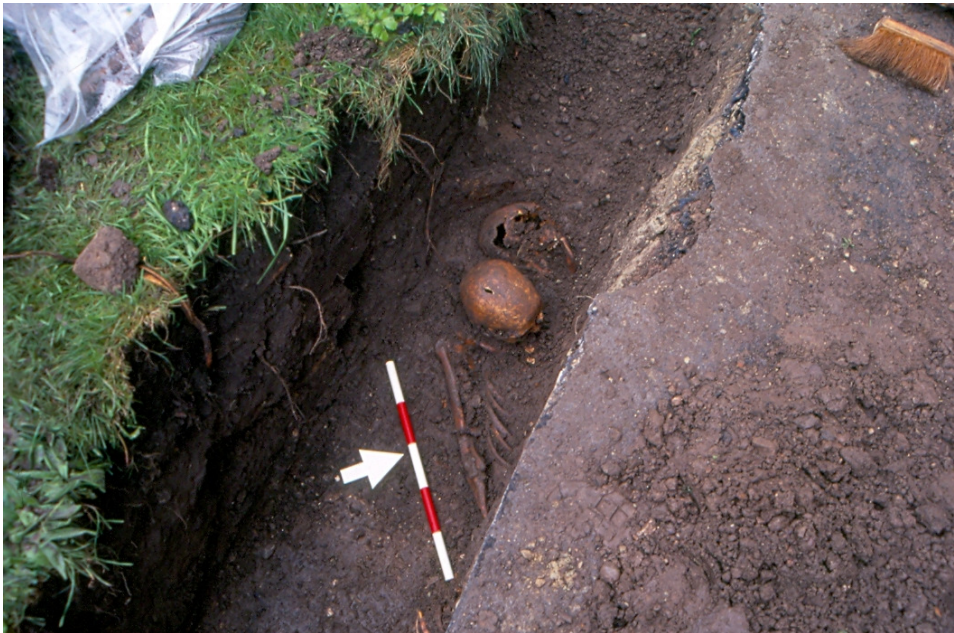
PI.14 Grave [324] (Sk 11 and 12), looking west. This grave was located to the southwest of the church within the external pipe trench. It was one of a number of graves located within this area.

To the south-west of the south aisle, skeletal remains Sk12 were identified in Grave [324] at a depth of about 0.45m below the path surface. The supine extended skeleton was aligned east-west, with the head at the west end but facing north. The cranium of a second skeleton Sk11 was also found within the grave. Coffin handles and nails were found in the grave (325).
