THE NEW VICARAGE, CHURCH WALK, BOURNE, LINCOLNSHIRE:
ARCHAEOLOGICAL RECORDING

NGR: TF 09691 20023
Planning Ref: S09/1362/Full
Site Code: BNVM 10
LCNCC Accn. No.: 2010.67
PCA Ref: 09/653

July 2010

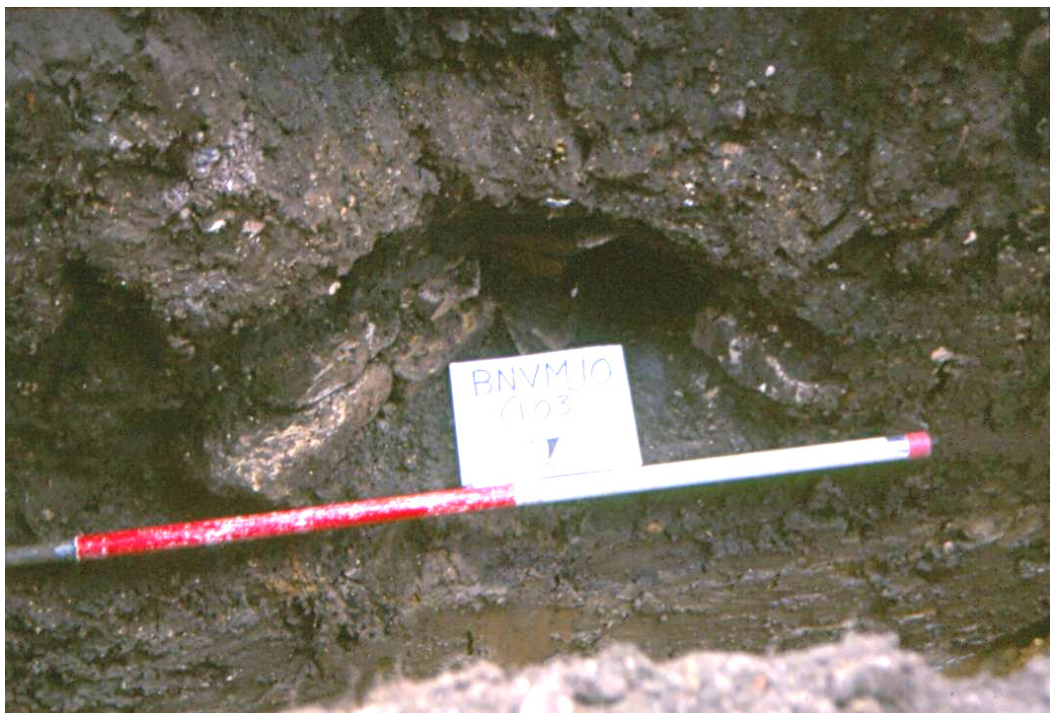
Pl. 3 Detailed shot of post-medieval drain (103), looking south. Scale 1m.

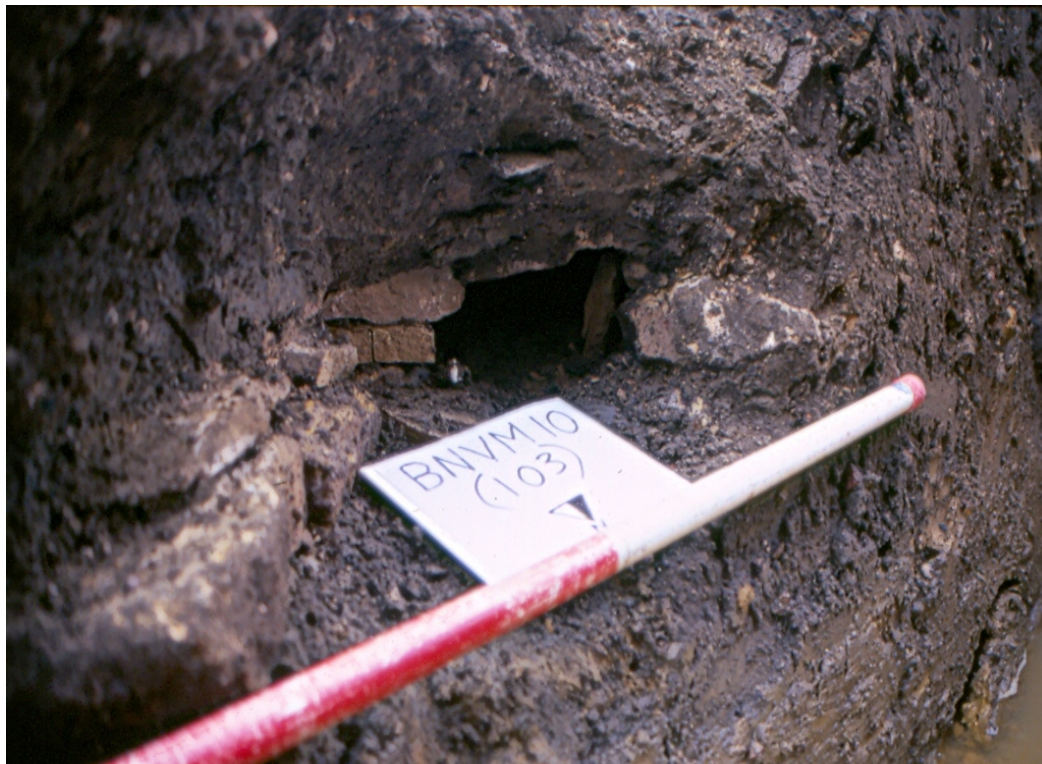
Pl. 4 Looking south-west along drain route exposed within the north facing face of the foundation trench (See section A).

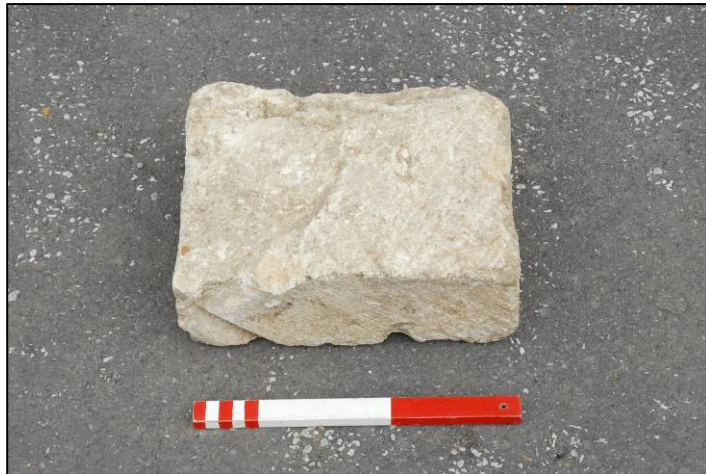
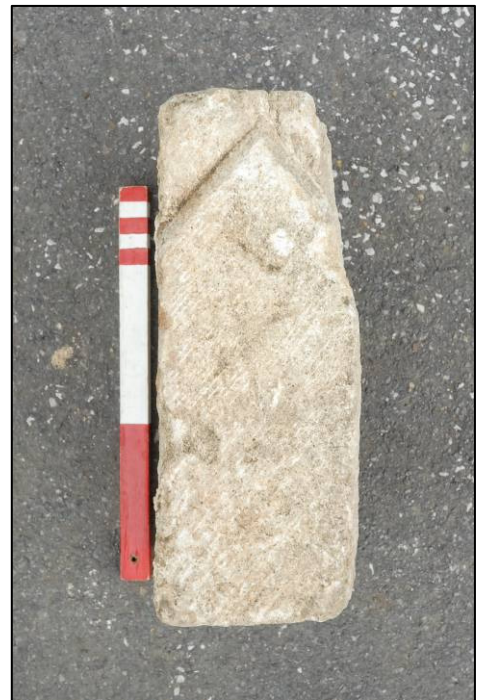
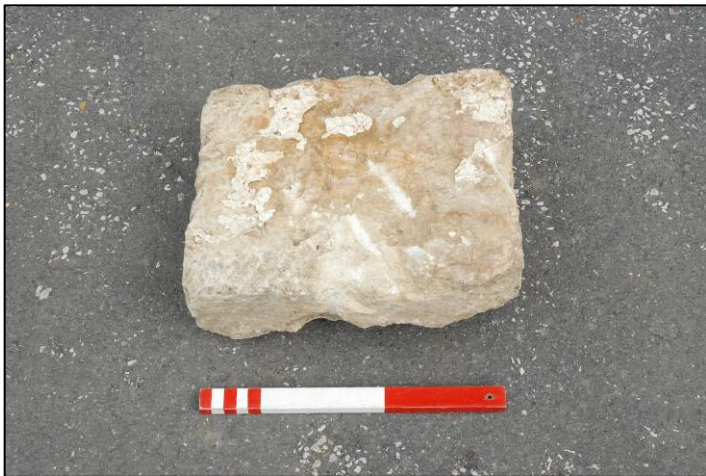
SF 1

Context: 103
Material: Oolitic limestone, probably Barnack
Colour: Off yellow/grey, occasionally orange
Conversion: Roughly squared
Dimensions: 265mm x 213mm x 98mm

Most faces display the remains of coarse diagonal chiselling (part of the squaring process) but one side has been given a smoother face with a finer chisel and this face has an incised 'chevron' (or 'V' shaped groove) near to its end. The groove is 20mm wide and 15mm deep, clearly part of a larger decoration. The angle of the faces of the groove is c.75° at its base, and the upper face has been locally thinned to 82mm on the side with the groove. With the exception of the decorated face, small amounts of a hard white lime mortar are present adhering to all surfaces but are predominantly present on the flat underside.

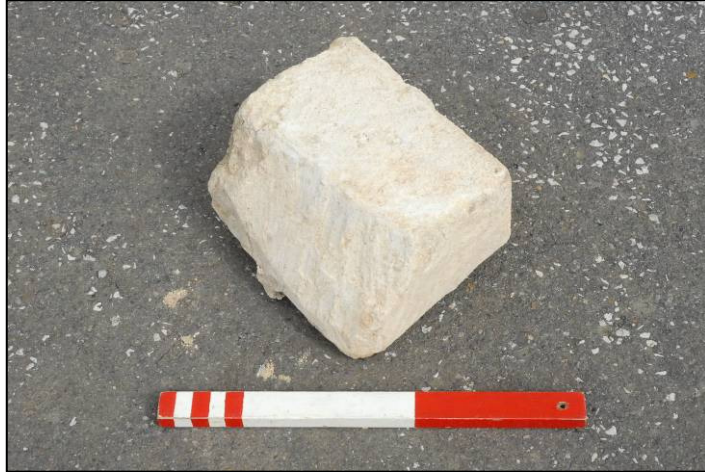
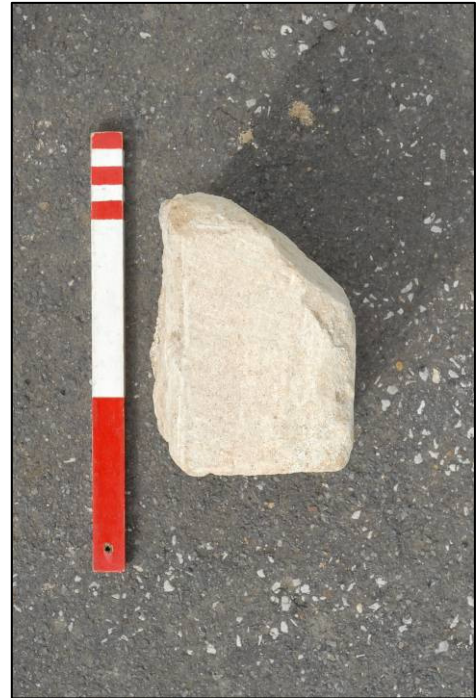
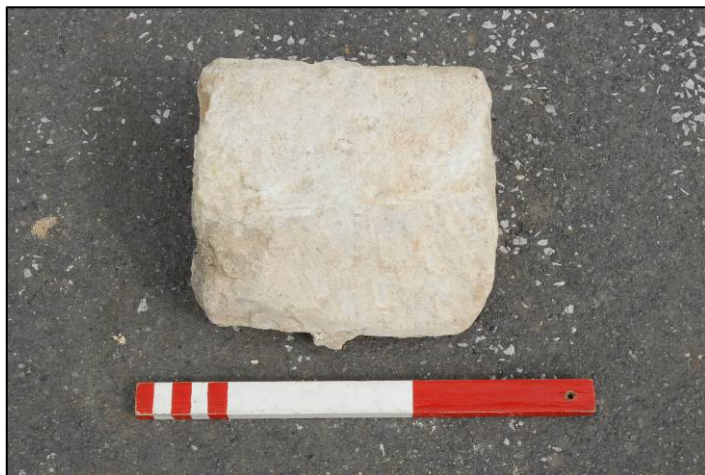
SF 2

Context: 103
Material: Lincolnshire limestone – probably Ancaster
Colour: Yellow/white
Conversion: Roughly squared
Dimensions: 158mm x 130mm x 85mm

Again, most faces display diagonal chisel marks. These are generally finer than those on SF1. The stone displays a clearly chiselled chamfer, however this is not regular to the block, being deeper and better defined on one side (where it is 80mm from the back edge and 24mm from the lower edge and at c.45° where well defined). The chamfer appears to only have been roughed out: it displays obvious deep chisel marks, from a tool with an edge at least 35mm in length. The unfinished appearance, and the presence of mortar on the lower edge of the chamfered face suggests that it may be reused or possibly an unsatisfactory practice piece later incorporated into a wall with the chamfer hidden.
