**THE COTTAGE, POST OFFICE LANE,
ASHBY-CUM-FENBY, NORTH-EAST LINCOLNSHIRE**

RETROSPECTIVE SCHEME OF WORKS

NGR: TF 2537 0073
PCAS Job No.: 746
Archive acc. code: ANAA

March 2011

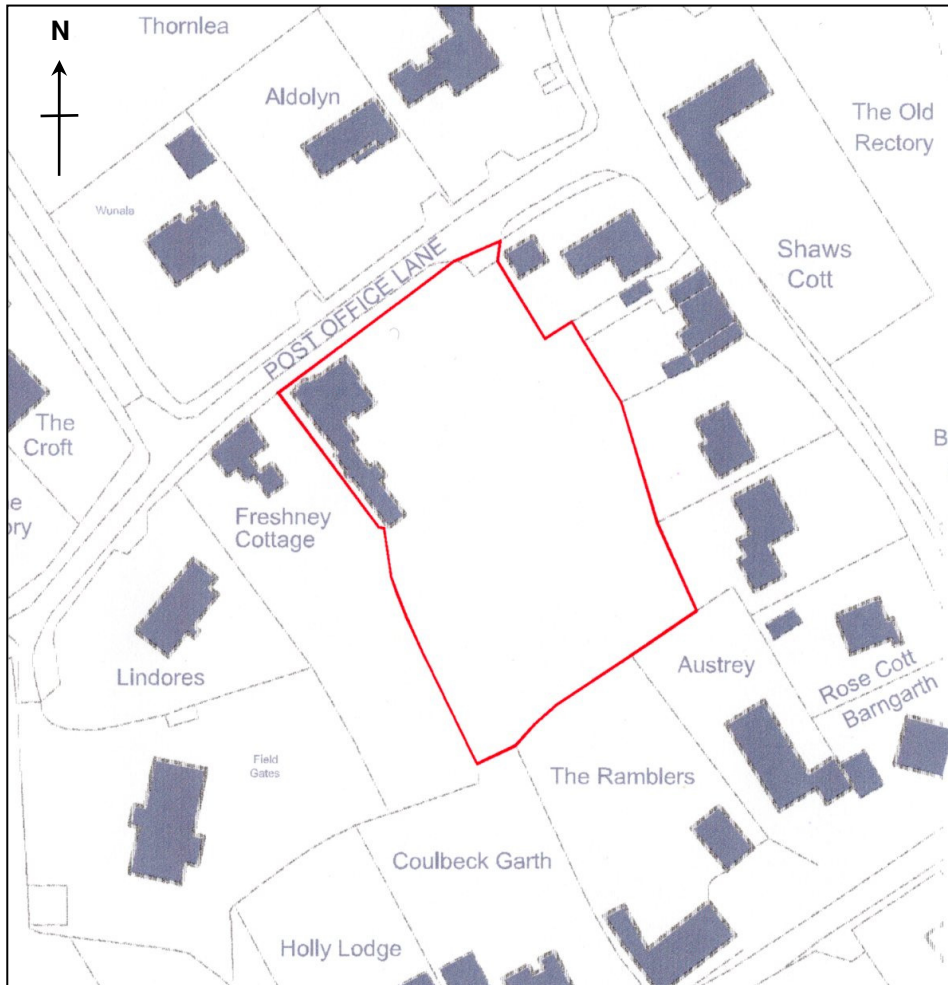
Figure 2: Location plan of the development site (outlined in red) at scale 1:1250. Plan supplied by Hodson Architects.

Post Office Lane is on the north side of Ashby-cum-Fenby, running in a south-easterly direction off the north-west to south-east running main road through the village. The development site fronts on to the south-eastern side of Post Office Lane, in an area characterised by new-build dwellings.

The site is a large, sub-rectangular plot, measuring roughly 70m x 45m, with the long axis oriented north-west to south-east. The Cottage, a modern dwelling, occupies the western corner of the plot; prior to the current development, the plot was otherwise chiefly open land, occupied by several derelict garage buildings and sheds and a greenhouse on a concrete base.

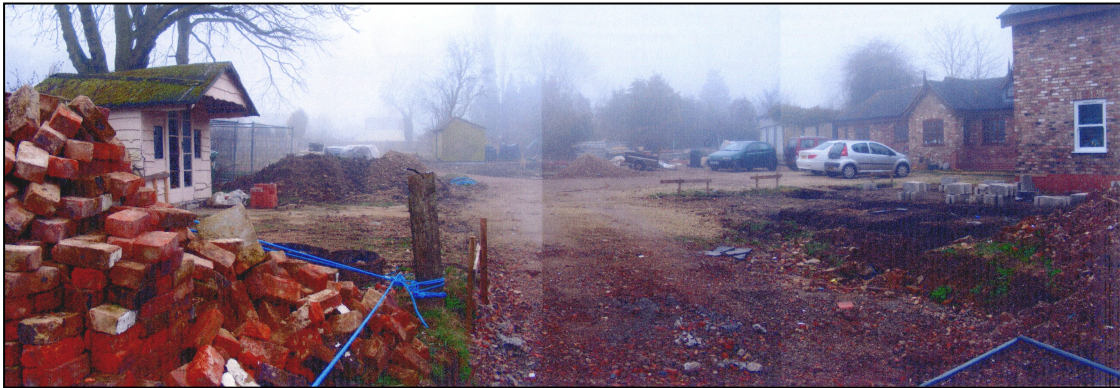
Plate 1: Composite shot of the site before trenching began, looking south from the site entrance.

Construction work on the house extension had been completed at the time of the archaeological intervention, and the foundations for the garage had been laid (plates 1 and 2). The 'remedial' trench was positioned close to the north-eastern side of the plot, in order to avoid newly laid drainage (fig. 3)

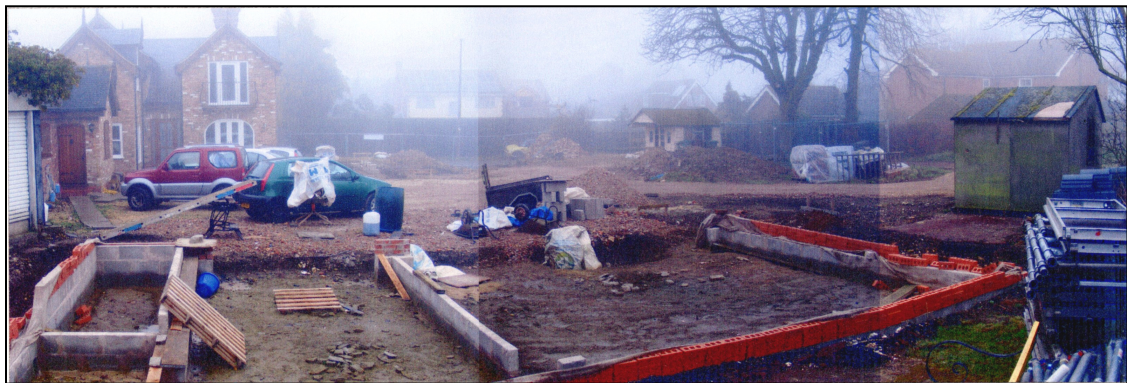
Plate 2: Composite shot of the site before trenching began, looking north towards Post Office Lane across the foundations of the new garage building.

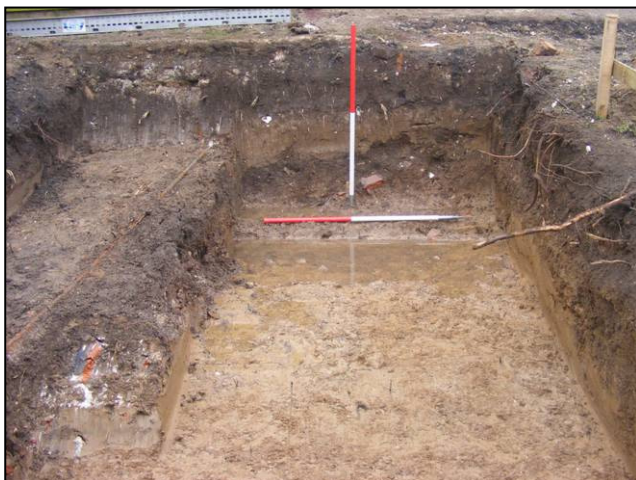
Plate 3: The south-eastern end of the trench, looking ESE, showing pit 005 and the course of the metal pipe that required the repositioning of the trench.

At the south-eastern end of the trench, layer 002 was cut by a large pit with irregular sides (plate 3). The full extent of pit 005 was not seen, as it extended beyond the trench footprint to the south and east, and it could not be excavated beyond a depth of 0.5m due to flooding. Two fills were recorded. The upper fill, 007, was a layer of redeposited material that appeared to be a levelling deposit; it was noted that the modern topsoil was deeper above the pit, indicating that considerable settling of its contents had occurred and repeated levelling actions had been necessary. Below fill 007 was a mixed clayey silt deposit, 006, which contained quantities of 19th and early 20th century refuse. Brick, mortar and pottery fragments were noted, but no animal bone was seen, suggesting a demolition dump rather than a midden.

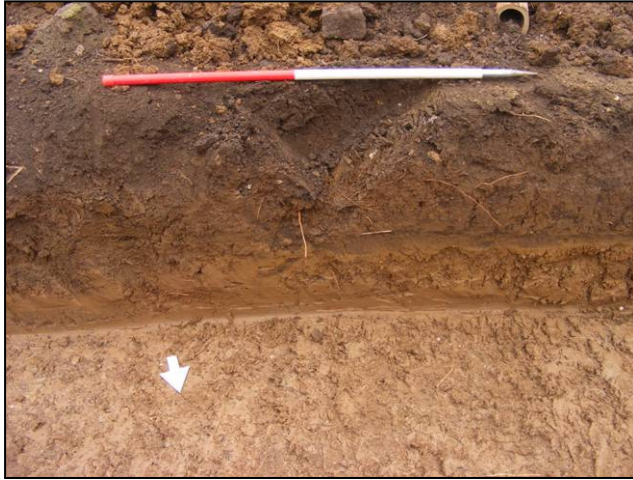
Plate 4: Sample section in the western side of the trench, looking west.

The buried topsoil 002 overlay a layer of dirty-looking reddish-brown clay, 003, which appeared to be a naturally arising subsoil (Plate 4). Below 003 was the natural glacial till, yellowish-brown clay 004: the interpretation of this deposit was confirmed by the excavation of a machine sondage (Plate 5).

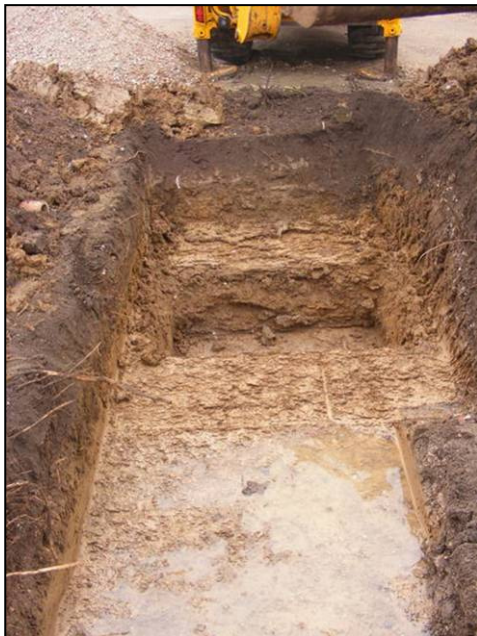
Plate 5: Excavation of a sondage in the north-western end of the trench, looking north-west.

The archaeological intervention took place on March 15th, 2011. The trench was excavated using a back-acting 180° excavator fitted with a smooth-bladed ditching bucket. It was 5.5m long and between 1.7m and 2.1m wide, and was excavated to a depth of 1.0m, slightly below the surface level of the natural glacial till (context no. 004). Initial excavation encountered a shallowly buried metal pipe: excavation was halted in this area, and the trench was moved 0.5m to the west in order to avoid it (plate 3). An additional sondage was machine excavated 0.70m into the natural to ensure that it had been correctly identified as such (plate 5).
