GENERAL BUILDINGS, BRAYFORD WHARF EAST, LINCOLN

ARCHAEOLOGICAL MONITORING AND RECORDING

CoLC Planning Ref.: 2008/0429/F
NGR: SK 97360 71093
Acc No: LCNCC: 2010.79
Site code: LBEG 10
PCA Ref: 662

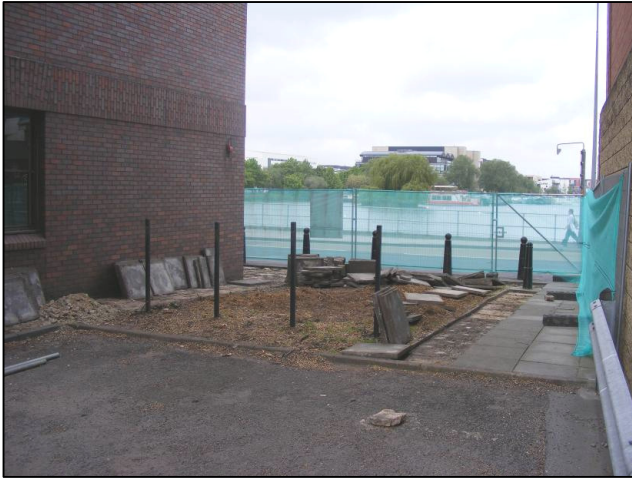
The site was previously covered in concrete slabs and tarmac, and contained a small area of ornamental planting. Ground level is c. 5m OD and slopes gently down to the northeast, towards the roadside. The geology of the area broadly comprises alluvium overlying Lower Lias clay, shale and rare limestone (BGS 1973).

Plate 1: General shot of the site before works began, looking northwest towards the Brayford Pool.

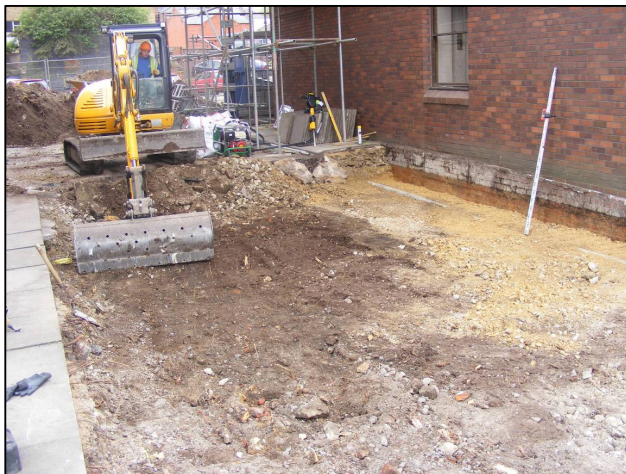
Initial excavation was carried out using a tracked excavator fitted with a 1.2m wide toothless ditching bucket (plate 2). This only removed modern material and no archaeological deposits were encountered. Excavation extended to a maximum of no more than 0.6m below the existing ground surface on the eastern side of the site, while the western side was excavated to less than 0.5m (blue broken line on fig. 2); features and deposits in this area were drawn, but not recorded.

Plate 2: Machining in progress on the eastern side of the site, looking southeast.

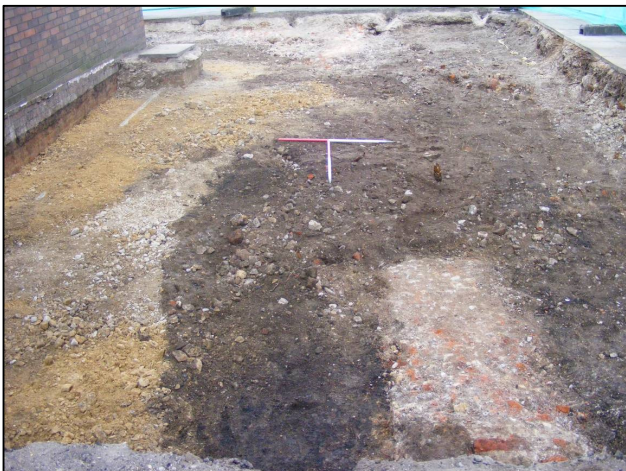
Plate 3: The eastern area of the site after cleaning and recording, looking west, with structure 003 in the foreground.

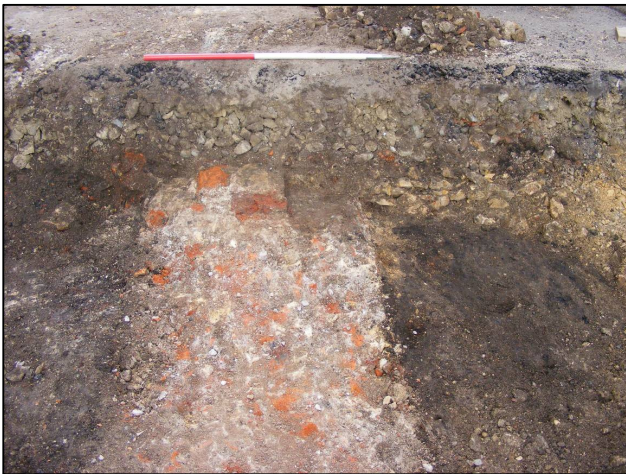
Two features were observed to have cut deposit 002. Structure 003, within construction cut 004, was a wall footing of crushed brick and cement, with a remnant

of brick wall surviving close to the section. (A similar footing was seen on the western side of the site, but was not recorded, as it lay within the area where the excavation depth had not reached 0.5m.) On the southern side of the recorded area, irregular cut 005 lay adjacent to the extant building and contained a fill of crushed stone, 006: this feature, which more or less followed the building's footprint, appeared to be its construction cut.

Only two archaeological features, of limited interest, were recorded during the monitoring scheme. The large, irregular cut 005 appeared to be the construction trench for the General Building itself, and so can be dated to the 1970s. Wall footing 003 is very likely to be a remnant of Dickinson's Mill, a steam-powered flour mill believed to have been built in the 1840s, and recorded prior to its demolition in 1972 (Stocker, 2003, p.352)

Plate 4: Structure 003, looking east towards the edge of the excavated area, showing the remnant of brick wall above the cement and crushed brick footing.

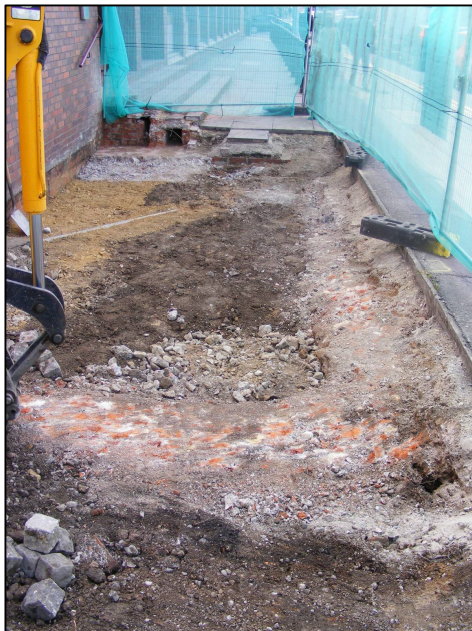
Plate 5: The unrecorded western area of the site after machining, looking south-west, showing the wall footing corresponding to structure 003.
