**Land at Windrush View
Lansdowne
Bourton-on-the-Water
Gloucestershire**

Programme of Archaeological Work

CA Project: 6315
CA Report: 18705
OASIS: cotswold2-335304

February 2023

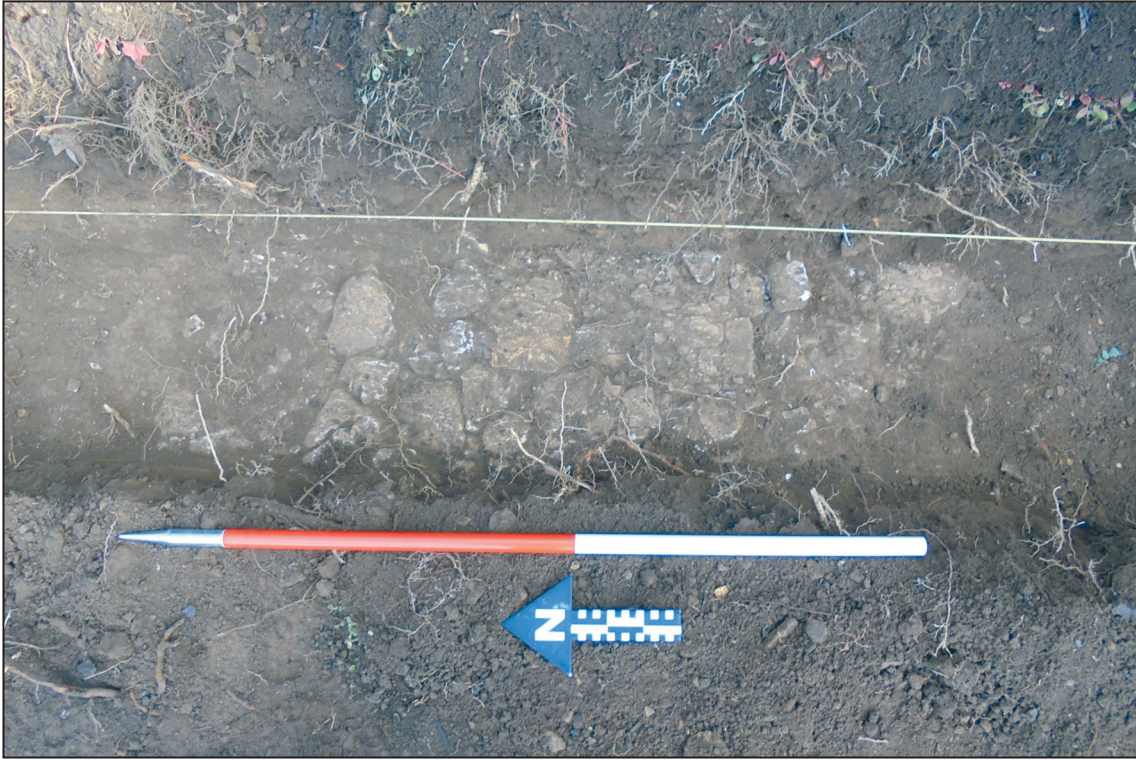
3

Wall 102, looking east (1m scale)

- 5.4. Wall 102 (Fig. 3) was identified within the south-eastern extent of the excavated area. It was aligned east/west and measured 1.1m in width. Wall 103 was located approximately 4m to the north of wall 102 and was also aligned broadly east/west, measuring 1.7m in width. Wall 104 (Fig. 4), recorded c. 2m to the west of wall 102 at the southern extent of the excavated area, was aligned north/south and measured 1.3m in width. Further investigation of the walls was not undertaken as they were below the formation level of the proposed construction groundworks and were to be preserved *in situ*. No artefactual material was recovered.

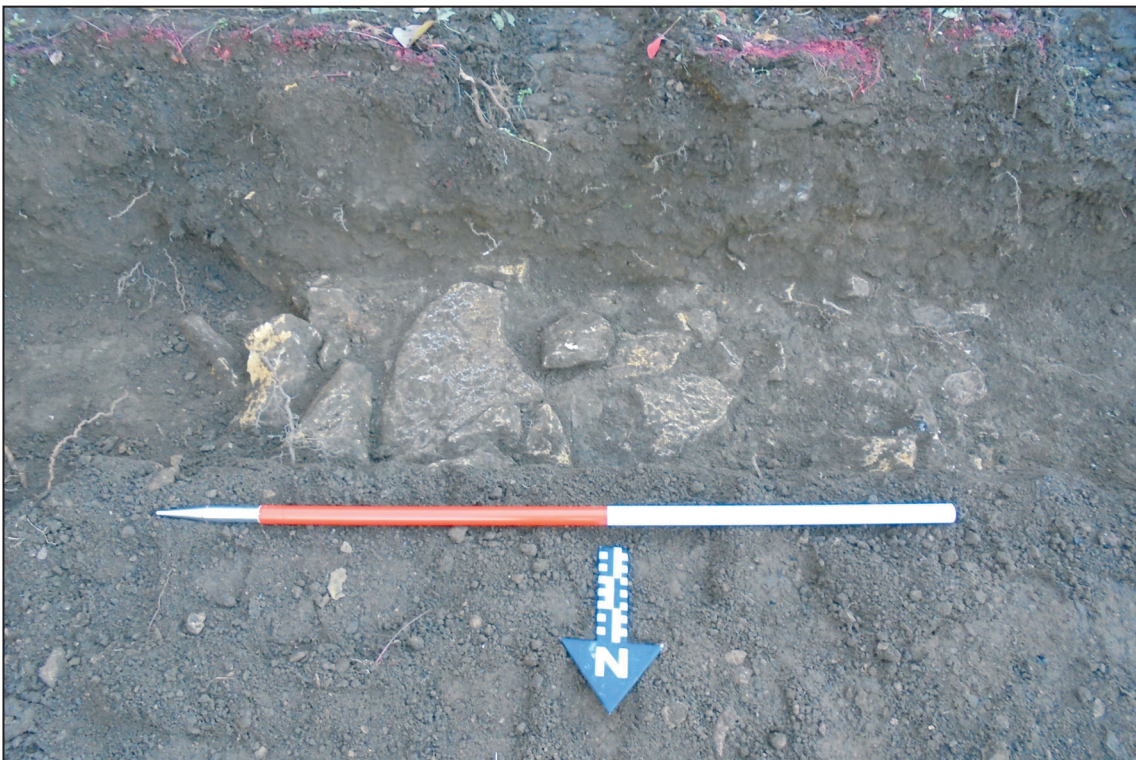
4

Wall 104, looking south (1m scale)
