Peel Centre
St Ann Way
Gloucester

Programme of Archaeological Investigation

CA Project: 6577
CA Report: 18262

August 2018

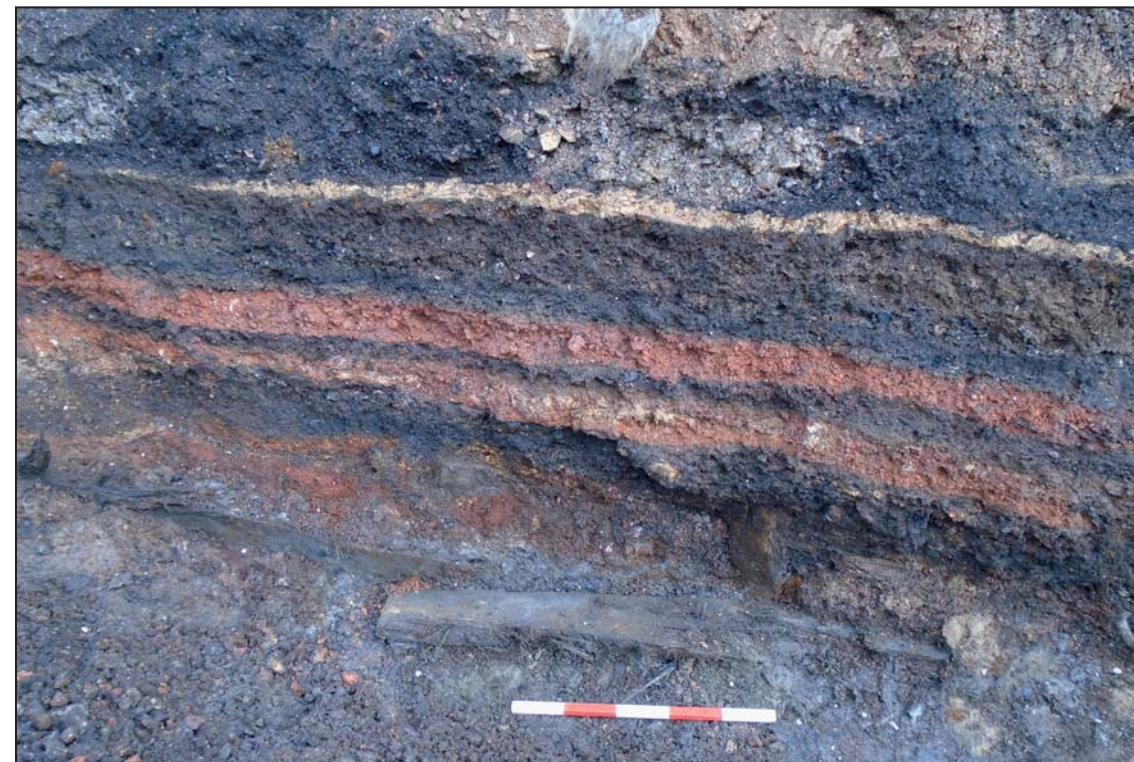
FIGURE TITLE
Trench 10: section and photograph

- 5.2 Trench 10 included the removal of concrete footings associated with a recently demolished building formerly occupying a large area in the central and north-eastern part of the site. Alluvial deposits 1034 (Fig. 3; Section AA) and 1045 comprised blue to light brown clay and silts, which were overlaid by dumped deposits 1033 and 1044 (not illustrated). These were up to 0.30m thick and included dark grey silts rich in charcoal and dark brown degraded wood deposits, interleaved with lenses of white sand and orange-red crushed building material. At the south-eastern end of the trench deposit 1033 was sealed by a sequence of overlaying mortar surfaces and their bedding layers (1031/1032, 1029, 1023, 1020, 1019, 1016, 1015 and 1014 respectively; Fig. 3; Section AA). These possible surfaces included a mixture of mortar, crushed brick and ash, each between 0.1m and 0.15m thick, with an overall total thickness of approximately 0.6m.

- 5.3 The sequence of surfaces was punctuated by a number of construction events associated with the development of the site. The earliest of these comprised trench 1030, which contained a lead pipe and was cut from the top of layer 1028/1029 (Fig. 3; Section AA). Cutting through from the top of layers 1017 and 1019 was cable duct 1026, which was constructed in timber coated with pitch. Possibly associated with the latest of these surfaces, 1014, was possible foundation wall 1011, comprising one remnant course of brick. The wall survived to 0.47m in width and 0.7m in depth and was clearly truncated by robber cut 1012. Later truncation associated with the 1990's development of the site comprised possible foundation trenches 1007 and 1009. This sequence was sealed by crushed stone bedding material 1001, associated with the levelling of the site prior to the erection of the cinema structure on the site.

Section AA

Photograph of cable duct 1026, looking north-east (scale 0.5m)

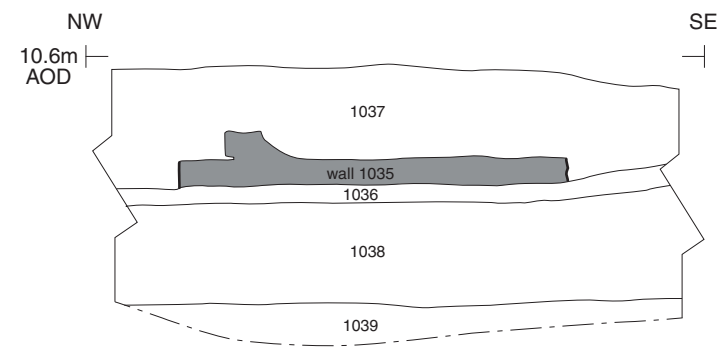
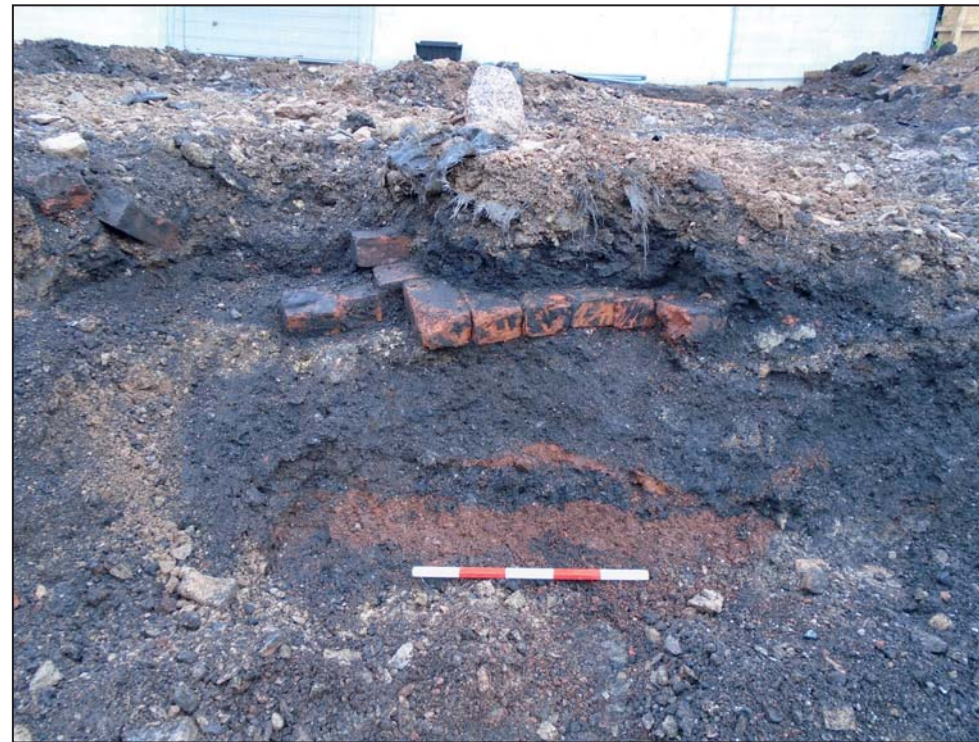
Section BB

- 5.4 To the west, possible surface 1039 (Fig. 4; Section BB), comprising compacted crushed brick (similar to 1028 further east), measured up to 0.12m thick and was overlaid by dumped layer 1038, which included very dark brown/black silt with cinders and brick fragments and measured 0.3m in thickness. Dumped deposit 1038 was in turn sealed by possible bedding layer 1036, comprising light grey lime mortar, 0.1m thick, which lay beneath brick floor surface or wall 1035, which was recorded only in section. It measured 1m in length, over 0.25m in width and 0.8m in height. Structure 1035 was sealed by demolition deposit 1037, which comprised black cinders with brick fragments and measured up to 0.3m thick.

Wall 1035, looking north-east (scale 0.5m)

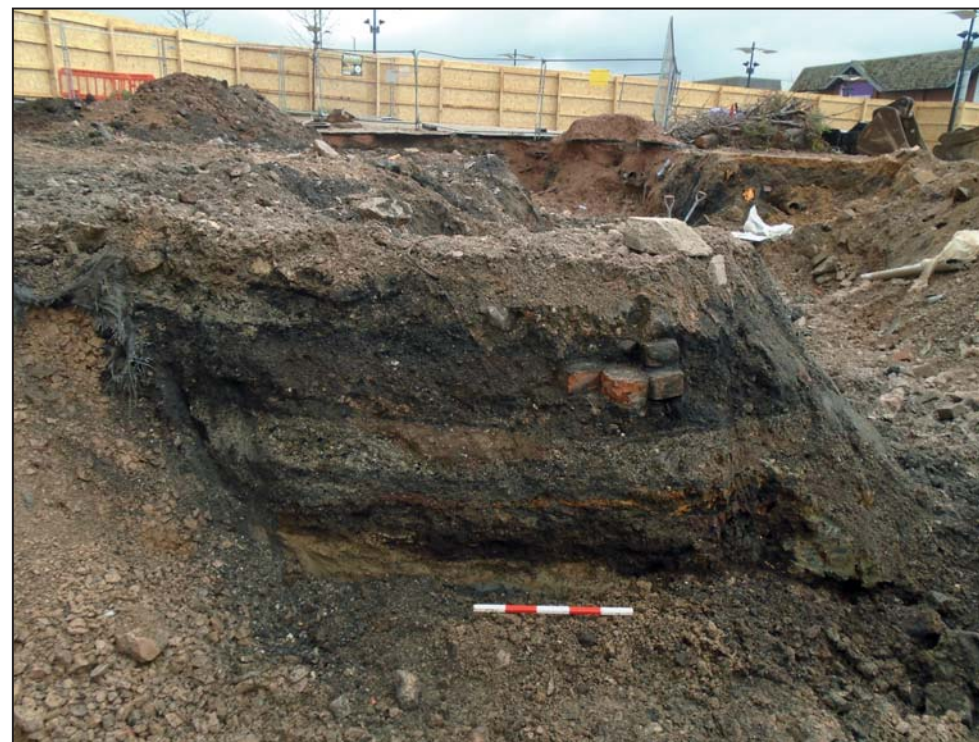
Section CC

- 5.5 A similar sequence was observed further west along the southern part of the trench where alluvial clay 1045 was overlaid by dumped deposits 1044 and 1043 (Fig. 4; Section CC). These layers were sealed by a deposit of cinders with brick fragments, 1042, which was 0.2m thick and was in turn truncated by the fragmentary remains of wall 1040. This comprised the lowest remaining two courses of brick and measured 0.4m in width and 0.15m in height. It was sealed by another deposit of cinders and demolition rubble, 1041.

Wall 1040, looking south-east (scale 0.5m)

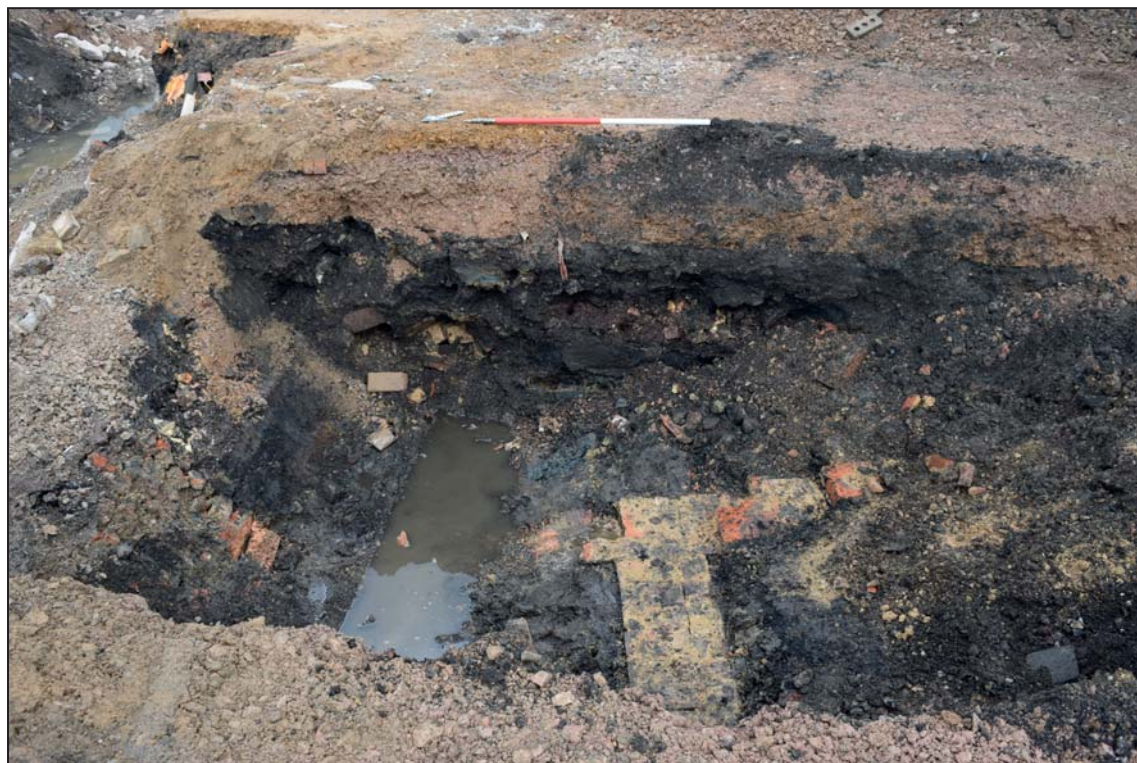
- 5.6 Excavation of Trench 15 exposed redeposited mid blue grey alluvium 1505 which, whilst similar in colour to the natural substrate found across the site, included common flecks of charcoal and wooden fibres at a depth of 1.45m bpgl. The height of the upper surface of this deposit, and the nature of the inclusions contained within it, suggest that layer 1505 was redeposited during construction works broadly contemporary with structures identified in Trench 10 and elsewhere across site. North-west/south-east-aligned possible partition wall 1502 was exposed at a depth of 0.88m bpgl, abutting north-east/south-west-aligned red brick wall 1503, which extended along the length of the trench, having previously been identified within the south-west facing section of the trench at a depth of 0.64m bpgl (Fig. 5). Made ground 1501, identified as the same as destruction layer 1005 in Trench 10, covered these wall courses to a depth of 0.52m bpgl, and was in turn sealed by modern bedding layer 1500.

Walls 1502 and 1503, looking south-east (scale 1m)

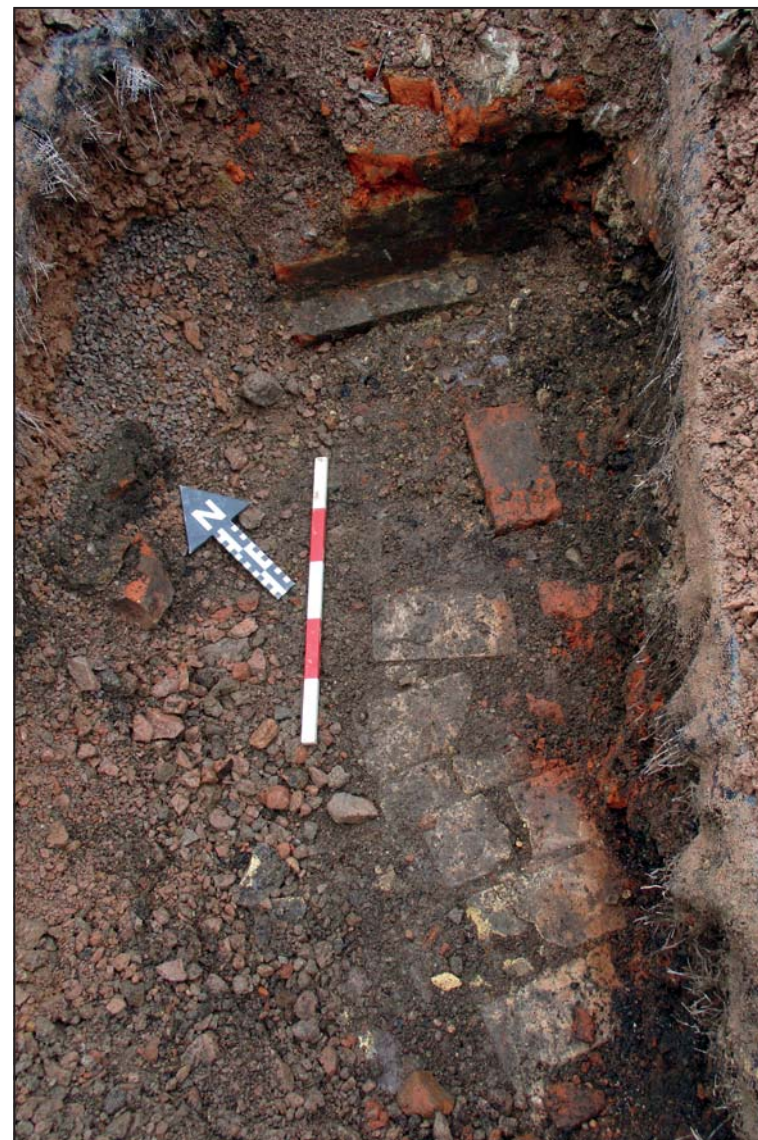
- 5.7 Excavation to a depth of 0.92m bpgl within Trench 16 also identified structural remains. North/south-aligned wall 1604, of irregularly coursed stock red brick, was exposed within the western half of the trench. At its northern extent, it appeared to

adjoin east/west wall 1603, however this relationship was obscured by later east/west-aligned drainage channel 1607. Brick wall 1605, identified only in section, appeared to represent a return to wall 1603, or possible capping for drain 1607.

- 5.8 These structures had clearly been heavily truncated within the north-eastern part of the trench by modern construction works. The surviving structures had been covered by modern geotextile membrane and hardcore 1601, associated with the cinema development.

Walls 1603, 1604 and drain 1607 capped by 1605, looking north-east (scale 0.5m)

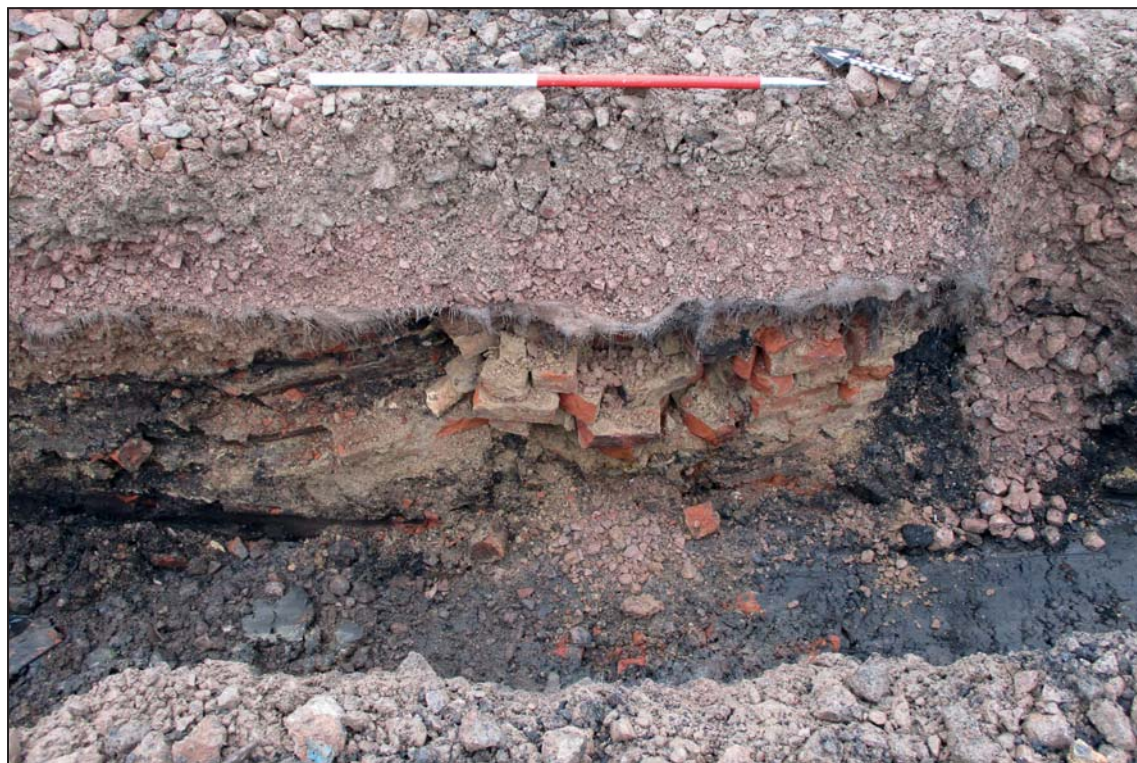
- 5.9 Service Trench 18 was excavated to a depth of 1.3m bpgl, revealing a number of red brick walls. Walls 1805, 1807 and 1810 had a broad north/south alignment, whilst 1806, 1808 and 1809 were orientated broadly north-west/south-east. As they were all constructed in unfrogged red stock bricks with an English bond they were probably broadly contemporary. The walls were all sealed by clay, cinder and ash deposit 1803, which was in turn covered by a geotextile membrane and two layers of hardcore, 1802 and 1801 respectively, deposited prior to the most recent construction on the site.

Wall 1808, looking north-east (scale 1m)

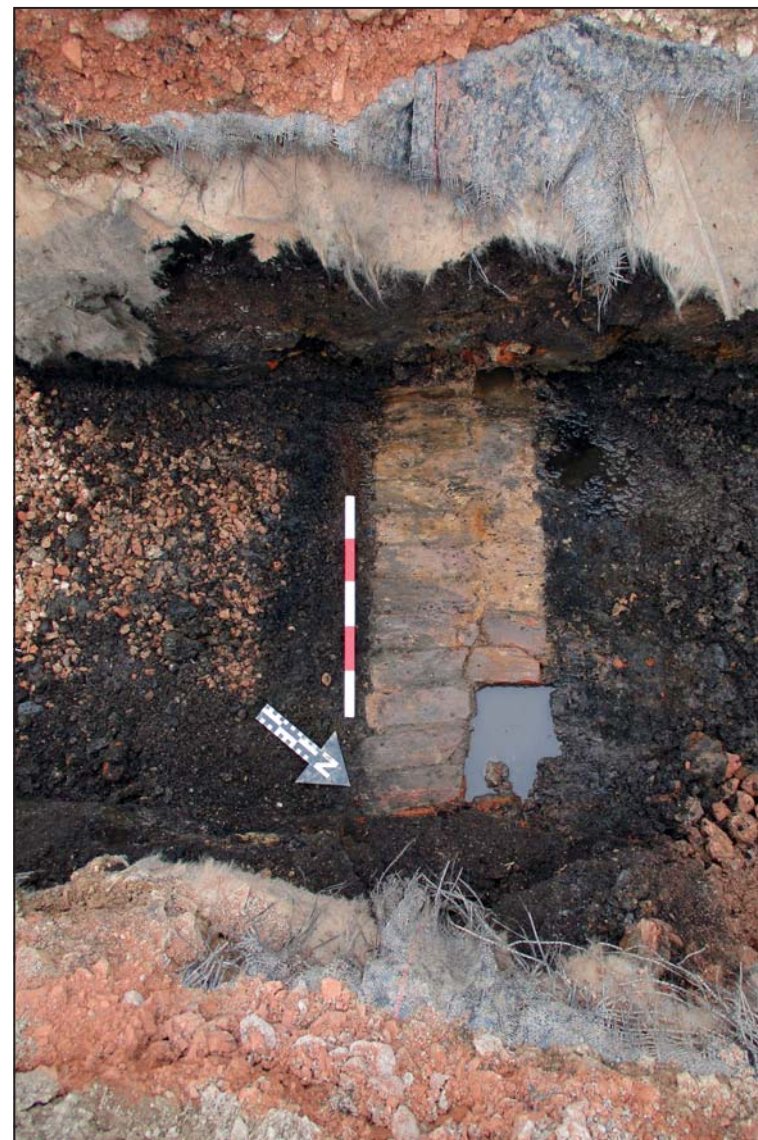
Wall 1810, looking south-west (scale 0.5m)

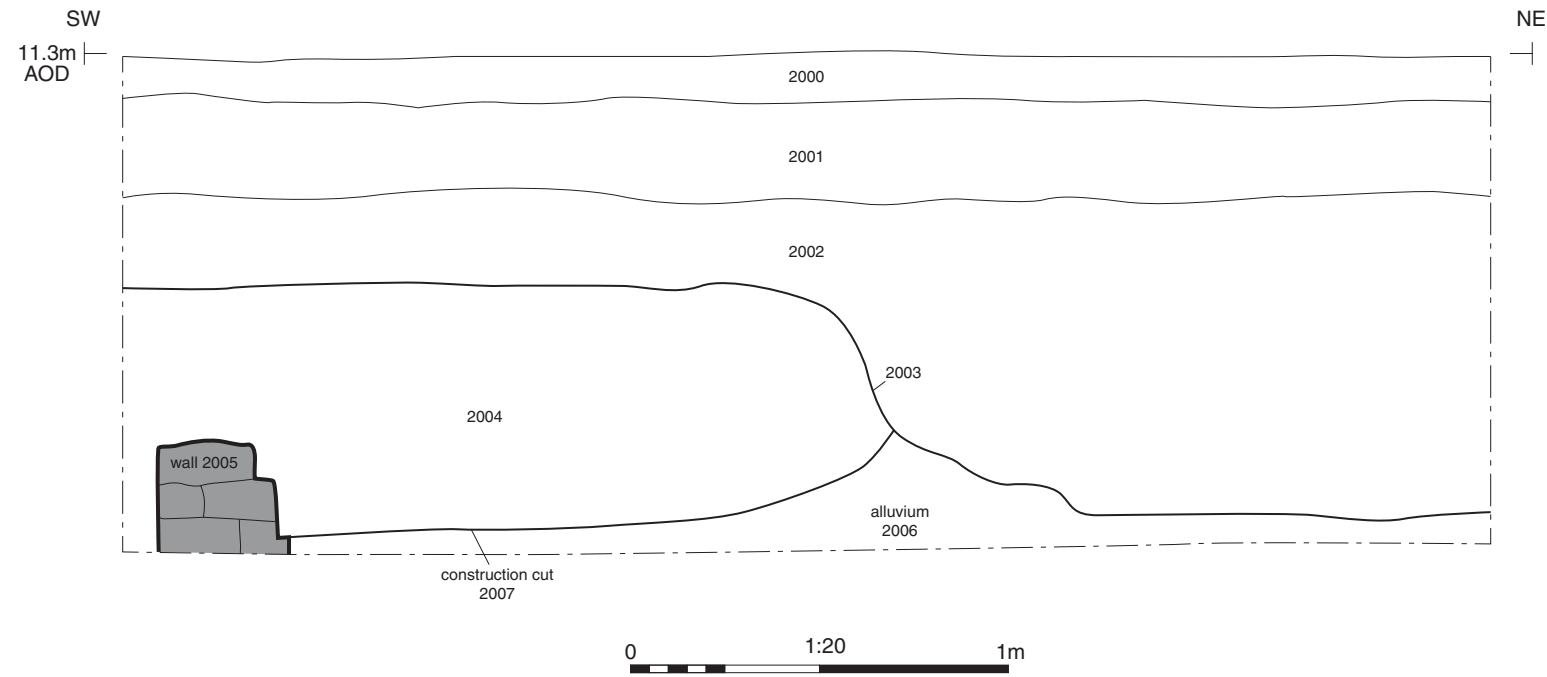
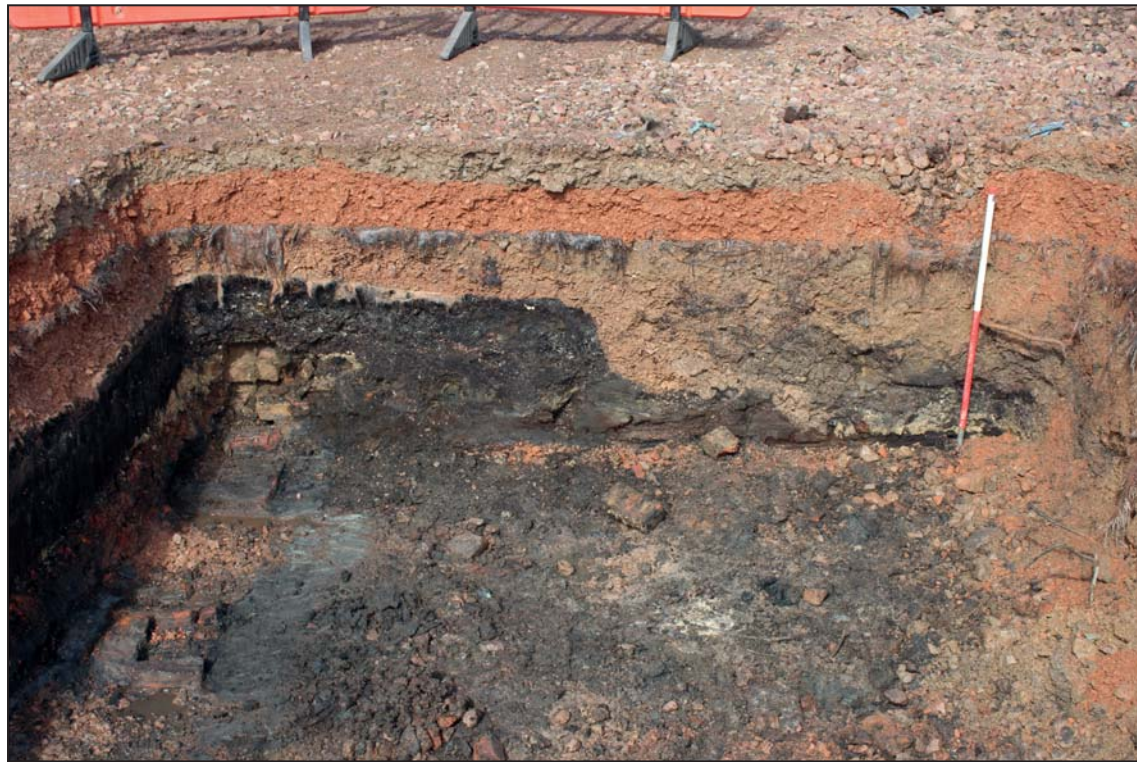
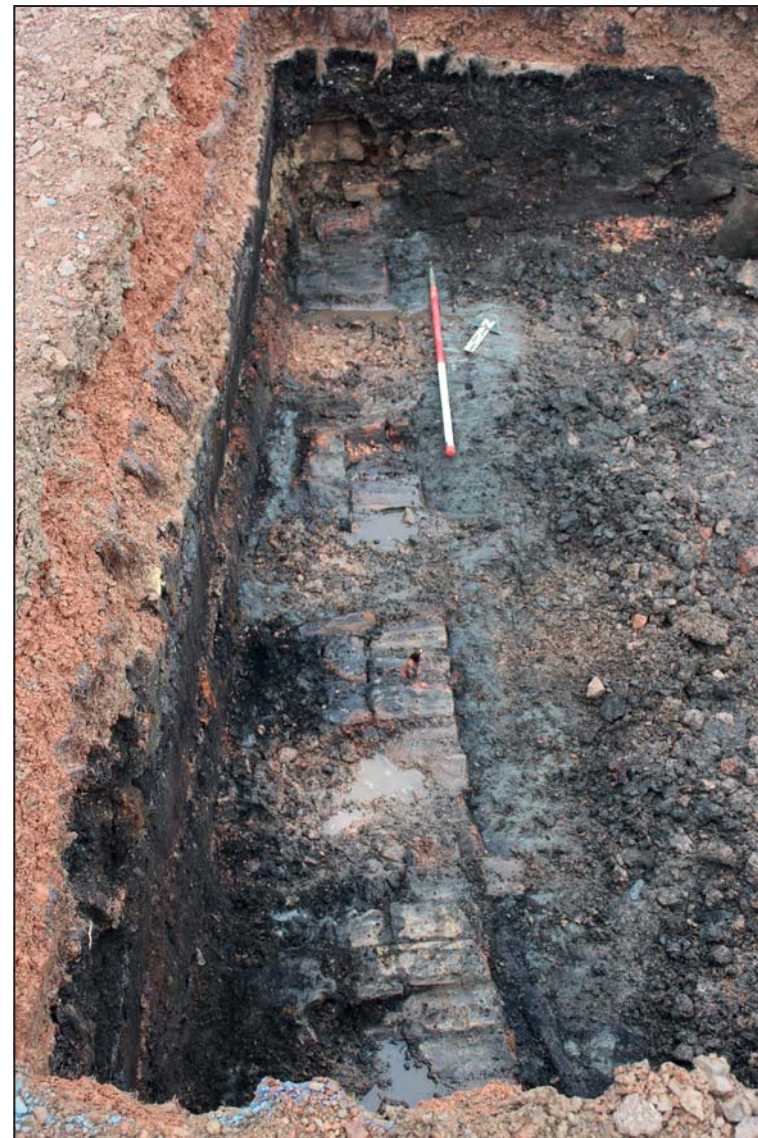
Section DD

- 5.10 Within Trench 20, blue green alluvial deposit 2008 was exposed at a depth of 1.3m bpgl. Into this layer, wall 2005 was cut, on a north-west/south-east alignment. The unfrogged red stock brick wall extended along the length of the trench (Fig. 7), and is likely to be associated with recorded in Trench 18. Like the walls in Trenches 15, 16 and 18 it was sealed by layer of ash, cinder and clay, recorded within this trench as deposit 2004. Deposit 2004 was truncated by modern cut 2003, which was in turn sealed initially by make-up deposit 2001 and finally by modern hardcore levelling deposit 2000.

Wall 2005, looking north-west (scale 1m)

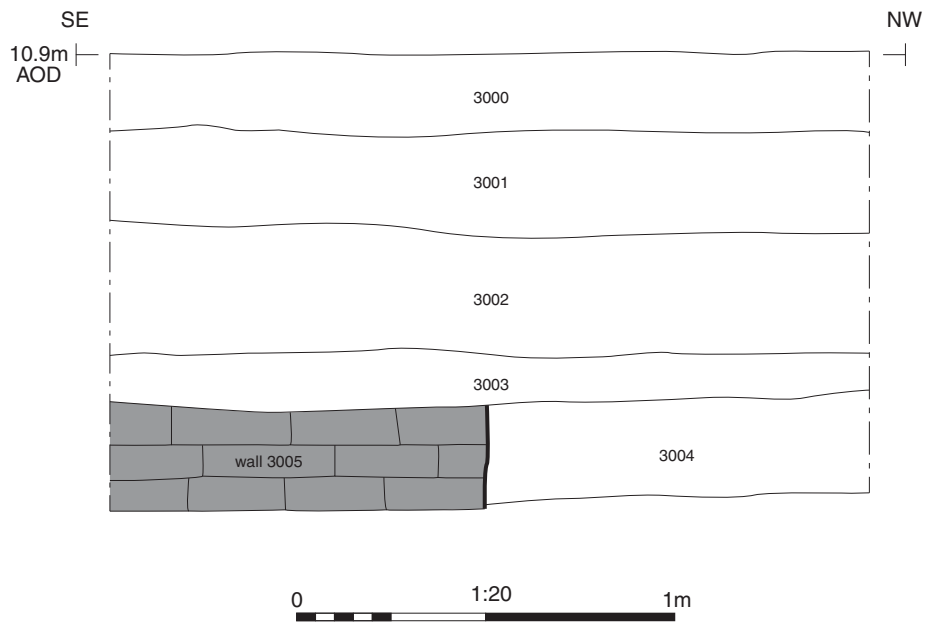
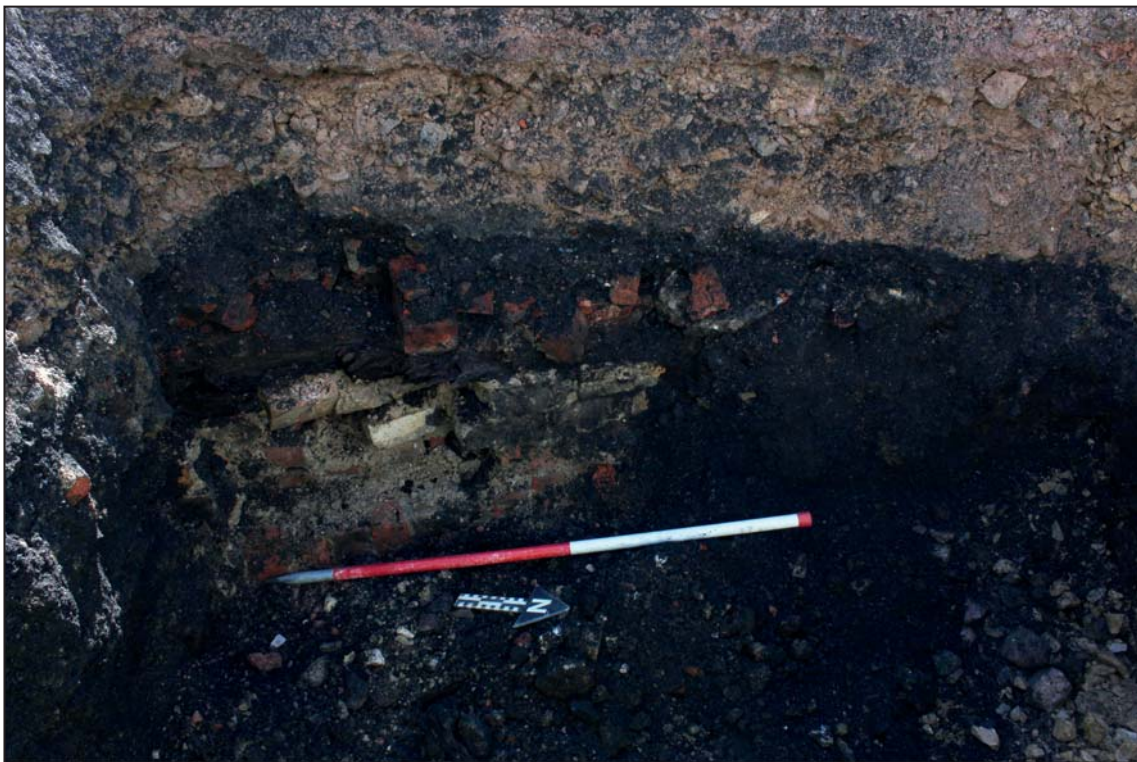
Section EE

- 5.11 Alluvial deposit 3006 was exposed at a depth of 1.2m bpgl. This was overlain by dark grey/black cinder layer 3004. Within the north-east-facing section of the trench, wall 3005, comprising at least three courses of red unfrogged bricks, was exposed at a depth of between 0.86m and 1.2m bpgl (Fig. 8). No construction cut was visible for 3005 through deposit 3004, therefore it is unclear whether the latter abutted the wall or was cut by the construction of it. Both deposit 3004 and wall 3005 were sealed by demolition rubble 3003, which was in turn overlain by demolition rubble

3002 (the same as 2004 in Trench 20) and modern levelling deposits 3001 and 3000 respectively.

Wall 3005, looking south-west (scale 1m)

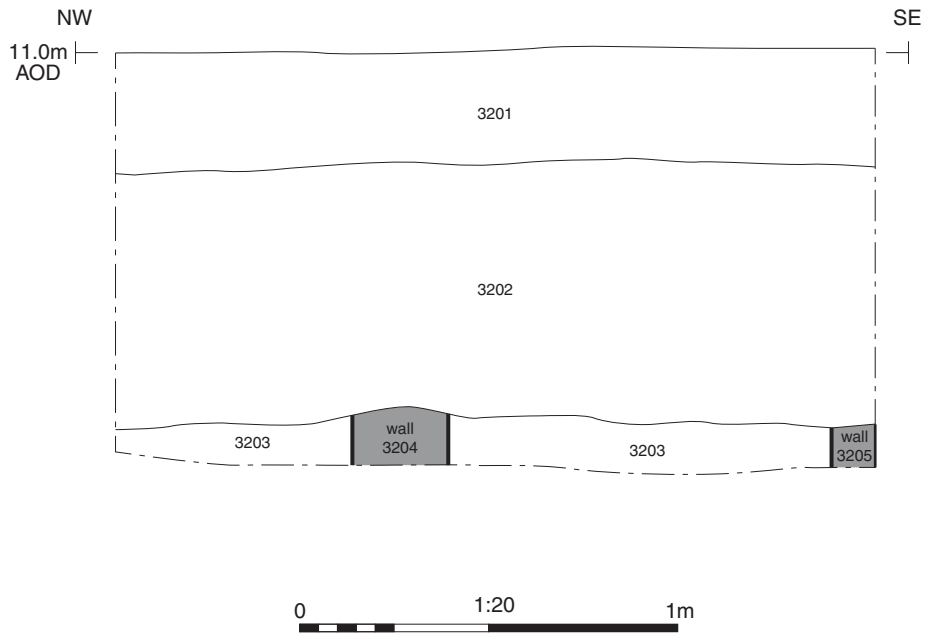
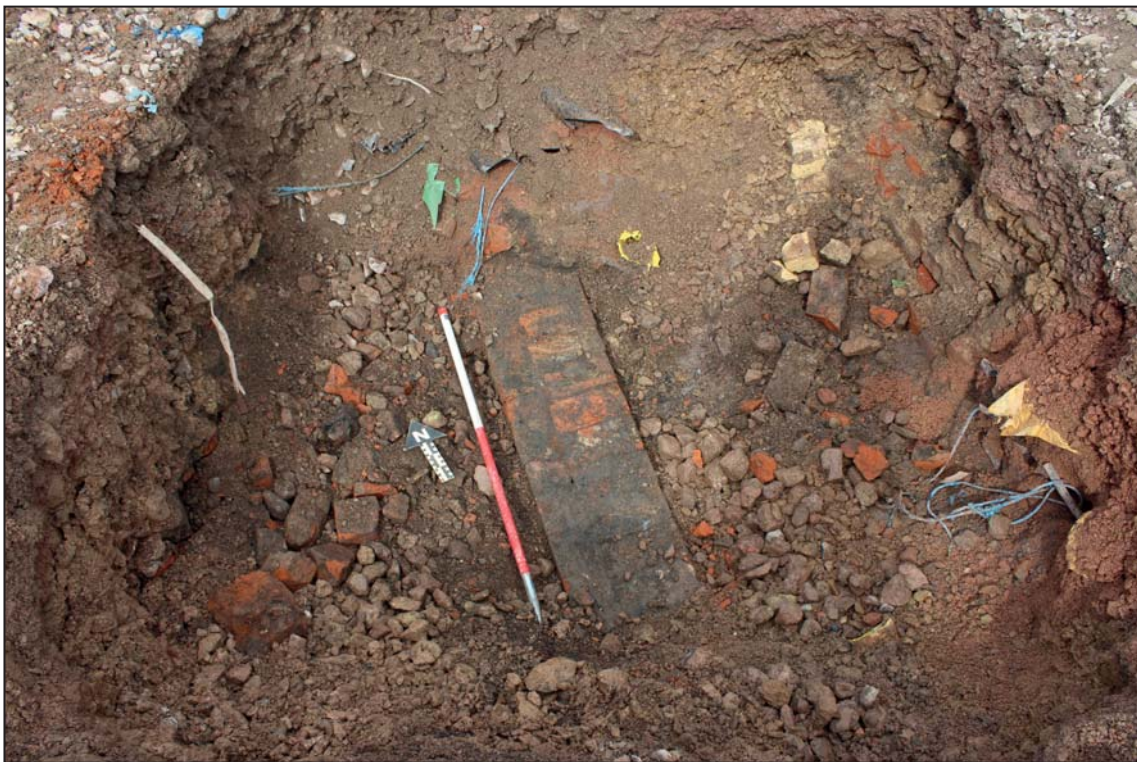
Section FF

- 5.12 Within Trench 32, two parallel, north-east/south-west-aligned red brick walls, 3204 and 3205 were exposed at a depth of approximately 0.95m bpgl. Wall 3205 was revealed within the eastern corner of the trench, whilst wall 3204 ran through the centre of it (Fig. 9). The walls were abutted by ash, cinder and clay deposit 3203, similar to that recorded elsewhere on site, where it more usually overlay the walls. Walls 3204 and 3205, together with deposit 3203, were covered by a substantial deposit of demolition debris, 3202, up to 0.7m thick, which was in turn sealed by crushed stone levelling layer 3201.

Wall 3204, looking north-east (scale 1m)

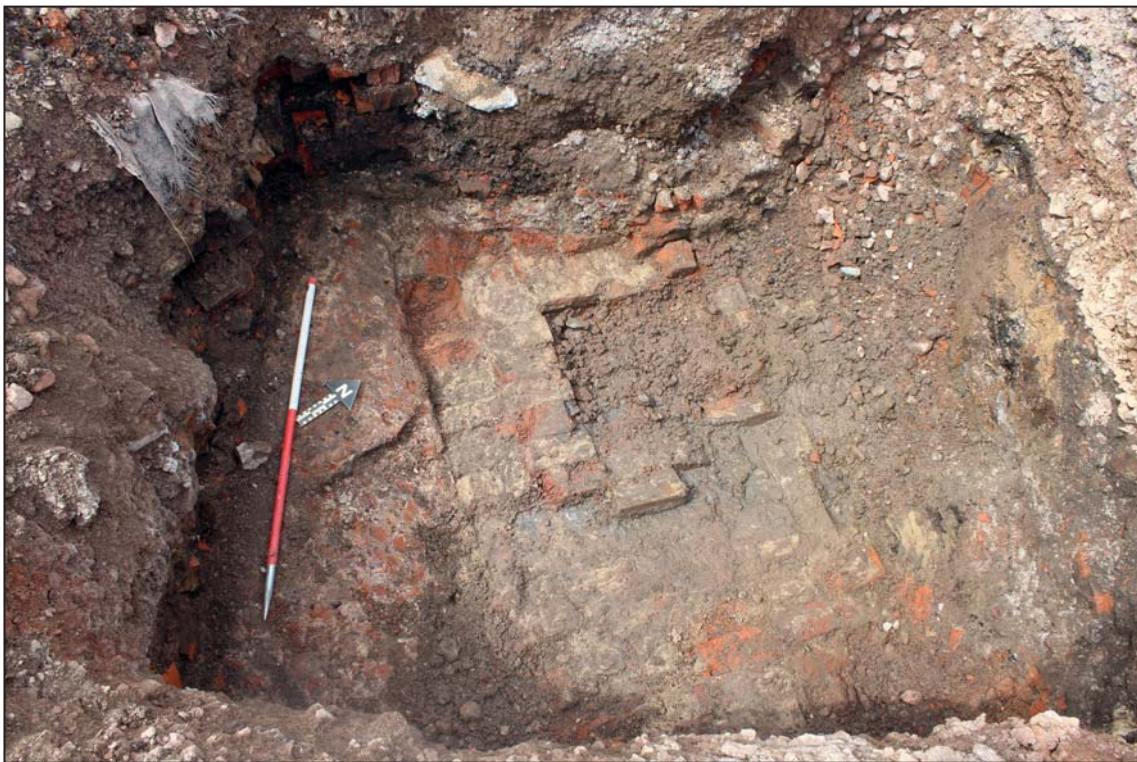
Section GG

- 5.13 Trench 35 was excavated to a depth of 1.4m. Exposed at the base of the trench was arched red brick structure 3506, possibly representing a culvert. This structure abutted rectangular red brick structure 3505, interpreted as a possible manhole. The latter was truncated by concrete slab 3504, and by north-west/south-east aligned red brick wall 3503. Although 3504 was sealed by demolition layer 3507 at its south eastern extent, elsewhere within the trench it and wall 3503 were both truncated by large, modern feature 3502, which in turn was infilled by a further deposit of demolition debris, 3501. The sequence was finally sealed by rubble levelling deposit 3500, associated with the 1990's development of the site.

Trench 35, c. 19th structure, possible manhole or possible culvert 3505 and arched wall 3504, looking north-west (scale 1m)

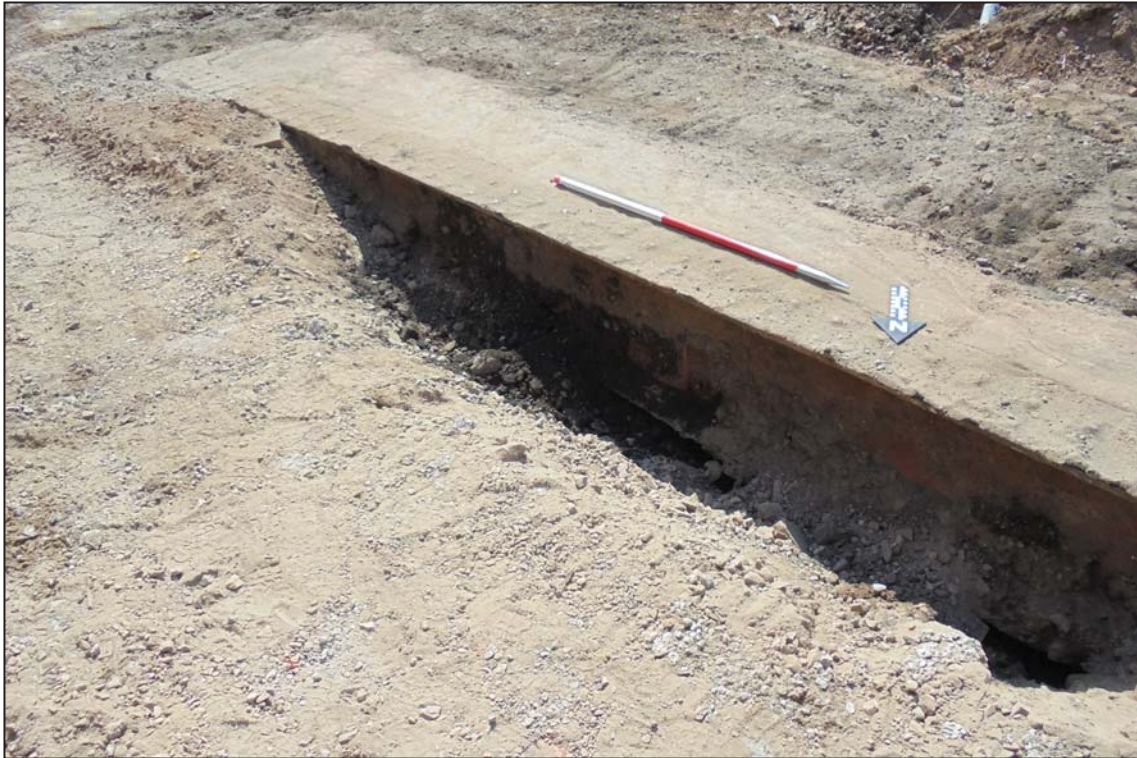
- 5.15 Within the base of Trench 48, steel girder 4801 was abutted by remnant concrete surface 4802. The girder was H-shaped and 0.24m wide and 0.47m deep. The concrete was exposed to a width of 0.56m and both were at least 6.7m long. They were sealed by gravelly make-up layer 4803, which was in turn covered by tarmac surface 4804.

Iron structure 4801 and concrete 4802, looking south (scale 1m)
