**Main PRV Installation opposite
St. James' Church, East Hill and the
junction of Priory Street/The Dell
Colchester, Essex**

Archaeological Watching Brief

CA Project: SU0438
CA Report: SU0438_1
OASIS ID: cotswold2-507591
HER Ref: ECC4717 and ECC4718

November 2022

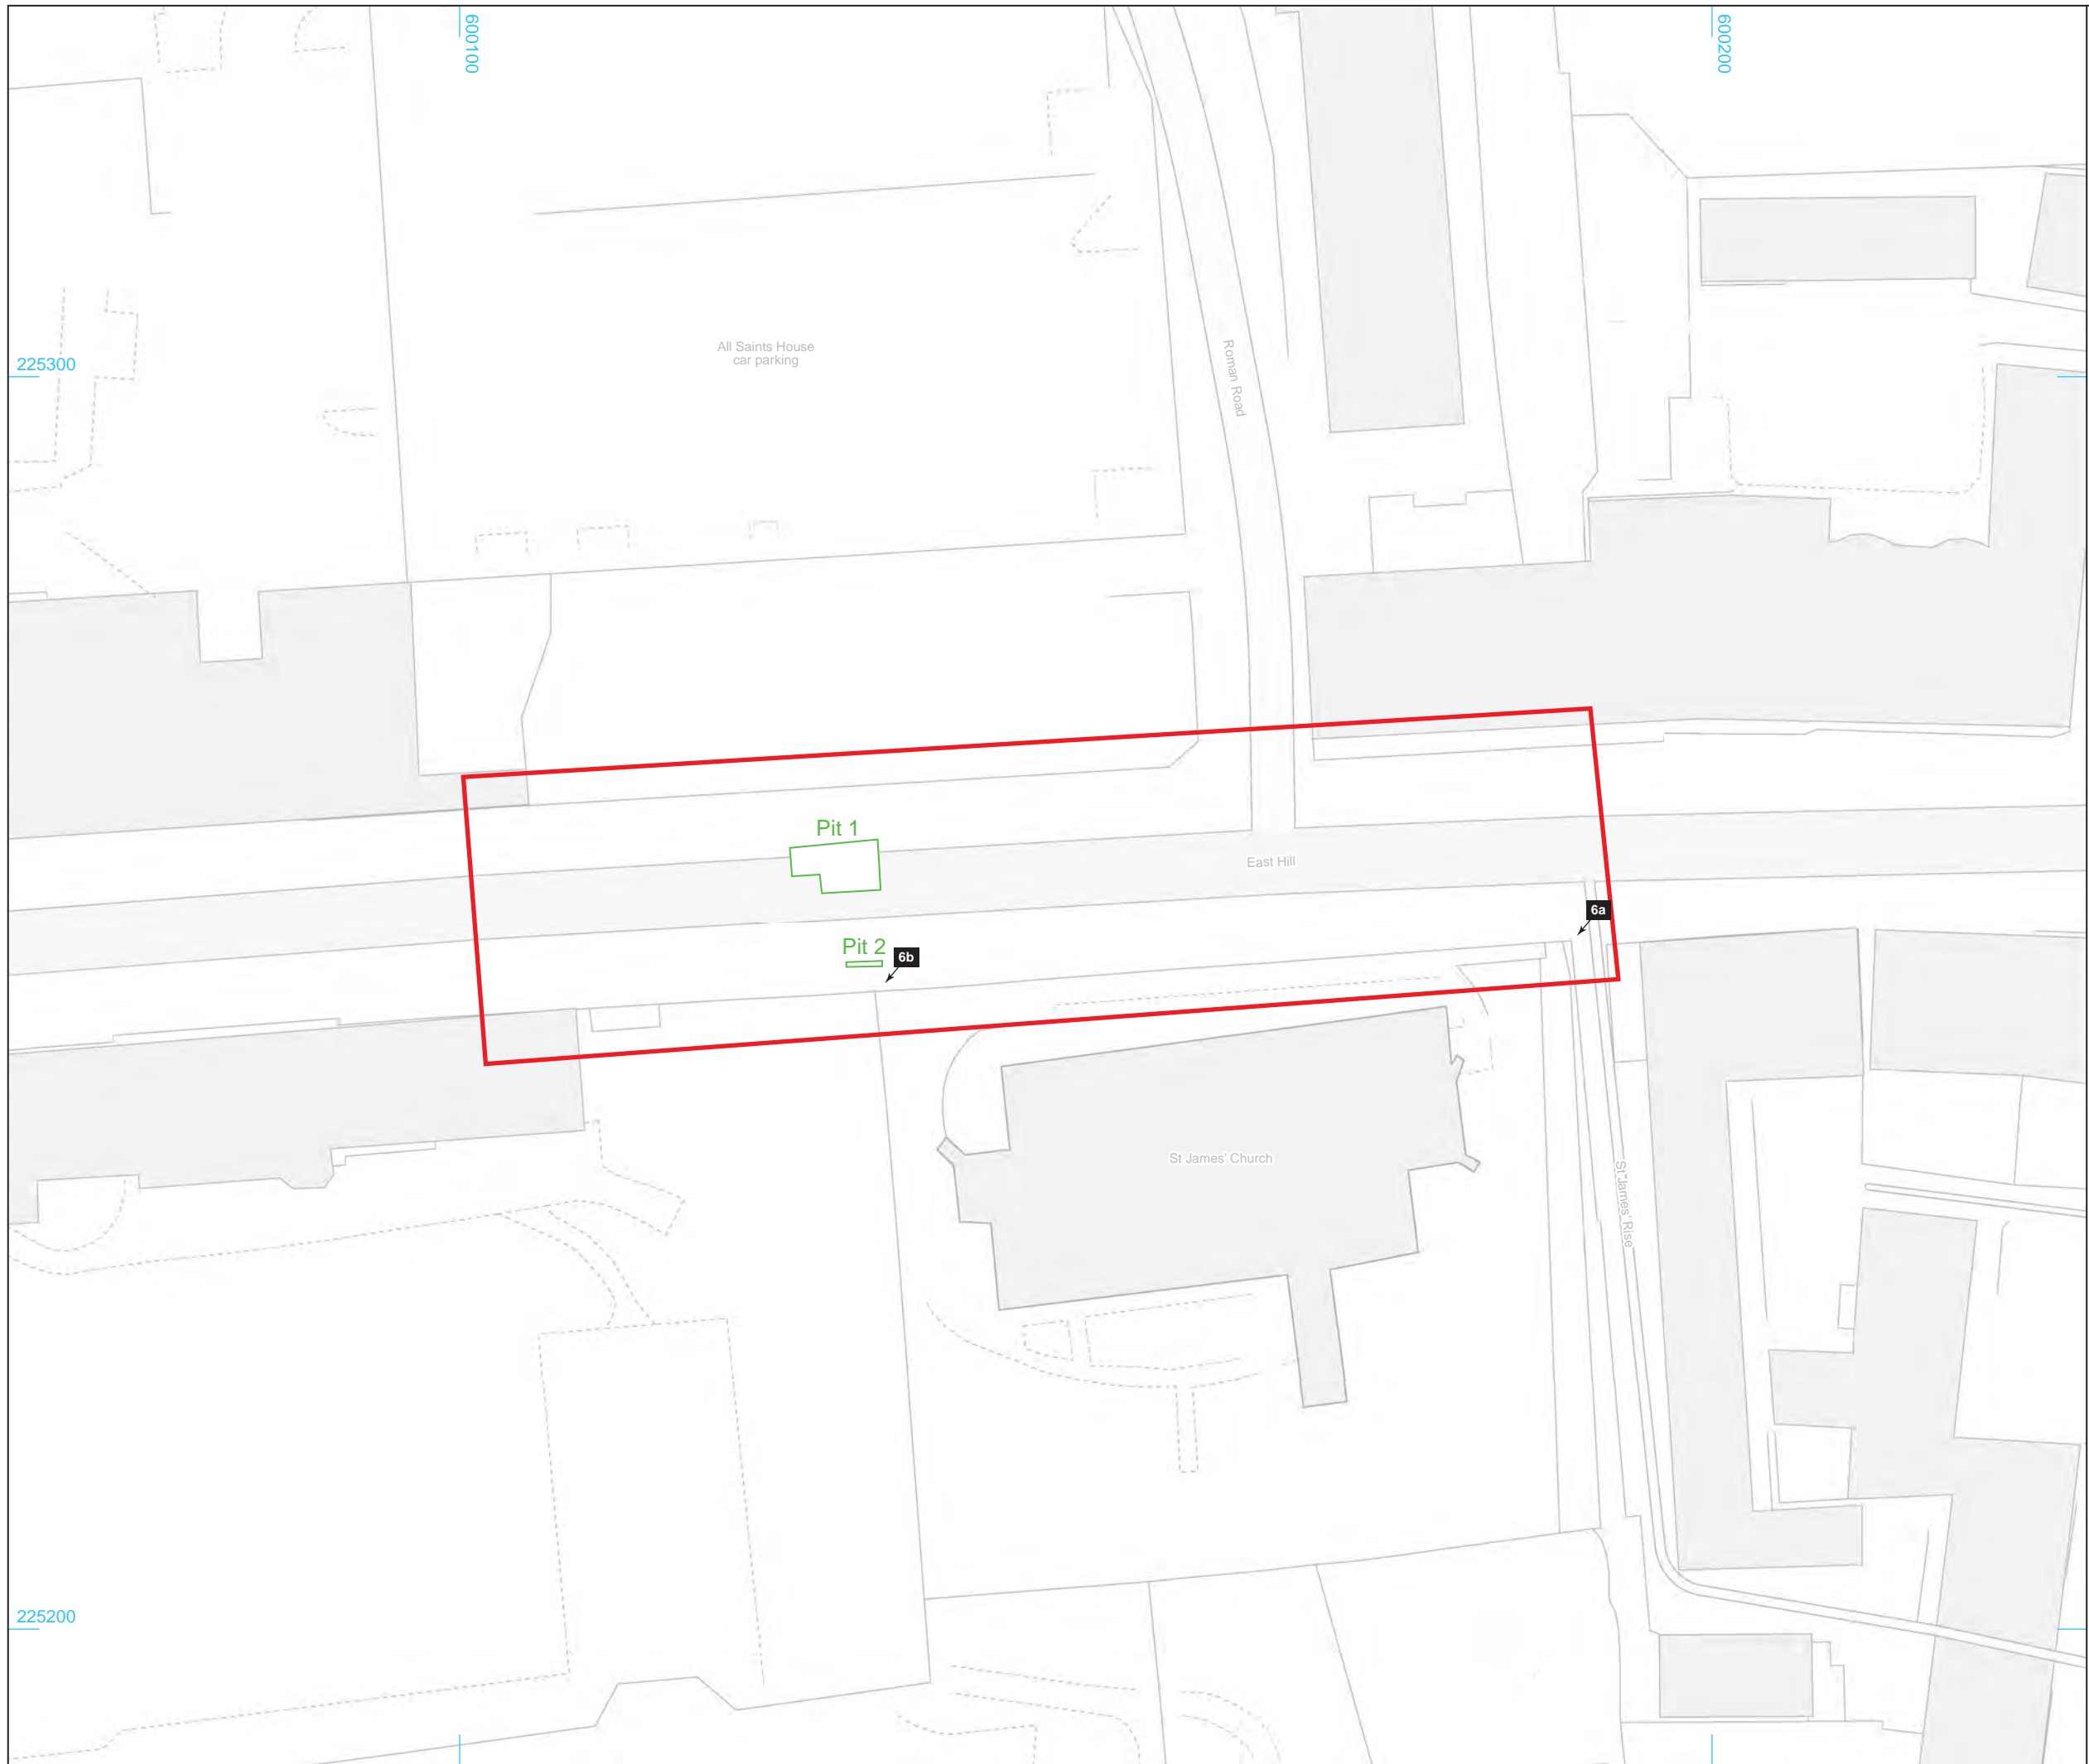
FIGURE TITLE
 Location of works in East Hill

- Site boundary
- Excavated pit
- ← 1 Photograph location and direction

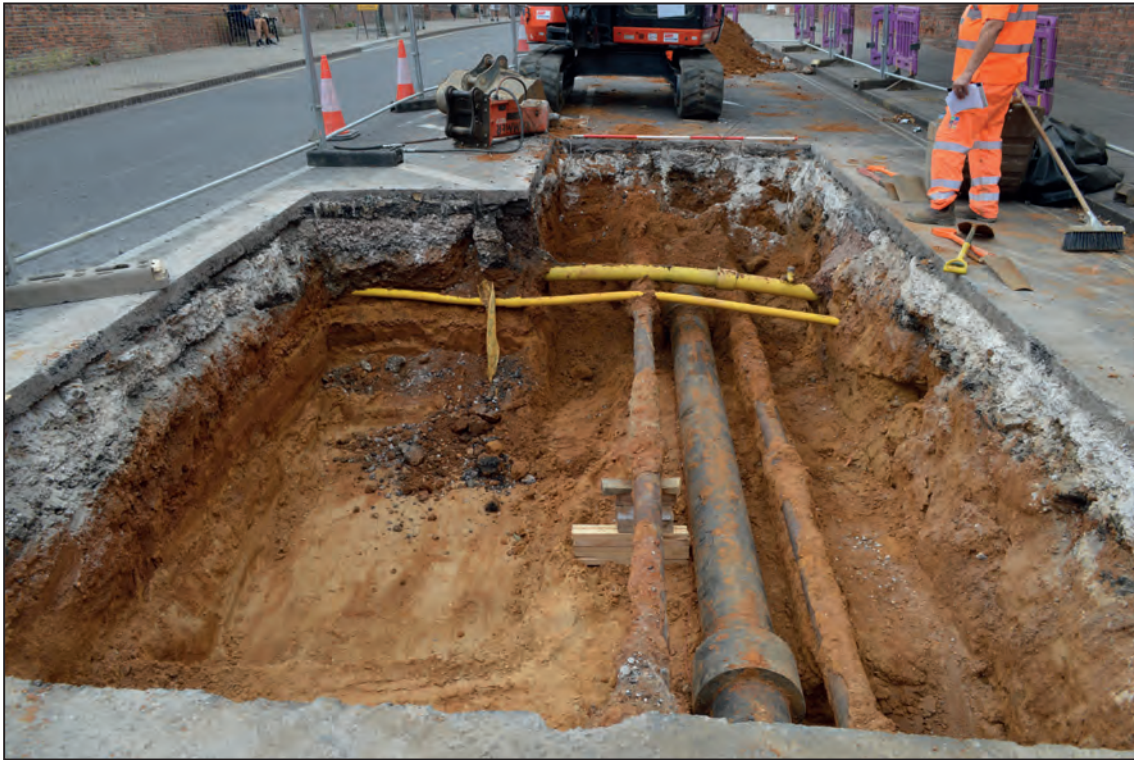
- 5.2. This excavation measured 7.1m by 4.1m and was cut to a maximum depth of 1.6m. The work was carried by a combination of machine and hand excavation.
- 5.3. A number of existing services, including the water main to which the PRV was to be fitted, were encountered within the northern half of the excavation. They consisted of two possibly redundant water pipes, electric cable and at least two gas pipes. The southern part of the excavation was to be the location of the chamber for the PRV and was fortunately clear of services.
- 5.4. The excavation entailed the removal of the modern road surface and a concrete subbase. This was found to be lying directly on the surface of a natural subsoil that comprised multiple layers of water sorted yellow and orange sands and gravel. No previous interventions or deposits were identified, and no artefacts were recovered.

Pit 1, East Hill, looking west (2m scale)

- 6.1. The excavation of Pit 1 revealed a large expanse of natural subsoil lying directly below the modern road surface and subbase with no earlier deposits or artefacts present. This complete absence of early material is probably the result of Georgian improvements undertaken in this area. The Victoria County History volume for Essex (Cooper and Elrington 1994) notes that in 1811 the Colchester improvement commission was set up to improve the town's roads. In 1817 the commission reduced the gradient of East Hill and Frere Street (as the eastern end of the High Street was then known) and demolished the last remnants of East Gate in 1819 (most of which had already collapsed in the 17th century). The brick underpinning of the Roman town wall near East Gate, which currently forms the eastern edge of the St. James' churchyard (Fig. 6, photo A) and the brick underpinning of the wall to the west of St. James' Church (Fig. 6, photo B) are a result of the reduction of the roadway gradient. The extent of the underpinning would suggest the removal of possibly up to 2m of material. This work would have undoubtedly destroyed any earlier evidence that may have been present.

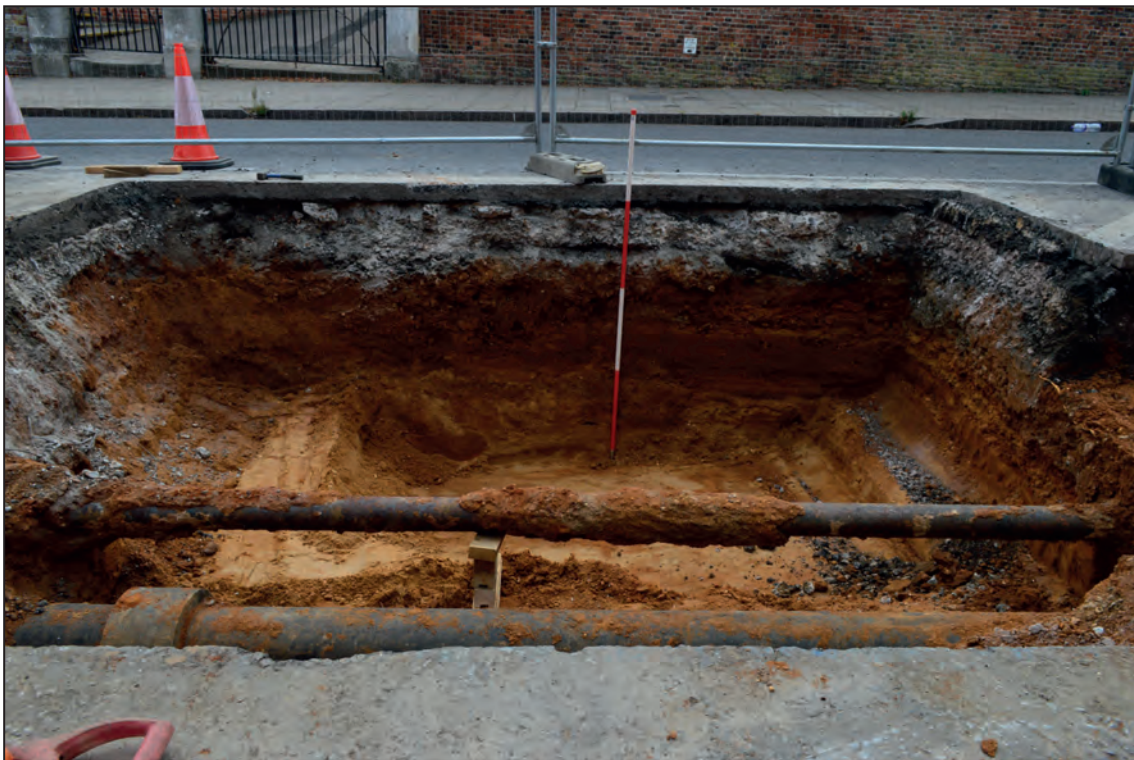
B

Pit 1, East Hill, soil profile as seen in southern edge of excavation, looking south (2m scale)

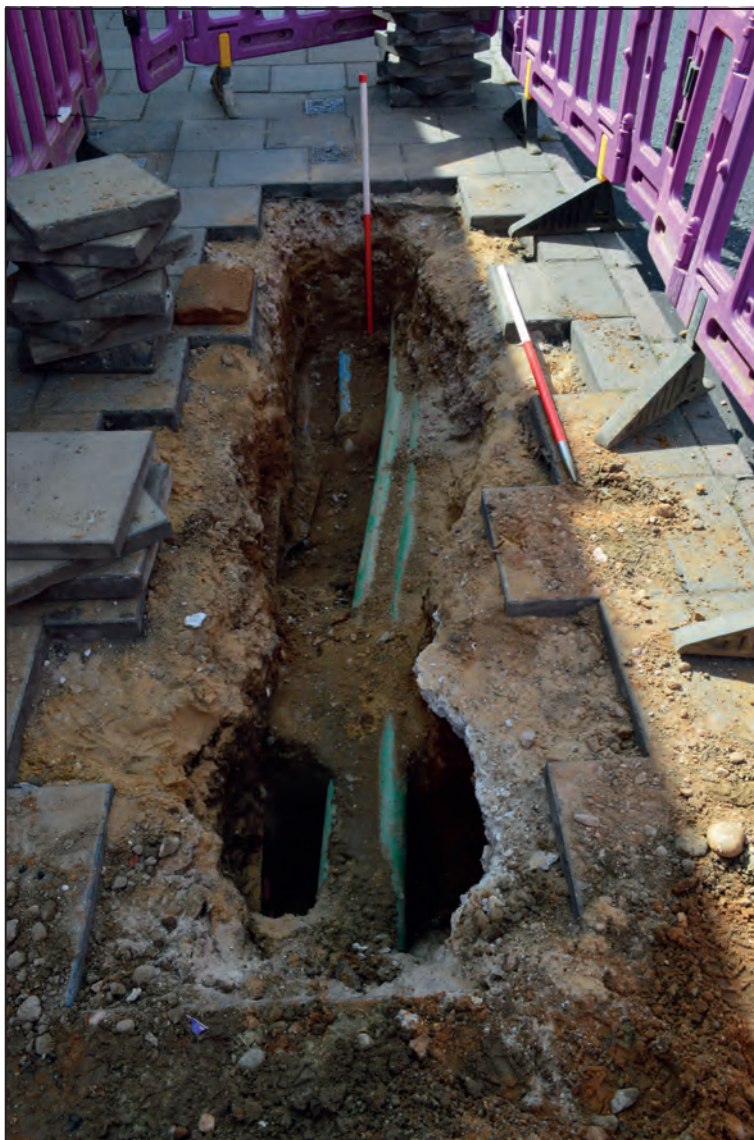
Pit 2 photograph

- 5.5. Pit 2 was a solely hand dug excavation in the pavement adjacent Pit 1. It comprised an irregular rectangle that measured c.3m by 0.6m and was cut to a depth of 0.6m. No archaeological deposits or artefacts were identified as the entire excavation was cut through backfilled trenches associated with existing services.

Pit 2, East Hill, looking west (1m scales)

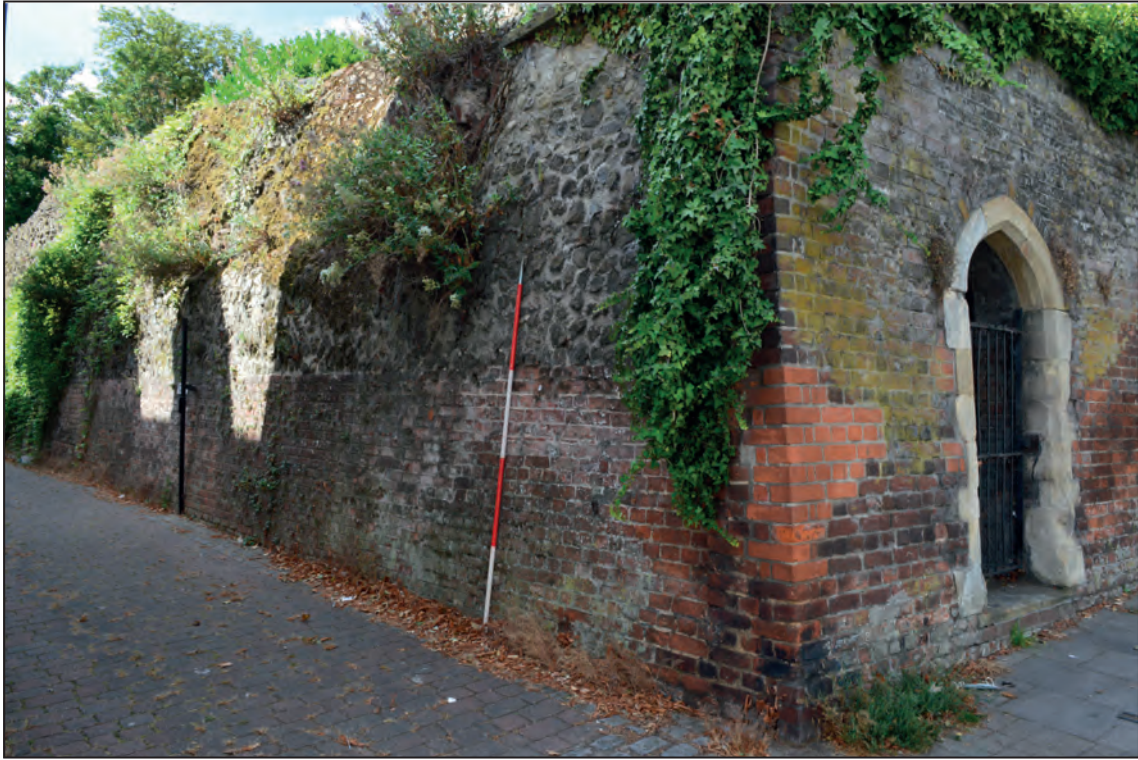
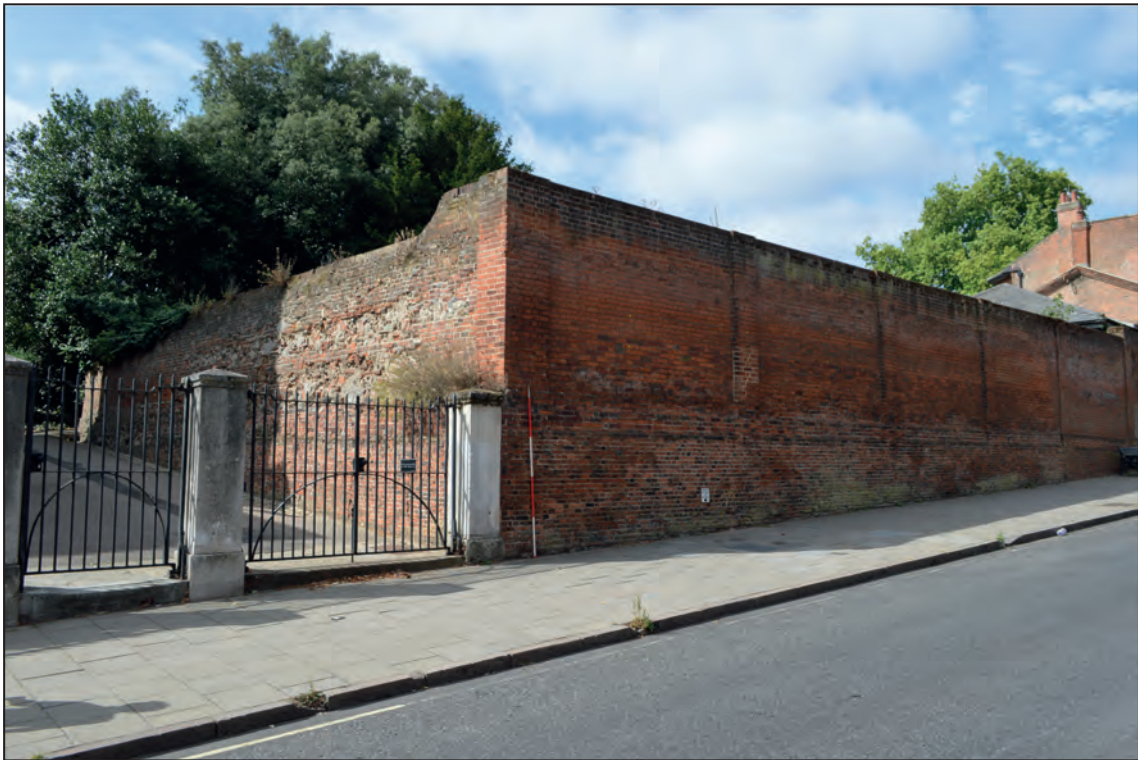
East Hill photographs

Underpinning of wall opposite East Hill excavations, looking south-west (2m scale)

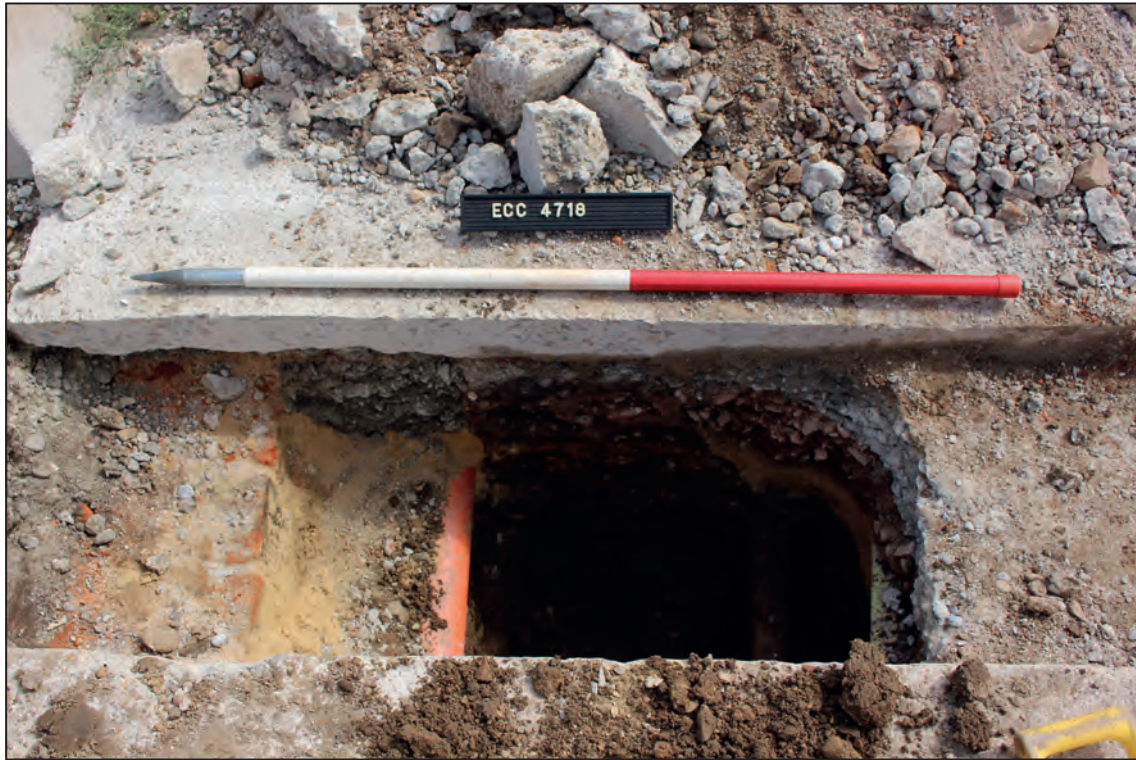
- 5.6. A rectangular pit hand dug within the pavement on the north side of Priory Street. It measured 1.6m by 0.45m and was cut to a depth of 0.65m. Below the concrete pavement surface the pit revealed made ground deposits containing fragments of soft red bricks and tile of probable 19th century date; two modern services were also exposed. A single course of a brick wall was seen at the northern end of the pit. It appeared to be formed of soft red bricks in a lime mortar. No significant archaeological deposits or artefacts were recorded.

Pit 3, Priory Street, looking north-east (1m scale)

-
- 6.2. The remaining excavations revealed only made ground deposits of late post-medieval or 19th century and modern services and the trenches cut for their installation. The fragment of brick wall noted in Pit 3 is likely to be the base of the front wall of one of the houses that formerly fronted to the north side of Priory Street.

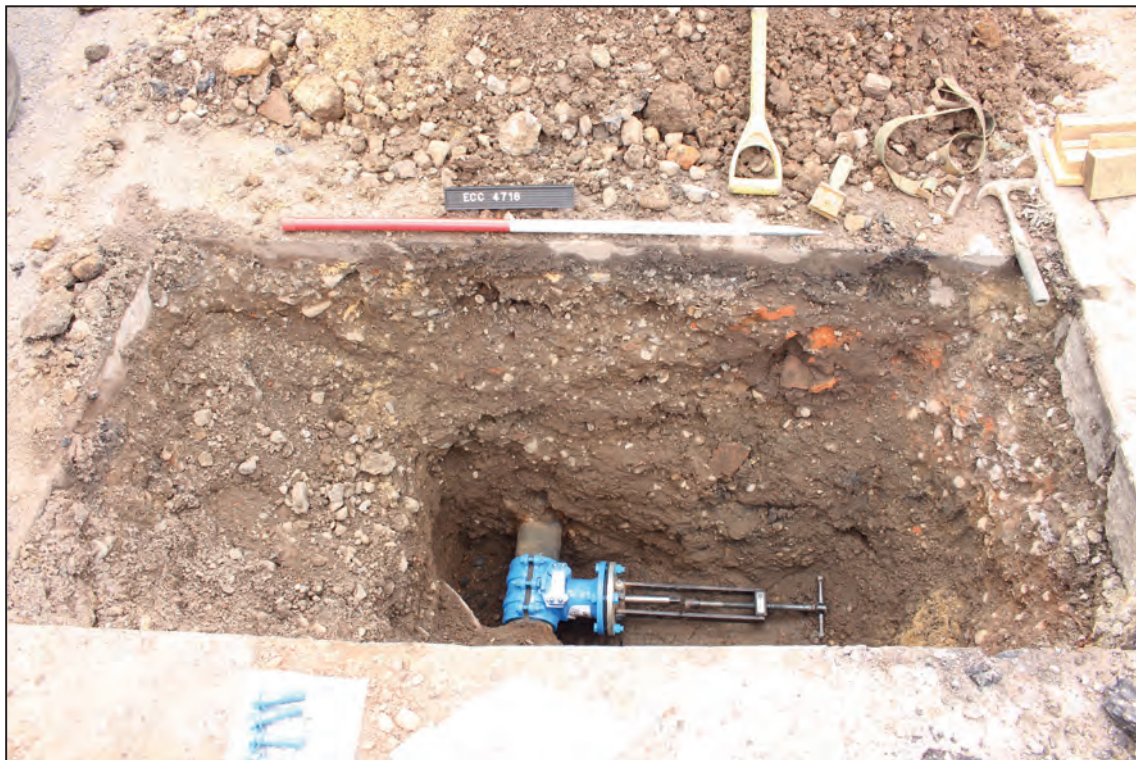
B

- 5.7. A rectangular pit cut into the carriageway of Priory Street, immediately to the south of Pit 3. It measured 1.95m by 0.85m and cut to a depth of 0.6m. Below the tarmac road surface, a dirty brown sand and gravel deposit containing fragments of late post-medieval/19th century brick and tile was encountered and continued to the base of the excavation. A cut for the trench containing the modern water pipe was clearly evident. No features or deposits of archaeological interest were observed and no artefactual material pre-dating the modern period was recovered.

Pit 4, Priory Street, looking south-west (1m scale)
