**Buchan St Neighbourhood Centre  
Buchan Street  
Cambridge**

*Archaeological Evaluation*

August 2022

CA Project: SU0413  
CA Report: SU0413\_1  
CHER Event Number: ECB6903  
OASIS Id ref: cotswold2-508718

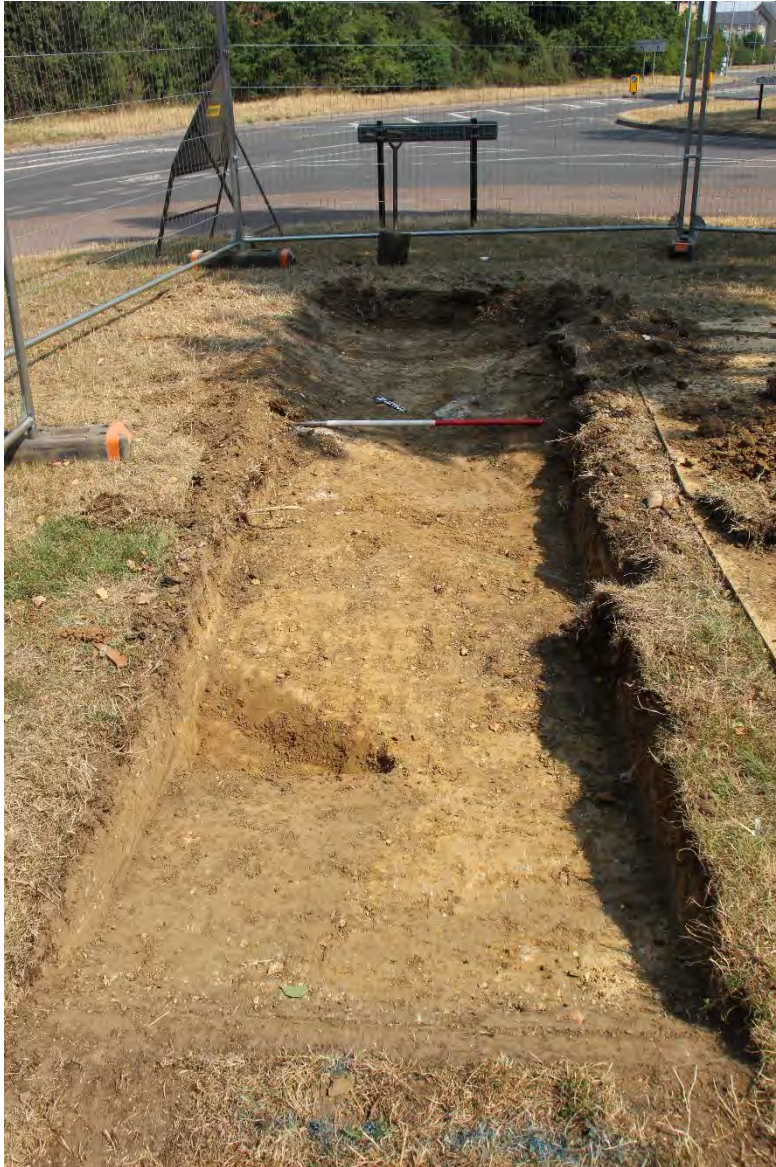
Fig. 3: Trench 1, looking northeast

- 5.2. Trench 1 measured 5 x 1.8m and was located in the north part of the site, in an area of amenity grassland to the south of the junction of Kings Hedges Road and Buchan Street. The deposit sequence comprised a thin turf and topsoil layer, approximately 10 – 15cm thick, directly overlying the natural substrate, which comprised an orange-brown gravelly clay with chalk fragments. A semi-circular feature at the south end of the trench was tested and shown to be modern in date, possibly relating to amenity planting of the area, while the trench was bisected by a modern service and also contained two concrete post or sign bases. No archaeological finds or features were encountered.

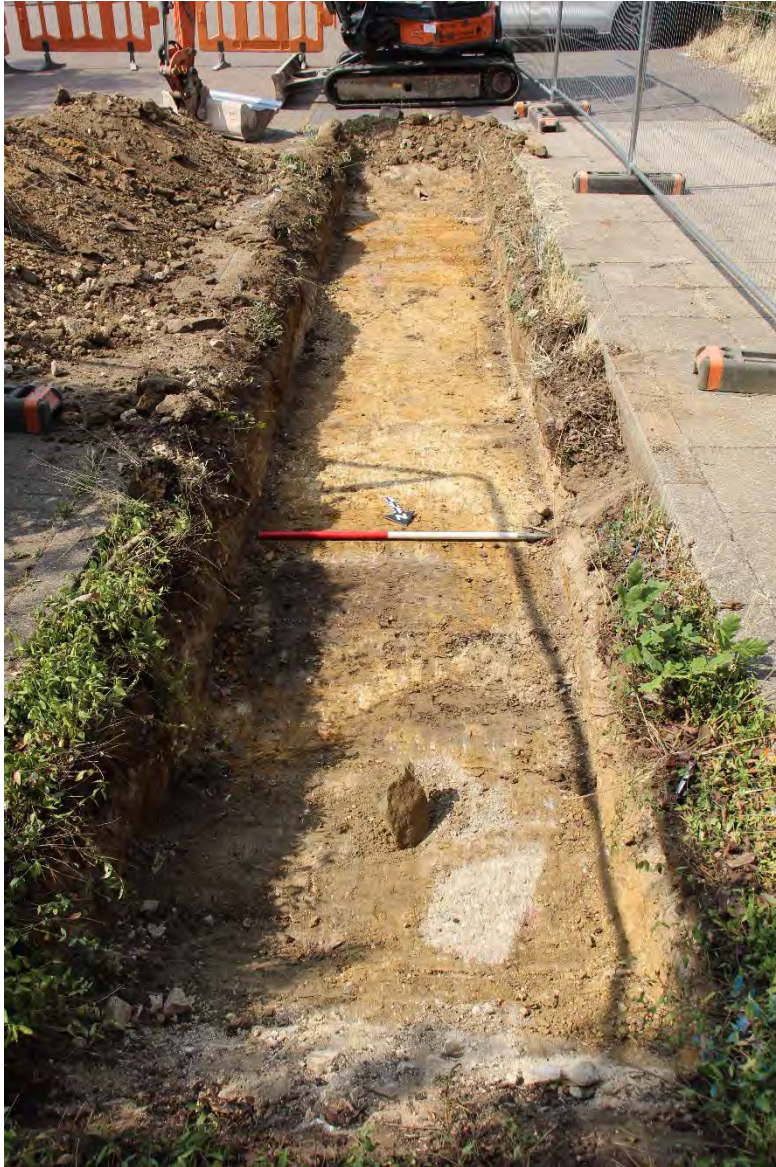
Fig. 4: Trench 2, looking northeast

- 5.3. Trench 2, measuring 10m long by 1.8m wide, was located in the north-central part of the site, in a block-paved parking area. The trench location was adjusted slightly from that shown in the WSI to take advantage of the presence of a flowerbed, within which the trench was subsequently excavated. The deposit sequence comprised a thin silty topsoil, approximately 10cm thick, overlying a deposit of modern made ground that became thicker in depth towards the northeast end of the northeast-southwest orientated trench. This sealed the natural substrate, which again comprised an orange-brown gravelly clay with chalk fragments. A modern service trench was present running across the southwest end of the trench. No archaeological finds or features were encountered.

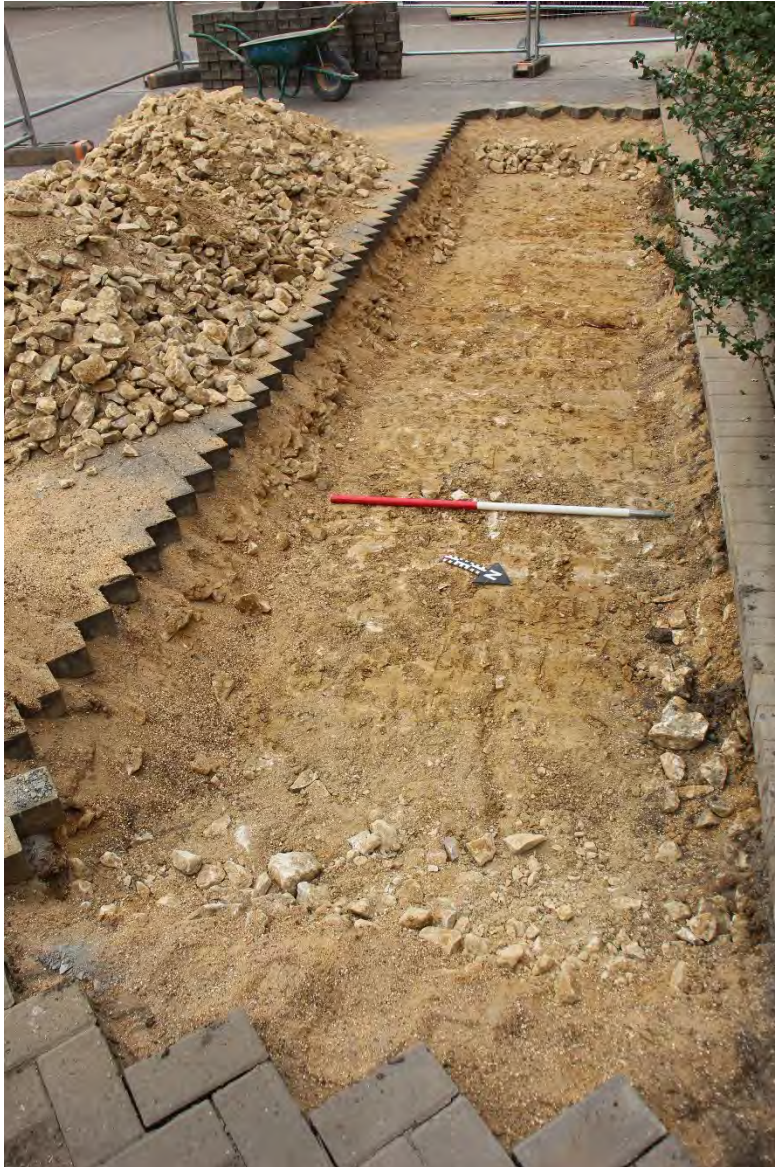
Fig. 5: Trench 3, looking west

- 5.4. Trench 3, measuring 10m long by 1.8m wide, was excavated in the west part of the site, in a block-paved area to the rear of the shop and café. The deposit sequence

comprised block paving over a crushed stone and sand base that in turn sealed the natural substrate of orange-brown gravelly clay with chalk fragments. No archaeological finds or features were encountered.

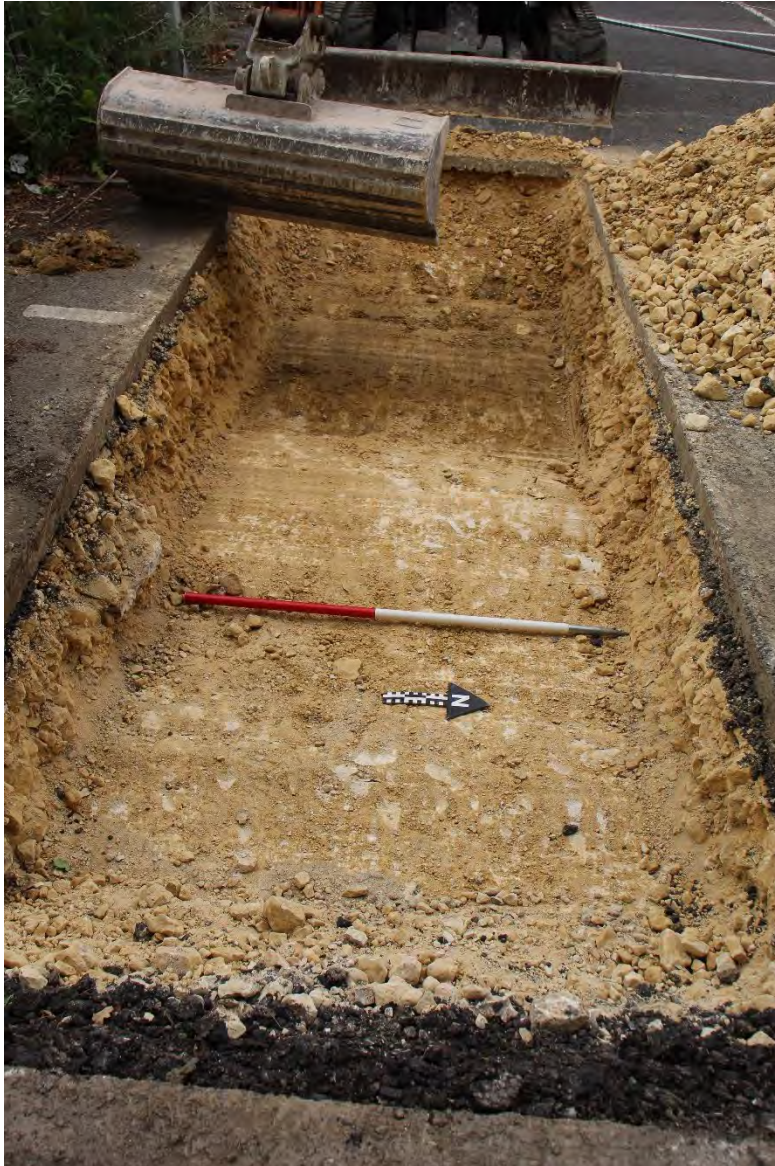
Fig. 6: Trench 4, looking west

- 5.5. Trench 4 was excavated in the southwest corner of the site, in an area covered by tarmac hardstanding and again evidenced extensive modern disturbance/ hard landscaping. Measuring 7m long, the tarmac surface was removed to reveal a thick layer of modern sand and crushed stone, becoming deeper toward the western end of the trench. This directly overlay the natural substrate, comprising a yellow gravelly clay with chalk, confirming that the area had previously been stripped of topsoil/ any subsoil prior to laying of the crushed stone. Once again, no archaeological finds or features were identified.

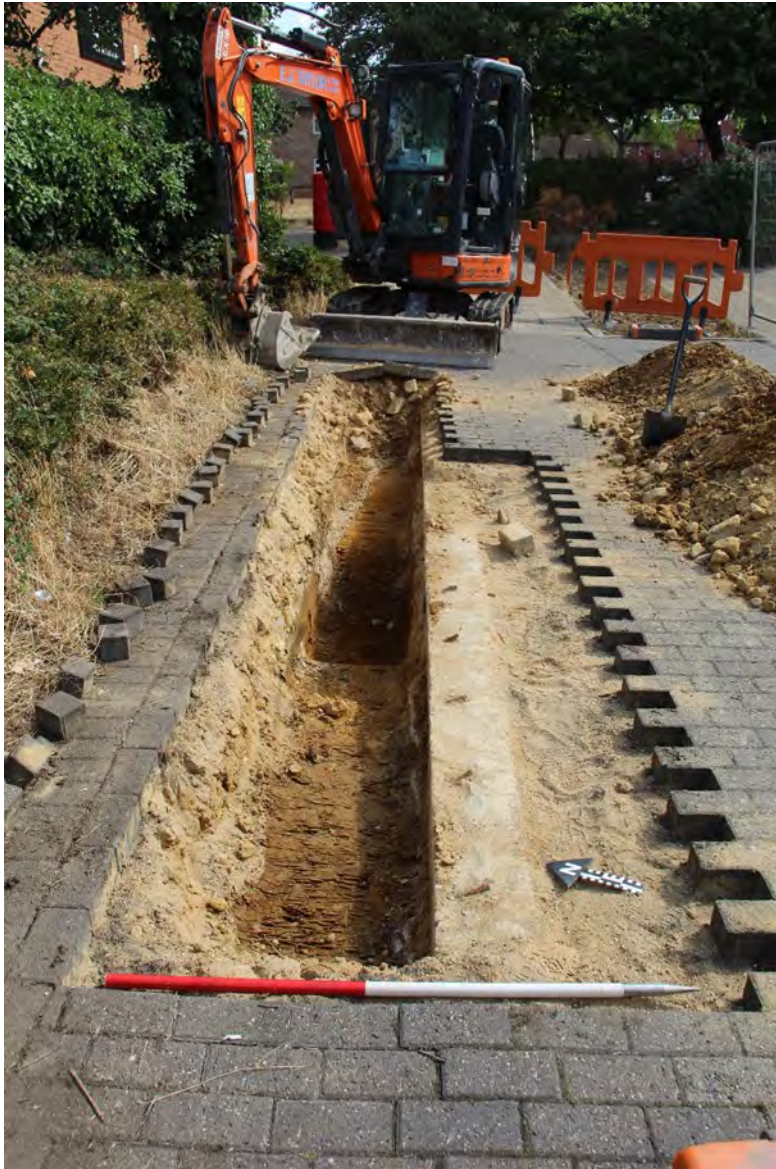
Fig. 7: Trench 5, looking northeast

- 5.6. Trench 5 was excavated in the central part of the site, to the southwest of trench 2. Measuring 5m long by 1.8m wide, this trench evidenced a high level of modern disturbance with the deposit sequence comprising block paving overlaying a concrete base, most likely for a metal fence, dividing the northeast-southwest orientated trench down the middle. Crushed stone and sand was present to either side of the fence base, with machine excavation along the northwest side of the base showing that the crushed stone was approximately 0.5m thick and overlay a mid brown silt clay presumed to be the natural substrate. No archaeological features or finds were identified.
