The Gatehouse, Bird Street Lichfield Staffordshire

Built Heritage Watching Brief and Level 2 Record

CA Project: 6178

CA Report: 17073

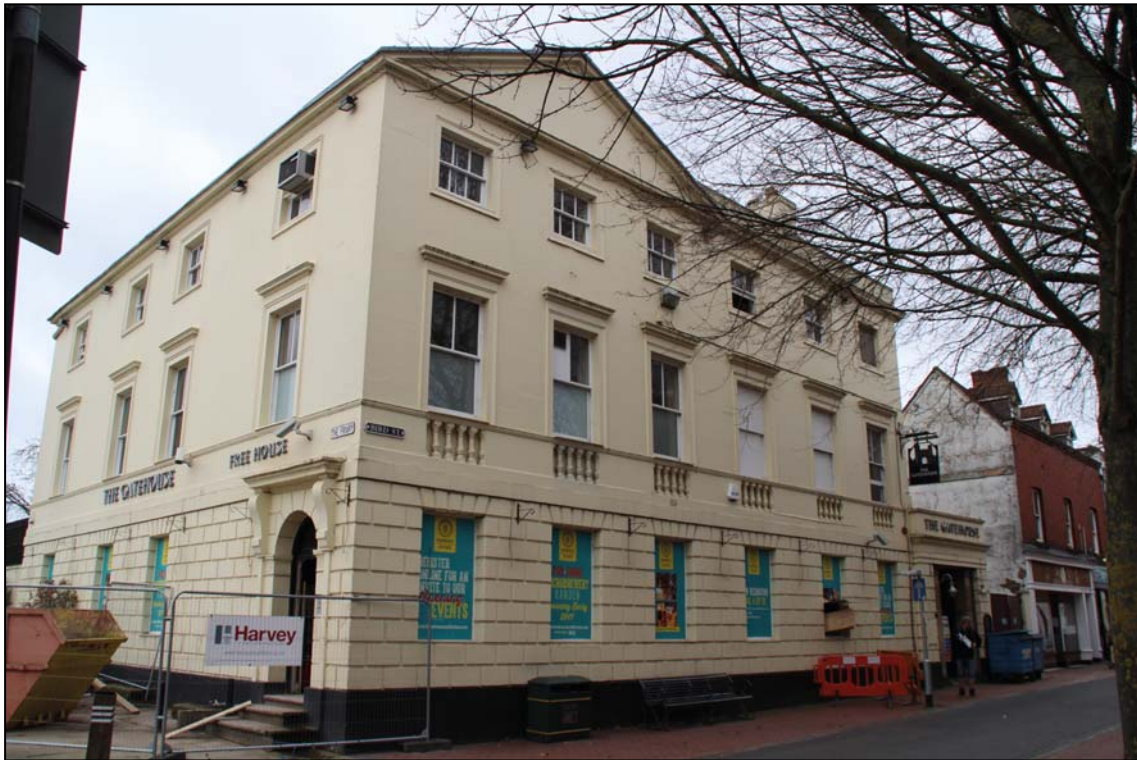
this, with the end elevations pedimented and properly divided into three bays (Fig. 8). The side elevation is four bays, implying an improper central column. The only entrance is on the south-east end of this elevation and not in any regular relationship with the bay system.

- 4.3 This entrance is very odd in its present form and has been modified (Fig. 8). It appears that its first form was simply a plain opening with a semi-circular head neatly integrated into the rustication. One of the voussoirs has slipped indicating that at least this element of the rusticated work is of ashlar. The jambs are simply the end of the adjacent walls marked only by impost blocks following the coursing and distinguished by a simple moulding top and bottom and vertical fluting.

The Bird Street or south-east elevation, looking west

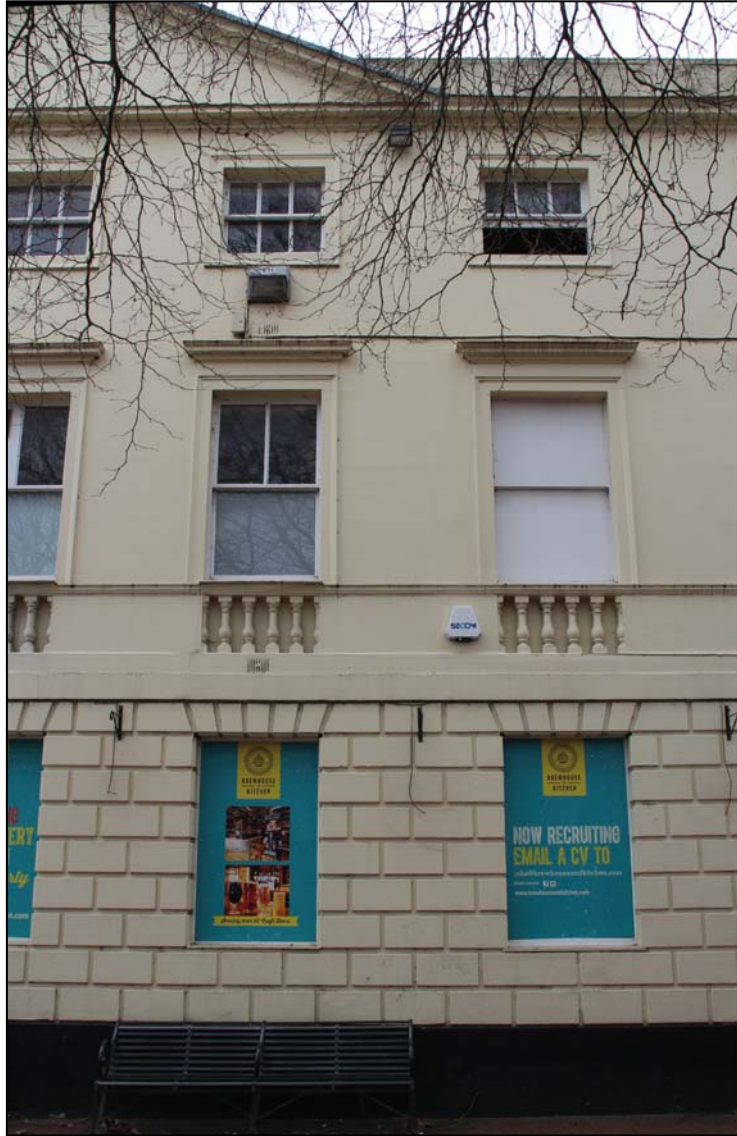
- 4.5 Otherwise the treatment of the elevations is a very correct Palladian form, with the rusticated ground floor acting as a notional basement for the *piano nobile* or main floor. The architraved and flat-pedimented windows sit on a plat band and string course that represents the pedestal of the implied order. The window aprons are cut back into the “pedestal” and supplied with vase balustrading on the Bird Street elevation. The windows are complimented by the correctly proportioned Palladian square windows with all round architrave on the top floor (Fig. 9).

The windows and architectural treatment in the Bird Street elevation

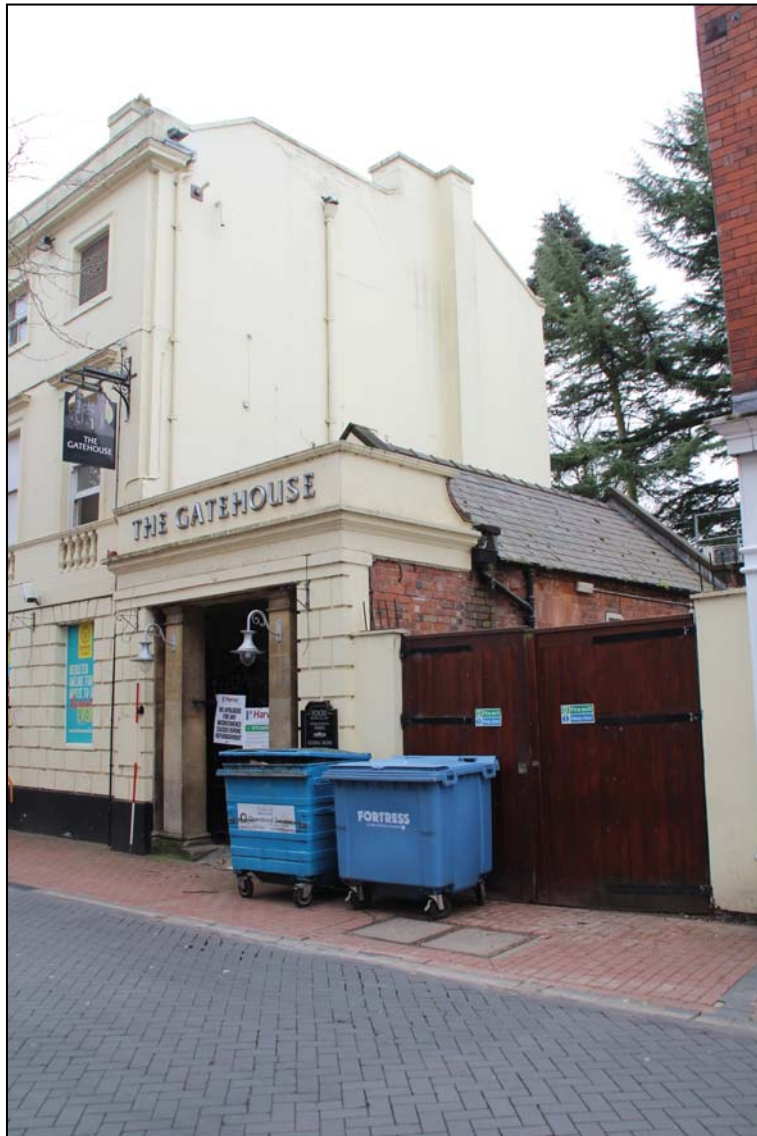
- 4.22 The addition may belong to the 1920s when the porch at the north-west end of the Bird Street range (Fig. 10) was added to the single-storey shed (on map evidence, after 1923). This seems to have replaced a smaller porch structure. The present appearance of the elevation above the ground floor was certainly in place by 1926, as it is visible on an aerial photograph on Historic England's *Britain from Above* web site.

The north-west end of the building from Bird Street (scale 2m)

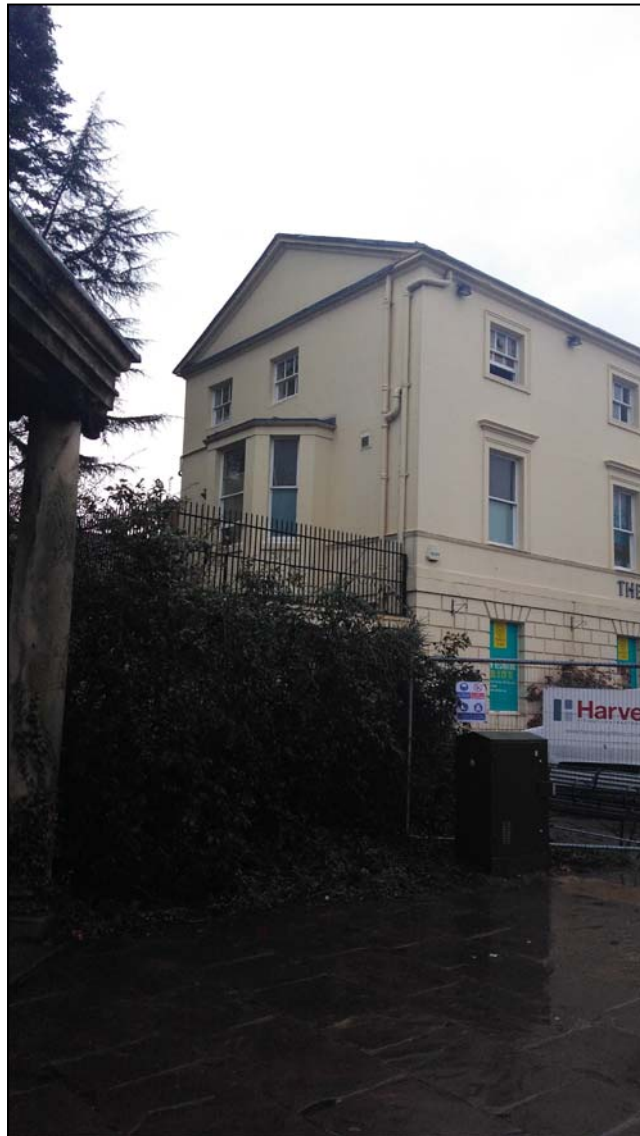
-
- 4.7 The south-western elevation is brick-built, thinly rendered and painted (Figs 11 and 13). It has a first floor bay window which is a later insertion. It is not clear whether the missing windows in the third bay (nearest Friary) were ever present.

The south-west end of the building, from Friary

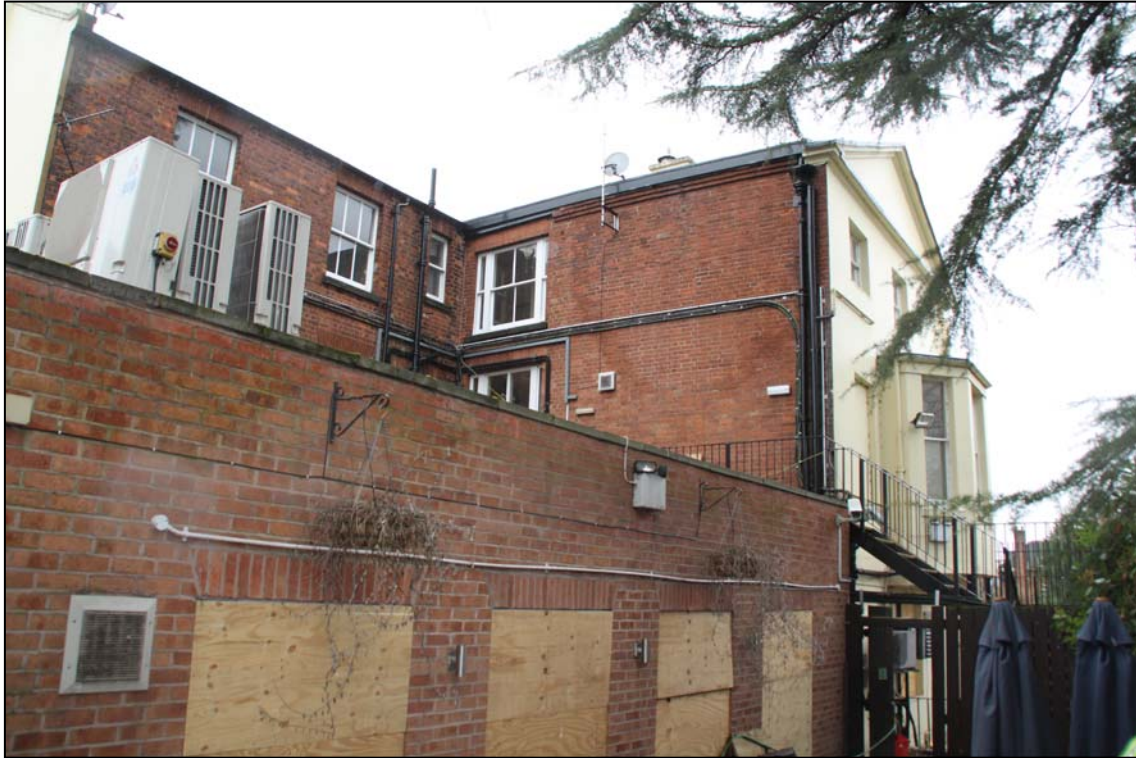
The rear, north-west elevation of the Friary range, looking east

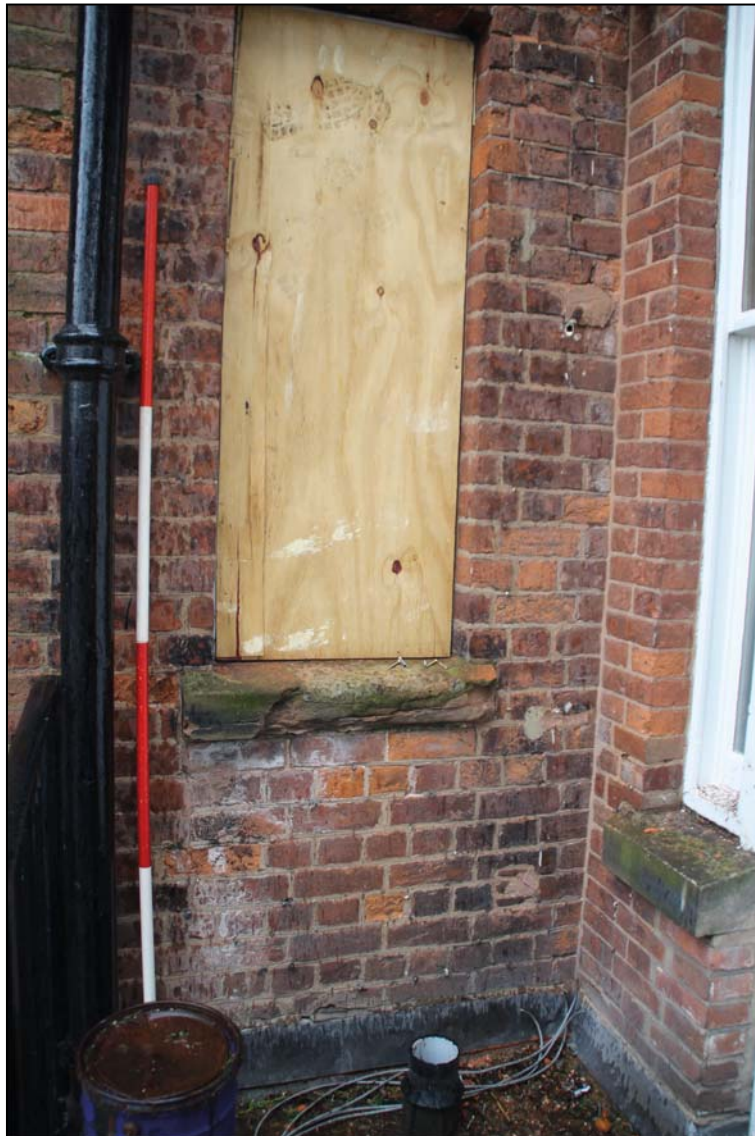
The unbonded internal corner of the Friary and Bird Street ranges showing different brick sizes and bonds (scale 2m)

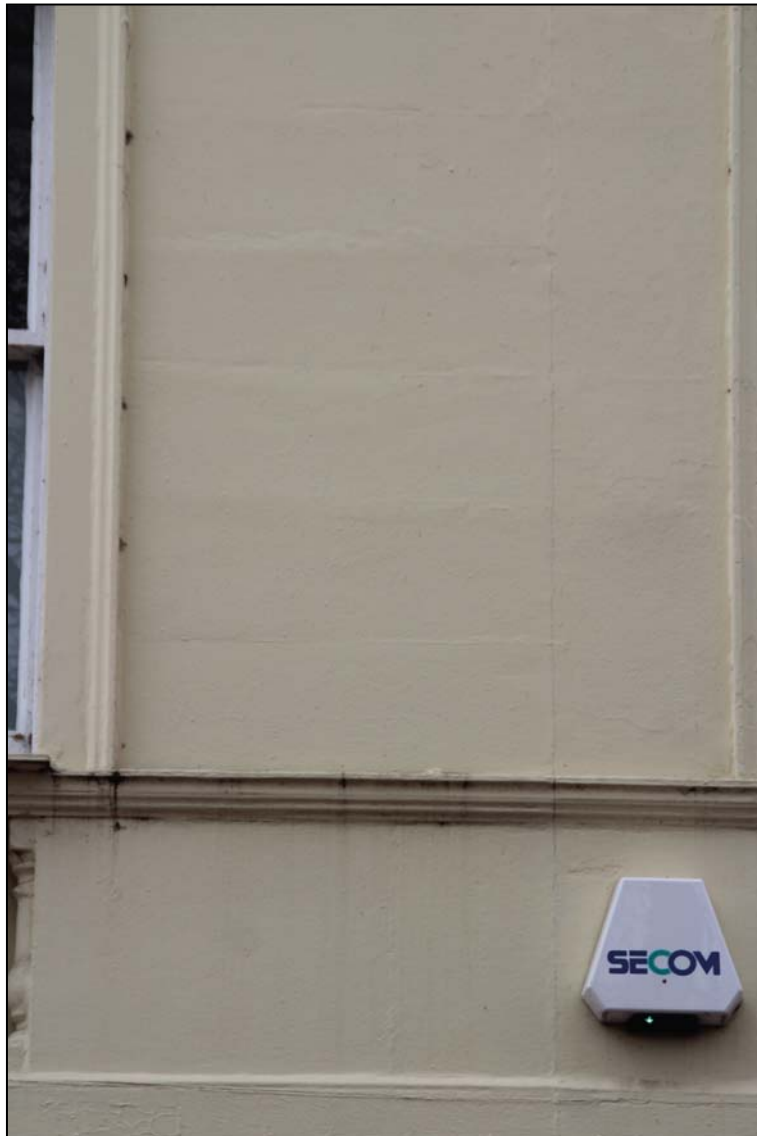
The junction of the painted ashlar facing on the Friary range with the painted render on the Bird Street block

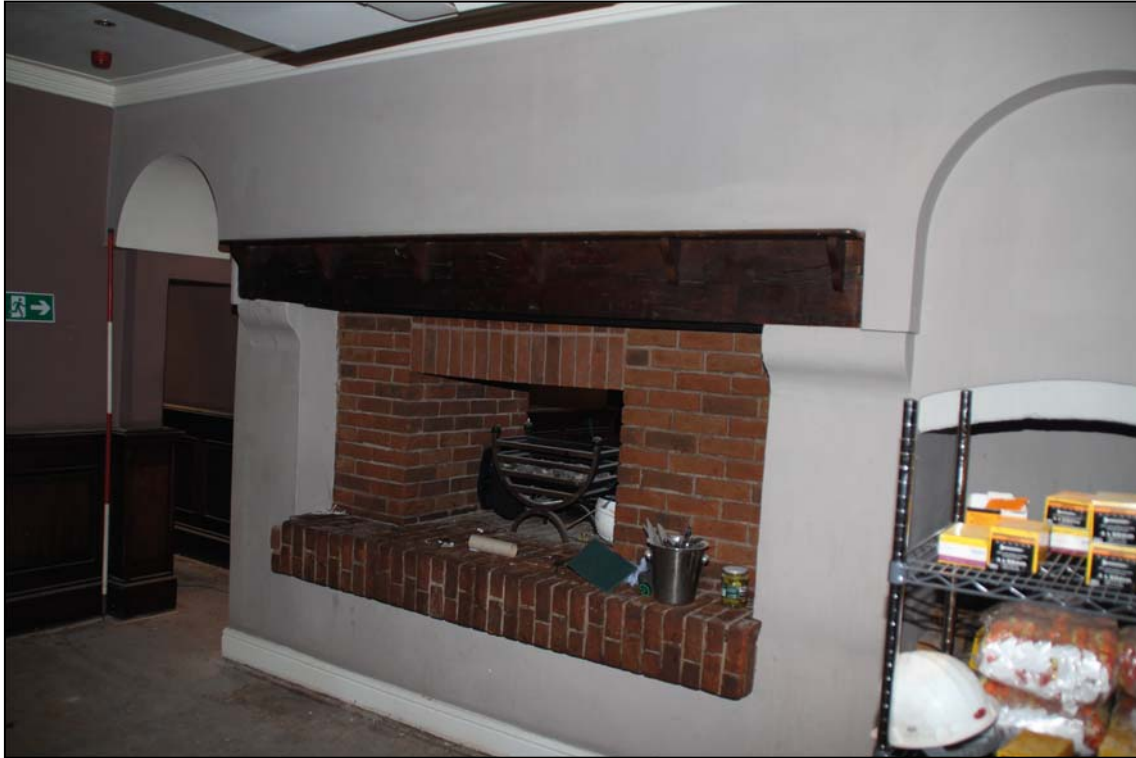
The through-fireplace in G7 with the oven on the right-hand side, looking north (scale 2m)

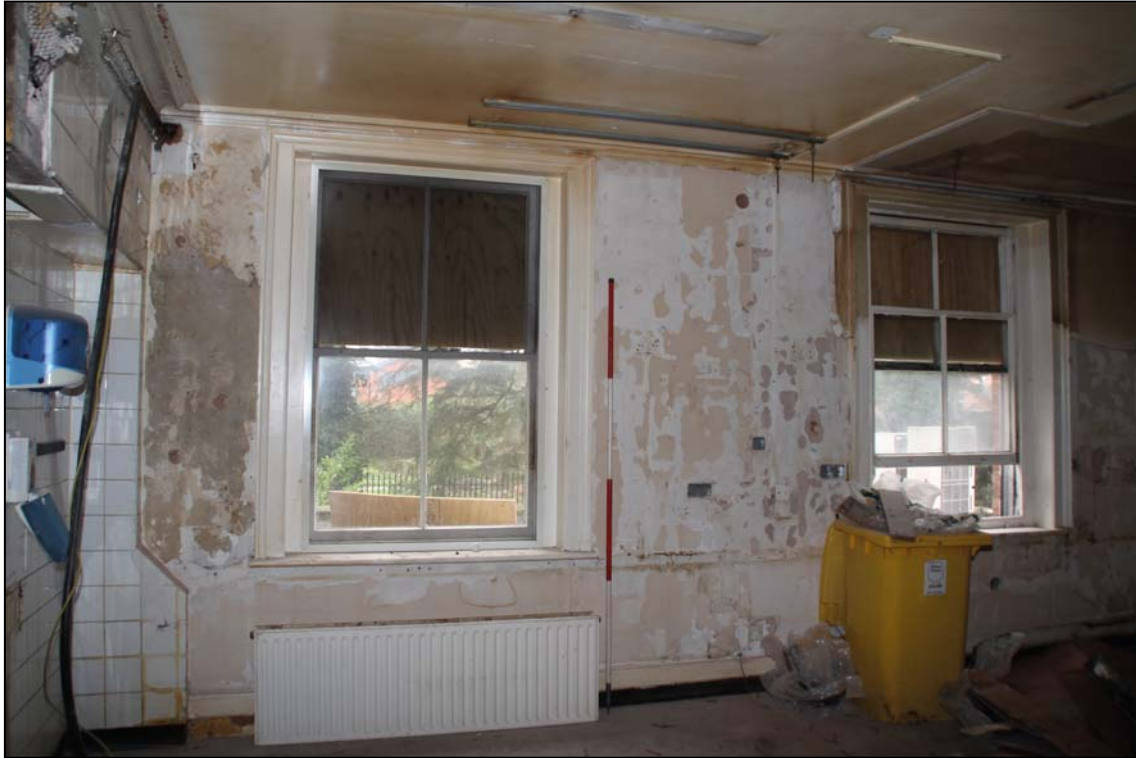
- 4.56 All the details in the rest of the rooms on this floor suggest a major refurbishment in the middle or later years of the 19th century (Figs 28, 29). This would include the two-over-two plate-glass sashes in 1.9 (Fig. 28) which seem likely to have replaced the three-

The south-west side of room 1.9 (scale 2m)

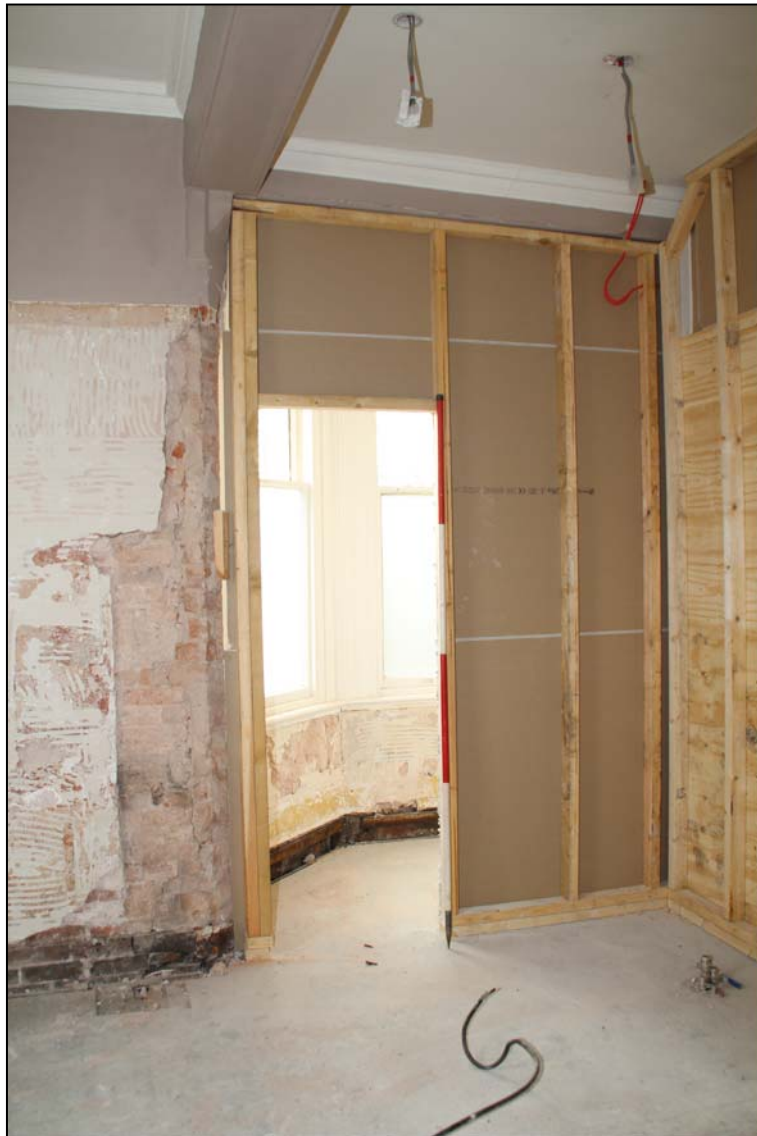
- 4.48 The centre of the south-west wall now has a deep bay window. It seems to be contemporary with the ceiling cornice, which respects it (Fig. 30).
- 4.49 The grandest room and the best preserved is 1.1. This has a dentil cornice, the top member of which appears to have some sort of decorative moulding such as bead and reel or acanthus but this is obscured by thick paint. There is a substantial dado rail which appears to have topped a panelled dado zone, now missing, having been replaced with tiling when this room was fitted out as a female WC (the tiling is now removed). The skirting is a late Georgian profile like that in 1.5 (Fig. 29).

The bay window off 1.6, looking west with corniced beam where was once a wall and modern stud work going in (scale 2m)

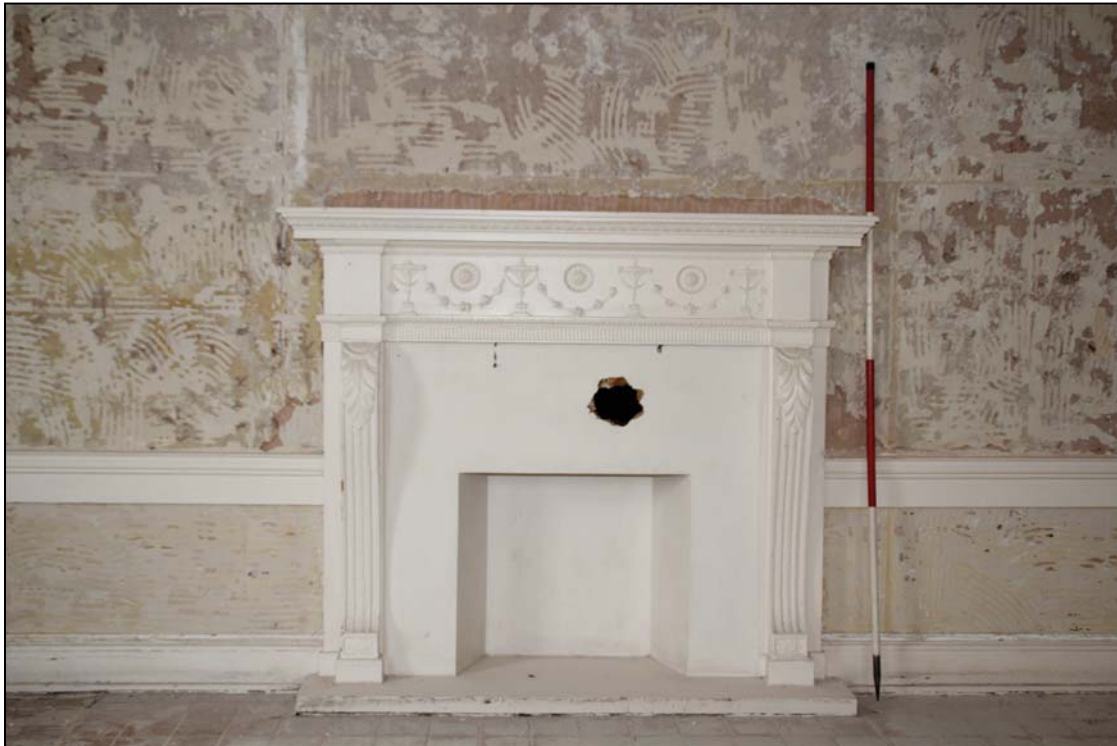
- 4.53 The fireplace is of a similar overall style, the very Adamesque lintel with swags, *paterae* and candelabra (?) supported on slightly less elegant reeded volutes with half a *patera* on top and a fleshy acanthus leaf. The hearth is missing and is boarded-in (Fig. 32).

The fireplace in 1.1 (scale 2m)

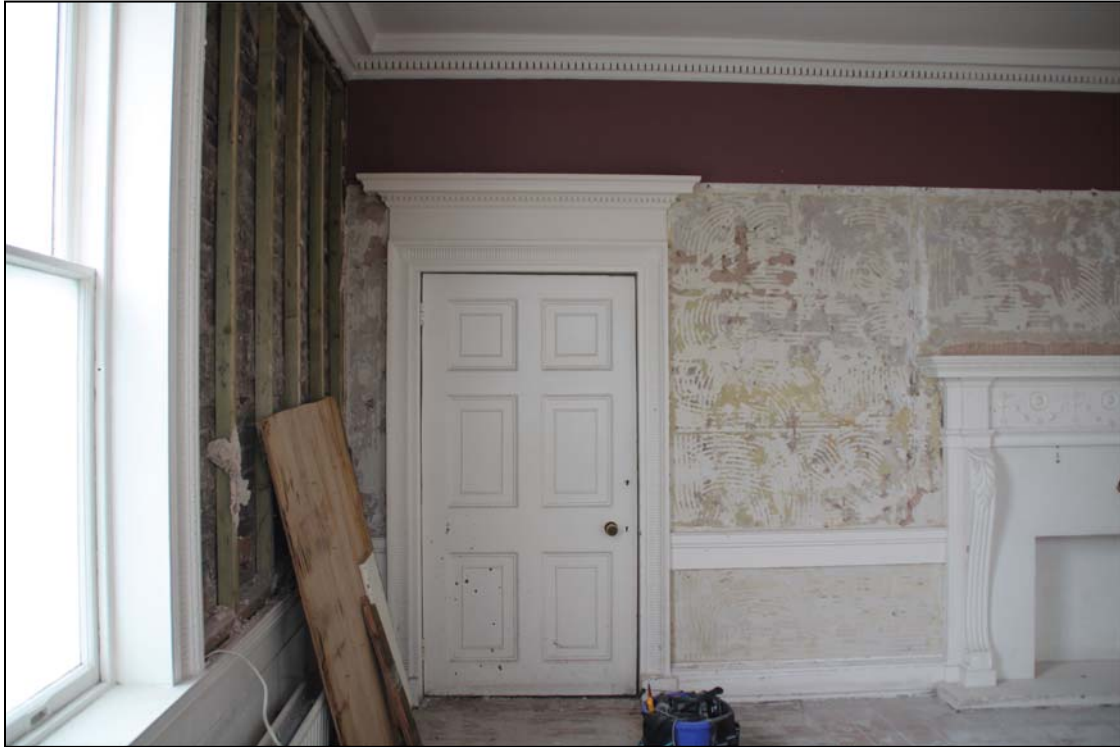
The door into the cupboard at the south-east end of the south-west wall of room 1.1 and the recent studding on the left (no scale)

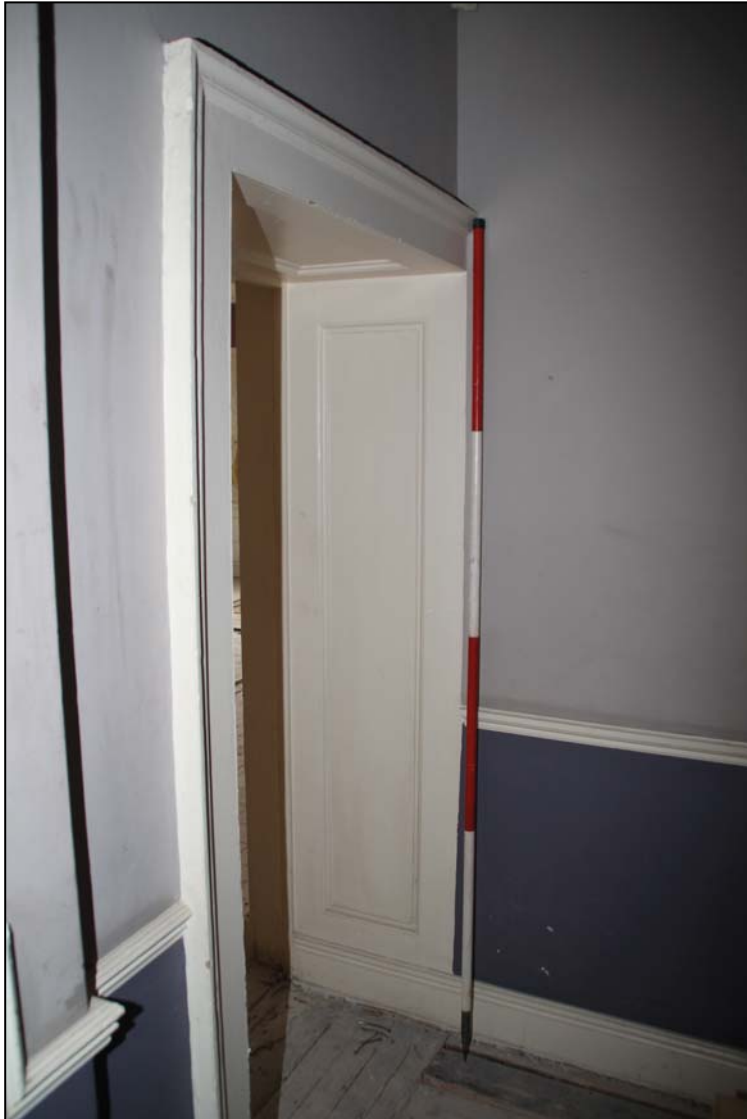
The south-east reveal of the door from 1.2 into 1.1. The skirting and dado on the right are later 20th century fittings around the stair enclosure. On the left is the mid 19th century dado (scale in 0.5m divisions)
