**Walsall Medical Centre
Hatherton Road
Walsall
West Midlands**

Archaeological Watching Brief

CA Project: CR0969
CA Report: CR0969_1

August 2022

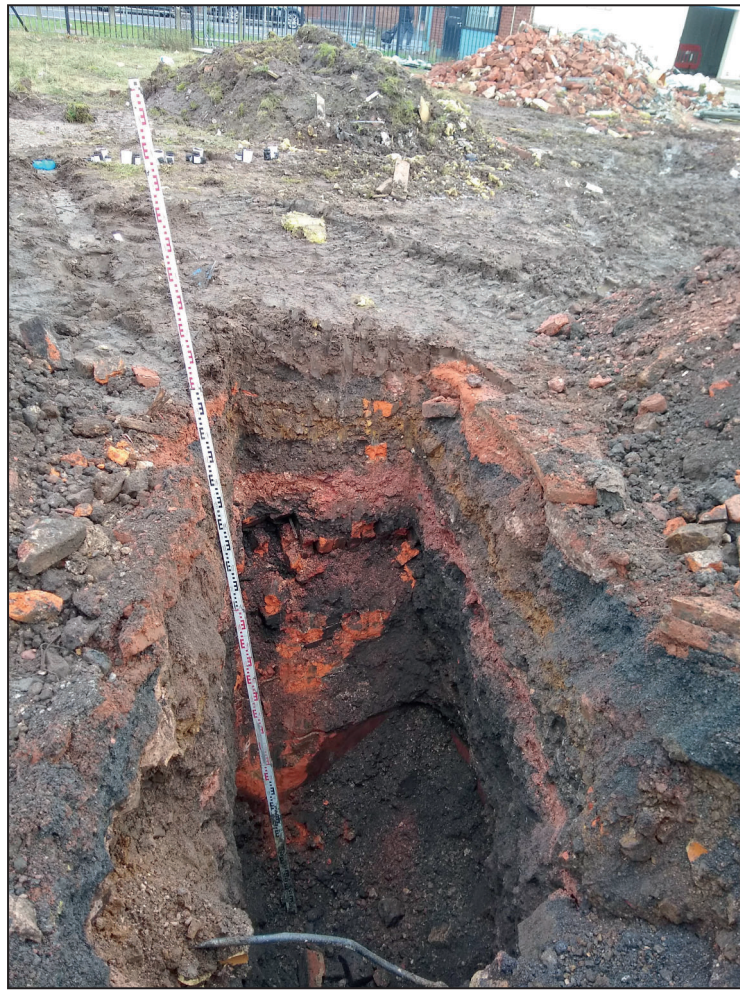
Test Pit 3, looking east (4m scale)

- 5.4. Brick structure 305 was identified at the base of excavation in Test Pit 3, at a depth of 1.5m bpgl. It was rectangular in plan and measured at least 2m in length, 1m in width and was at least 1.3m in depth. The location of structure 305 broadly correlates to the mapped interior of a larger 'malthouse' building depicted on the First Edition OS mapping. Deposit 304 was recorded filling the structure, comprising of a mixture of dark brown sandy silt with brick rubble, slag and stone. This was, in turn, sealed by successive layers of made ground and modern surfacing.

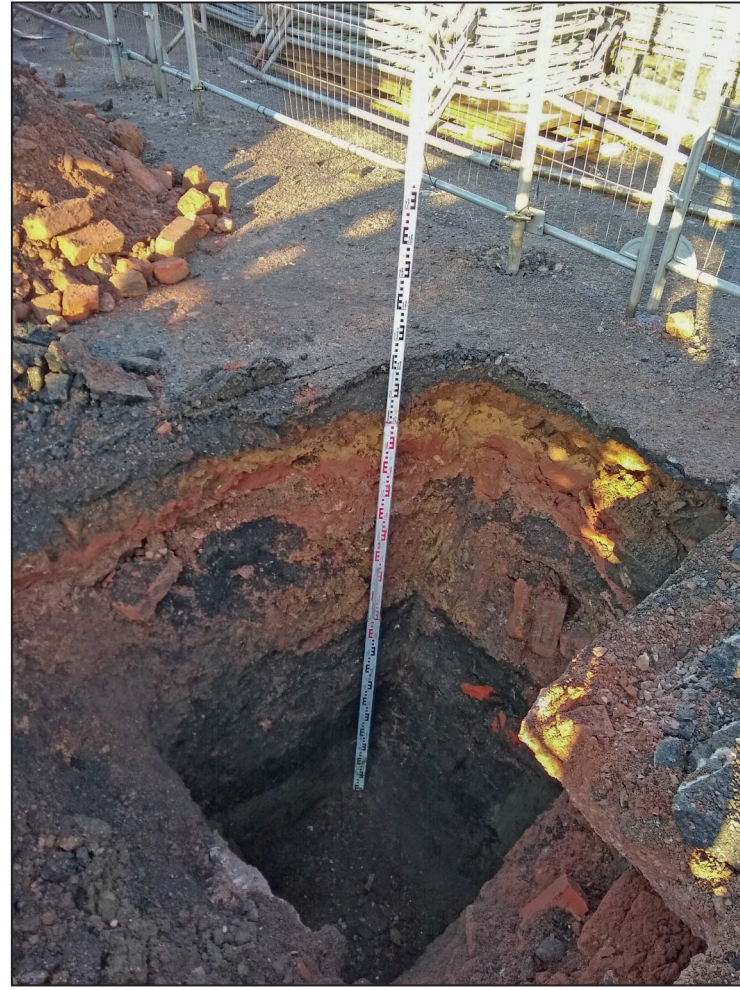
Test Pit 7, looking north-west (3m scale)

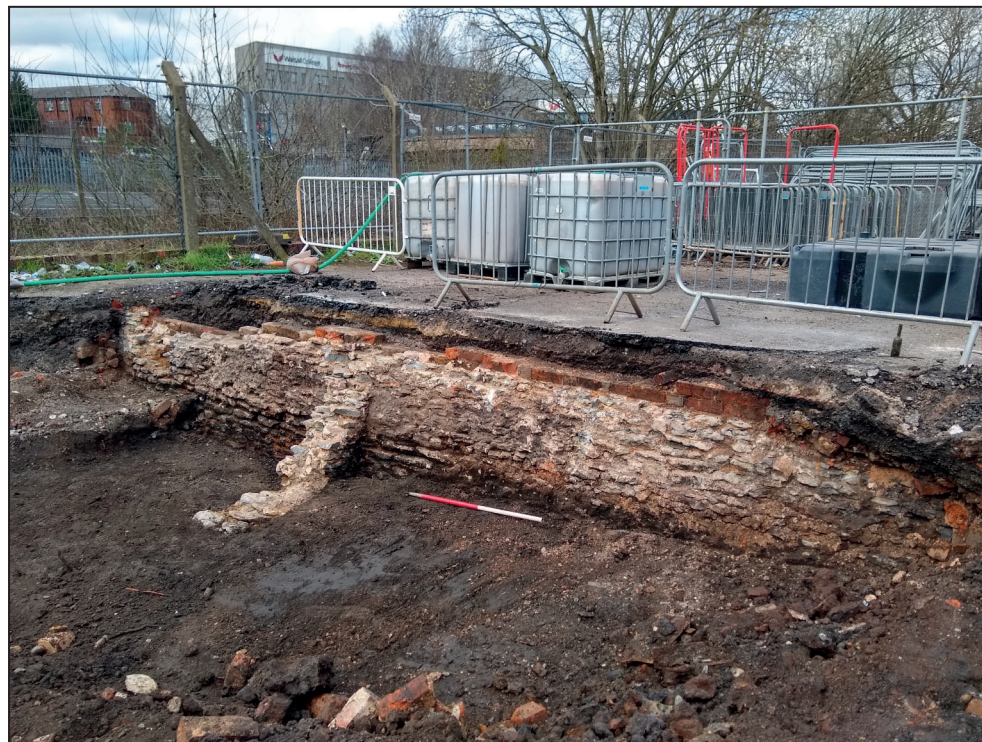
Trench 9, structures, looking north-east (1m scale)

- 5.5. Stone wall 907 was identified at the northern edge of Trench 9. It was aligned east/west and had two north/south aligned buttresses on its southern side. The wall measured at least 7m in length, 0.4m in width and at least 0.75m in height. Brick wall 905 was built directly on top of the remains of wall 907 and remnant brick surface 906 butted the northern side of the later wall. Collectively, these structural remains correlate closely to a 'malthouse/tannery' structure depicted on the First Edition OS map.

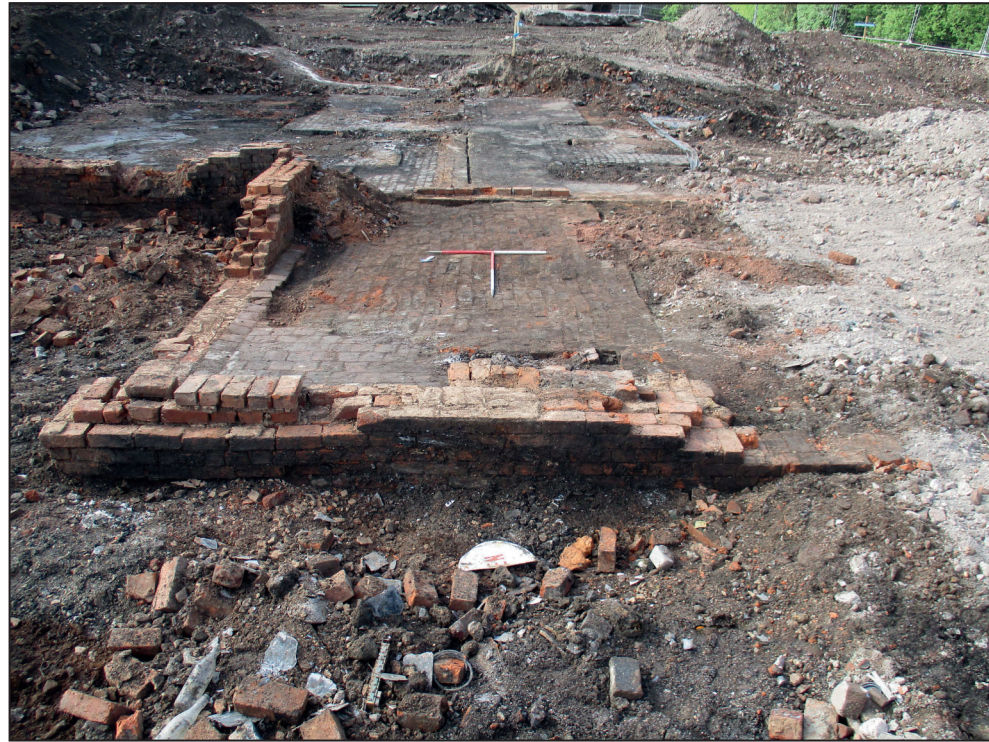
Trench 11, structure 1104, looking south (1m scales)

- 5.7. Brick structure 1104 appears to represent an eastward continuation of wall 905 identified in Trench 9, and two further sides of a room, likely associated with the 'malthouse' structures depicted on the First Edition OS map. Overall, the room measured 5.9m in length, 4.5m in width and individually the walls measured at least 0.9m in height. Within the interior of the room brick and tile floor surface 1105 was identified (Fig. 4).

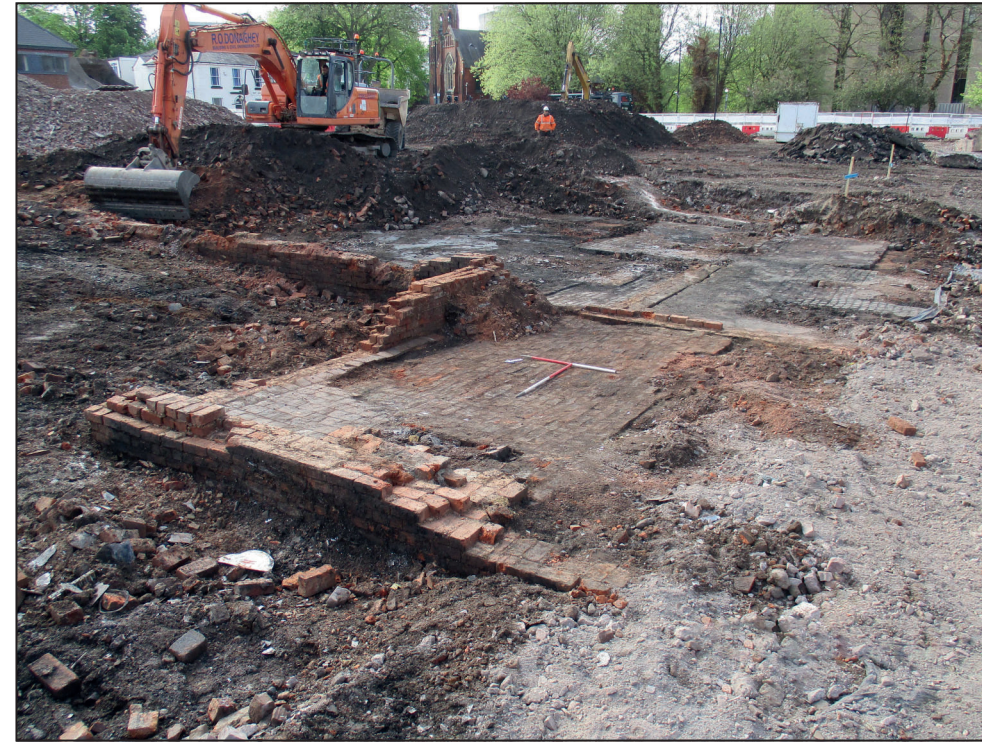
Trench 11, structural remains, looking south-east (1m scales)

- 5.6. Trench 11 comprised of a series of adjoining mechanically excavated interventions covering the majority of the northern part of the site. Within these, the substantial

remains of a number of structures were identified, all of which correlated closely to 'malthouse' and 'tannery' buildings depicted on historic mapping.

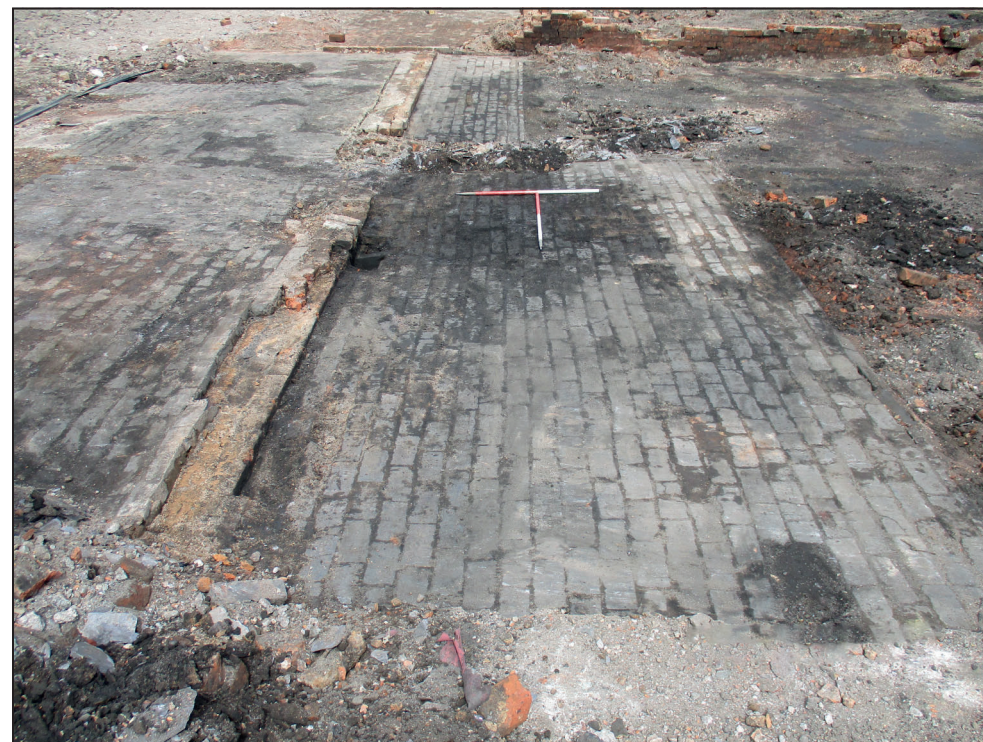
Trench 11, wall 1107 and floors 1108 and 1109, looking north (1m scales)

- 5.8. North/south aligned brick wall 1107 adjoined the southern wall of structure 1104 and appears to form an internal dividing wall within the malthouse building (Fig. 4). Wall 1107 was butted to the east by floor 1108, comprising blue bricks, and to the west by floor 1109, which was made up of blue and red bricks and stone cobbles. These would both appear to represent internal floor surfaces within the malthouse building.
